## ENGINE EXAMINATION REPORT

<b>ENGINE MODEL</b>	TSIO-520-NB
<b>ENGINE SERIAL NUMBER</b>	503140
<b>AIRCRAFT MAKE &amp; MODEL</b>	Cessna 414A
<b>AIRCRAFT SERIAL NUMBER</b>	414A0495
<b>AIRCRAFT REGISTRATION</b>	N789UP
<b>FILE NUMBER</b>	14-488

<b>EXAMINATION</b>		<b>ACCIDENT DATA</b>	
<b>DATE</b>	09/02/2015	<b>NTSB ACCIDENT #</b>	CEN15FA190
<b>FACILITY</b>	Continental Motors	<b>NTSB INVESTIGATOR</b>	Todd Fox
<b>ADDRESS</b> [REDACTED] Mobile, AL 36615		<b>FAA INVESTIGATOR</b>	Stanley Swank II
		<b>ACCIDENT DATE</b>	04/07/2015
		<b>ACCIDENT LOCATION</b>	Bloomington, IL

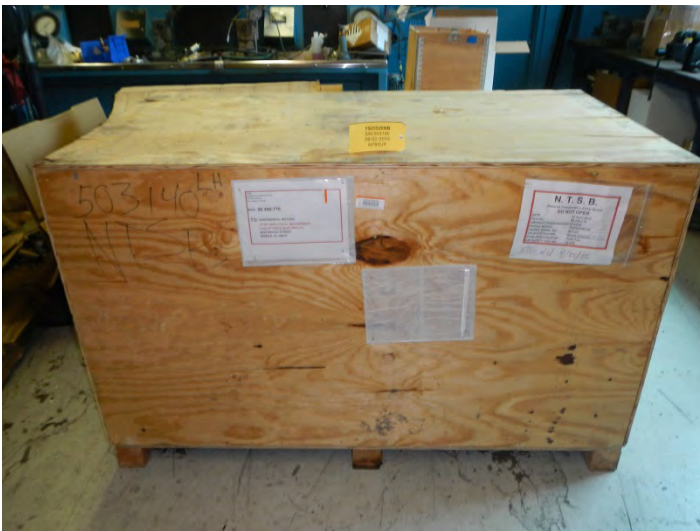
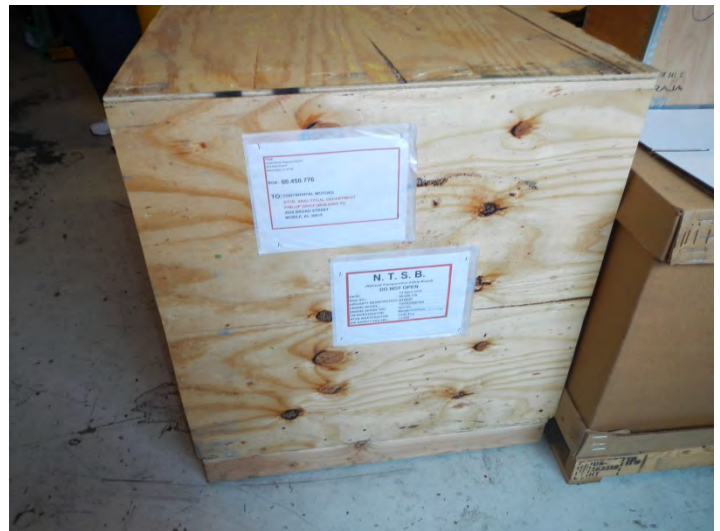
The engine was shipped to Continental Motors in a wooden crate with a number of components, such as the vacuum pump, turbocharger/wastegate, turbo controller, throttle body/fuel metering unit, engine-driven fuel pump and fuel pump coupling, removed from the engine and boxed separately within the crate. The propeller flange was separated from the crankshaft at the crankcase and was included with the boxed components. The portion of crankshaft that remained with the separated propeller flange displayed a bend in one direction with circumferential cracks noted on the tension side of the bend. The fracture surface associated with the tension side of the bend displayed a 45-degree lip. The fracture surface on the compression side of the bend was irregular and jagged in shape.

The bottom side of the engine nacelle was crushed upward around the oil sump and remained with the engine. The intercooler remained attached to the engine/nacelle and was displaced upward into the backside of the engine. The oil sump was crushed from the bottom side up as were the exhaust manifolds and front side exhaust risers. The exhaust manifolds on both sides were flattened. The intake manifolds also sustained impact, puncture, and deformation damage on the bottom sides. The induction balance tube was flattened.

The backside of the engine and its related components sustained thermal damage.

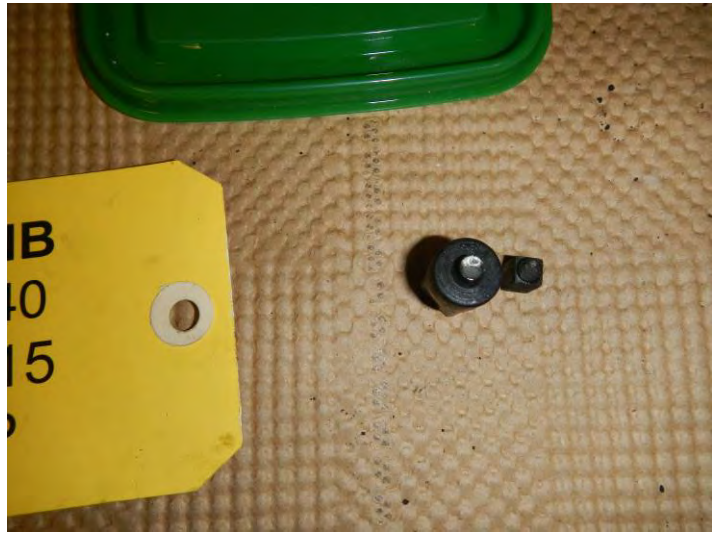
According to the NTSB IIC, the engine-driven fuel pump was partially separated from the backside of the engine at the accident site. The NTSB IIC rotated the crankshaft prior to the complete removal of the engine-driven fuel pump. The drive coupling was found fractured. Close examination of the drive coupling revealed that the fracture surface was irregular in shape with bending observed adjacent to the fracture surfaces. There was no soot noted on the fracture surface. Examination of the fracture surface by a Continental Motors metallurgist revealed that the fracture was a result of overload.

The engine-driven fuel pump's aneroid housing was thermally damaged, exposing the thermally damaged aneroid. Re-solidified molten metal was adhering to the safety wire. The pump was exposed the thermal stresses significant enough to char the diaphragm and compromise the insulator. Disassembly of the fuel pump revealed that the pump vanes were intact and no pre-accident anomalies were noted with the internal components.

The throttle body/fuel metering unit was thermally damaged and the mixture and throttle levers were bent. The throttle housing was partially melted away and the valve was loose and detached from the housing remnants. The fuel metering unit was removed from the throttle body and the fuel inlet screen was removed. Some debris consistent with soot and dirt was observed in the inlet area; however, the screen was clear and free from any obstructions. The throttle and mixture cams were removed and charred debris was observed in the metering unit body, but the metering plug holes were not obstructed. Besides the thermal damage and debris, no pre-accident anomalies were noted with the observed components.

The fuel injection nozzles were removed from the cylinders. The #1, #3, and #5 nozzles contained dirt and debris that was blown out with compressed air. There were no signs of obstructions. The nozzles were reattached to their respective lines and the fuel manifold valve and nozzles were taken to the production test stand for a flow test. The unit did not meet the production test standards as it flowed slightly lower than new standards throughout all test ranges; however, it did function properly

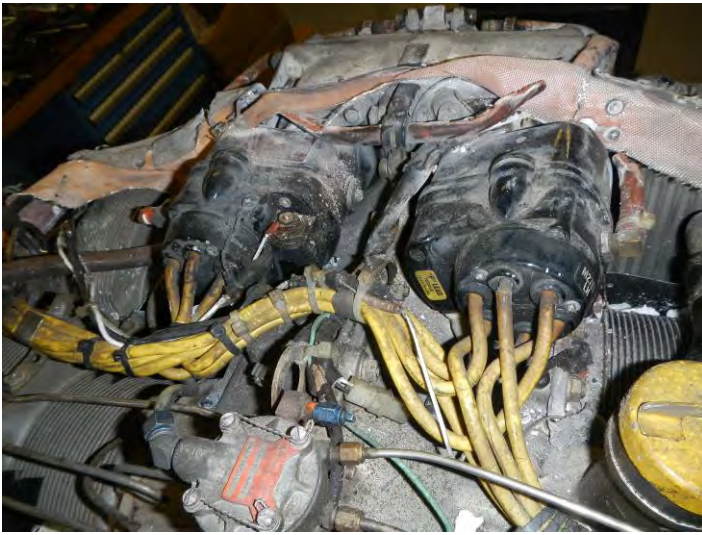
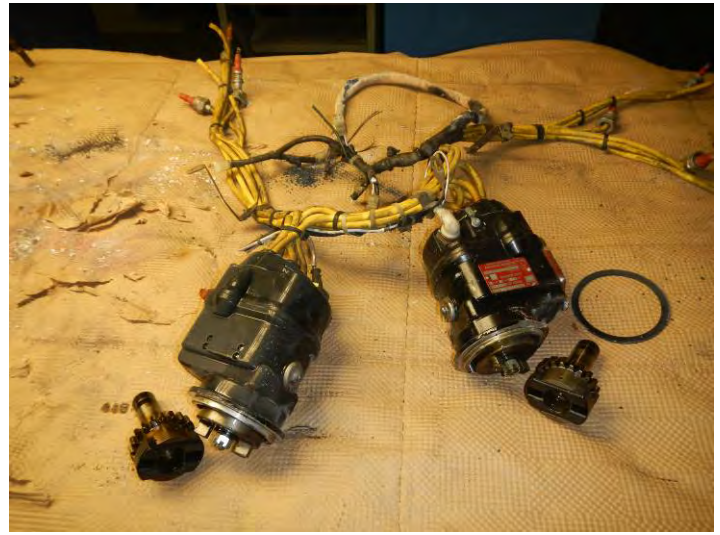
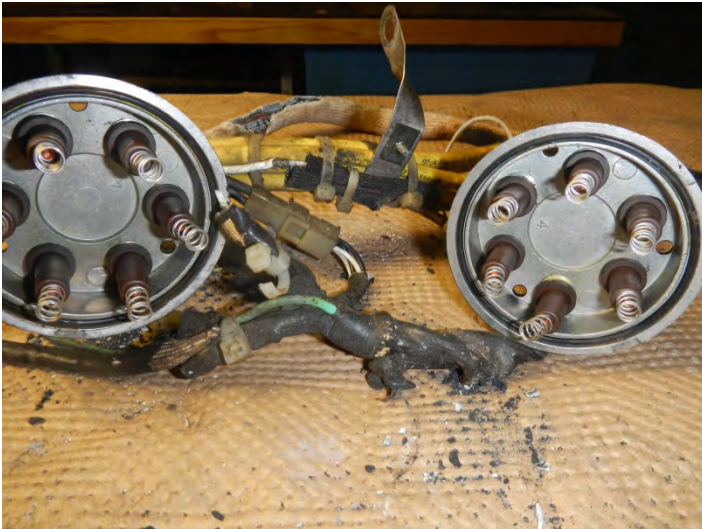
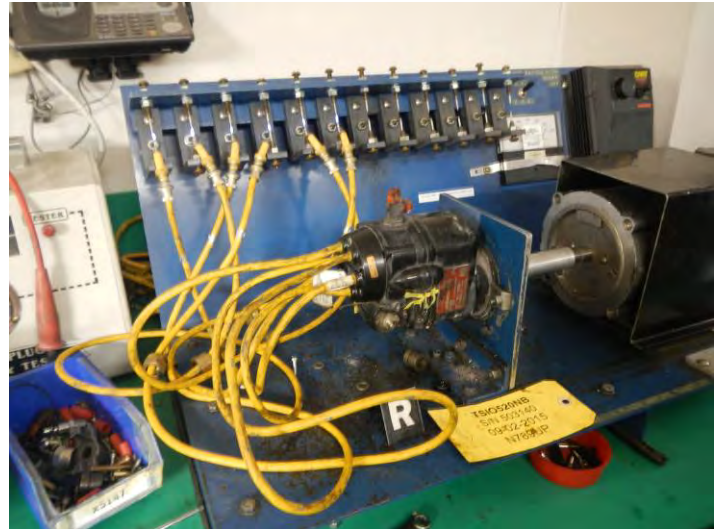
The magnetos remained in place and secured to the mount flanges. The ignition harness sustained damage in the accident that separated a few leads. The terminal ends remained attached to their respective sparkplugs and the sparkplugs remained secured to their cylinders. The ignition harnesses were removed and the magnetos were placed on a test bench with replacement ignition harnesses. Both magnetos produced a blue spark across a 7mm gap during all RPM ranges. No pre-accident anomalies were noted with either magneto.

The top sparkplugs were removed during the on-scene portion of the investigation. All of the sparkplugs were removed and they all displayed little-to-no wear. They were all covered with normal combustion deposits. The #1 and #5 bottom sparkplugs were oil coated and the #1, #3, and #5 sparkplugs bottom sparkplugs were covered with debris; however, there was no sign of fouling.

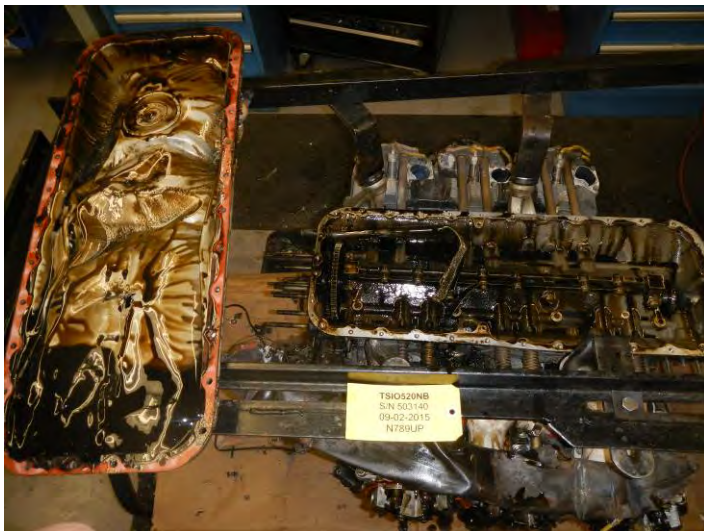
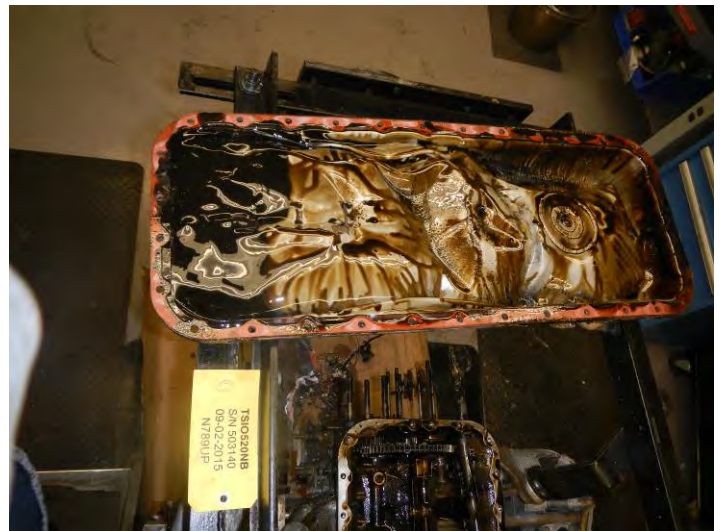
The oil sump was crushed from the bottom side up and was punctured. Removal of the oil sump revealed residual oil. The oil pickup screen and tube were displaced upward. The screen was not obstructed and there were no signs of blockage. The oil pump was removed and the gears and drive shaft were intact. The oil filter was thermally damaged. It was cut open and the filter element and canister did not display any signs of significant contamination or blockage. All of the engine components appeared to be well lubricated and there was no sign of lubrication distress.

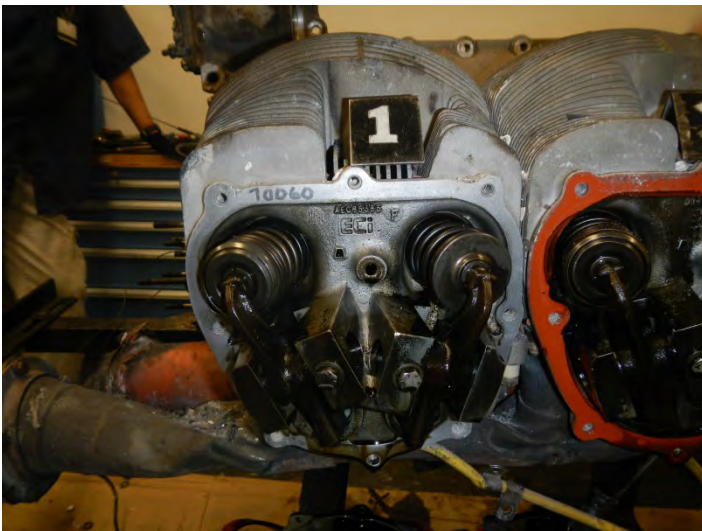
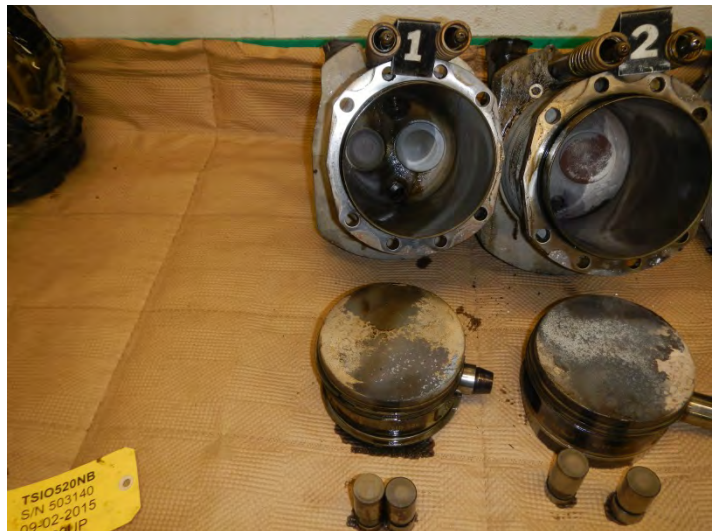
No pre-accident anomalies were noted with any of the cylinders or their associated components.

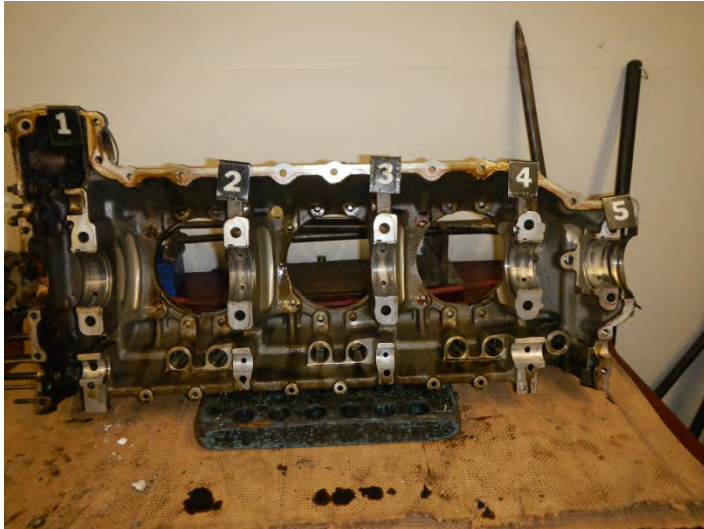
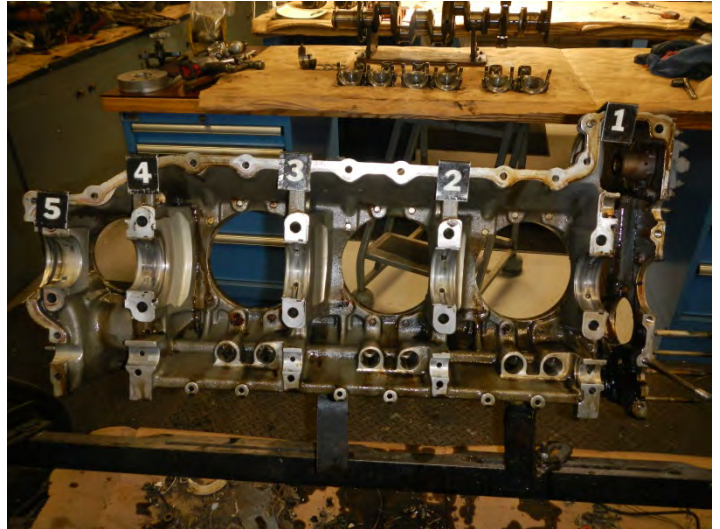
The crankcase halves remained secured to each other and no pre-accident anomalies were noted with either crankcase half. Disassembly of the crankcase revealed that the main bearings were in place and there was no sign of bearing movement. The bearing saddles and saddle mating surfaces did not reveal any sign of fretting or gouging.

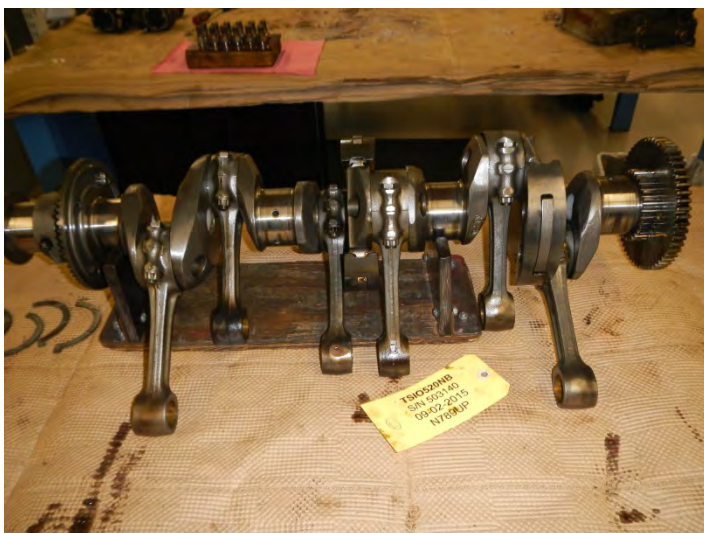
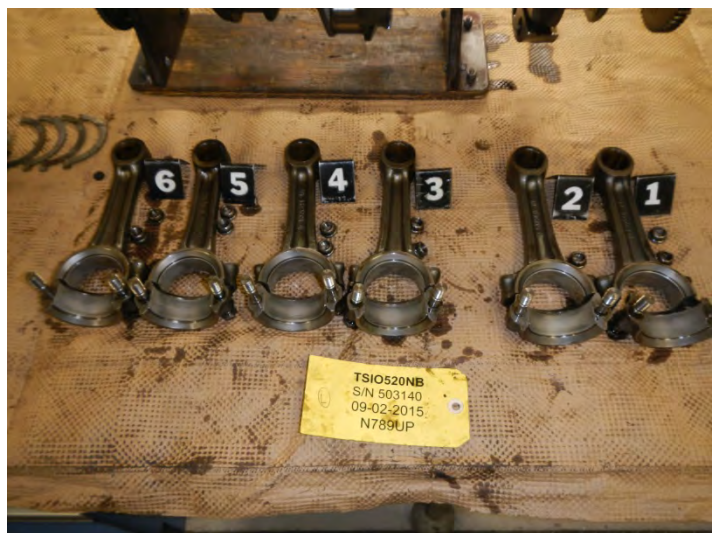
The crankshaft was intact with the exception of the fracture noted aft of the propeller flange. There were no pre-accident anomalies noted on any of the crankshaft main journals, connecting rod journals, crankshaft gear, or counterweights.

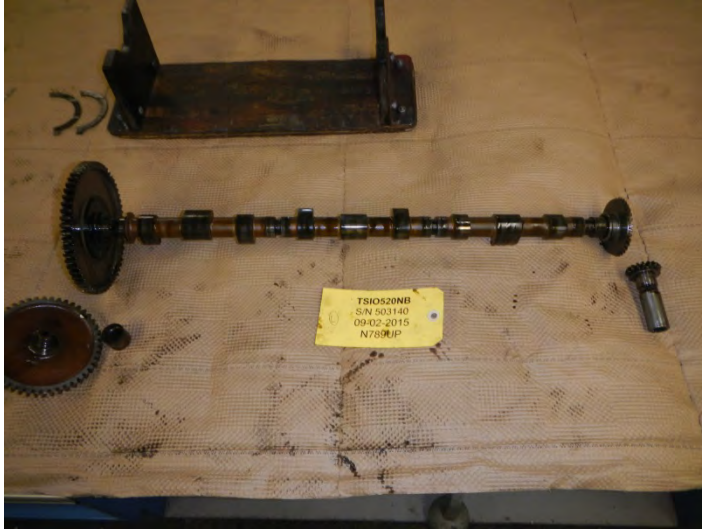
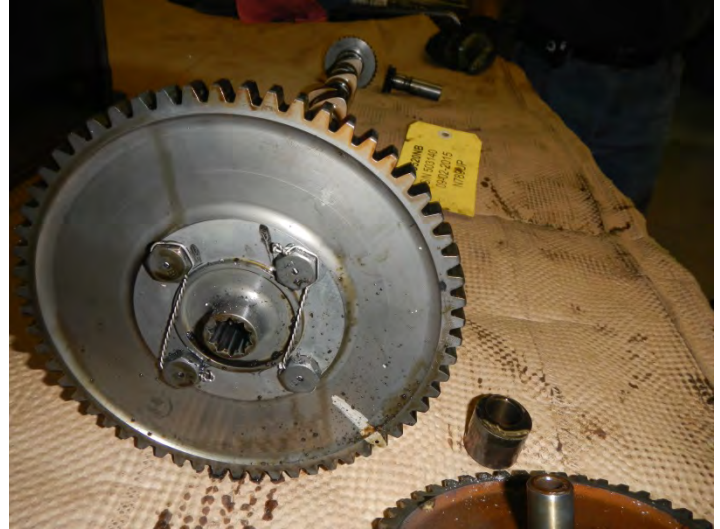
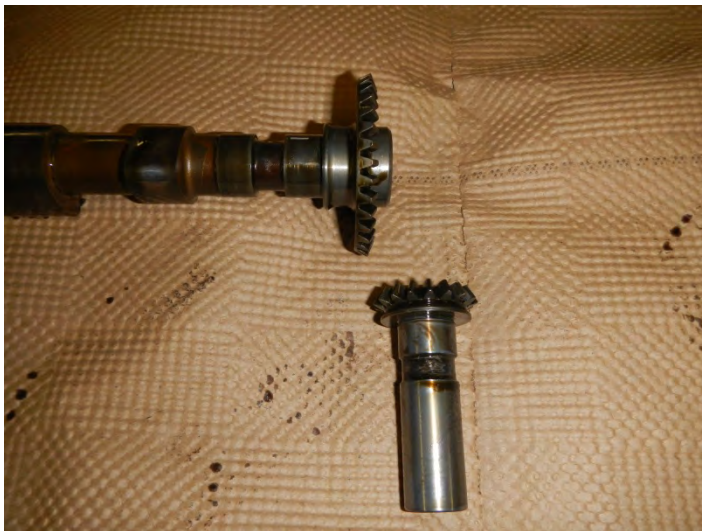
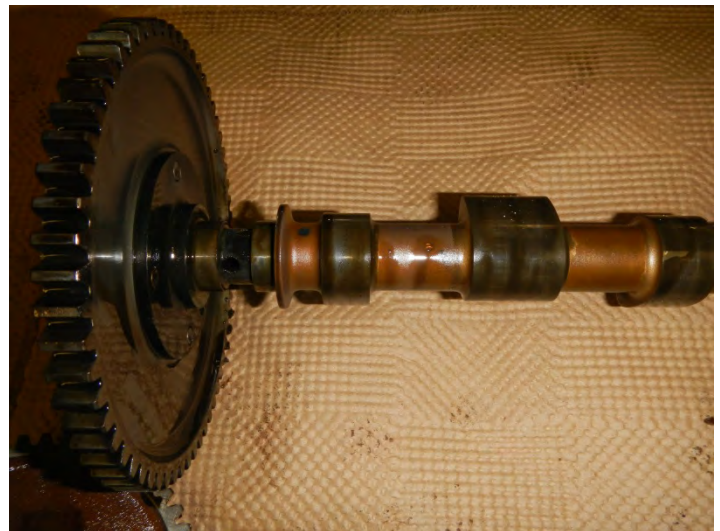
No anomalies were noted with the hydraulic lifters. The camshaft lobes did not display any anomalies or signs of excessive wear. The camshaft gear did not display any pre-accident anomalies.

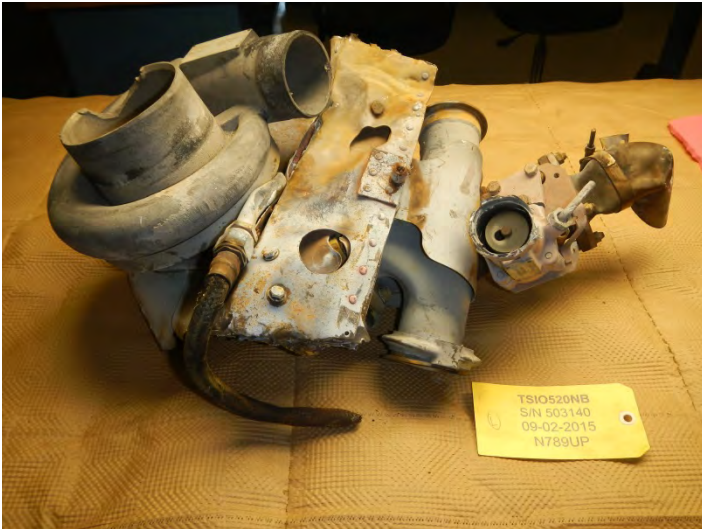
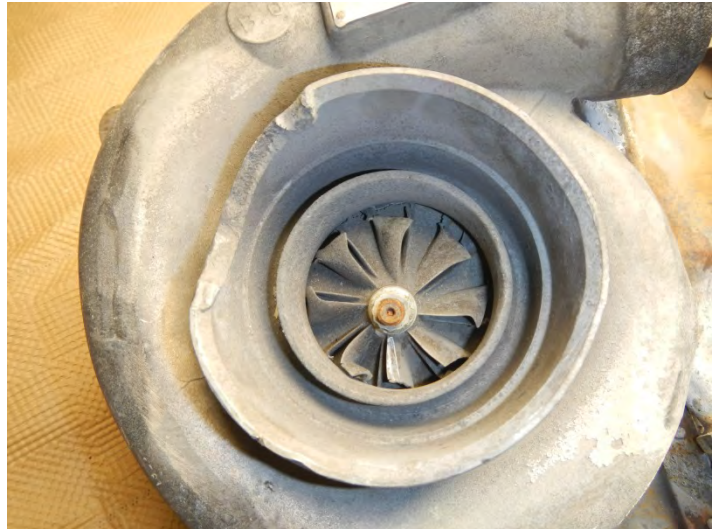
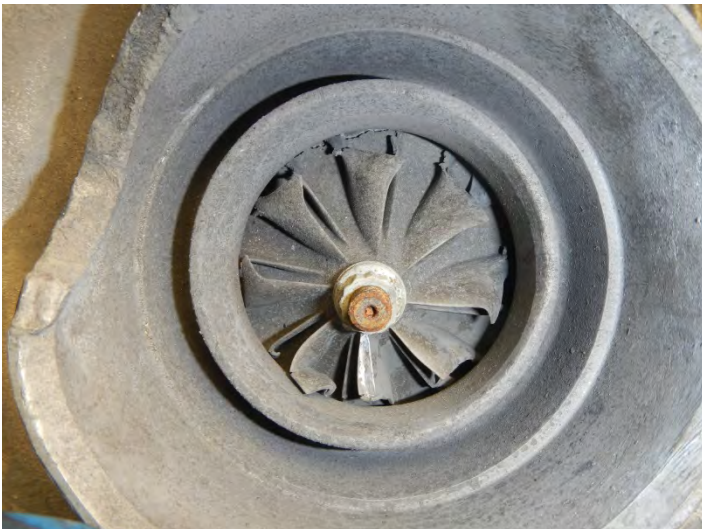
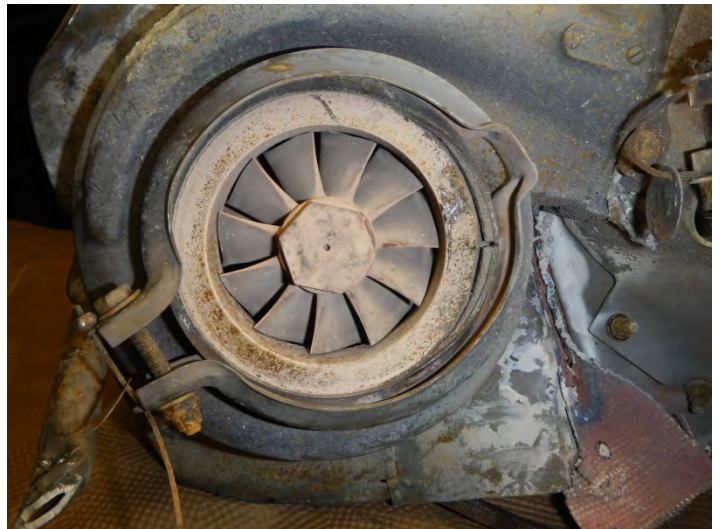
The turbocharger components were visually examined and readied for transport to the Hartzell facility. The overboost valve was not observed and is presumed destroyed. No external pre-accident anomalies were noted with any of the components.

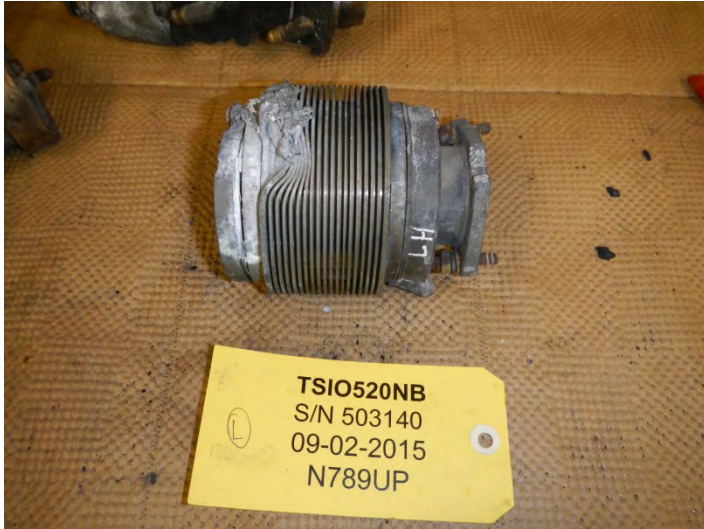
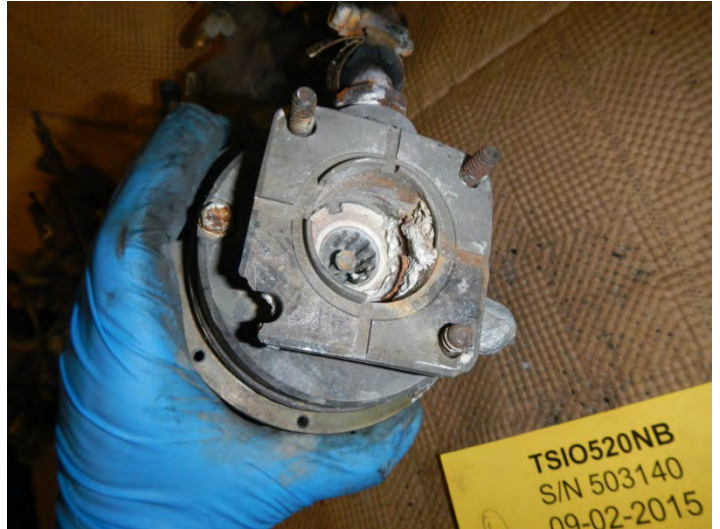
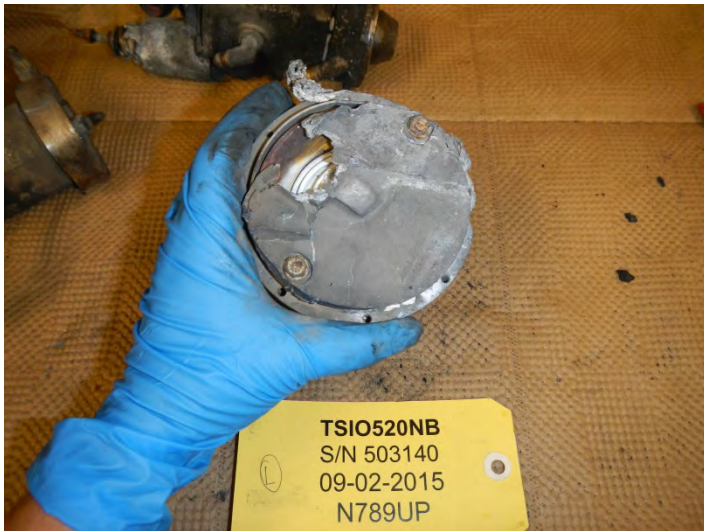
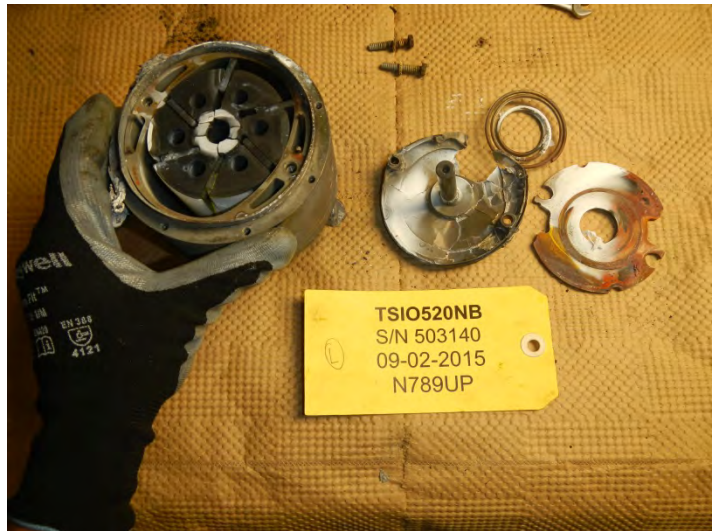
The vacuum pump was removed from the engine prior to the examination and it sustained impact and thermal damage that exposed some of the internal components. Removal of the cap revealed that all of the vanes were intact, but the rotor was fractured.

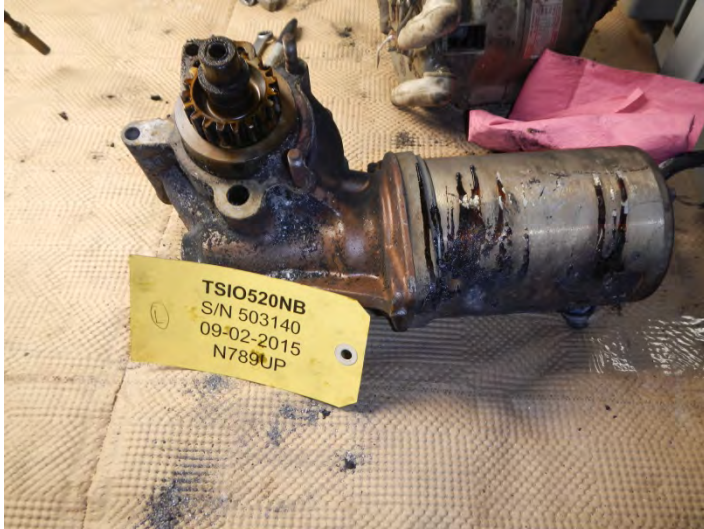
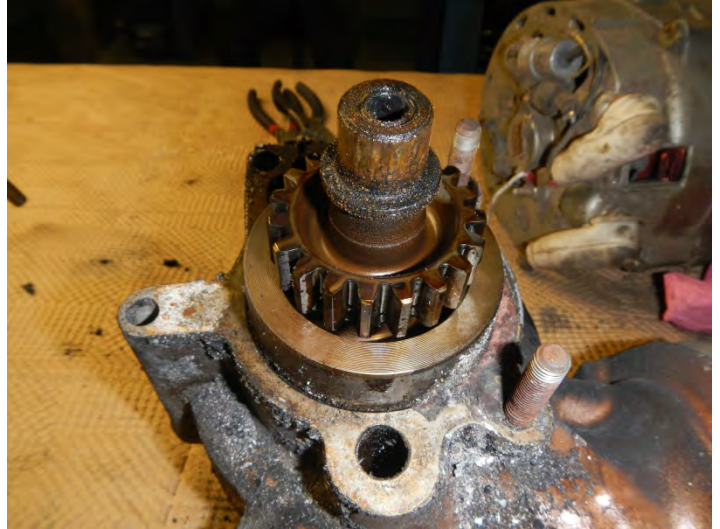
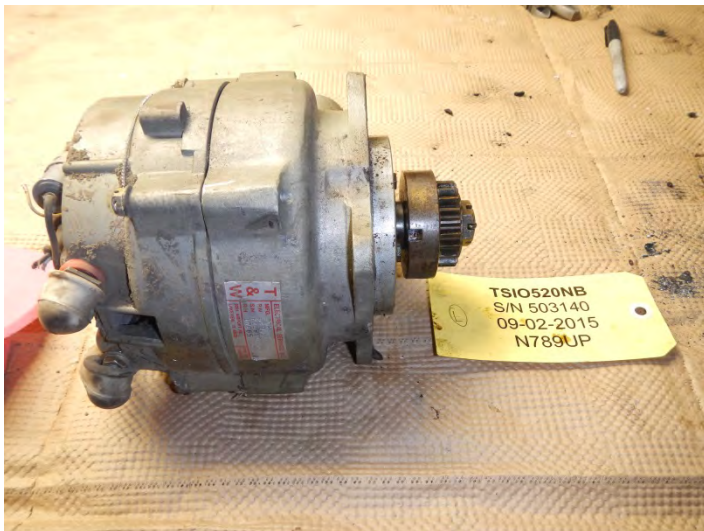
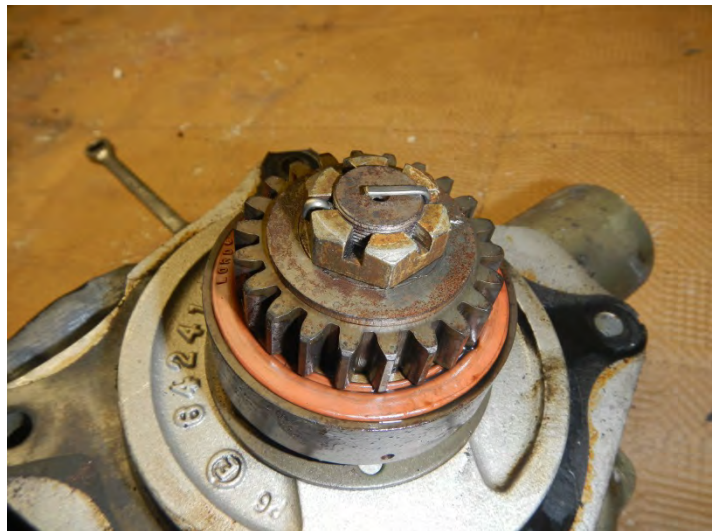
No pre-accident anomalies were noted with the alternator, starter motor and starter adapter, or the propeller governor.
