## ENGINE EXAMINATION REPORT

<b>ENGINE MODEL</b>	TSIO-520-NB
<b>ENGINE SERIAL NUMBER</b>	519303
<b>AIRCRAFT MAKE &amp; MODEL</b>	Cessna 414A
<b>AIRCRAFT SERIAL NUMBER</b>	414A0495
<b>AIRCRAFT REGISTRATION</b>	N789UP
<b>FILE NUMBER</b>	14-488

<b>EXAMINATION</b>		<b>ACCIDENT DATA</b>	
<b>DATE</b>	09/01/2015	<b>NTSB ACCIDENT #</b>	CEN15FA190
<b>FACILITY</b>	Continental Motors	<b>NTSB INVESTIGATOR</b>	Todd Fox
<b>ADDRESS</b>	[REDACTED] Mobile, AL 36615	<b>FAA INVESTIGATOR</b>	Stanley Swank II
		<b>ACCIDENT DATE</b>	04/07/2015
		<b>ACCIDENT LOCATION</b>	Bloomington, IL

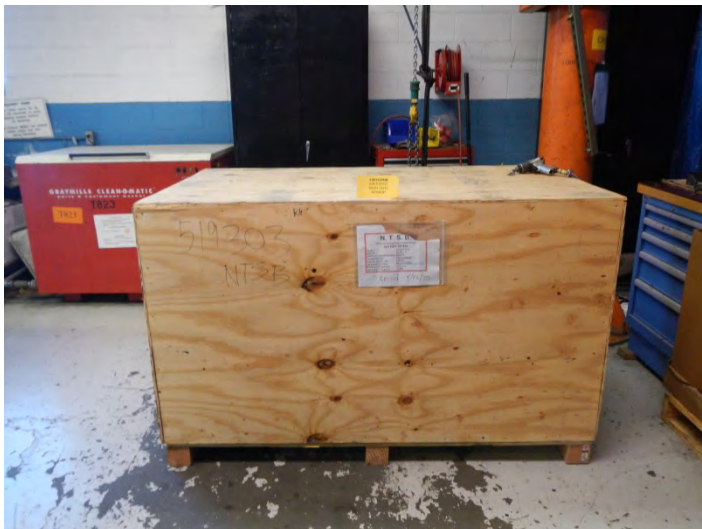
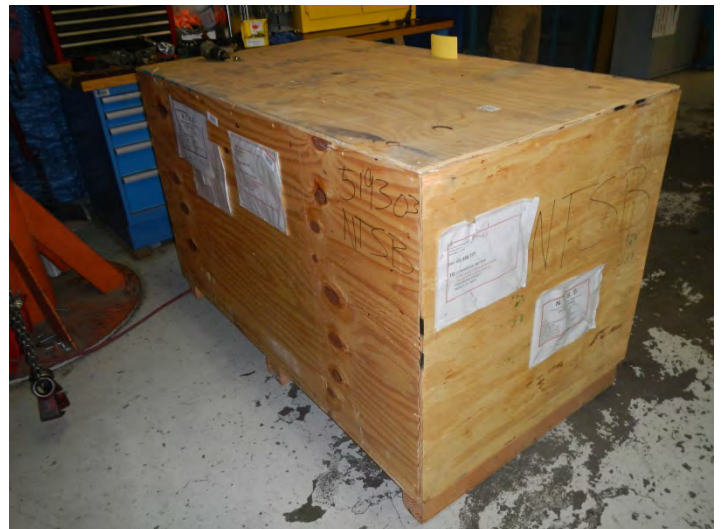
The engine was shipped to Continental Motors in a wooden crate with a number of components, such as the turbocharger/wastegate, turbo controller, throttle body/fuel metering unit, engine-driven fuel pump and fuel pump coupling, removed from the engine and boxed separately within the crate. The propeller flange was separated from the crankshaft at the crankcase and was included with the boxed components. The portion of crankshaft that remained with the separated propeller flange displayed a bend in one direction with circumferential cracks noted on the tension side of the bend. The fracture surface associated with the tension side of the bend displayed a 45-degree lip. The fracture surface on the compression side of the bend was irregular and jagged in shape.

The left magneto was separated from its mounting pad and it was lying on the top of the engine still connected to the ignition leads. Its mounting flange was fractured and portions of the flange remained secured under the attaching hardware. The right magneto remained secured to its mounting flange. The ignition harnesses remained attached to their respective magnetos. The top sparkplugs were removed from the engine during the on-scene portion of the investigation.

The bottom side of the engine nacelle was crushed upward around the oil sump and remained with the engine. The intercooler remained attached to the engine/nacelle and was displaced upward into the backside of the engine. The oil sump was crushed from the bottom side up as were the exhaust manifolds and front side exhaust risers. The exhaust manifolds on both sides were flattened. The intake manifolds also sustained impact, puncture, and deformation damage on the bottom sides. The induction balance tube was flattened. The #2 and #4 pushrod shrouds were deformed upward.

The backside of the engine and its related components sustained thermal damage.

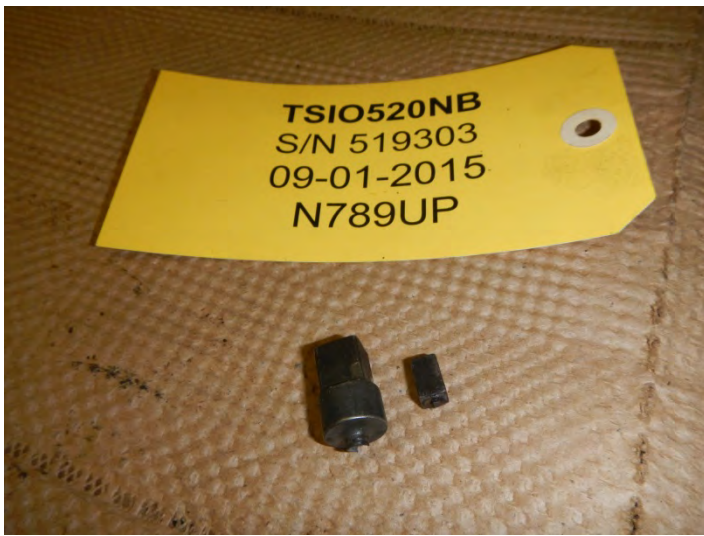
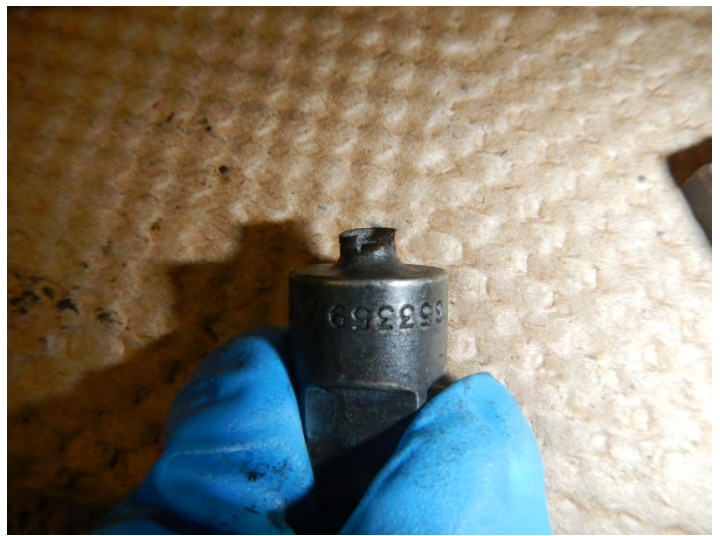
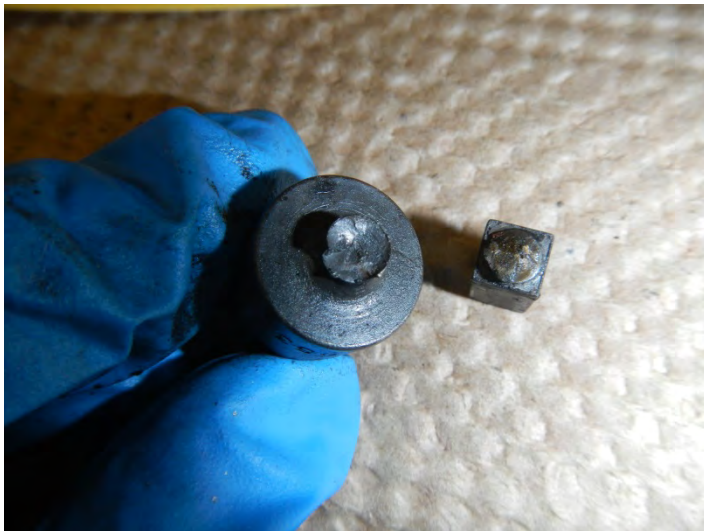
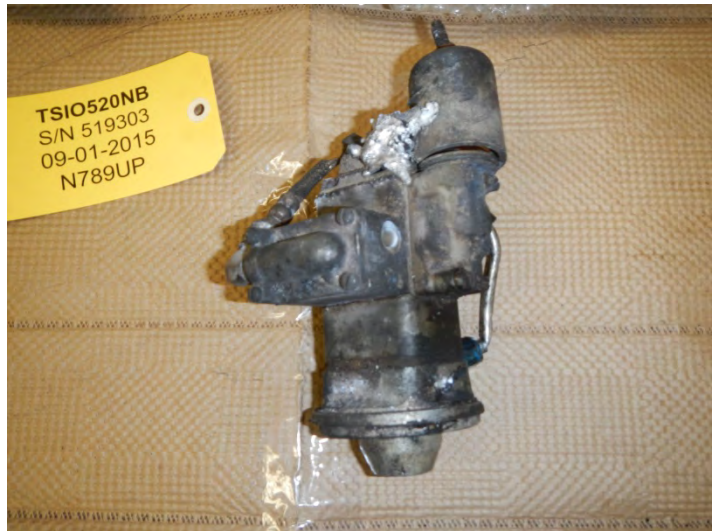
The throttle body/fuel metering unit was thermally damaged and the mixture and throttle levers were bent. The throttle valve was near idle position. The inlet and return fittings were fractured. The fuel metering unit was removed from the throttle body and the fuel inlet screen was removed. Some debris consistent with soot and dirt was observed in the inlet area; however, the screen was clear and free from any obstructions. The metering unit sustained deformation damage that prevented the mixture shaft/cam from being removed. Besides the thermal damage and debris, no pre-accident anomalies were noted with the observed components.

The fuel injection nozzles were removed from the cylinders and none were obstructed. The nozzles were reattached to their respective lines and the fuel manifold valve and nozzles were taken to the production test stand for a flow test. The unit did not meet the production test standards as it flowed slightly lower than new standards throughout all test ranges; however, it did function properly throughout the test.

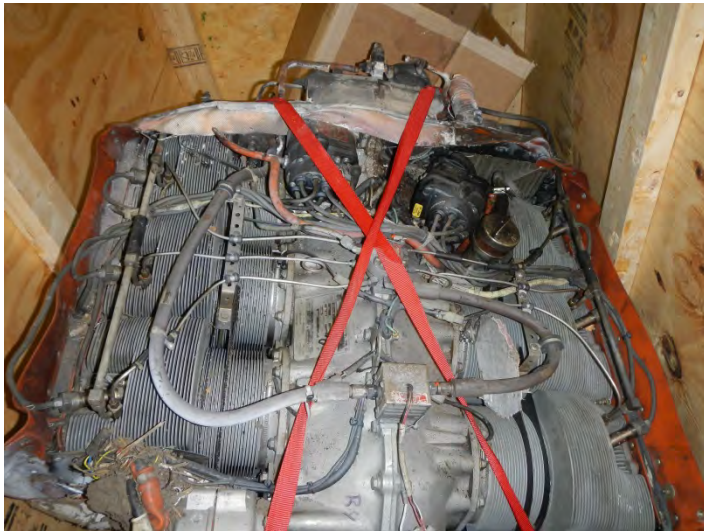
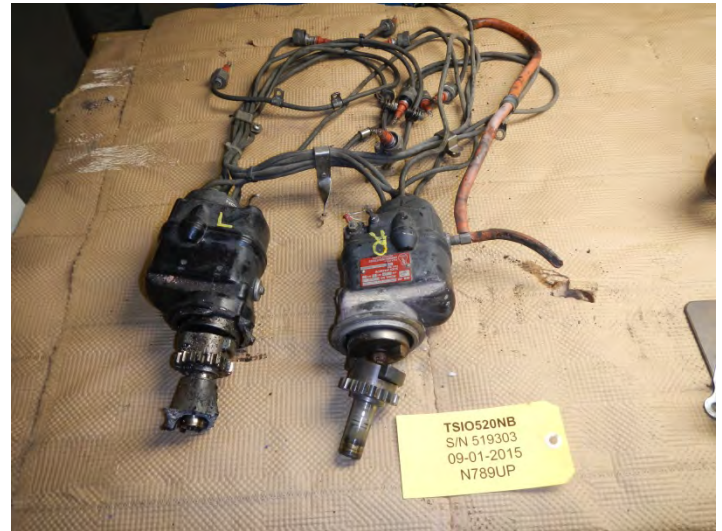
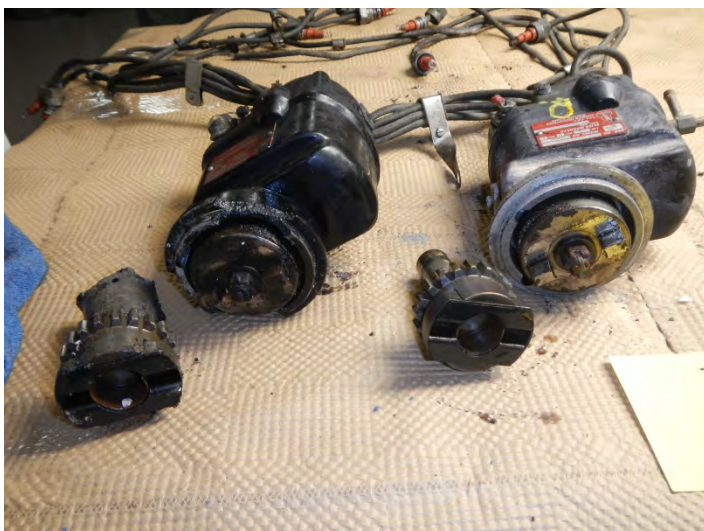
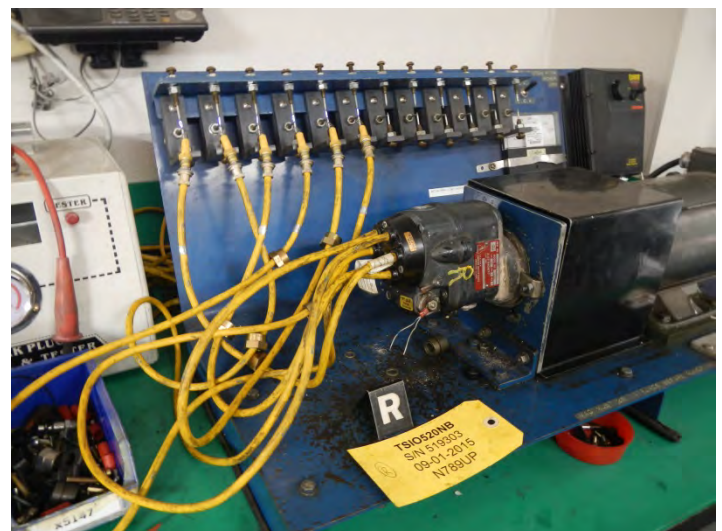
The left magneto was separated from its mounting pad but remained attached to its ignition leads. The magneto's mounting flange was fractured and deformed and was the drive gear boss. The right magneto remained in place and secured to the mount flange. The ignition harness sustained damage in the accident that separated a few leads. The terminal ends remained attached to their respective sparkplugs and the sparkplugs remained secured to their cylinders. The ignition harnesses were removed and the magnetos were placed on a test bench with replacement ignition harnesses. The right magneto produced a blue spark across a 7mm gap during all RPM ranges. The left magneto drive shaft would not rotate. Disassembly of the left magneto revealed that the drive gear shaft was displaced within the housing. No pre-accident anomalies were noted with either magneto.

The top sparkplugs were removed during the on-scene portion of the investigation. All of the sparkplugs were removed and they all displayed little-to-no wear. They were all covered with normal combustion deposits, and the #2 and #4 bottom sparkplugs displayed solidified material on the electrodes and insulator, but there was no sign of fouling.

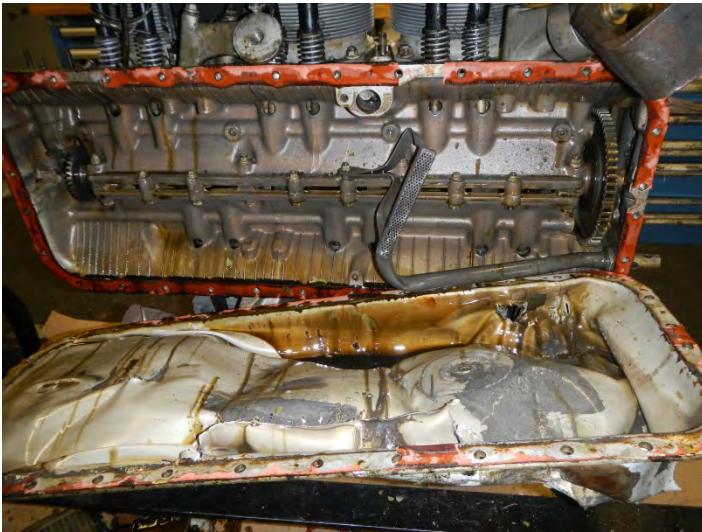
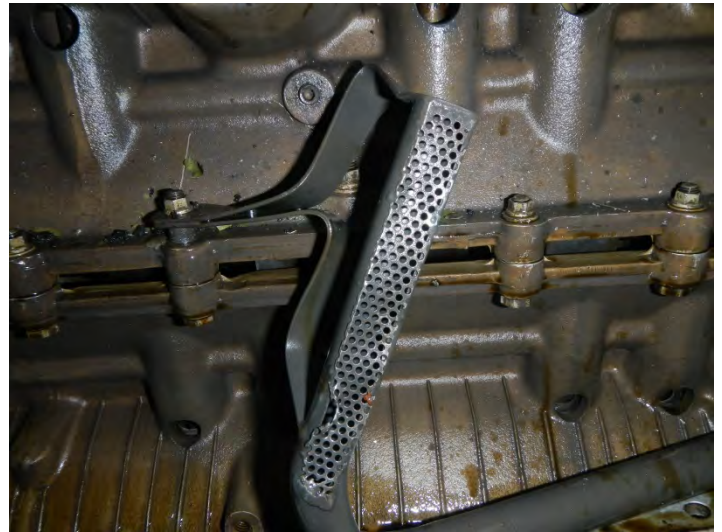
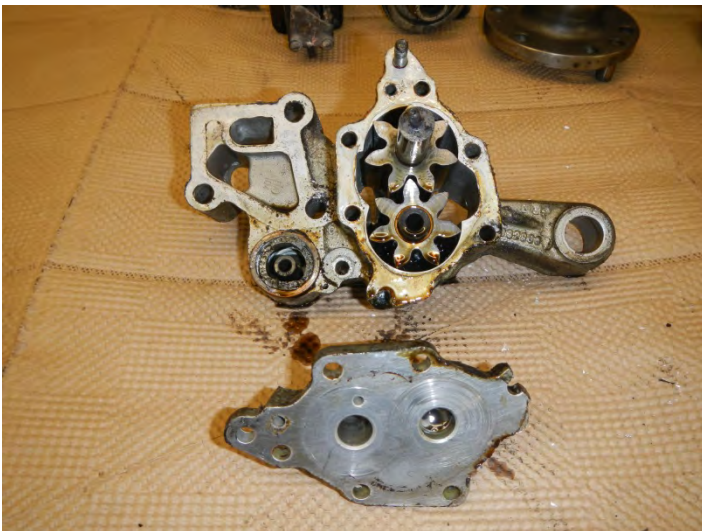
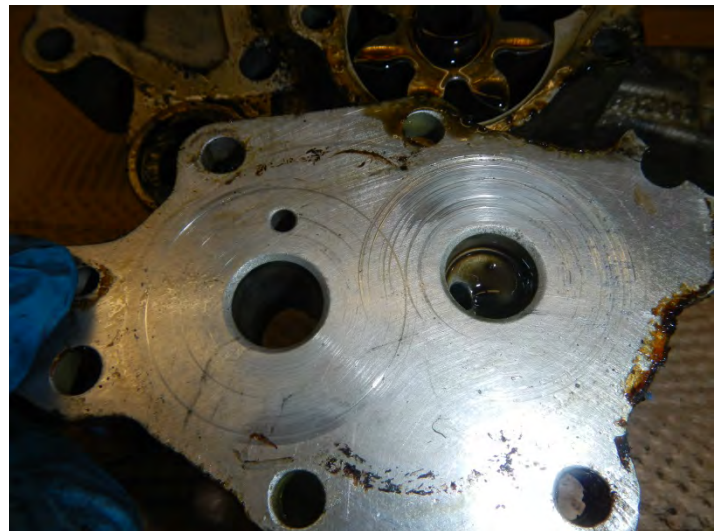
The oil sump was crushed from the bottom side up and was punctured. Removal of the oil sump revealed sludge and residual oil. The oil pickup screen and tube were displaced upward. The screen was not obstructed and there were no signs of blockage. The oil pump was removed and the gears and drive shaft were intact. The oil pump walls displayed circumferential scoring consistent with hard particle passage. The oil filter was cut open and metallic debris was noted within the filter element. All of the engine components appeared to be well lubricated and there was no sign of lubrication distress.

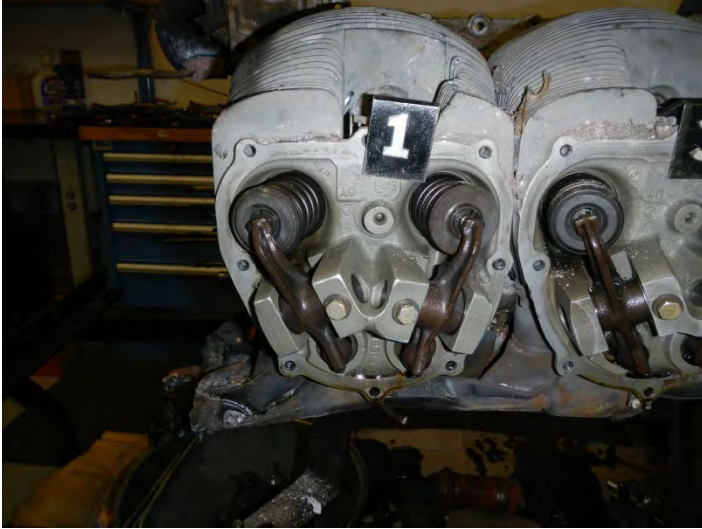
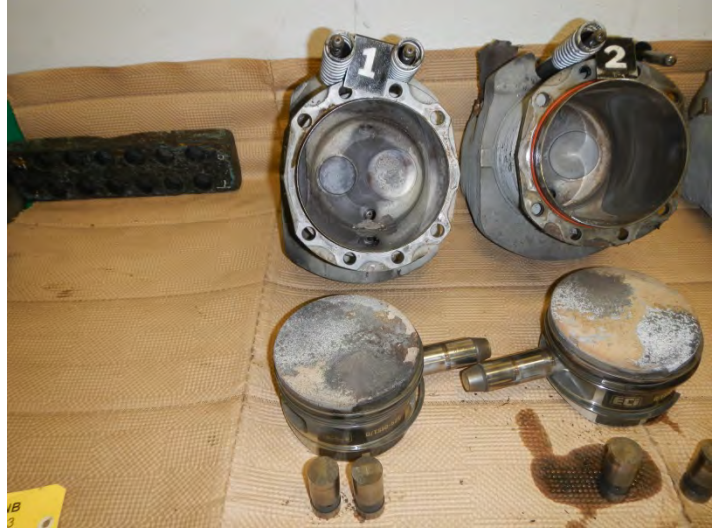
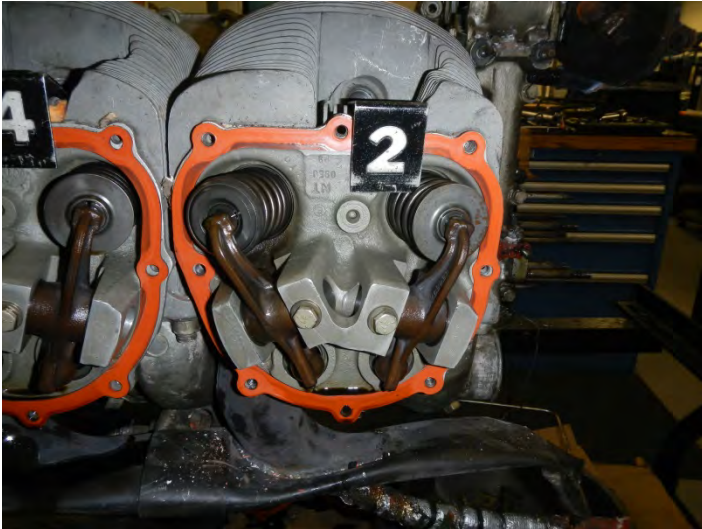
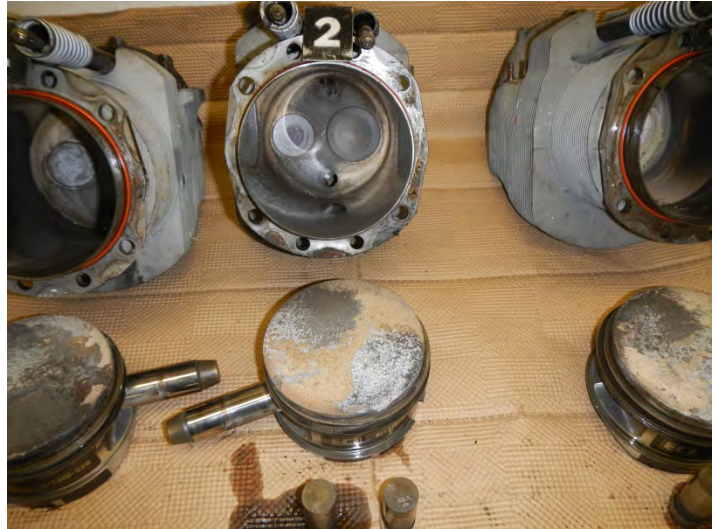
No pre-accident anomalies were noted with any of the cylinders or their associated components.

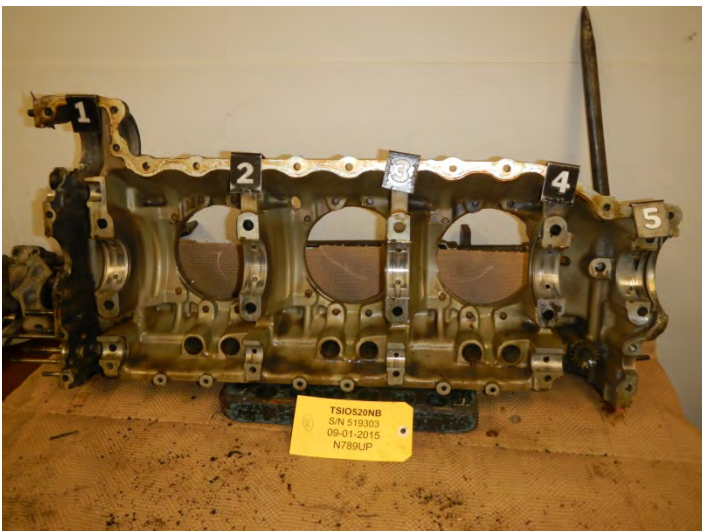
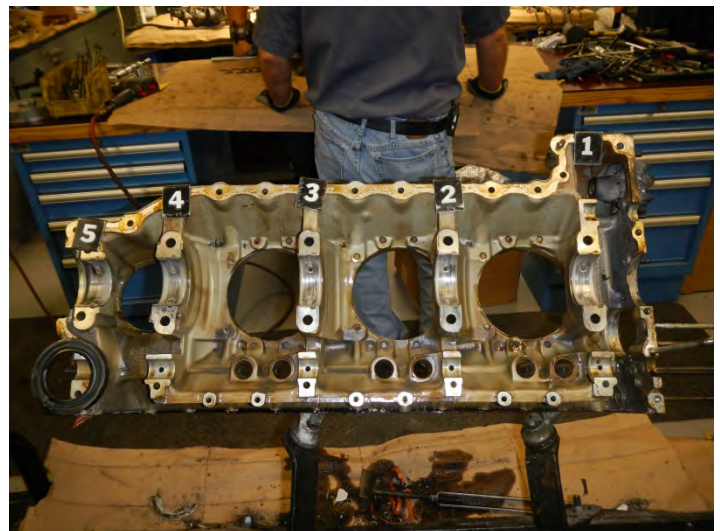
The crankcase halves remained secured to each other and no pre-accident anomalies were noted with either crankcase half. Disassembly of the crankcase revealed that the main bearings were in place and there was no sign of bearing movement. The bearing saddles and saddle mating surfaces did not reveal any sign of fretting or gouging.

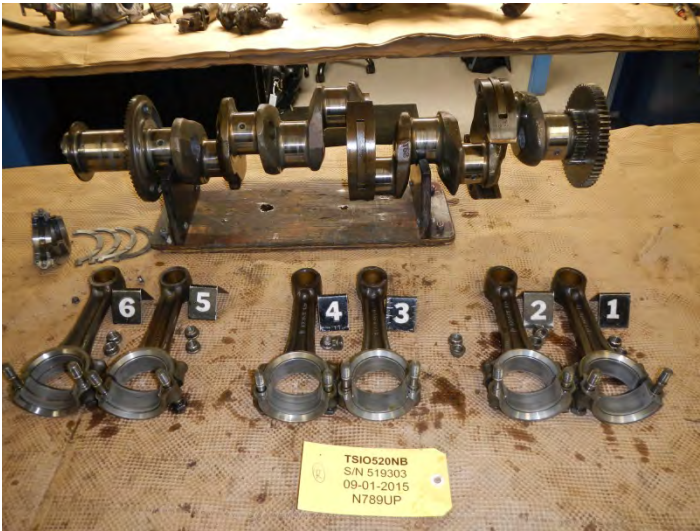
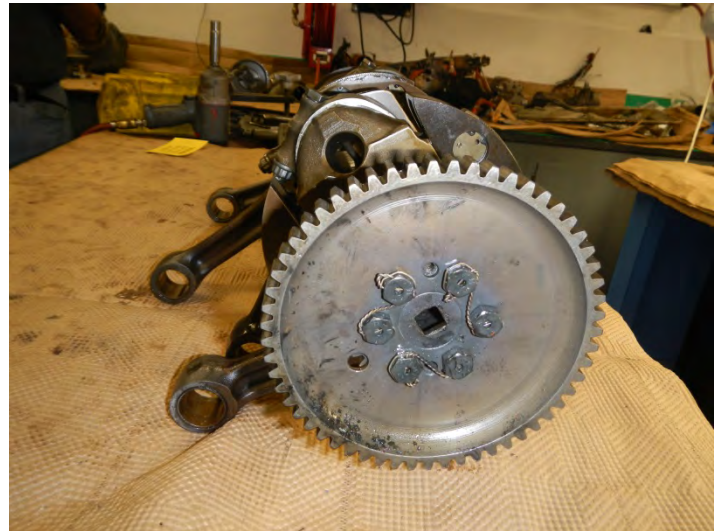
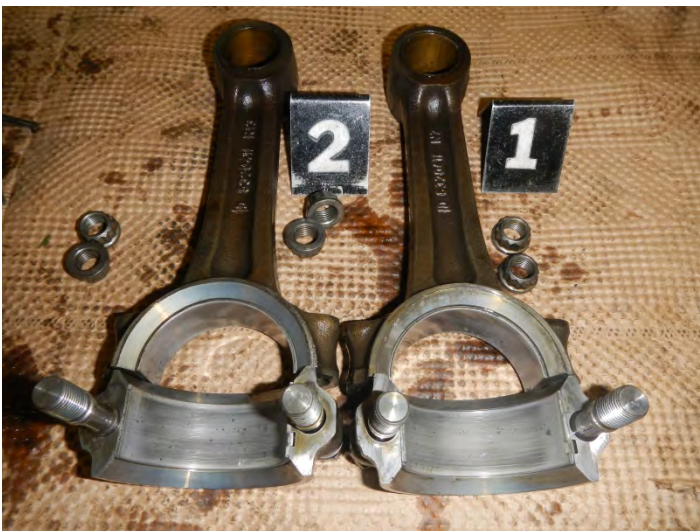
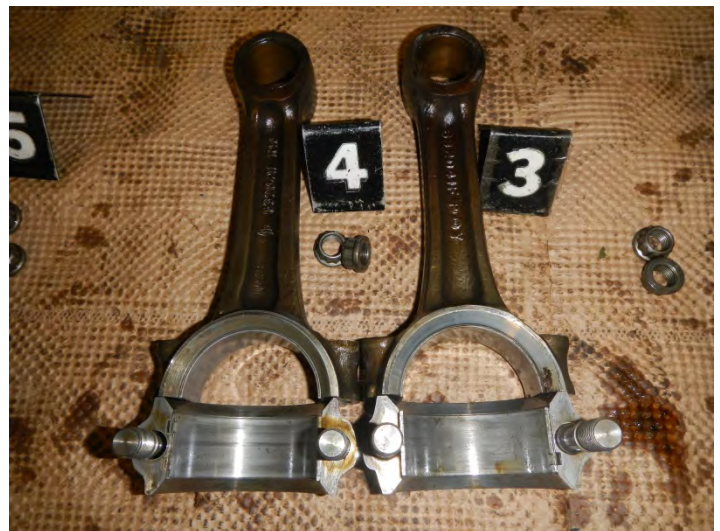
The crankshaft was intact with the exception of the fracture noted aft of the propeller flange. There were no pre-accident anomalies noted on any of the crankshaft main journals, connecting rod journals, crankshaft gear, or counterweights.

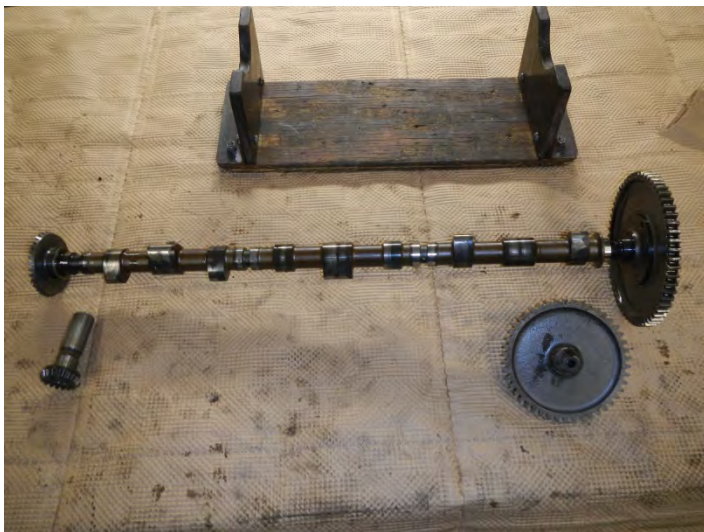
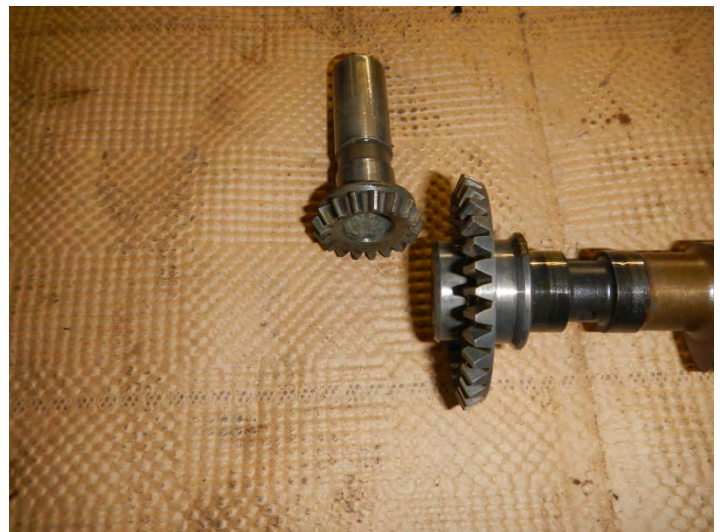
Some of the lifters displayed spalling damage. The camshaft lobes did not display any anomalies or signs of excessive wear. The camshaft gear did not display any pre-accident anomalies.

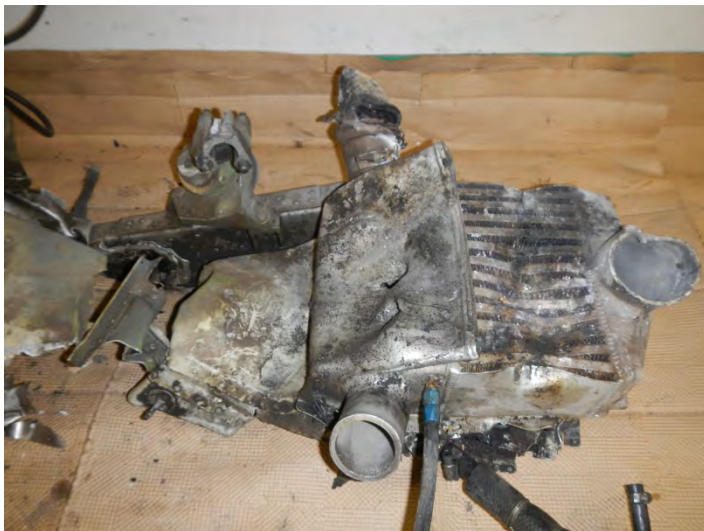
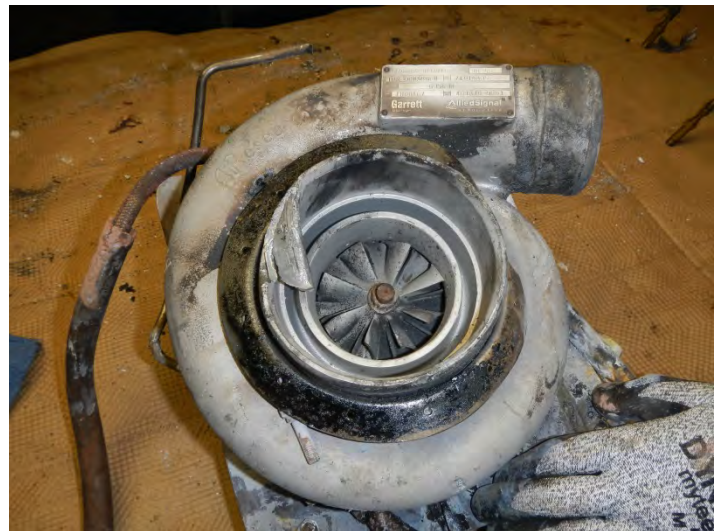
The turbocharger components were visually examined and readied for transport to the Hartzell facility. The overboost valve was not observed and is presumed destroyed. No external pre-accident anomalies were noted with any of the components.

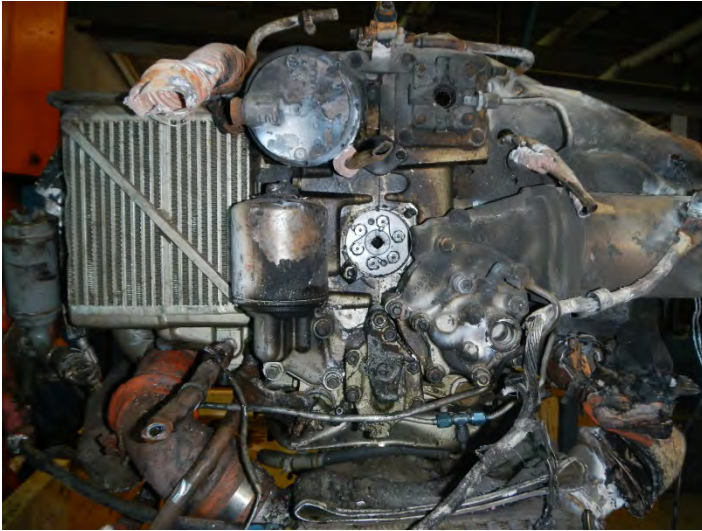
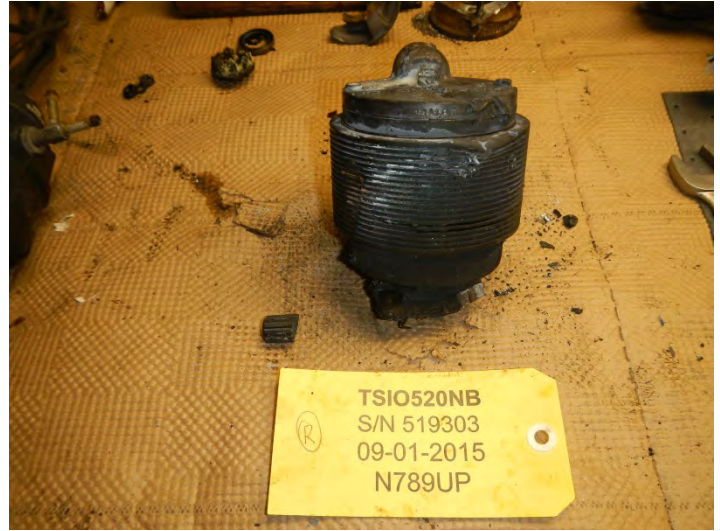
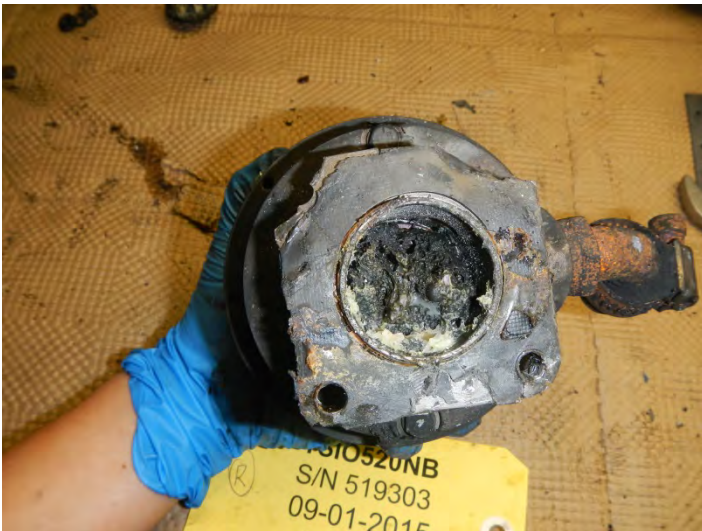
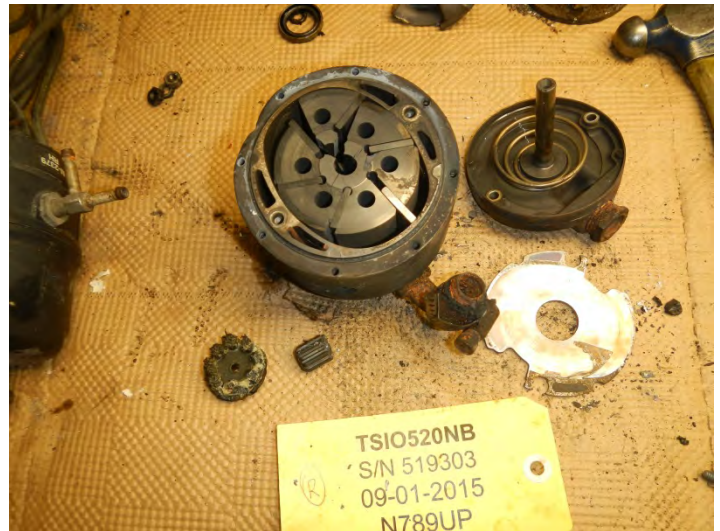
The vacuum pump was displaced on its mounting pad and the housing sustained deformation and thermal damage. Disassembly of the vacuum pump revealed that all of the vanes were intact, but the rotor was fractured.

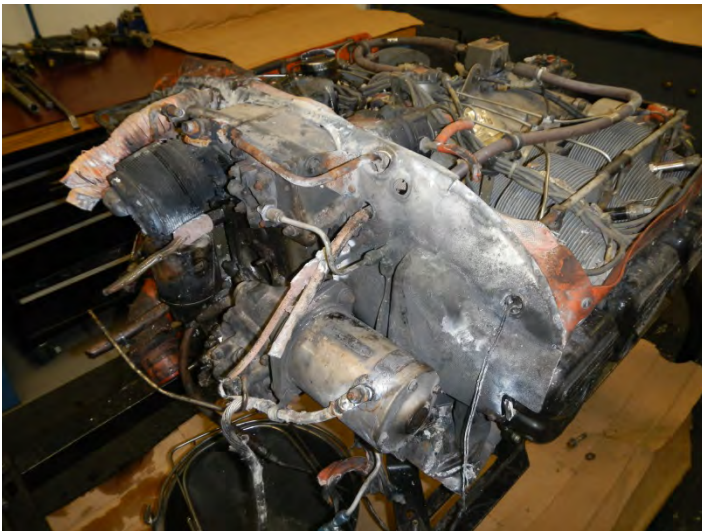
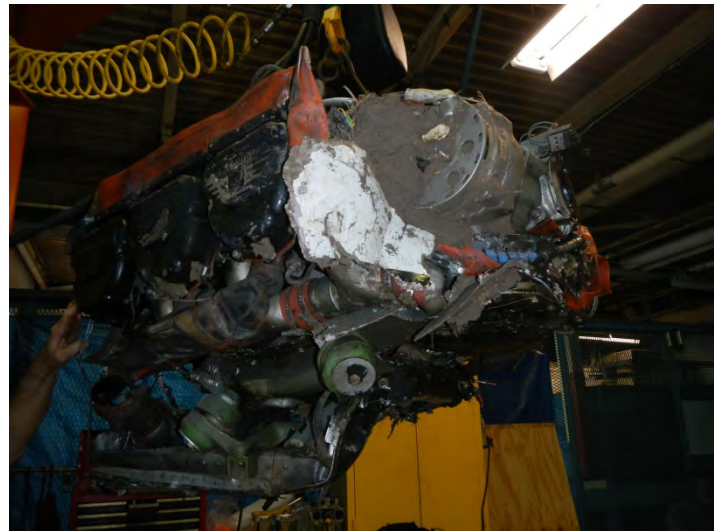
No pre-accident anomalies were noted with the alternator, starter motor and starter adapter, or the propeller governor.
