**Turbines Incorporated
Terre Haute, In**

Engine Failure Report

PT6A-34AG, S/N PCE-50188

TSN: 10,791.5 hrs.

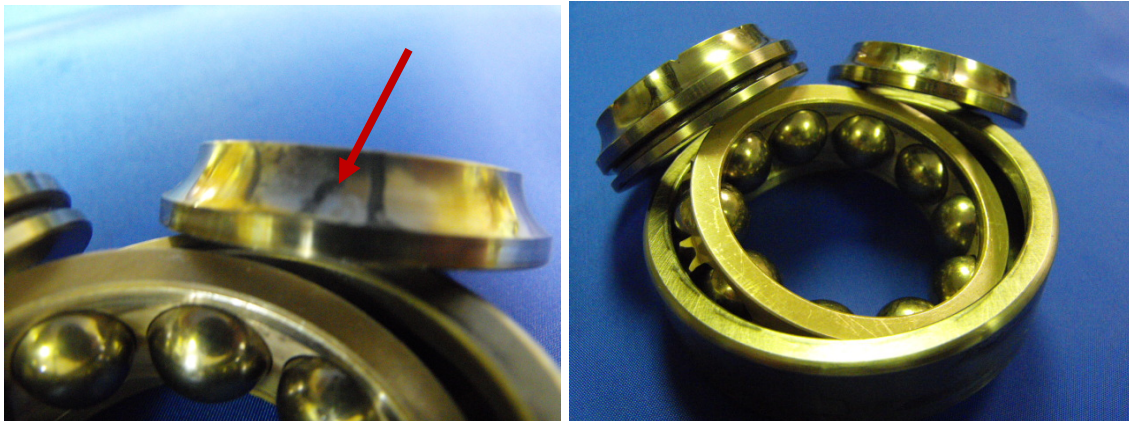
- Power Section was damaged due to impact only.
- The hot section was damaged due to impact
- The compressor was damaged due to impact, with an imminent # 1 brg failure noted due to condition of the bearing

- The Accessory Gearbox was found to be heavily corroded
- Accessory Gearbox was damaged and corroded due to improper storage.

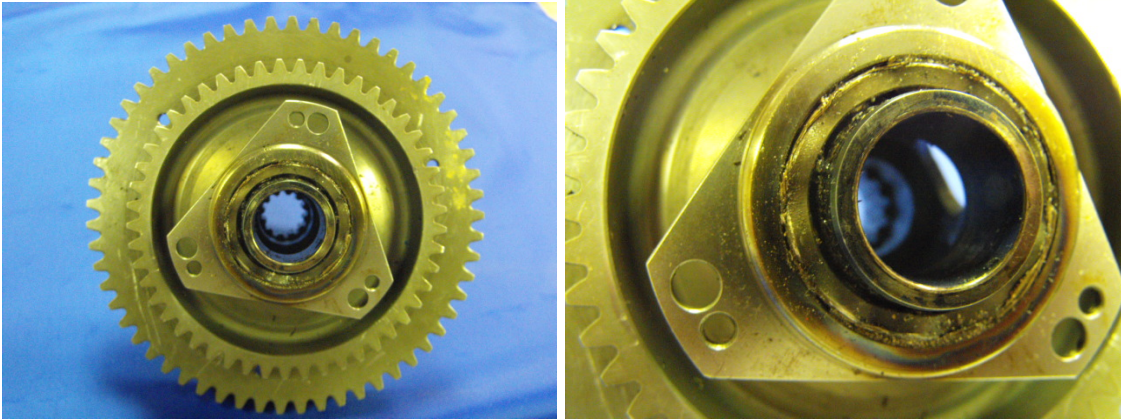
Based on the information provided and the physical review of the engine we can conclude that the engine failure was a direct result of a bearing failure caused by the engine not being stored properly and the accessory gearbox being contaminated. This resulted in a drive train failure that caused the engine to shut off.

As the bearing failed the compressor speed was dragged down until the engine stopped due to a lack of fuel. The starter generator gear is directly connected to the Fuel Pump drive gear and would have resulted in the gear stopping thus shutting off the fuel and the engine shutting down. Further investigation in the gearbox area showed more evidence of storage contamination/corrosion.

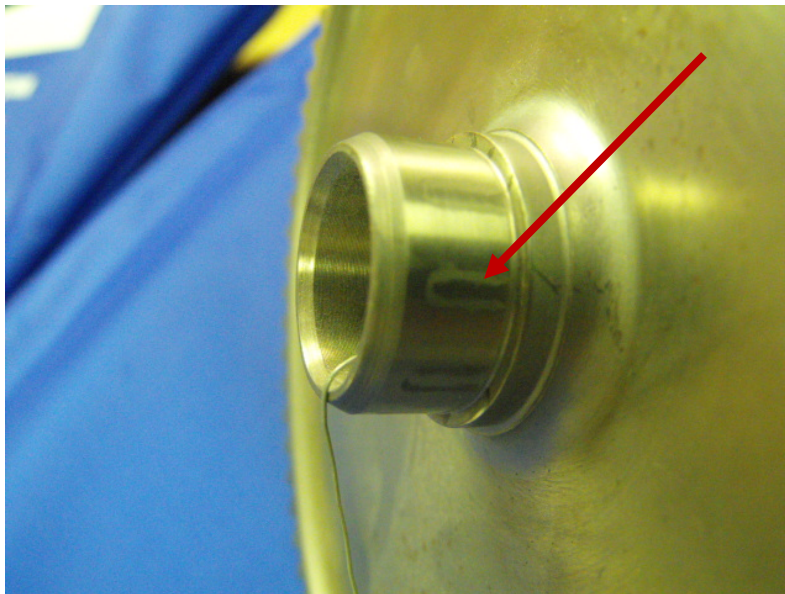
Corrosion Marks Due to Contamination

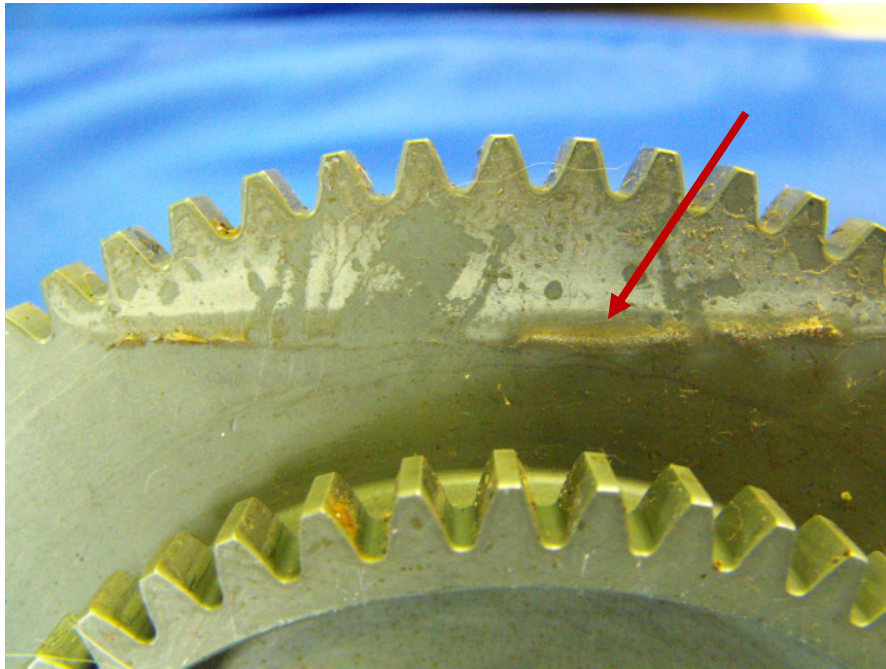
Gearbox Contamination
