NATIONAL TRANSPORTATION SAFETY BOARD

ENGINE AND AIRFRAME EXAMINATION

WPR17FA085

Location: Eugene, OR
Date: April 7, 2017
Aircraft: Piper PA-46-310P, Registration Number: N123SB, Serial #: 46-8508023
NTSB IIC: Maja Smith

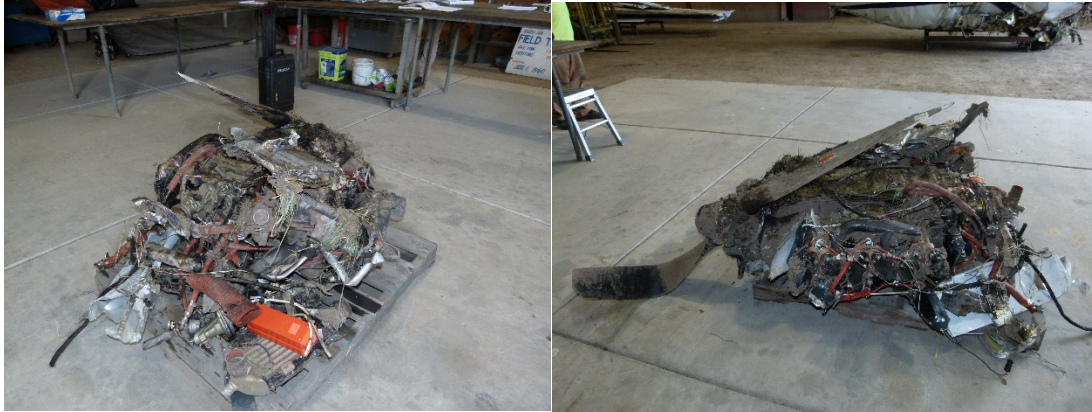
Photo 1 - Engine

The engine was covered in soil and grass and crankcase exhibited impact damages.

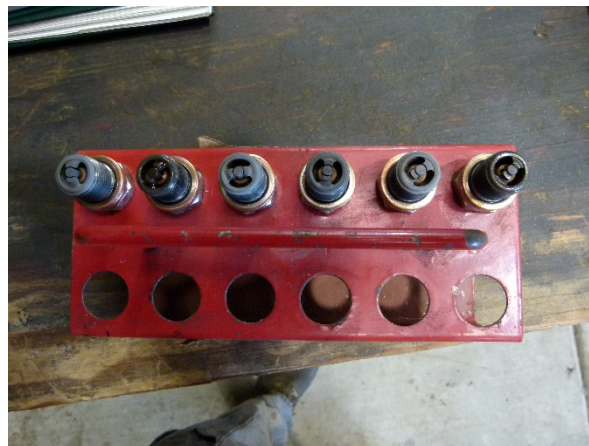
Photo 2 – Top spark plugs

The top sparkplugs were removed, and a lighted borescope inspection was performed. All valves and piston domes appeared normal. Top sparkplugs were inspected and appeared to have “normal” wear and coloration except for cylinders 2 and 6 which were contaminated with engine oil.

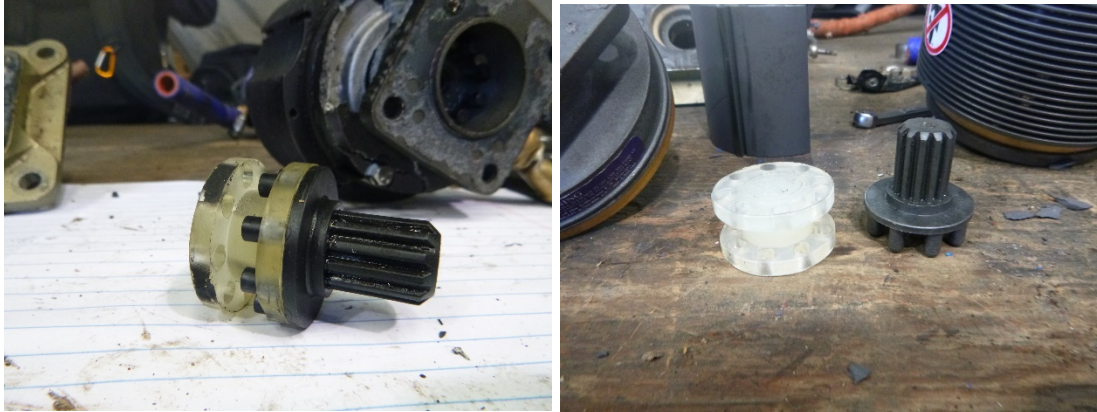
Photo 3 – Right and left vacuum pump plastic drive couplings

Both vacuum pumps remained attached to the engine. The right vacuum pump exhibited damage consistent with the impact. Both pumps were removed and disassembled. Plastic drive couplings were intact. The rotor in the right pump was shattered as a result of the impact. A half of the rotor in the left pump was intact and carbon veins were undamaged; the other half was shattered. The pump cavity in both pumps was smooth.

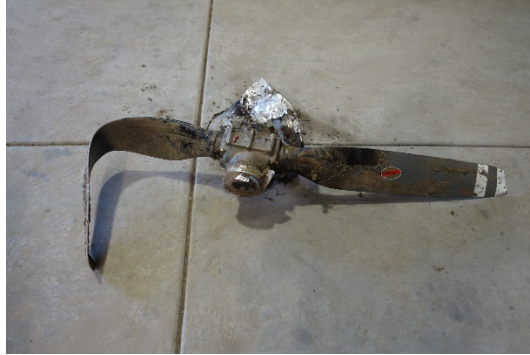
Photo 4 - Propeller

The two-blade propeller was found detached from the crankshaft displayed damage consistent with impact damage. Both propeller blades displayed chordwise scratches, significant blade polishing, and significant bending and twisting deformation. There were no anomalies noted with the propeller.

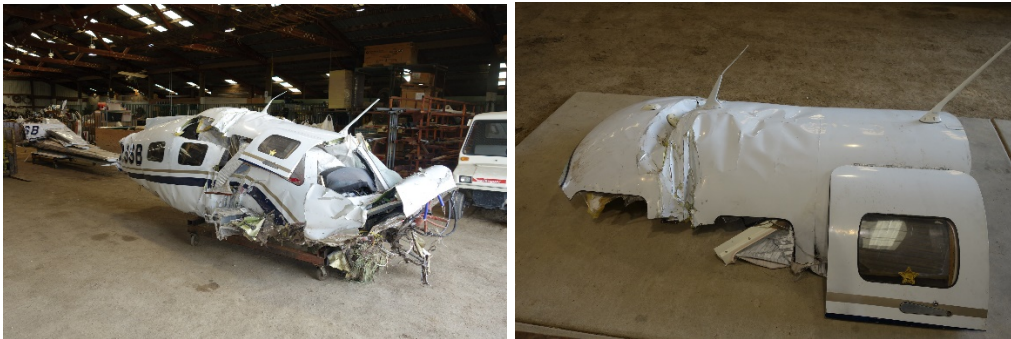
Photo 5 - Airframe

Examination of the airframe revealed that the roof of the fuselage was cut off by rescue personnel. The aft cabin door handle remained in the latched position and exhibited no signs of forced separation. The emergency exit window sustained impact damage and deformation consistent with the window being in the frame at the time of impact.
