**NATIONAL TRANSPORTATION SAFETY BOARD**  
Office of Aviation Safety-Eastern Region  
Ashburn, Virginia 20147  
June 5, 2014

**AIRFRAME AND ENGINE EXAMINATION FIELD NOTES**

**Location:** Burnham, Maine  
**Date:** July 3, 2013  
**Time:** 1648 EDT  
**Aircraft:** N888ZW, Sikorsky 269C

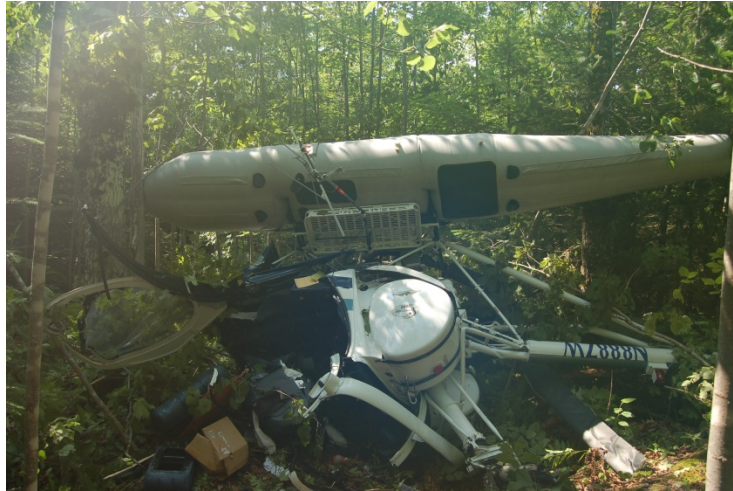
Figure 1: Helicopter at the accident site.

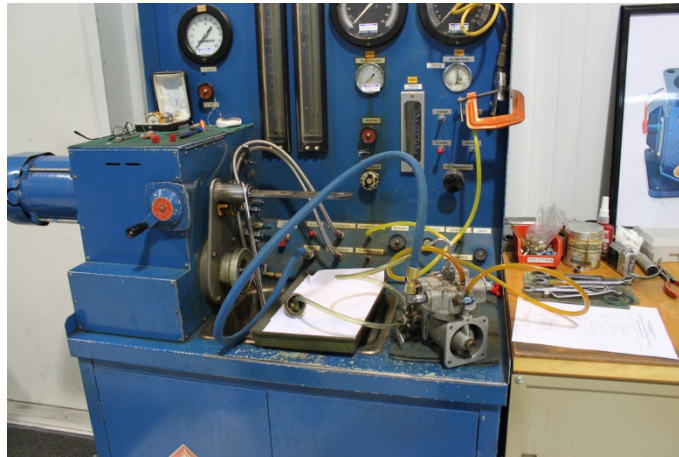
The Bendix Servo Fuel Injector RSA-7AA1, Parts List 2524347-10, S/N 70018202 was taken to a FAA certified repair station for bench testing (see Figure 2). Prior to bench testing the applied air fitting, gauge air fitting, and flow divider splitter were removed for bench testing. The unit was placed on the test bench as received and no contamination was noted coming from the unit. The unit passed 5 test points but failed the idle cutoff leakage amount. In that test the allowed leakage is 5 cc in 1 minute (measured leakage was 1 pound-per-hour). The servo fuel injector was not disassembled.

Figure 2: Servo fuel injector on test bench.

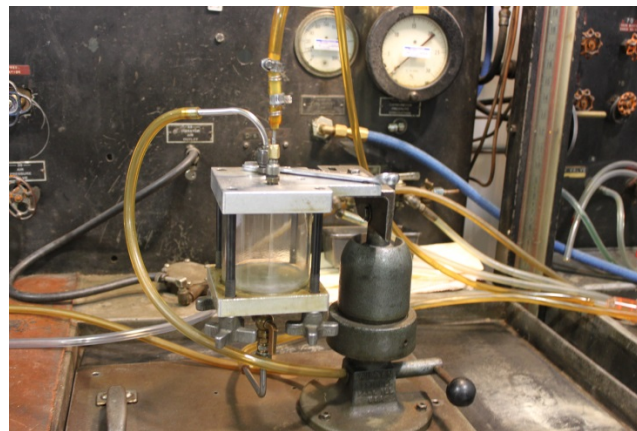
The fuel injector nozzles which were secured to the fuel injector lines and wrapped in plastic bags were removed from the bags and the lines. The insert for the No. 4 nozzle was not present. The nozzles were placed in a test fixture (see Figure 3) and all exhibited good flow pattern and good atomization, but all flowed 0.4 pounds-per-hour greater than specified. The insert from the No. 3 fuel injector nozzle was used to bench test the No. 4 fuel injector nozzle.

Figure 3: No. 1 fuel injector nozzle during testing.

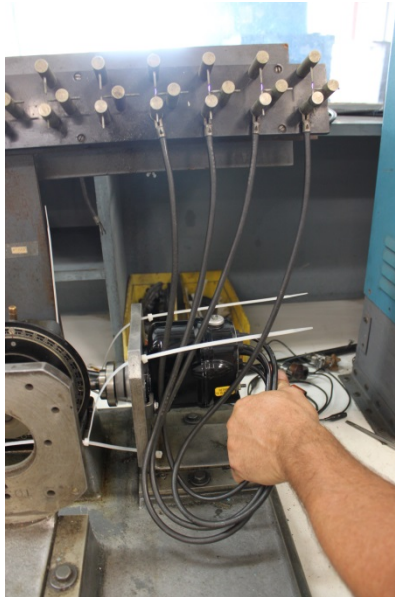
Inspection of both magnetos was performed at a FAA certified repair station with NTSB oversight. Slick magneto model 4345, S/N 93090020, was manufactured in September 1993, and assigned sequence number 0020. The magneto was placed on the test bench as received with a slave ignition harness and was noted to produce consistent spark that jumped a 5 mm gap from all leads from 300 to 4704 magneto rpm (see Figure 4). Intermittent firing was noted between 250 and 300 magneto rpm. The magneto was removed from the test bench and complete disassembly of the magneto was performed. The distributor gear was tight and the e-gap was slightly advanced. The tab on the coil was bent up (see Figure 5); the coil tab should be flush to 1/32 inch below and parallel to the parting surface of the magneto frame. Inspection of the coil tab revealed wear due to its incorrect position and contact by the distributor gear shaft; the wear amount was not quantified. The point gap measured within limits, and slight pitting was noted on

the contact surfaces. The cam wear was normal. The coil primary and secondary resistance readings were within limits, and no carbon tracking was noted on the distributor gear or distributor gear support. The condenser tested within limits.

Figure 4: Magneto during bench testing.

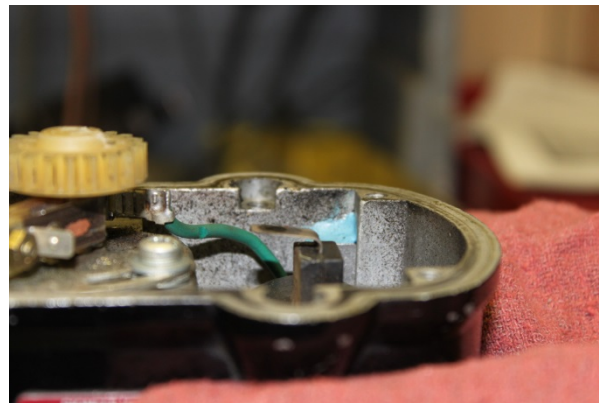
Figure 5: View of the coil tab position

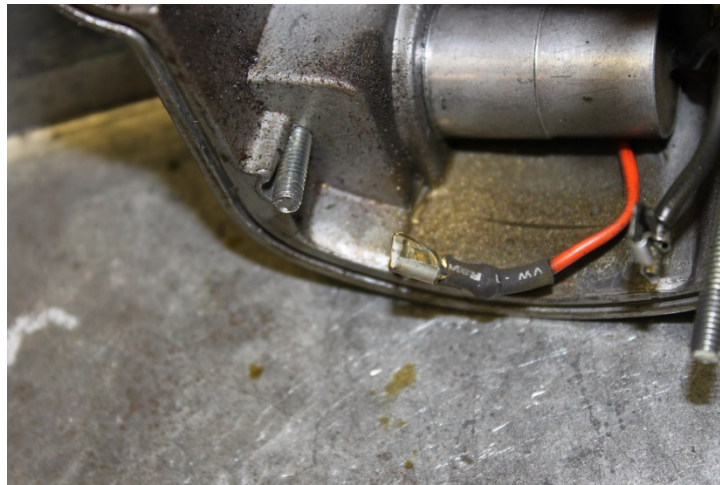
Slick magneto model 4345, S/N 94100005 was manufactured in October 1994, and assigned sequence number 0005. The magneto was placed on the test bench as received with a slave ignition harness and was noted to produce consistent spark that jumped a 5 mm gap from all leads from 150 to 4704 magneto rpm; no discrepancies were noted during the bench testing. The magneto was removed from the test bench and complete disassembly of the magneto was performed. During removal of the distributor housing assembly the retard breaker switch lead separated easily from the contact breaker assembly. Further inspection of the retard breaker switch lead revealed 1 side of the push-on connector was broken (see Figure 6); this would affect starting only. The condenser lead at the contact breaker assembly was tightly secured. The distributor gear was slightly loose (should be a press fit). The tab on the coil was bent up; the coil

Figure 6: Broken push-on connector of the retard breaker switch lead.

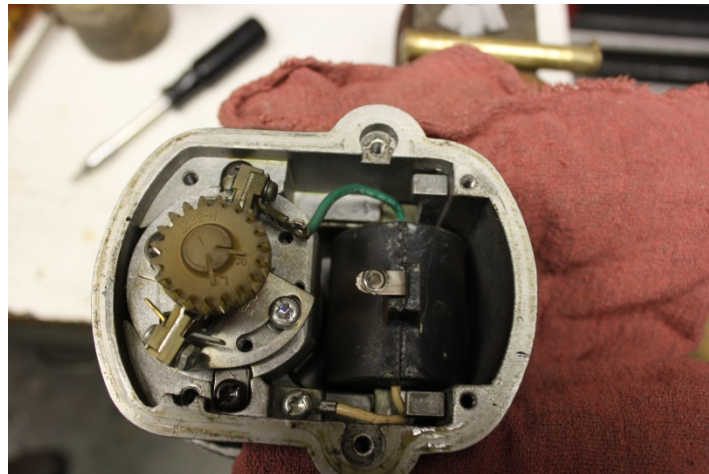
tab should be flush to 1/32 inch below and parallel to the parting surface of the magneto frame. Inspection of the coil tab revealed wear due to its incorrect position and contact by the distributor gear shaft (see Figure 7); the wear amount was not quantified but was significant. The point gap measured within limits, and slight pitting (normal) was noted on the contact surfaces. Slight wear of the cam was noted. The coil primary and secondary resistance readings were within limits, and no carbon tracking was noted on the distributor gear or distributor gear support. The condenser tested within limits.

Figure 7: Wear on coil tab.
