*Non-Destructive Evaluation*  
*on*  
*Headers, Water and Steam Drums*  
*On the S.S. Norway*  
*for*  
*National Transportation Safety Board*  
*June 26, 2003*

## S. S. Norway

Headers, Water Drums, and Steam Drum in Boilers 21, 22, & 24  
Final Magnetic Particle and Ultrasonic Crack Sizing Examination

Report # FS-03-239

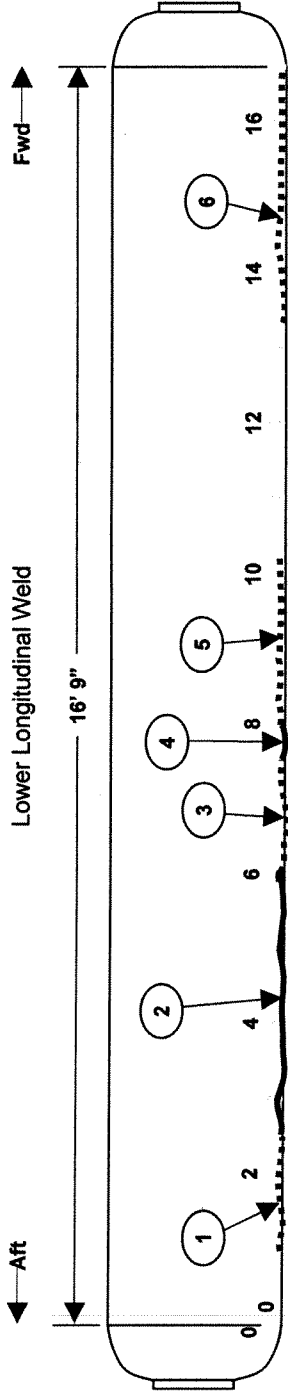
## Header 21

| 1. 1' thru 2'6" | Intermittent Cracks | 1.5' long |
| 2. 2'6" thru 6' | Continuous Crack | 3.5' long |
| 3. 6' thru 7'6" | Intermittent Cracks | 1.5' long |
| 4. 7'6" thru 8' | Continuous Crack | 6" long |
| 5. 8' thru 10'3" | Intermittent Cracks | 2.25' long |
| 6. 13'4" thru 16'9" | Intermittent Cracks | 3'5" long |

1. Located at 3', three overlapping cracks measuring approximately 0.040" deep.
2. Located at 7'9", single crack measuring 0.070" deep.
3. Located at 15', numerous small cracks too small to properly measure, estimate 0.010 – 0.015" deep.

**Note:** This header was not prepared (cleaned) for examination as well as the others examined. Some of the intermittent cracks noted might become continuous if the surface of the weld area were cleaner at the time of inspection.

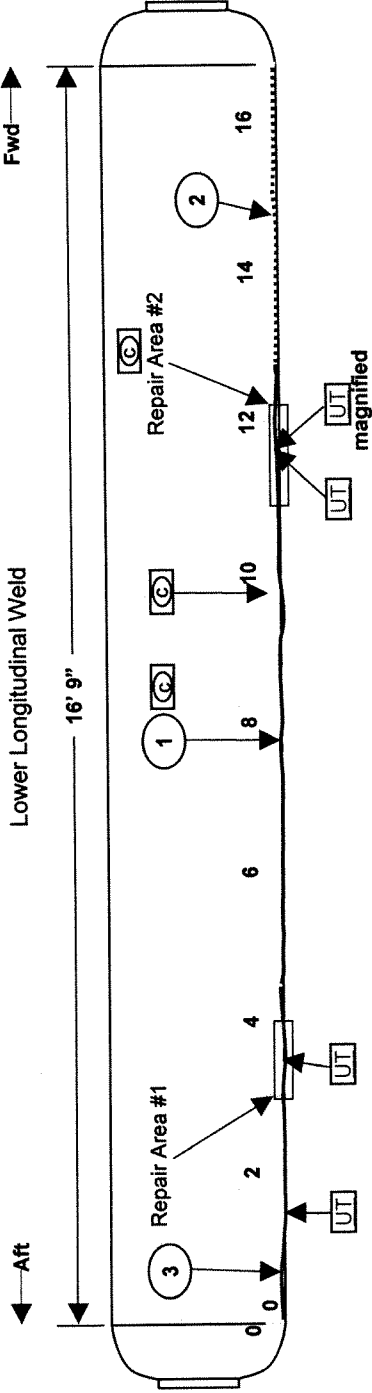
## Header 22

1.	4'6" thru 12'9"	Continuous Crack	8'3" long
2.	12'9" thru 16'9"	Intermittent Cracks	4' long
3.	0' thru 4'6"	Continuous Crack	4'6" long

Note: Area 3 was not examined with Fluorescent Magnetic Particle technique due to residual ultrasonic couplant on the weld surface. However, cracks were present in this area for the full length.

1. Located at 1.5', crack measuring approximately 0.040" deep.
2. Located at 3.5', single crack measuring 0.080" deep. This crack is in the repaired area of the weld.
3. Located at 7', single crack measuring 0.080" deep.
4. Located at 8'7", single crack measuring 0.120" deep.
5. Located at 11.5', single crack measuring 0.250" deep. This crack is in the repaired area of the weld.

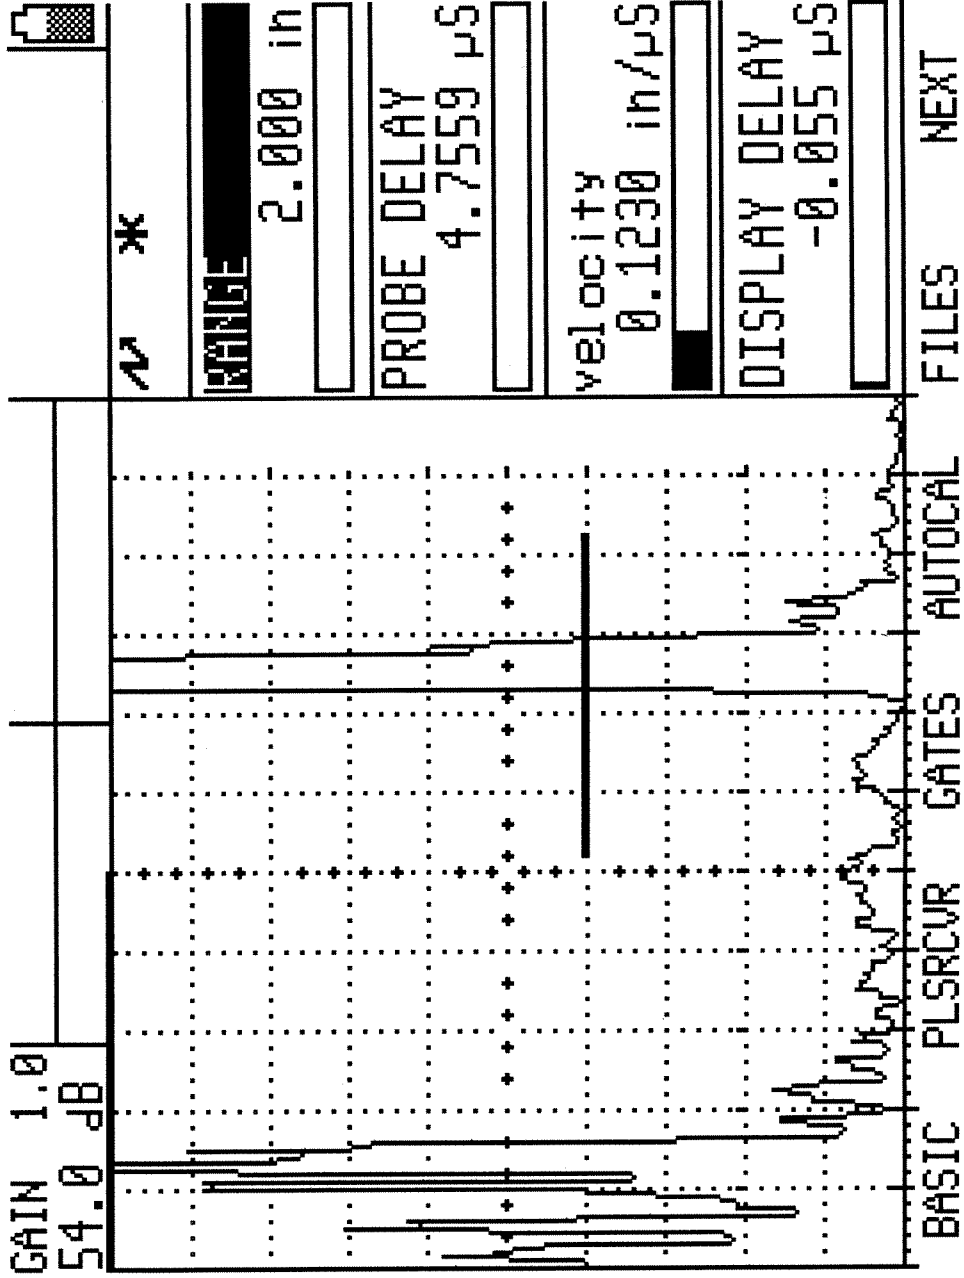
S. S. Norway – Header 22 – Ultrasonic Size on Crack #1

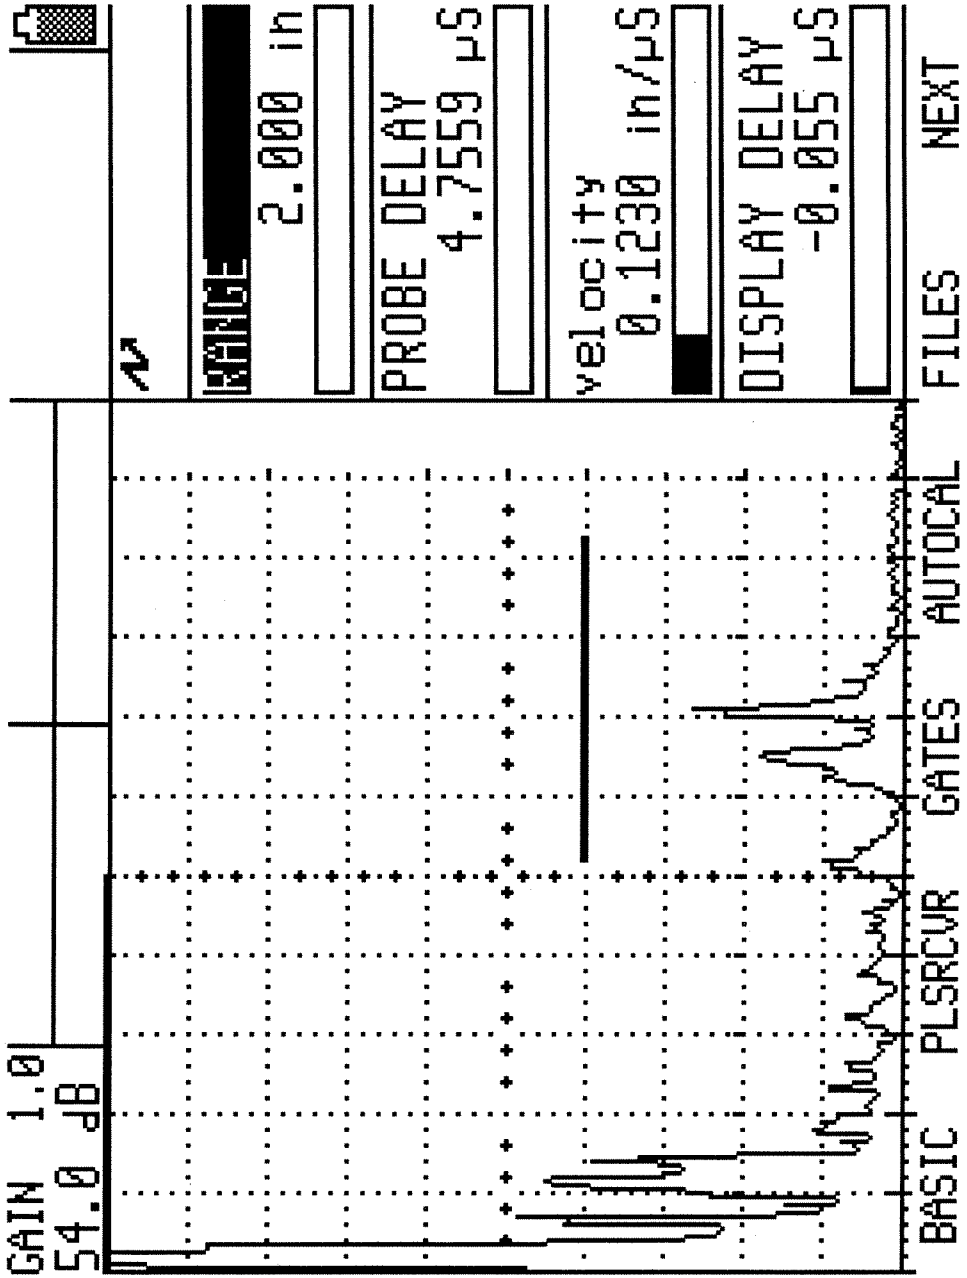
S. S. Norway – Header 22 – Ultrasonic Size on Crack #2

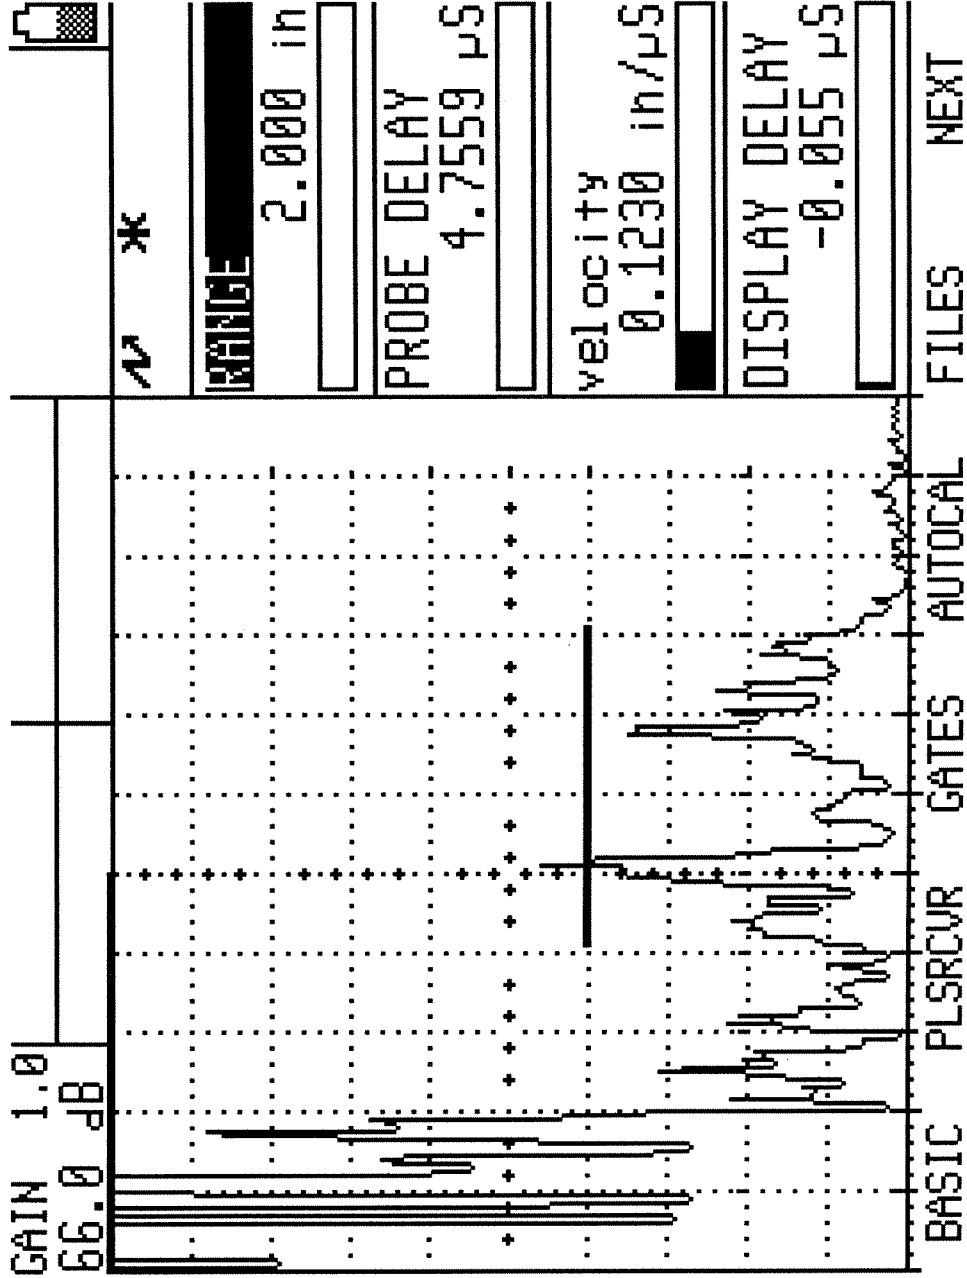
S. S. Norway – Header 22 – Ultrasonic Size on Crack #5

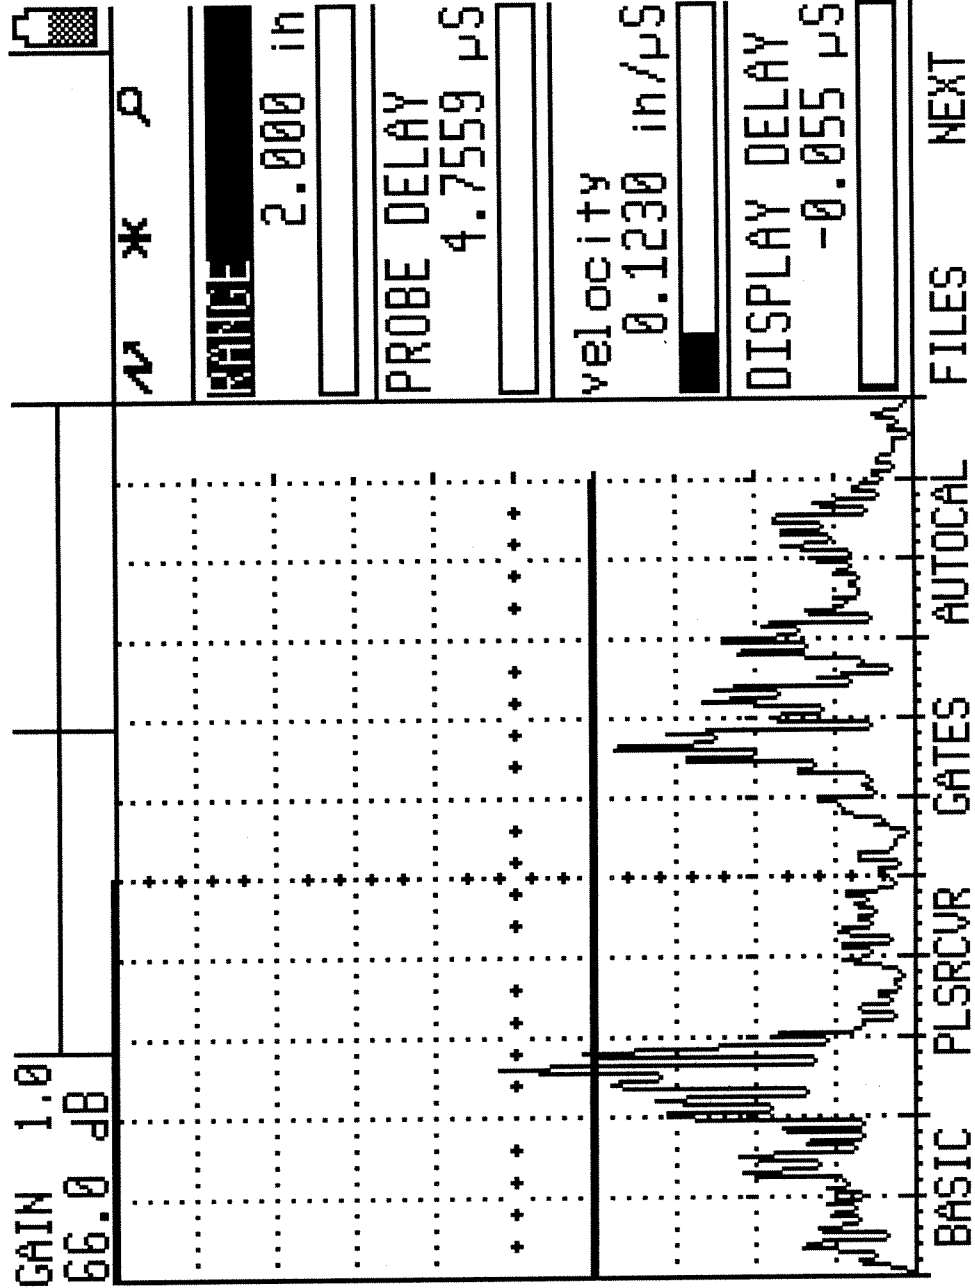
S. S. Norway – Header 22 – Ultrasonic Size on Crack #5  
 Showing Sizing Measurement of 0.250"

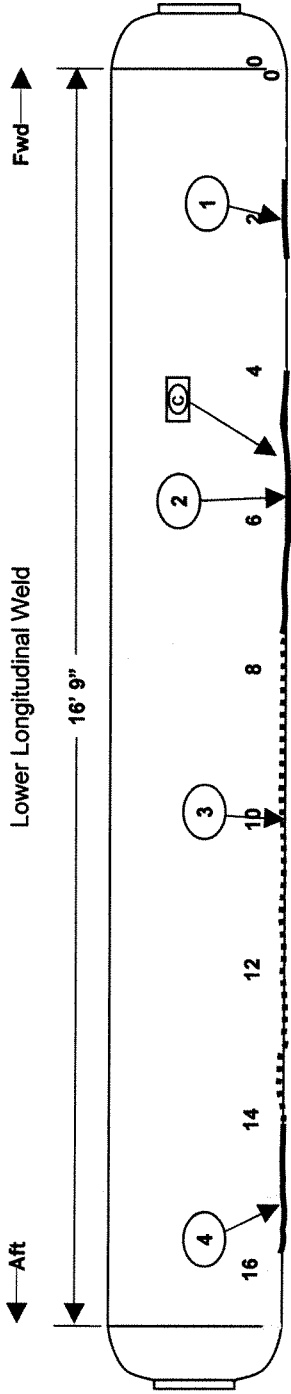
## Header 24

| 1. | 1.5' thru 2.5' | Continuous Crack | 1' long |
| 2. | 4' thru 7.5' | Continuous Crack | 3.5' long |
| 3. | 7.5' thru 14' | Light Intermittent Cracks | 6.5' long |
| 4. | 14' thru 15'9" | Continuous Crack | 1'9" long |

1. Located at 2', multiple overlapping cracks measuring 0.080 – 0.100" deep.
2. Located at 5.5', single crack measuring 0.090" deep.
3. Located at 15', single crack measuring 0.090" deep.

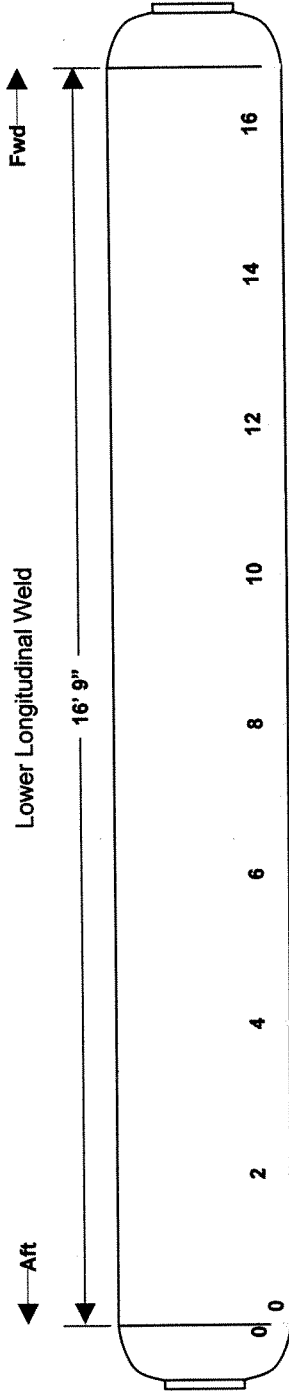
Water Drum 21

There were no cracks detected in this examination.

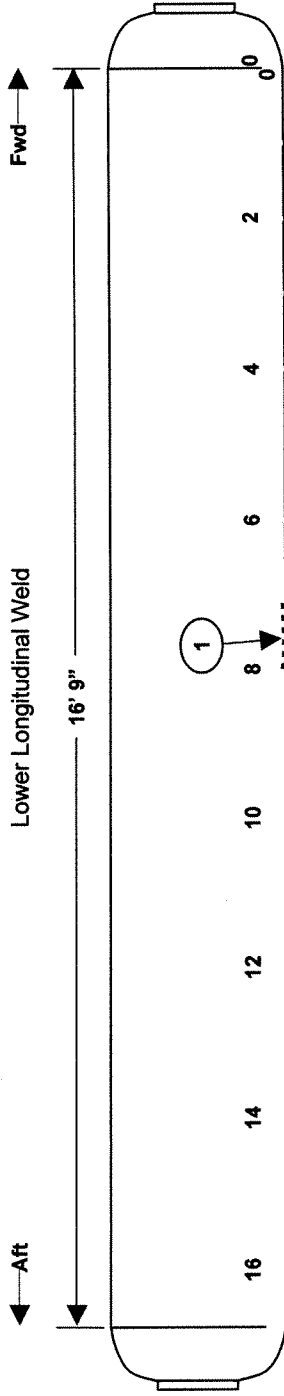
Water Drum 24

Intermittent Cracks 1' long

1. 7' thru 8'

1. Located at 7.5', Lightly Intermittent Cracks were visible at this location with ultrasonic scanning but no separation of the crack base and tip were observed, therefore, no depth is given and it is assumed that the depth is less than 0.015"

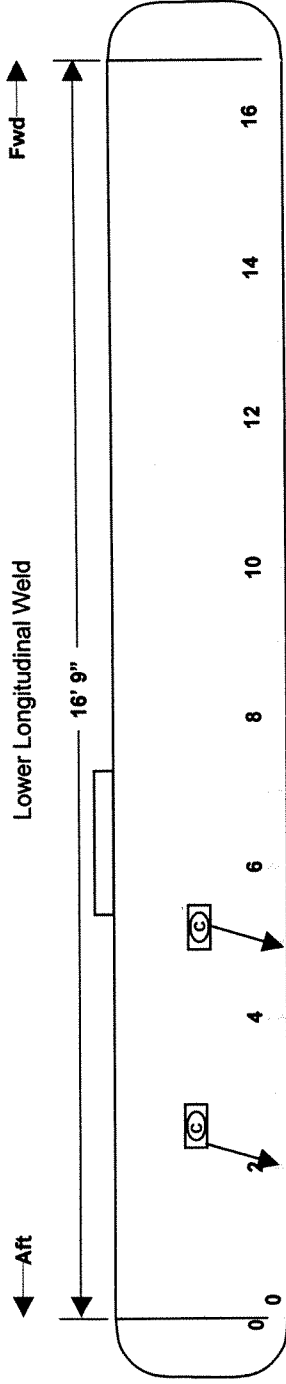
# S. S. NORWAY Steam Drum 22

The weld area from 0' thru 5' was examined with Fluorescent Magnetic Particle technique with no crack indications noted.

The areas at 6", 1.5', & 5' were examined with ultrasonic scanning. Only geometric reflectors were noted, no cracks were detected.
