## Cracking of cylinder cover cooling jacket for 50 & 60 MC, MC-C engines

**Service Team  
Junma Services Pte Ltd**

19<sup>TH</sup> July 2012

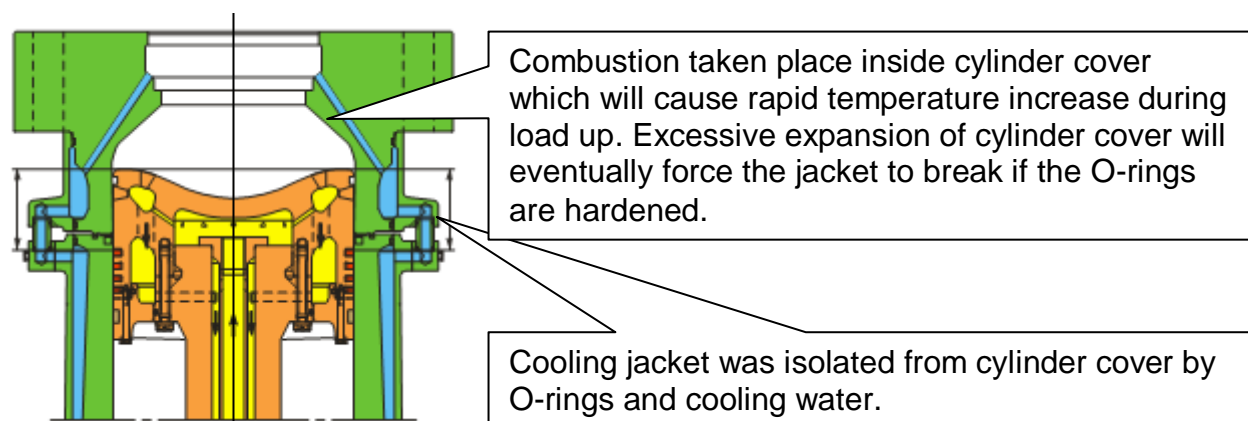
The design of cylinder cover cooling chamber had been changed from a welded ring to a thin wall cooling jacket (the thickness of the jacket wall is about 11 mm). The difference between a welded cooling ring and cooling jacket is that heat can easily transferred to the welded ring through direct contact but not through rubber O-rings (jacket type). In this regard, the temperature deviation between cylinder cover and jacket can be excessive during load up and the expansion force will BE transferred to the cooling jacket through less elastic (aged) O-rings and eventually cause the jacket to break.

**Remove the cooling jacket whenever cylinder unit is to be overhauled. Carry out cleaning of the cooling space and renew the O-rings.**

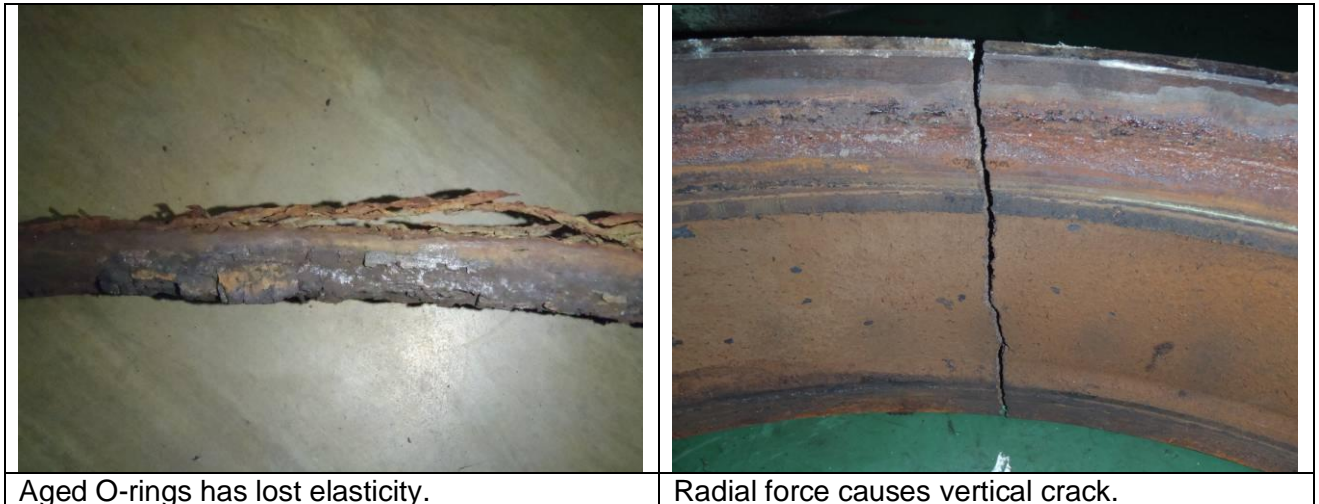
Scale formation in the cooling jacket reduces the heat transfer rate further that introduce extra thermal overload.

Slower response or malfunctioned thermostatic valve in jacket cooling water system will adversely affect the thermal load.

Rapid load change (speed increase) may be the last factor contributes to jacket breakage especially when fouling to the hull/propeller increases.

Although it may appeared like breakage is related to load change, problem with thermostatic valve and/or cooling water treatment, the root cause is still the aging O-rings and deviation in temperature between cylinder cover and jacket. However, if engine is maintained well with regards to above the jacket breakage may be postponed but unlikely avoidable.

Jacket cooling water must be treated with correct inhibitors. Carry out cleaning and descaling every 4-5 years as according to instructions in Operation manual.

Thermostatic valve in the jacket cooling system should be adjusted properly to reduce the temperature fluctuation during load change.
