BALLARD
MARINE CONSTRUCTION

Project Report Prepared For:

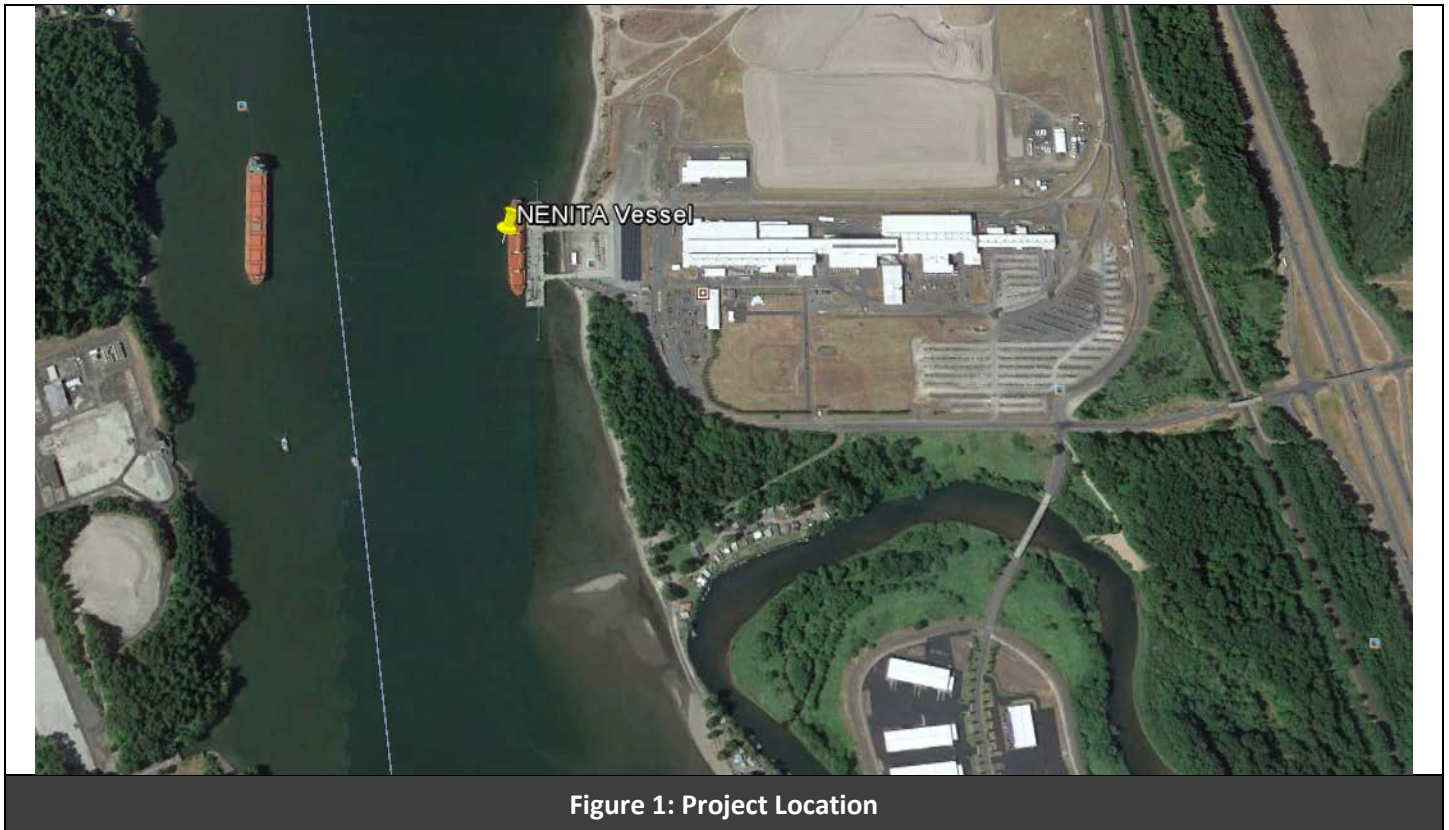
The Nenita Vessel was located at the Port of Kalama, WA North Dock, tied bow upriver, port to dock.

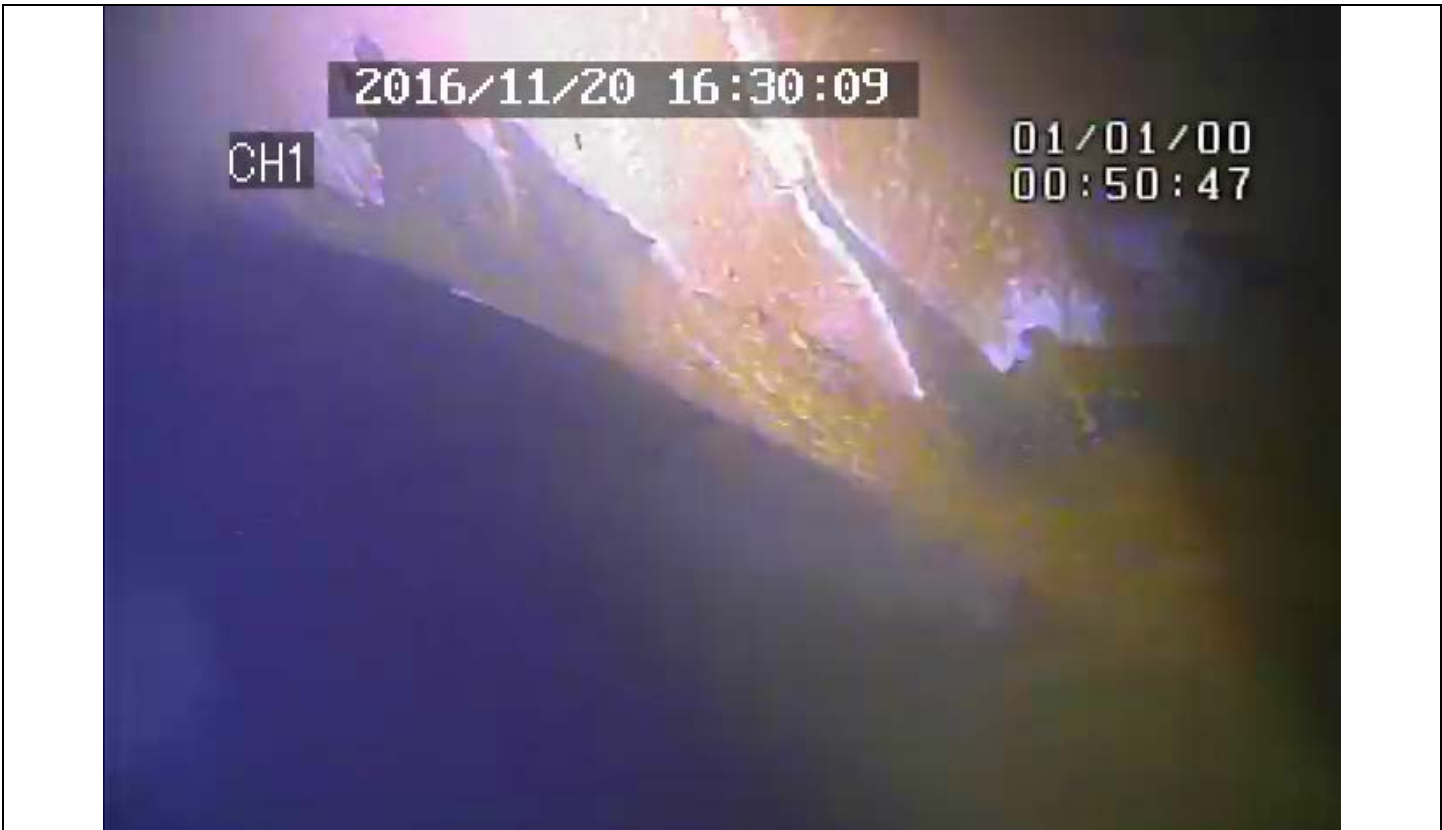
Photo #1: Hull Damage Near Turn of the Bulbous Bow

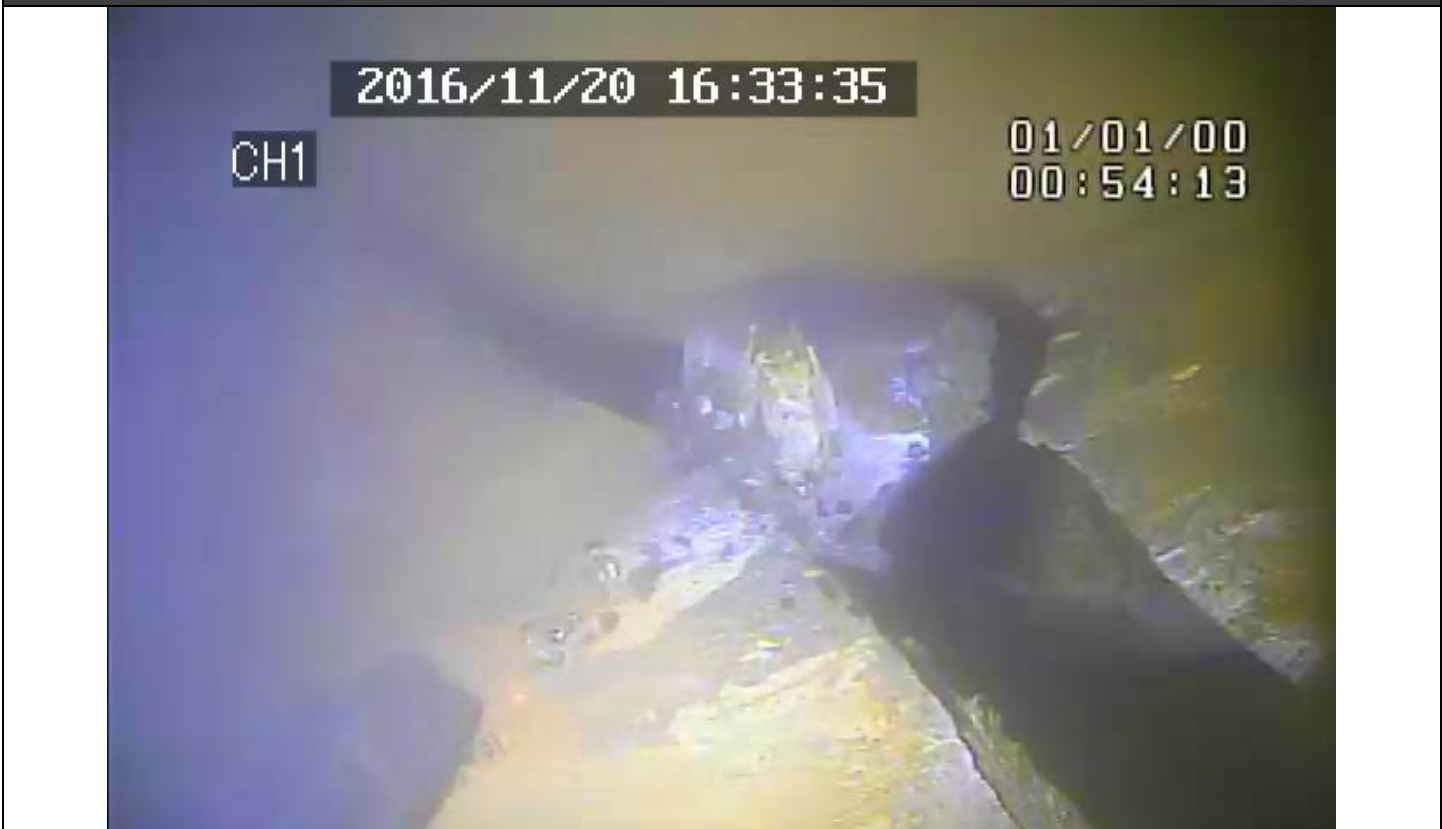
Photo #2: Tear Near Bulbous Bow
