# EC135 ALERT SERVICE BULLETIN

## Indicating and Recording Systems – Instrument Panel – Inspection and modification of switches ENG CONTROL on switch unit 20VE

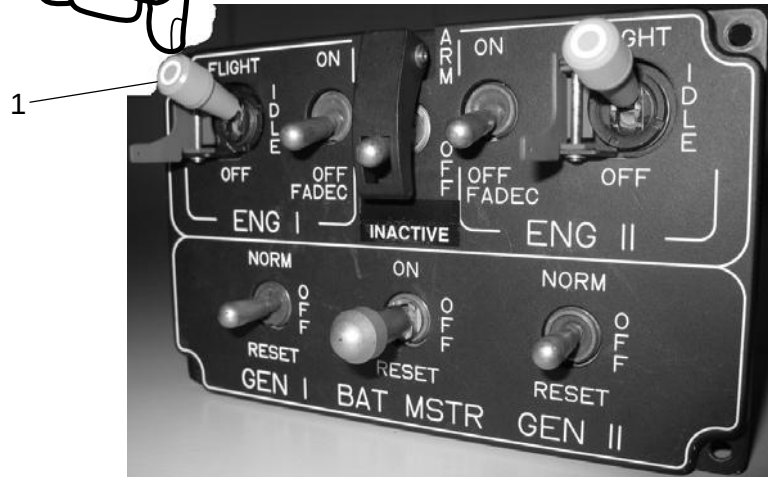
Inspection of Locking Groove  
Figure 1

**NOTE** For proper operation of the engine switch ENG CONTROL (ENG I or II) the switch lever must be pulled before it is set from position OFF to position IDLE, from position FLIGHT to position IDLE or from position IDLE to OFF. If the engine switch is not properly operated the locking groove on the switch lever will wear.

- 1 Switch lever
- 2 Locking groove

- (1) De-energize helicopter electrical system i.a.w. AMM, 24-00-00, 2-1.
- (2) Set switch lever ENG CONTROL (1, Figure 1) to position FLIGHT.
- (3) Accomplish a visual check of the locking groove (2, Figure 1) for signs of wear.
- (4) Check, that the switch ENG CONTROL can not be set from position FLIGHT to position IDLE by applying low pressure, but without pulling the switch lever (1, Figure 1, View A).
- (5) If switching is possible or the locking groove has visible signs of wear switch ENG CONTROL must be replaced as follows:
  - (a) Remove switch unit 20VE i.a.w. AMM, 31-11-20, 4-1.
  - (b) Fold up switch lock (5, Figure 2) of the switch to be replaced. Loosen nut using a suitable tool and pull out switch (6).

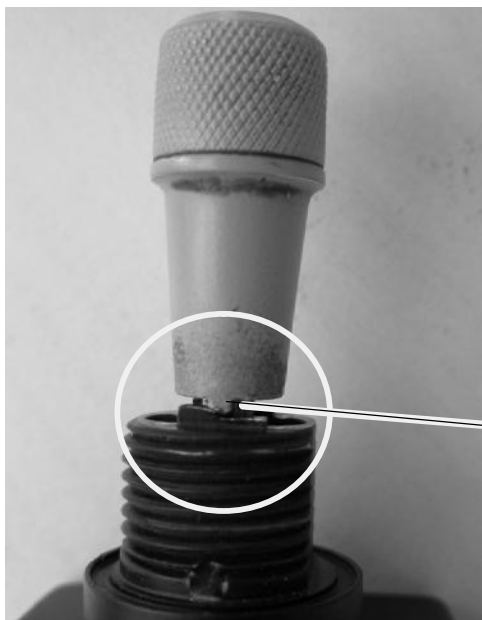
View B

If the engine switches are not properly operated the locking groove on the switch lever may quickly wear. Under these circumstances a secure and exact positioning of the switch lever cannot be ensured. In order to ensure the proper functioning, an inspection that must be accomplished every 400 fh is introduced with this Alert Service Bulletin.

Worn locking groove

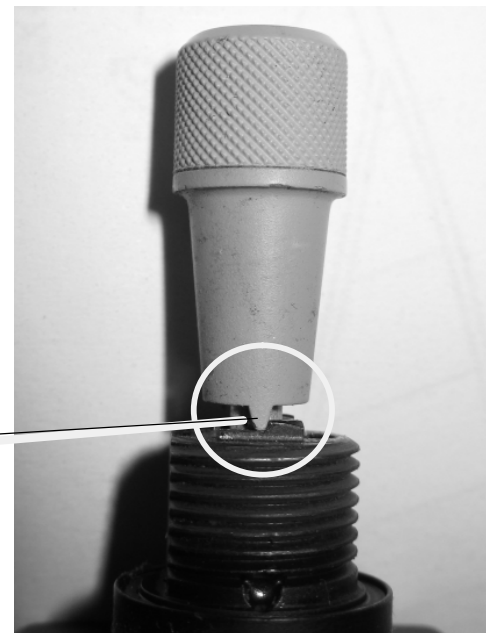
View C

Not worn locking groove

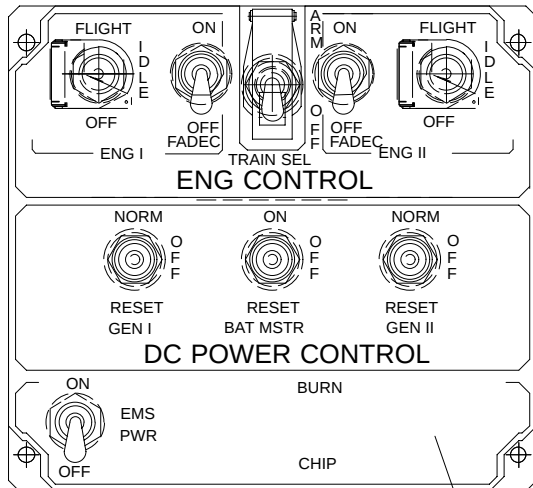
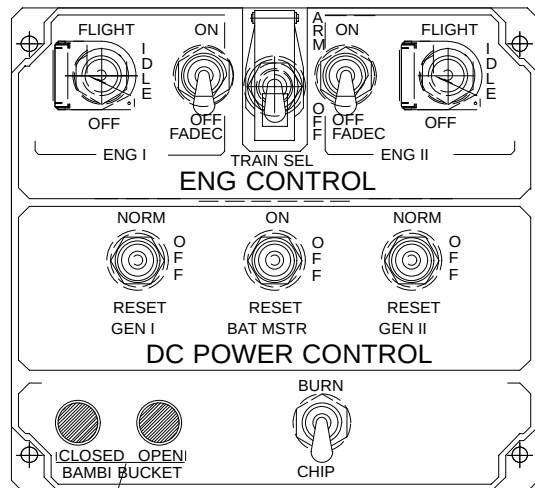
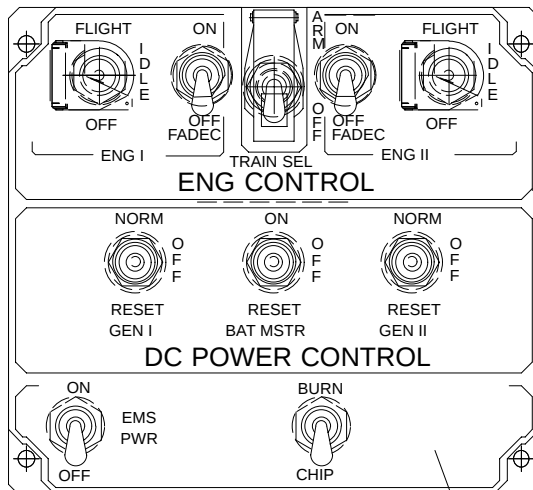
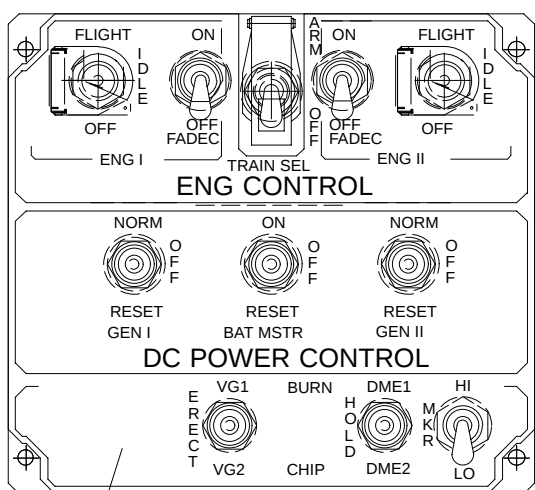
Possible Variants of Switch Units (up to and including H/C S/N 0168)  
Figure 3

**NOTE** On helicopters up to and including S/N 0168 a switch unit can be installed that has an additional switch row (see Figure 3, 4) with part numbers L311M1085101 up to and including L311M1085109. For the wiring of the additional switch levels the same instructions are applicable as for switch unit L311M1034102.

- (3) Compare switch unit with the possible variants shown in Figure 3 – Figure 5 and verify new part number.
- (4) Using a permanent, black pen, write verified part number onto placard (8, Figure 2).
- (5) If switch unit 20VE cannot be verified contact ECD customer support.
