NATIONAL TRANSPORTATION SAFETY BOARD

On-Scene Exam

WPR12FA010

Location: Cle Elum, WA
Date: October 13, 2011
Aircraft: Flugzeugbau DG-1000S; Registration #: N7760A, Serial #: 10-34 S-33
NTSB IIC: Dennis Hogenson

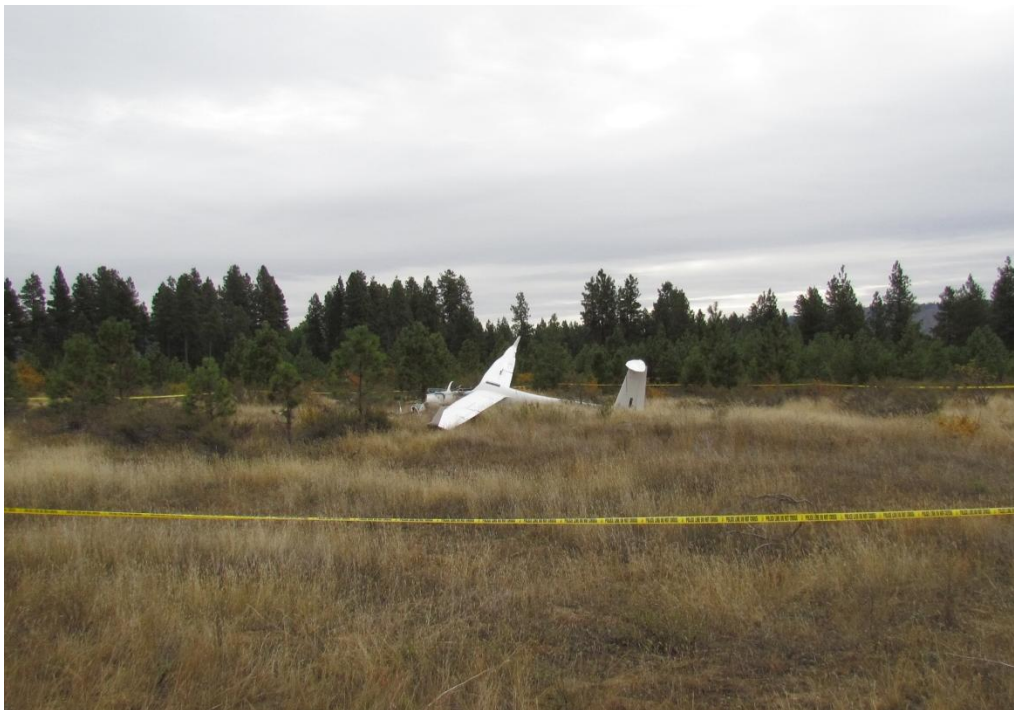
Figure 1: Overall Accident Scene

The glider was mostly intact and came to rest in high grass adjacent to the departure of runway 7 at the Cle Elum Municipal Airport. The first identified point of contact was an approximate 10 inch deep crater, which contained debris from the glider's nose, about two feet directly in front of the main wreckage. No other ground scars, or tree damage was noted; the debris was concentrated to the area of the main wreckage with the exception of the rope used to tow the glider.

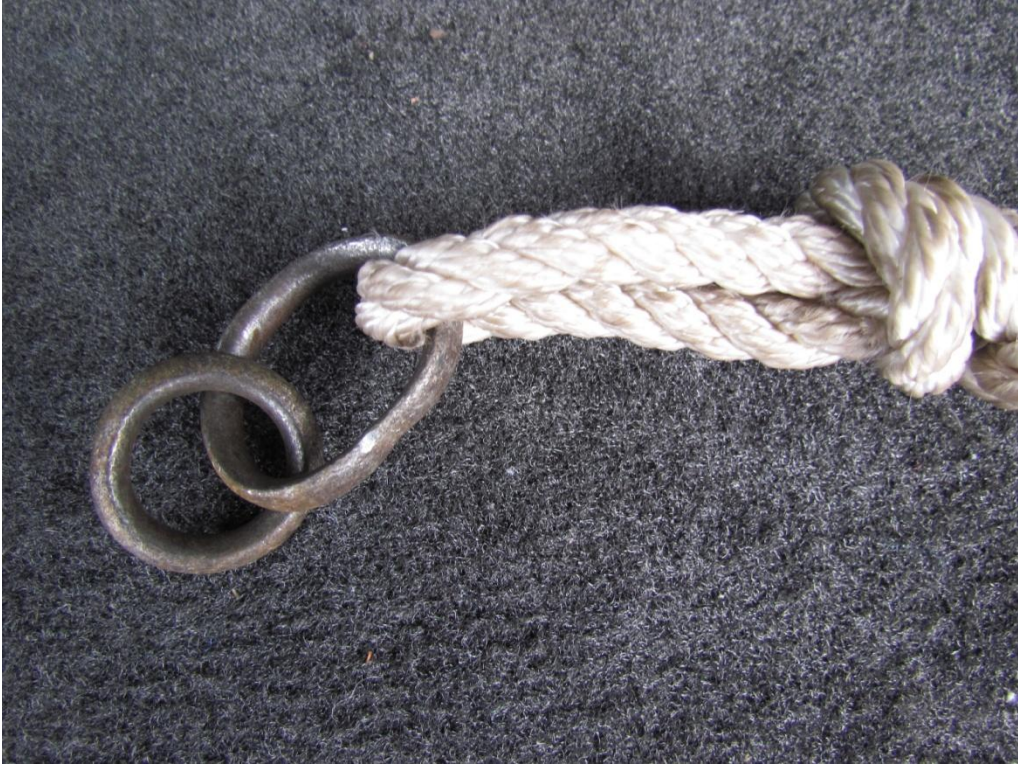
Figure 2: Tow Rope - Glider Attachment Side

The tow rope was found near the departure end (north side) of the runway. The glider end of the tow rope was intact and no damage was noted. The tow vehicle end of the rope (found secured to the tow vehicle trailer hitch attachment point) separated just below the tow ring connection loop knot. The rope separation points were frayed and unraveled; however, there was no indication of preexisting damage to the rope. The overall length of the tow rope, to include the separated section, was about 234 feet in length.

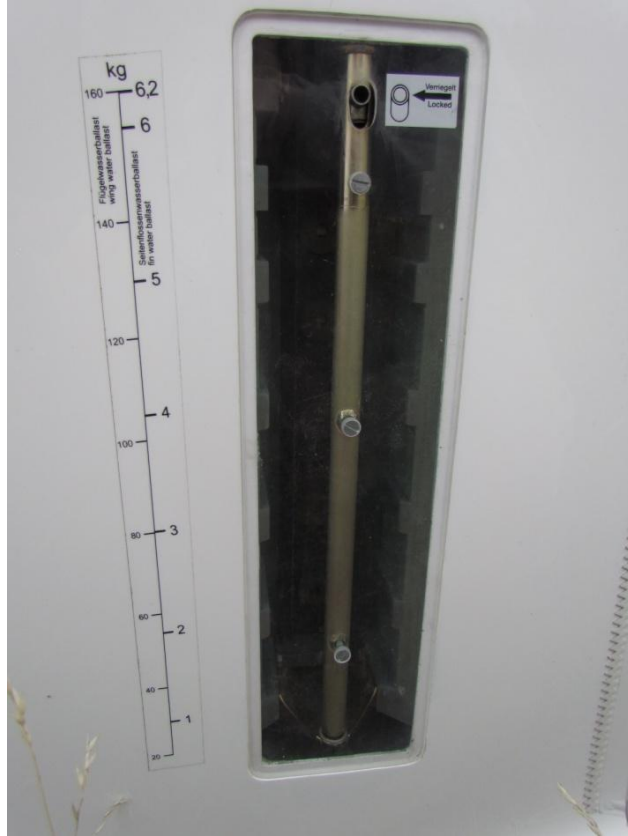
Figure 4: Weight Ballast located in Vertical Stabilizer

The tail section of the glider, to include the horizontal and vertical stabilizer, sustained negligible impact damage. The N number on both sides of the vertical stabilizer was taped over with white tape. No weights were observed in the ballast located on the vertical stabilizer. The elevator

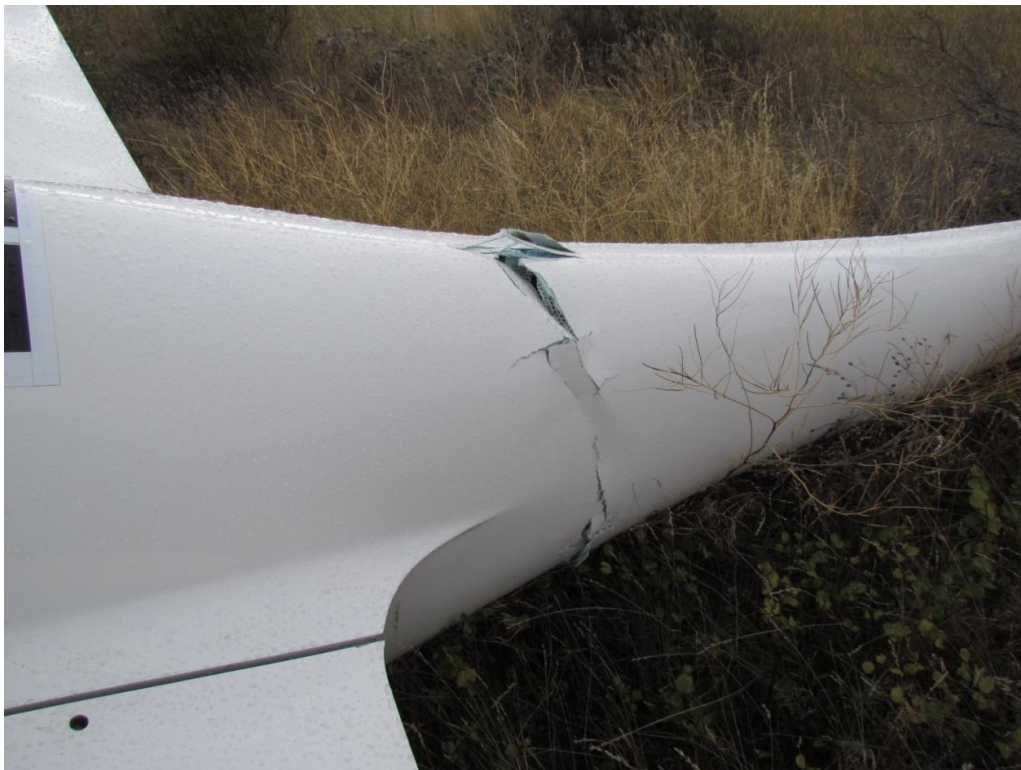
Figure 5: Aft Fuselage Cracking

A large full thickness crack around the entire circumference of the aft fuselage, just aft of the aft bulkhead, was noted.

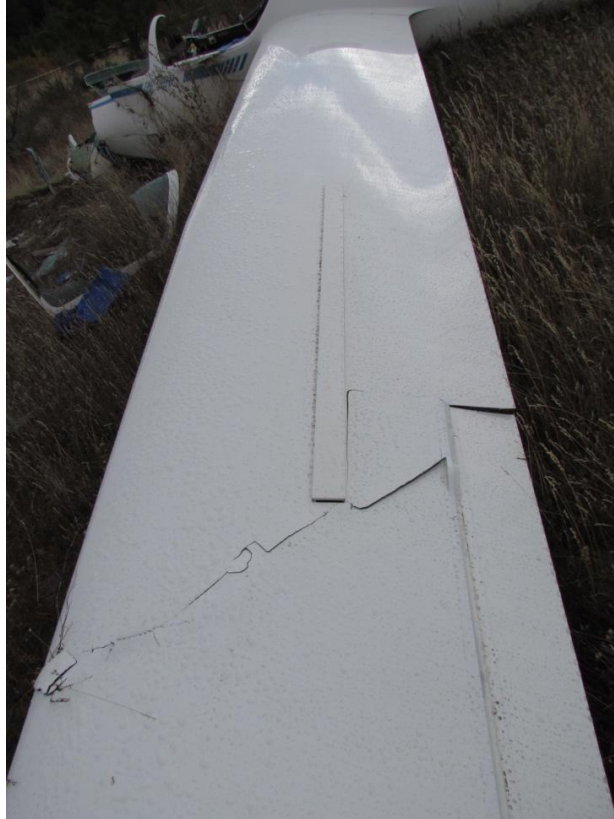
Figure 6: Left Wing Mid-span Chordwise Cracking

The left wing sustained little impact related damage. Chordwise cracks, about midspan, that started at the leading edge and extended fully aft were noted. Control continuity to the left aileron and left speed brake was established from the bulkhead through the wing root and to their respective control surfaces.

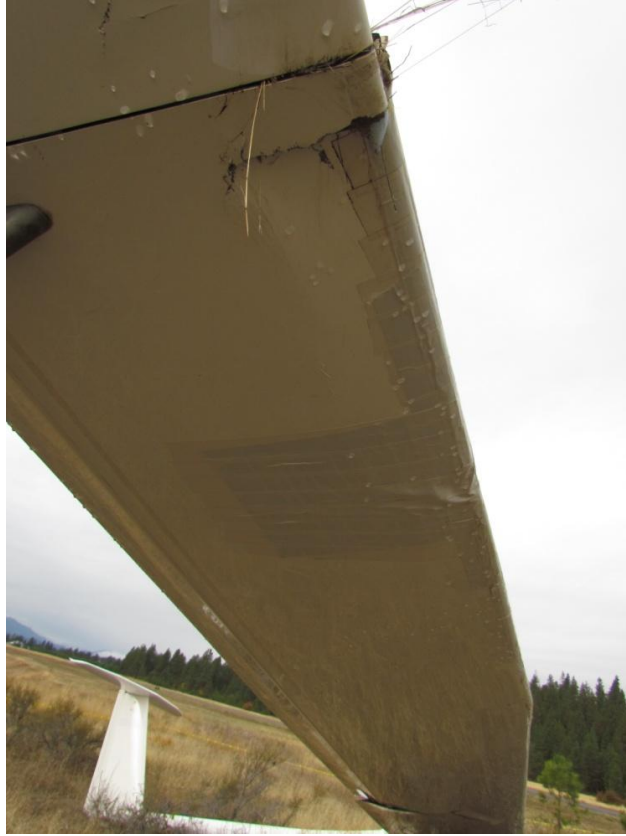
Figure 8: Bottom of Outboard Right Wing Repair

The right wing sustained extensive damage. The wing contained chordwise cracks to the composite skin material near the wing root and about midspan. The composite material was also cracked horizontally across the entire leading edge of the right wing. Pre accident damage and subsequent repair was noted to the outboard section of the wing. The repair contained about 3 feet of "200 mph" tape running along the leading edge of the wing. About midway through the repair the tape extended aft along the wing in an approximate one foot by one foot square on both the top and on bottom of the wing. Control continuity to the right aileron and right speed break was established from the bulkhead through the wing root and to the control surfaces.
