INCIDENT INVESTIGATION REPORT IRN000102 Issue 1

MEGGITT RETURN No	N/A	PART No	DAP00100-07	QTY	1
DESCRIPTION	BCU	SERIAL No	230000159		
DATE OF MANUFACTURE	Aug 2011	MOD. STATE	1		
OPERATOR	Flight Options LLC	REPORTED USAGE	Unknown		
AIRCRAFT	EMB-505	DATE OF INCIDENT	05/08/2013		
CONSTRUCTOR	Embraer	CUSTOMER ORDER	N/A

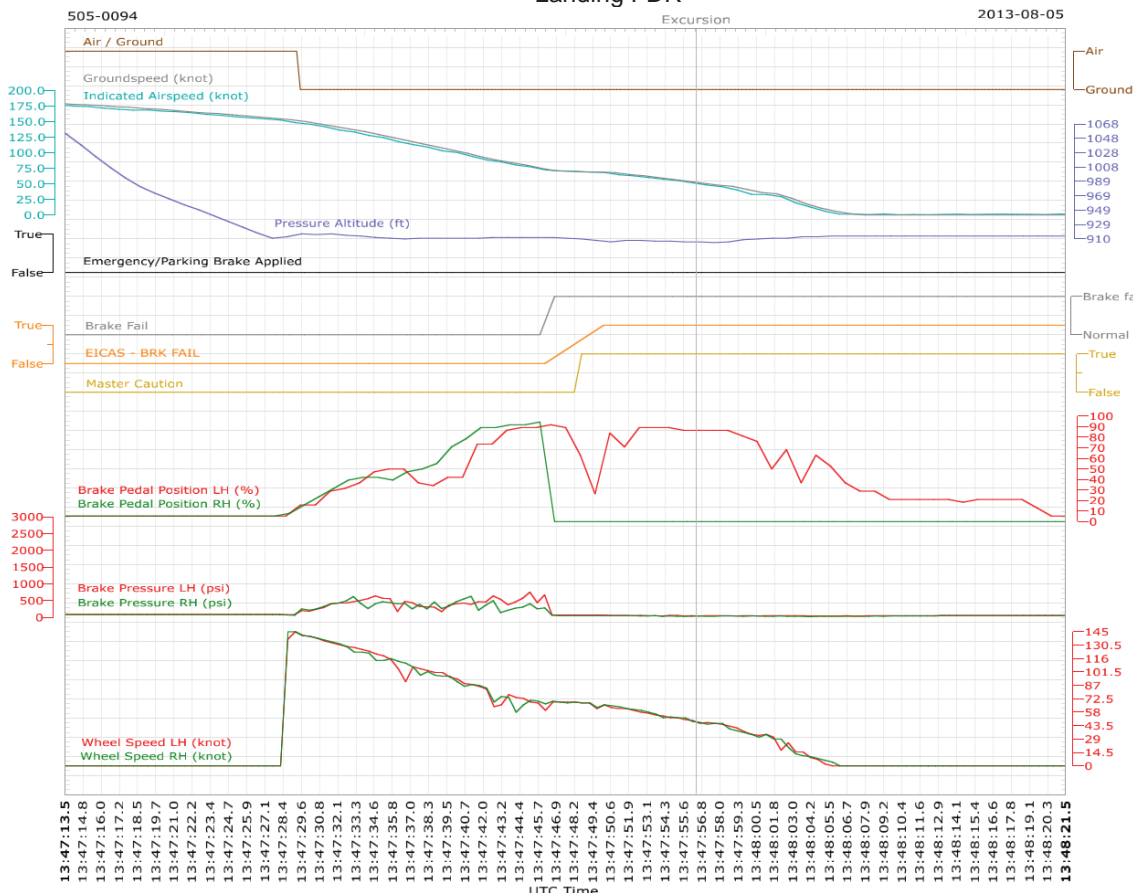
Landing FDR

Touchdown and brake pedals applied at 13.47:29.

Brake pressure shows that approximately 4 seconds after the brakes are applied there is anti-skid activity which occurs until loss of brake pressure.

At approximately 17 seconds, right pedal displacement goes to 94.49% of travel and then goes to zero displacement.

At the same time the main brake pressure drops from 670 psi to 50 psi, and the warning BRKFAIL is generated. Three seconds later the CAS BRKFAIL warning is generated.

As the brake pressure drops, the aircraft stops decelerating for approximately 3 seconds before decelerating at a slightly slower rate.
