FILE COPY
Pacific Gas and Electric Company
Department of Engineering
Bureau of Tests and Inspection

Report No. 1475

EXAMINATION OF SECTION OF 34" PIPE
REMOVED FROM MAIN 300B NEAR TRONA

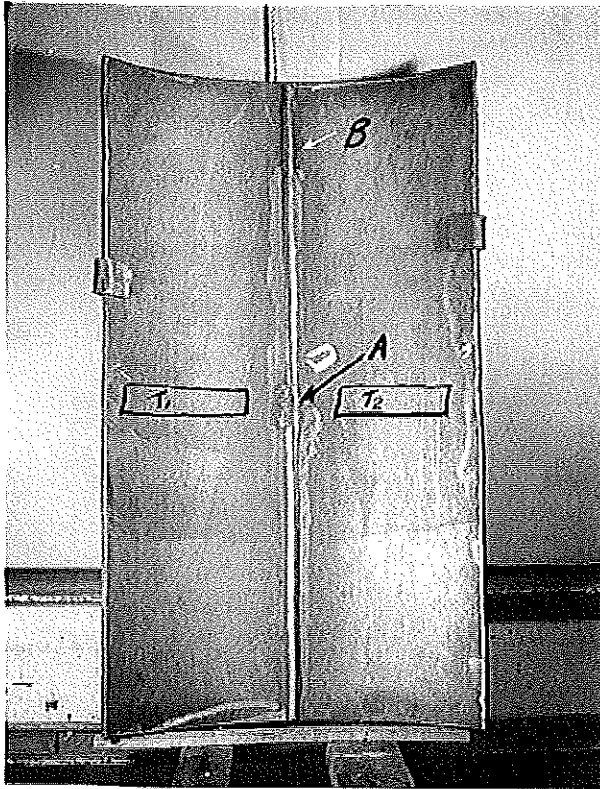
Photograph No. 1 shows the inside of the section as received with the areas from which samples were cut marked as A and B. Photograph No. 2 shows Area A (where the leak developed) from the inside and Photograph No. 3 shows the same area from the outside. Photograph No. 4 shows Area B from the inside.

Photograph No. 1
General view of section of
pipe from main 300B,
mile 172.

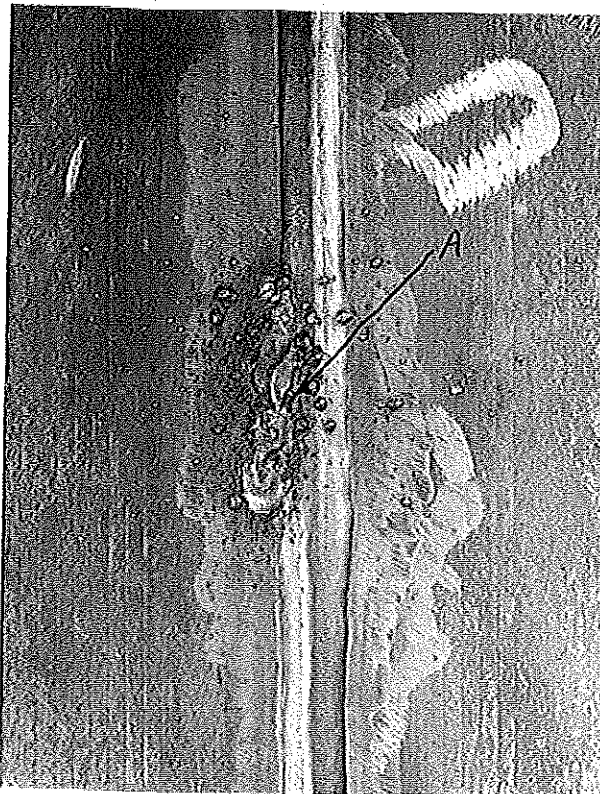
As may be noted from these photographs, there is evidence of extensive grinding over most of the section sent us, and, as indicated in Photo No. 4, evidence of rewelding over the ground portion. In addition, there had been a crude attempt to cover up a defect apparently discovered in Area A.

Photograph No. 2
Inside of 36" pipe showing
area of failure.

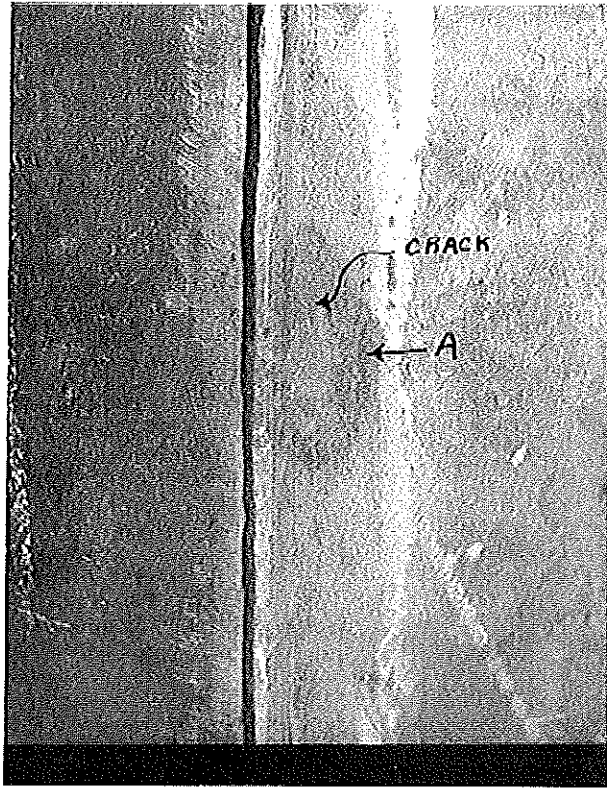
Photograph No. 3
Outside of 3/4" pipe at area
of failure showing crack.

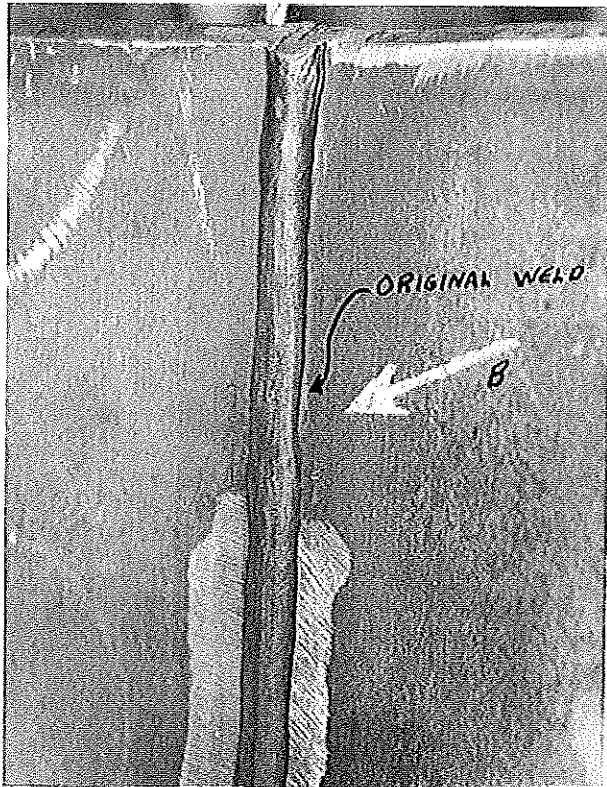
Photograph No. 4
Inside of 3/4" pipe at area "B",
showing overwelding.

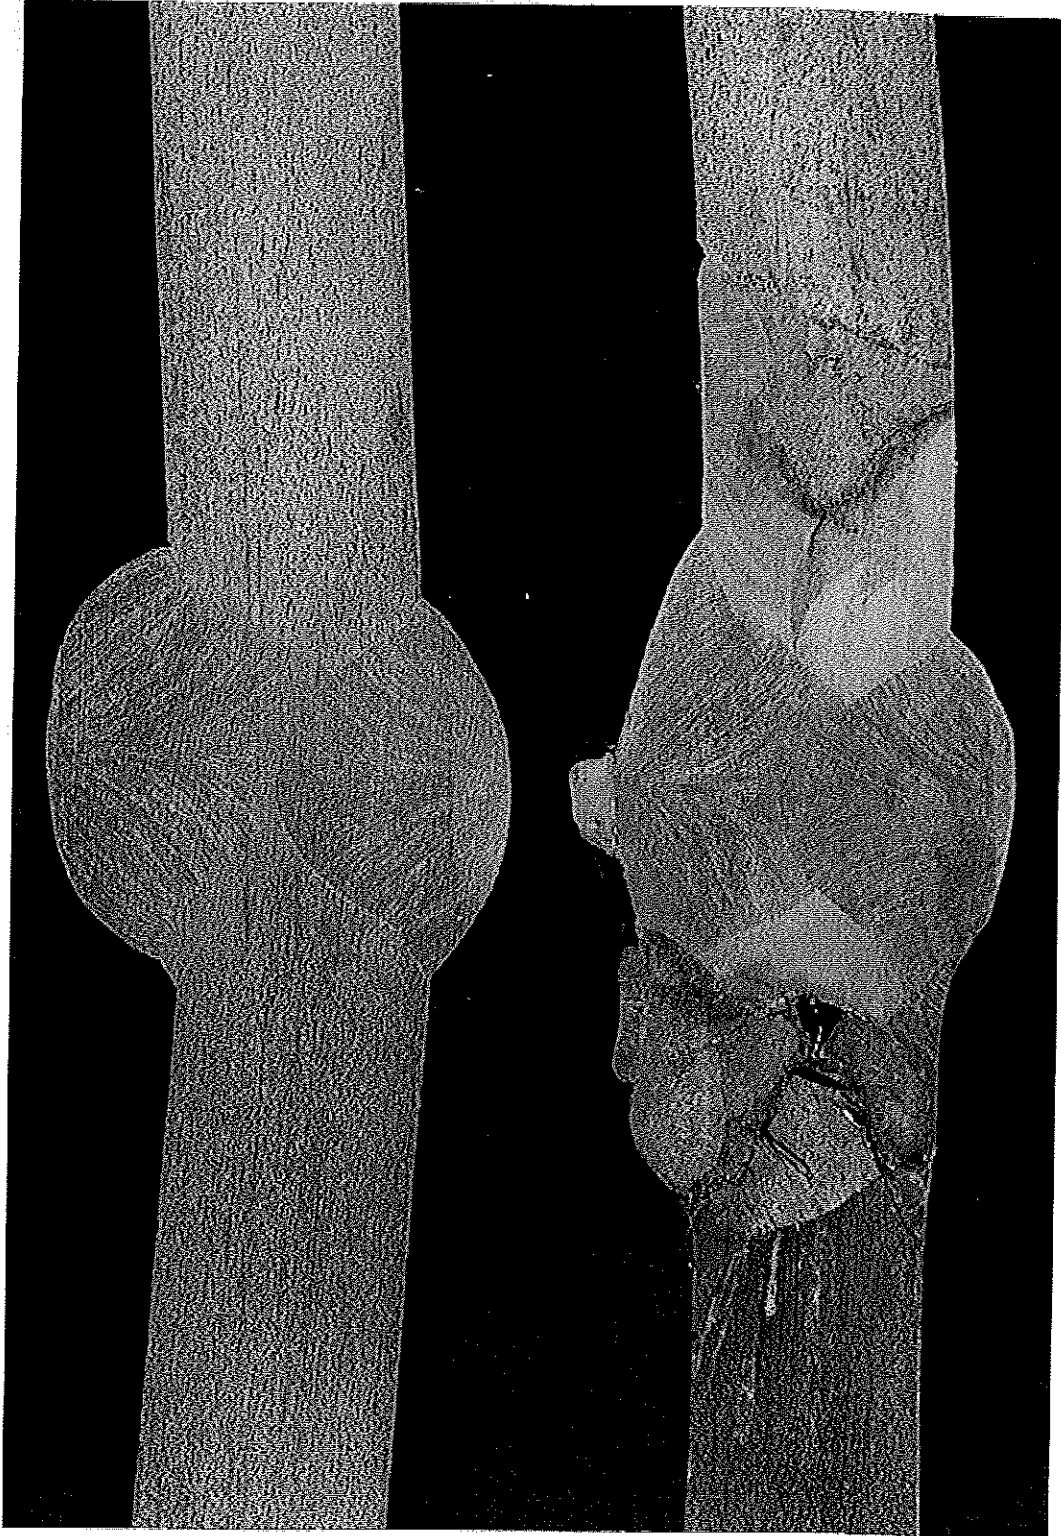
PHOTOGRAPH No 5

Small sections were cut from the pipe with a De-ALL SSW, at Areas A and B which were polished, etched and photographed. These sections are shown in Photograph No. 5.

Weld Structure: Photograph No. 5A shows the weld structure in the area of failure. Apparently there have been at least three welds made in this area, and it appears that attempts have been made to repair defects in either the plate or the weld by building out the plate with weld metal, grinding and reworking and rewelding. The exact sequence of these operations can not be determined, but it is obvious that such repairs are unsatisfactory and should have been caught during shop inspection.

Photograph No. 5B shows the excellent reweld obtained some fifteen inches from the area of failure.
