This engineering report provides the inspection results for spoiler actuator, P/N 1524800-19, removed from Cessna C650, S/N 7063 which experienced unexpected roll during flight.

Item: Servo Actuator Assembly, Spoiler Hydraulic  
P/N: 1524800-19 (Cessna P/N 9914155-19)  
S/N: 2641  
MFG Date: 2.20.1995

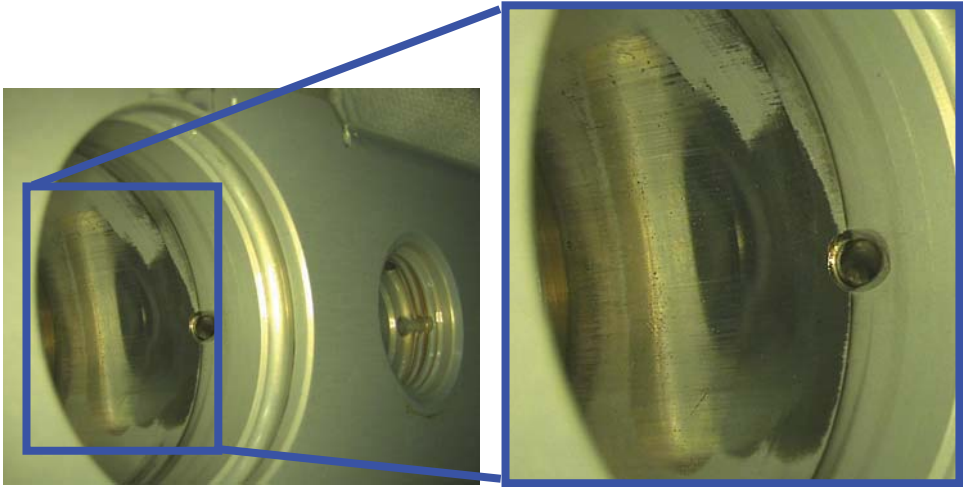
<u>Wear Mark, Housing Inner Bore</u>

#	Findings	Descriptions
1	Wear mark and linear scratch on inner bore, housing, P/N 1524801-7	<ul style="list-style-type: none"><li>➤ Wear mark was observed on inner bore of housing.</li><li>➤ Minor linear scratches were also observed on inner bore of housing.</li></ul> (Refer to Page 2 of Appendix 2 for details)

#	Findings	Nabtesco's Assessment
1	Wear mark and linear scratch on inner bore, housing, P/N 1524801-7 (Item #1 of Table 1)	Wear mark is considered due to side load on the piston during field operation. However, amount of wear is minor and bore diameter was still within the drawing requirement. It is hard to consider that the wear mark resulted in the events observed during the aircraft or actuator level investigations. Linear scratches are considered due to contamination sticking between housing inner bore and piston head. However, scratch was very minor and hard to consider that the scratch or contamination itself resulted in the events.
2	Dents on gears (shaft), P/N 1524823 (Item #2 of Table 1)	Major dents observed were on teeth not being used in operation. Small dents on other teeth were minor and, according to Miyako Seiki, gear manufacturer, no effects on gear operation can be considered. Therefore, it is hard to consider that the dents observed gear teeth resulted in the events observed during the aircraft or actuator level investigations.

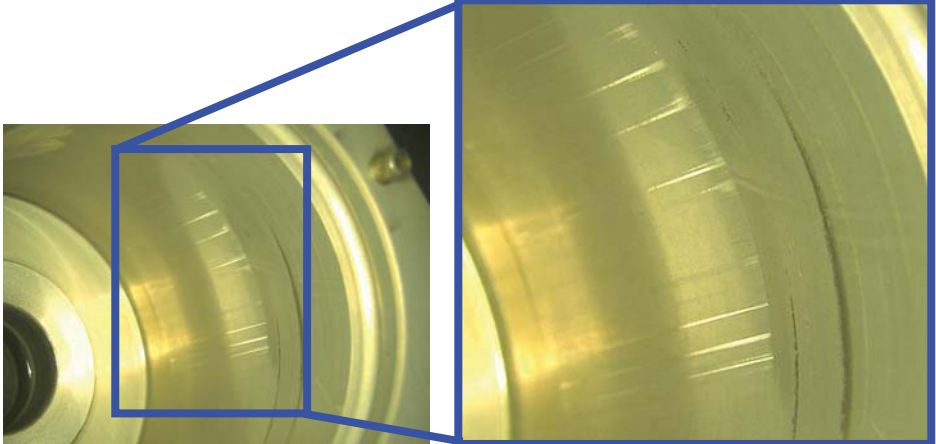
<p style="text-align: center;"><u>Linear Scratches, Housing Inner Bore</u></p>
2	Dents on gears (shaft), P/N 1524823	<ul style="list-style-type: none"> <li>➢ Major dents on 1st, 2nd and 16th gear teeth and a minor dent on 15th gear tooth were observed on the Manifold side shaft.</li> <li>➢ Major dents on 16th gear tooth and minor dent on 12th gear tooth were observed on the cover side shaft.</li> </ul> <p>(Refer to Page 5 thru Page 8 of Appendix 2 for details with magnified photos)</p>

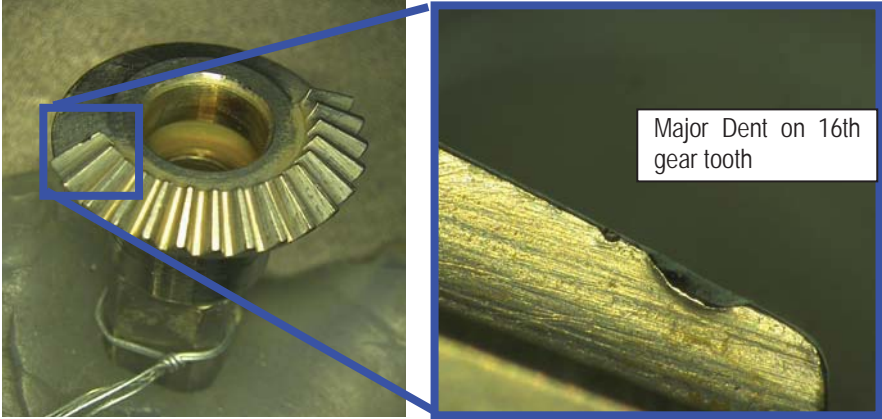
#	Findings	Descriptions
	Dents on gears (shaft), P/N 1524823 (continued)

<p style="text-align: center;"><u>Dents on Gears, Cover Side Shaft</u></p>
3	Wear of electro film, bearing, P/N 1524828	<p>➤ Electro film on flange were worn out for both bearings, cover and manifold side. (Refer to Page 10 of Appendix 2 for details with visual inspection results)</p>

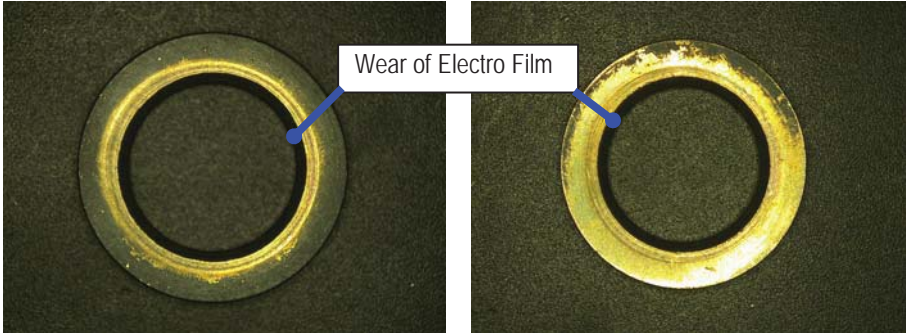
<p style="text-align: center;"><u>Electro Film Wear, Cover Side Bearing</u>    <u>Electro Film Wear, Manifold Side Bearing</u></p>
4	Linear scratch on piston head, piston, P/N 1524802-3	<p>➤ Minor linear scratch was observed on piston head, piston head side. (Refer to Page 12 Appendix 2 for details)</p>

3	Wear of electro film (Item #3 of Table 1) & Out of drawing requirement, flange thickness, bearing, P/N 1524828 (Item #1 of Table 2)	Out of bearing flange thickness from the drawing requirement is due to wear of electro film. And wear of electro film is considered as common wear often observed on the units returned after 17 years field operation. Amount of wear was minor and, even with electro film worn out, it is designed to provide appropriate bearing function with base material of aluminum nickel bronze. Therefore, it is hard to consider that the out of bearing flange thickness resulted in the events observed during the aircraft or actuator level investigations.
4	Linear scratch on piston head, piston, P/N 1524802-3 (Item #4 of Table 1)	Linear scratches are considered due to contamination sticking between housing inner bore and piston head, and side load against housing bore diameter. However, scratch was very minor and it is hard to consider that the out of bearing flange thickness resulted in the events observed during the aircraft or actuator level investigations.
