On May 27, 2011 during landing approach of A/C G200 #165 at Stewart International Airport (SWF), Newburgh, NY, The right hand main landing gear collapsed causing the right hand wing and associated parts to contact the runway surface.

This document presents the investigation results of the right main landing gear Actuator 27300-000-05 IL 111 A/C 165.

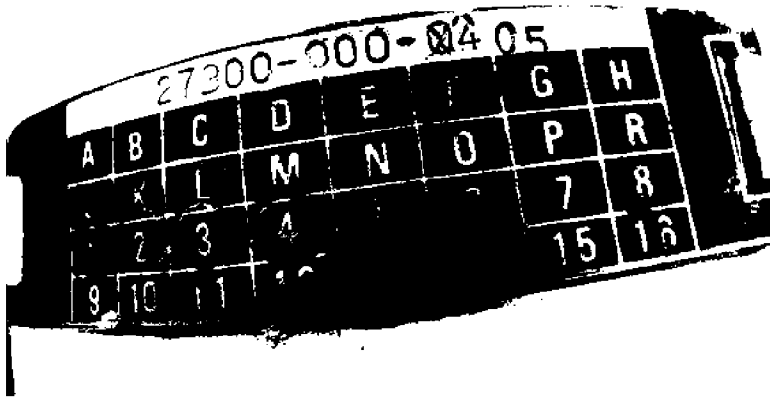
1. Name plate improper marking (see fig. 1, 2).

Fig 1 Name plate improper marking

The name plate should be replaced when updating the actuator, and not doing it by crossing the old number and adding the new version on the old name plate.

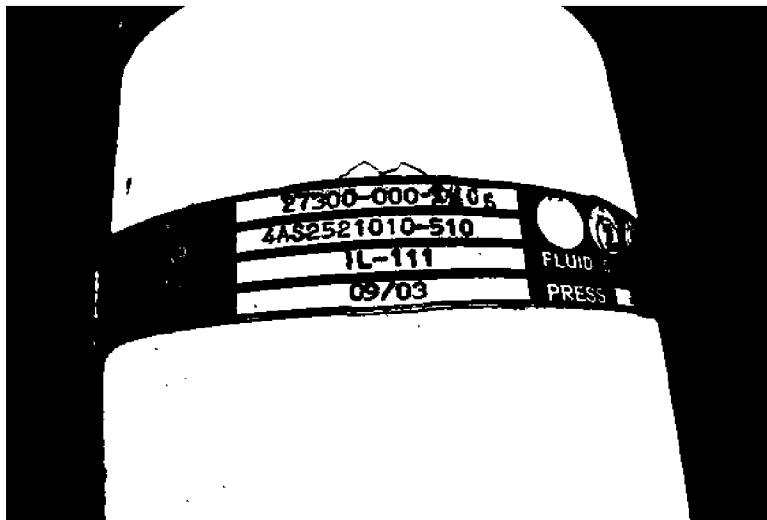
Fig 2 Name plate improper marking

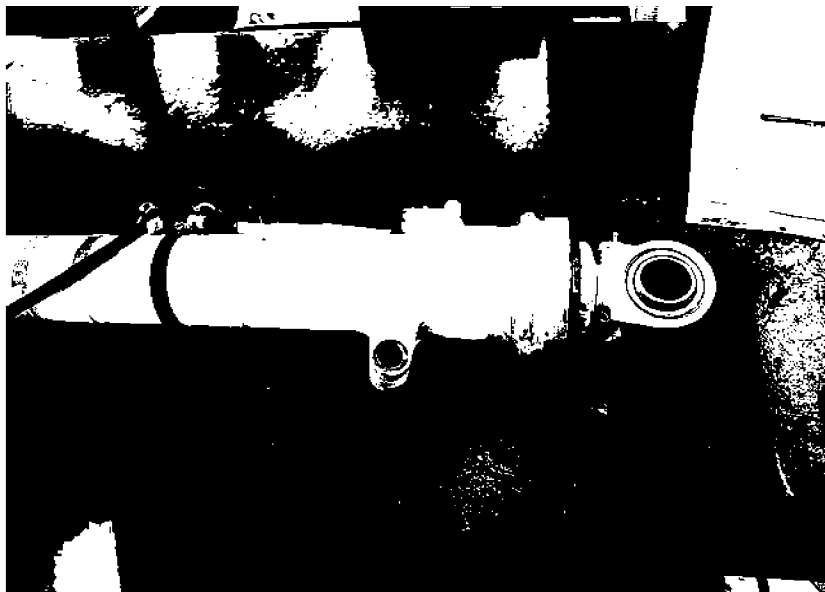
3. Released actuator rod end nut.

The rod end nut was found released (see fig 4), it should be tighten.

Fig 4 Release actuator rod end nut.

Release Rod end nut

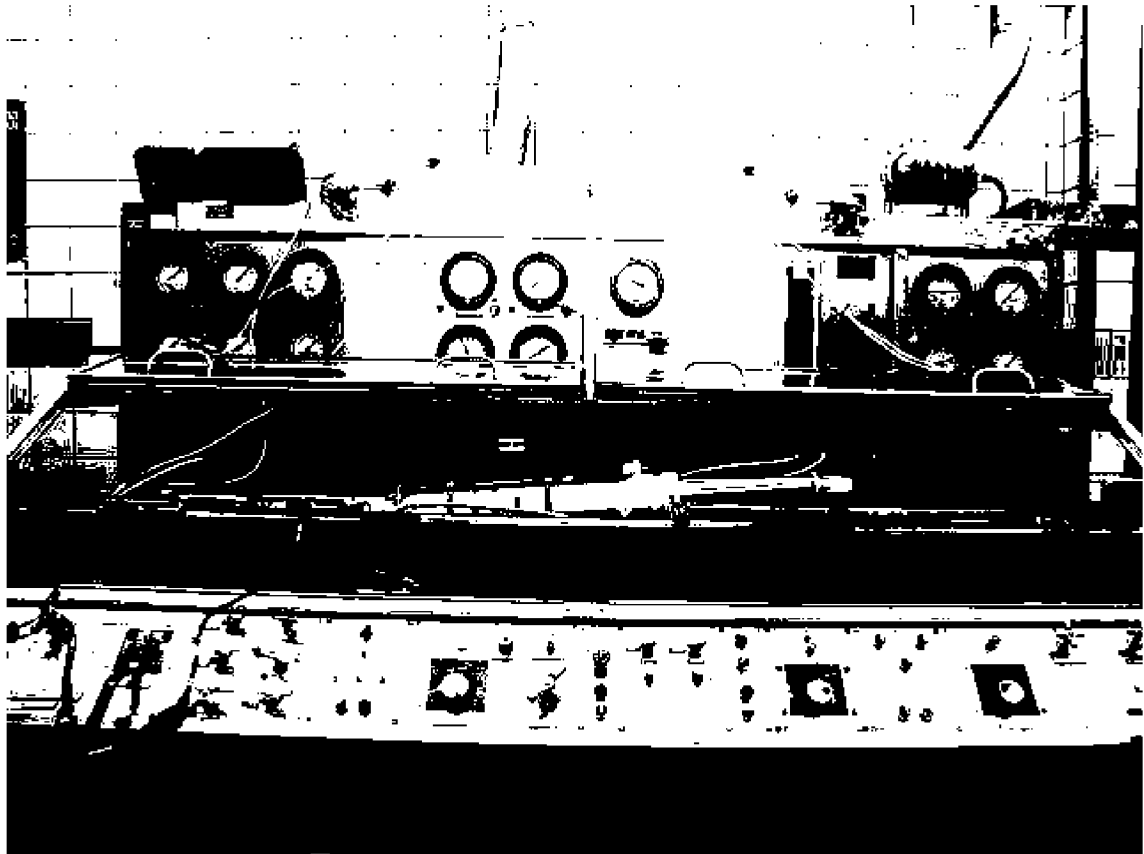
Fig 5 Test rig.

- a. No evidence of locking/unlocking problems or electric indication failure was found during actuator ATP test.
- b. The locking/unlocking pressure results show compliance with ATP requirements.
- c. Clearance measurements of the piston rod at locked position show compliance with the ATP requirements (see attached ATP).
- d. Excessive hydraulic leakage from the actuator gland and cylinder were detected during the ATP

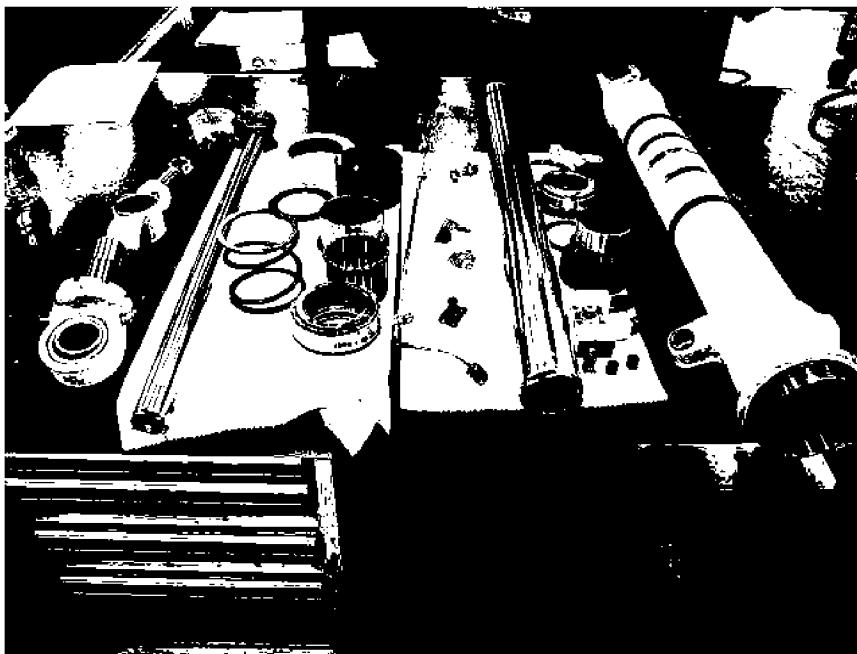
Fig 6 Disassembly of actuator

No defects or damage marks has been observed on actuator parts.
Results of dimensional inspection performed on several parts were OK:
