2. FINDINGS OF PART NUMBER 2524644 SERIAL NUMBER 324947.

NTSB ID WPR13FA119

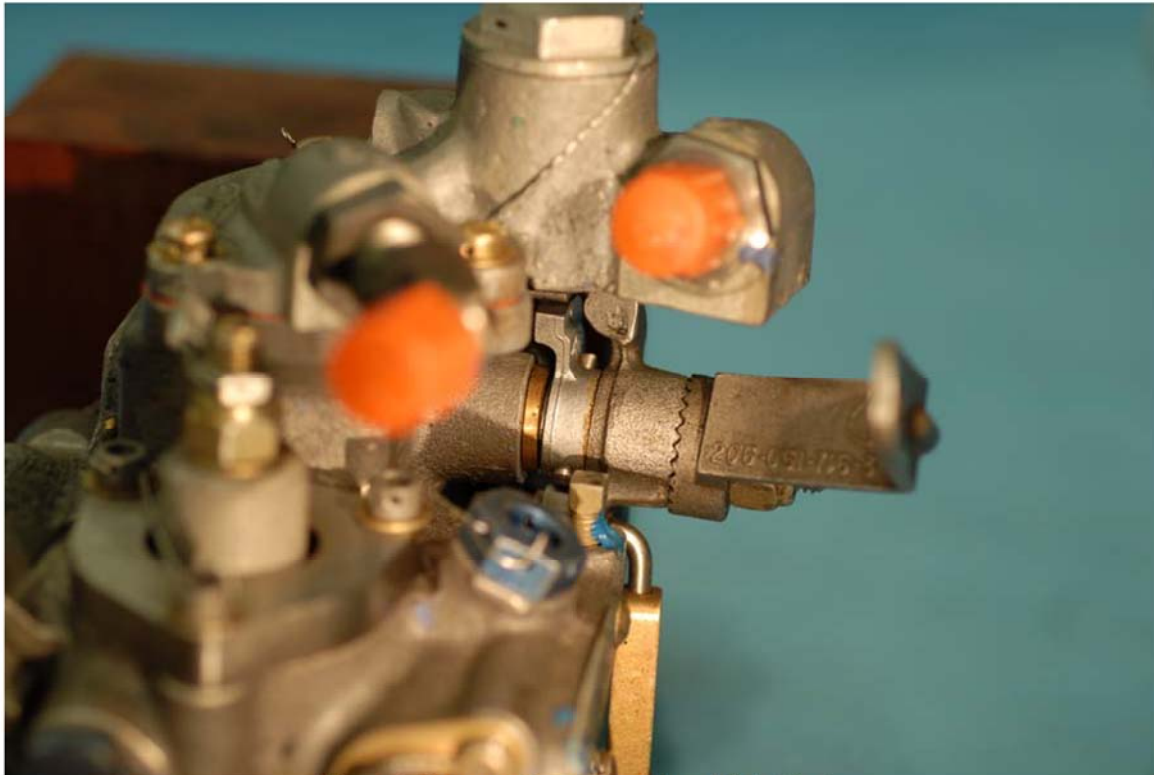
- 2.1.1. All Lock wire and seals were in place.
- 2.1.2. The PLA Shaft was bent but rotated normally.
- 2.1.3. The Drive Shaft rotated normally.
- 2.1.4. The Cut-off Lever was bent inboard to the FCU.
- 2.1.5. PR, PG, PY and PC fittings were found to be unobstructed.

Figure 7 Impact Damage - Bent PLA Shaft

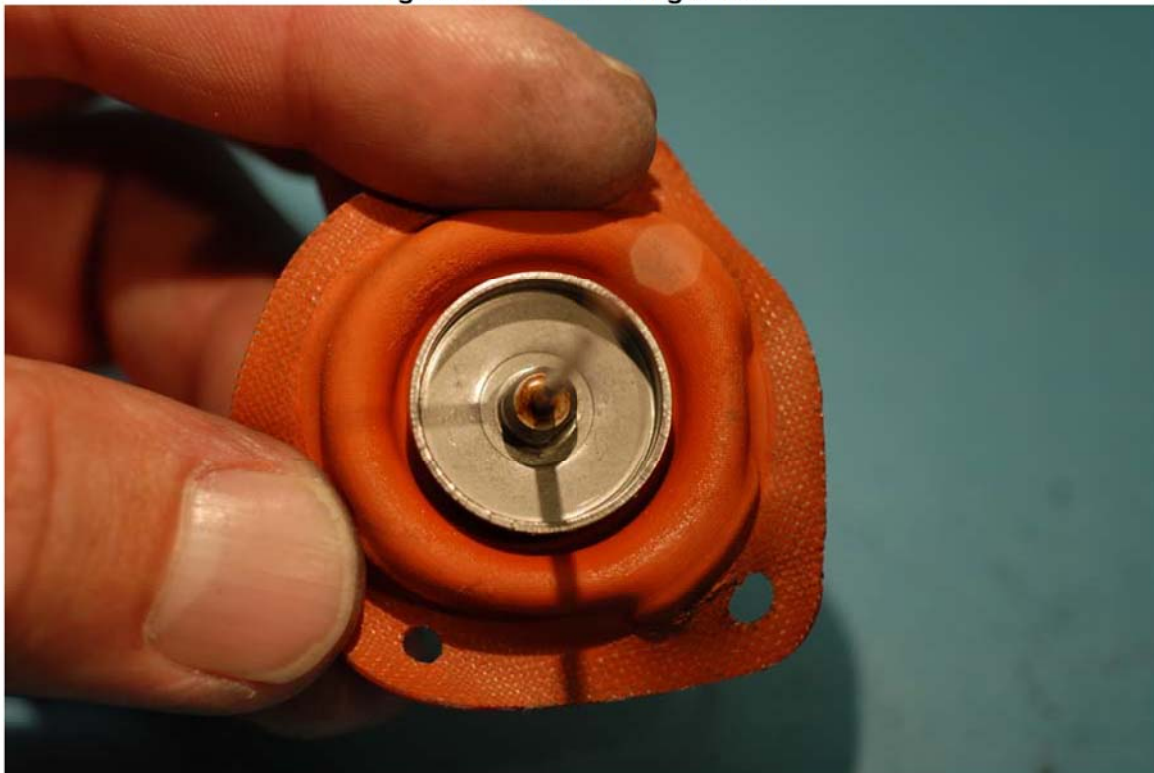
- 2.3.1. The PR/PG Regulator diaphragm was found to be normal.
- 2.3.2. The PR/PG Valve translated normally in the reset body bore.
- 2.3.3. The Pressure Relief Valve was found to translate normally.

Figure 12 Reset Diaphragm

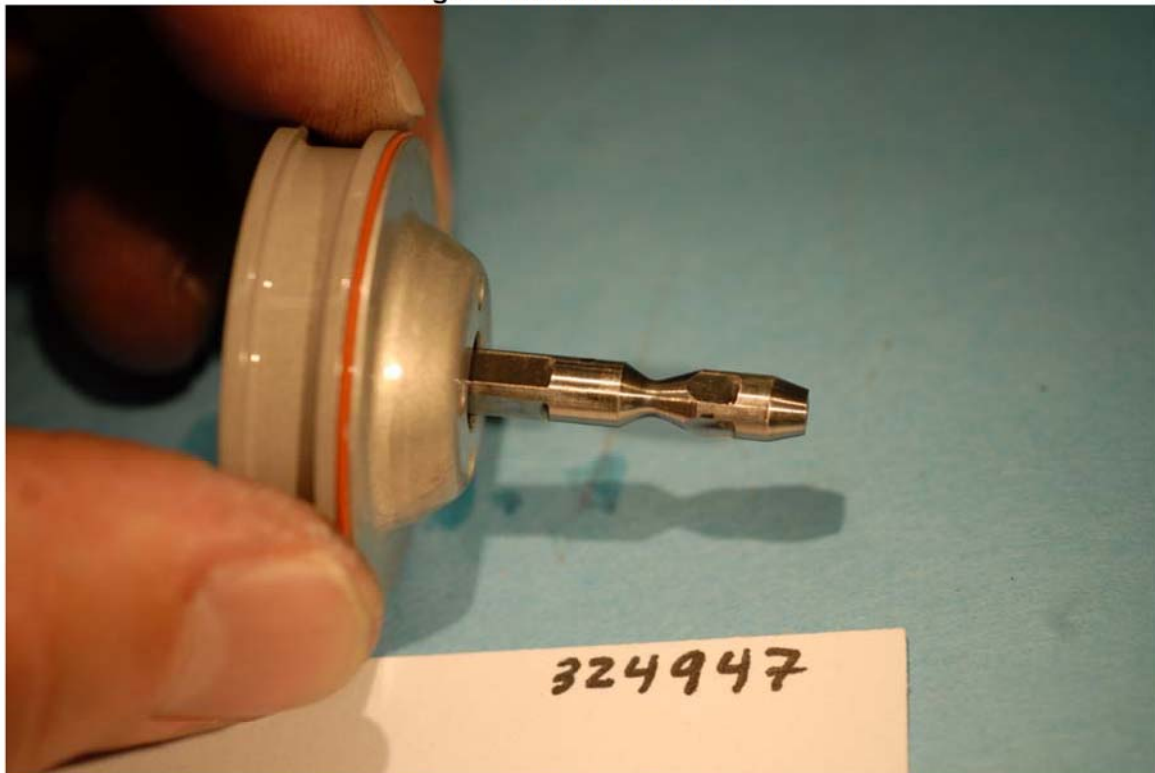
- 2.3.4. The Bypass Valve was found to translate normally in the Bypass Sleeve.
- 2.3.5. The Bypass Valve Sleeve exterior color was a non-standard color. The lands of the sleeve were normal steel color however, the barrel sections of the sleeve were black in color indicating a possible coating was in place.

Figure 14 Bypass Valve

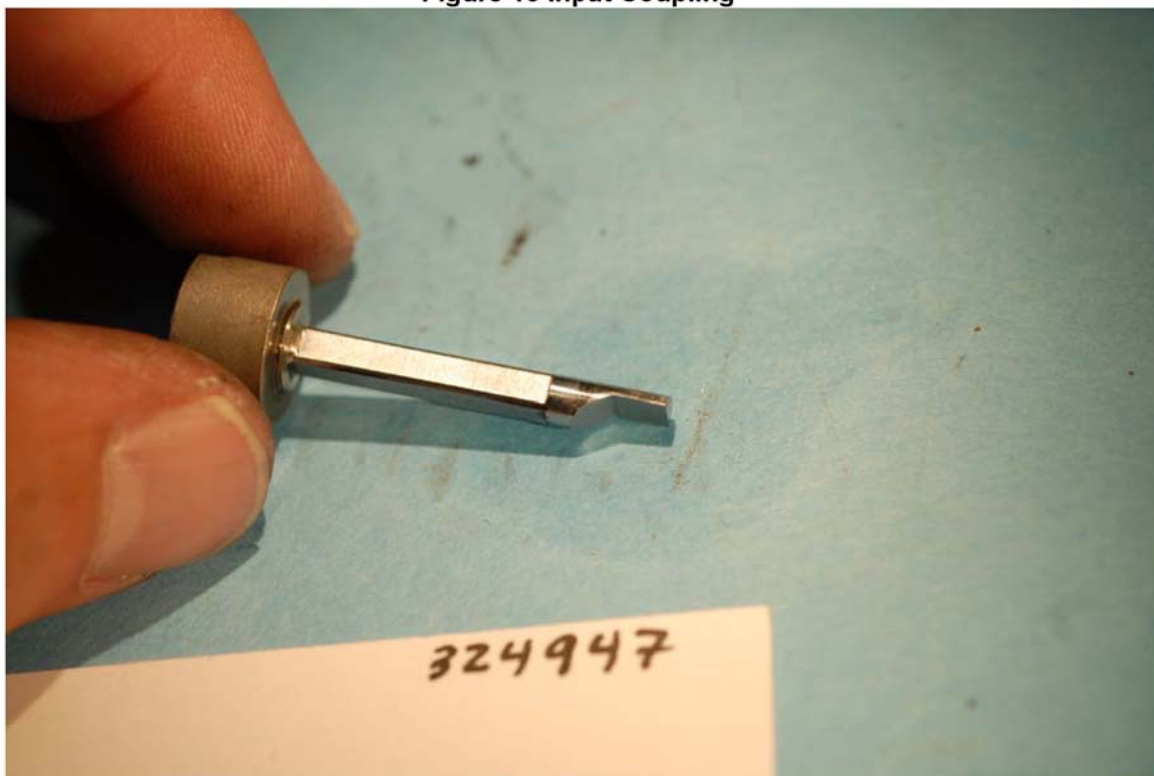
- 2.3.6. No anomalies were found with the Metering Valve and Sleeve Assembly.
- 2.3.7. No anomalies were found with the Ratio Lever Arms.
- 2.3.8. The Torque Tube Assembly had no anomalies.

Figure 16 Metering Valve

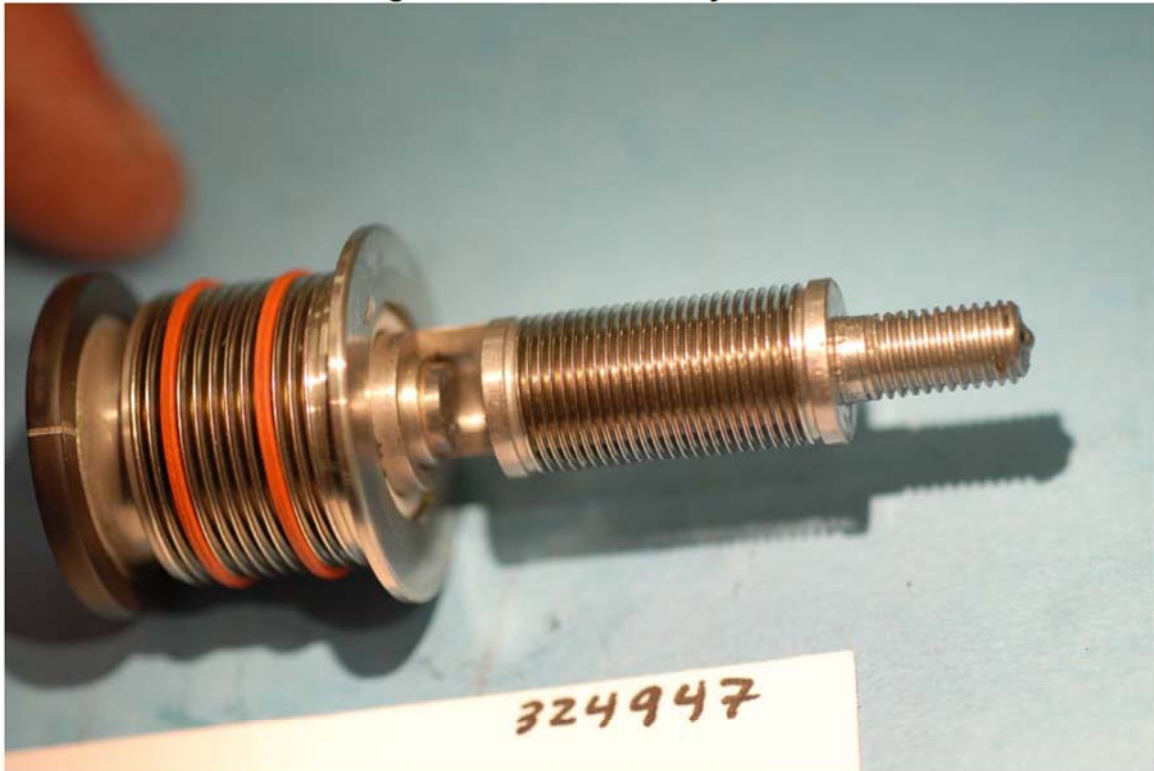
- 2.3.9. The Acceleration Bellows length was checked and found to be 1.012 and deemed to be acceptable. Manufacturer recorded length was 1.009.
- 2.3.10. No anomalies were found with the Cut-off Valve Assembly.

Figure 18 Bellows Assembly

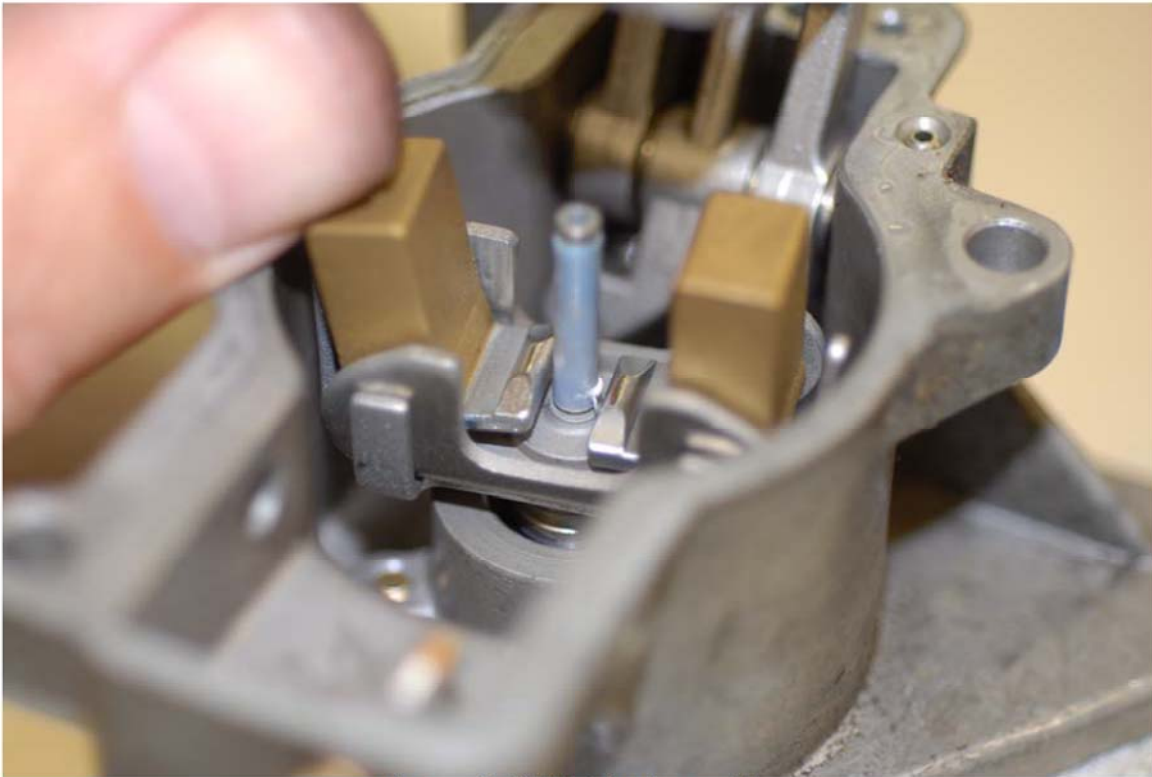
- 2.3.18. The Drive Shaft Assembly flyweights pivoted normally.
- 2.3.19. The Drive Shaft splines were found in good condition.
- 2.3.20. The Drive Shaft end play was normal.

Figure 19 FlyWeight Assembly

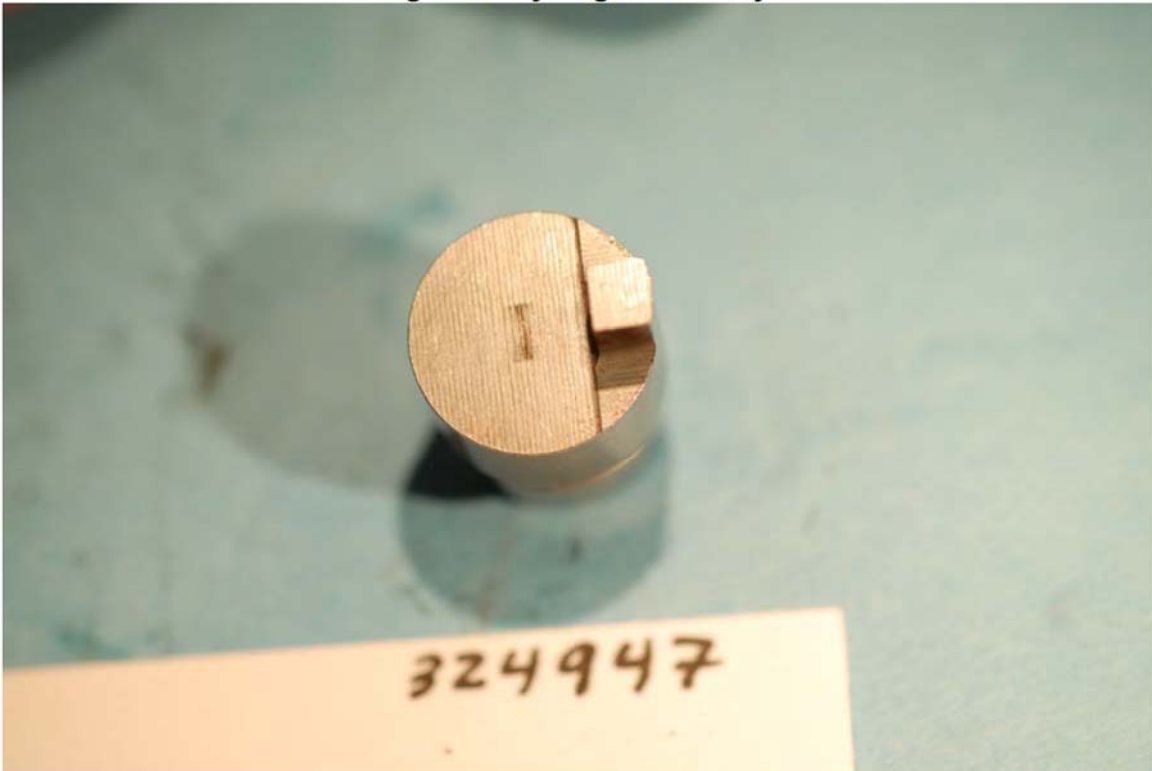
- 2.3.14. The Spool Bearing and Cap were found to be in good condition. Based on the appearance and finish of the spool bearing cap it is not a genuine Honeywell part and is considered a PMA part. Reference figure 26.

Figure 20 Spool Bearing Cap

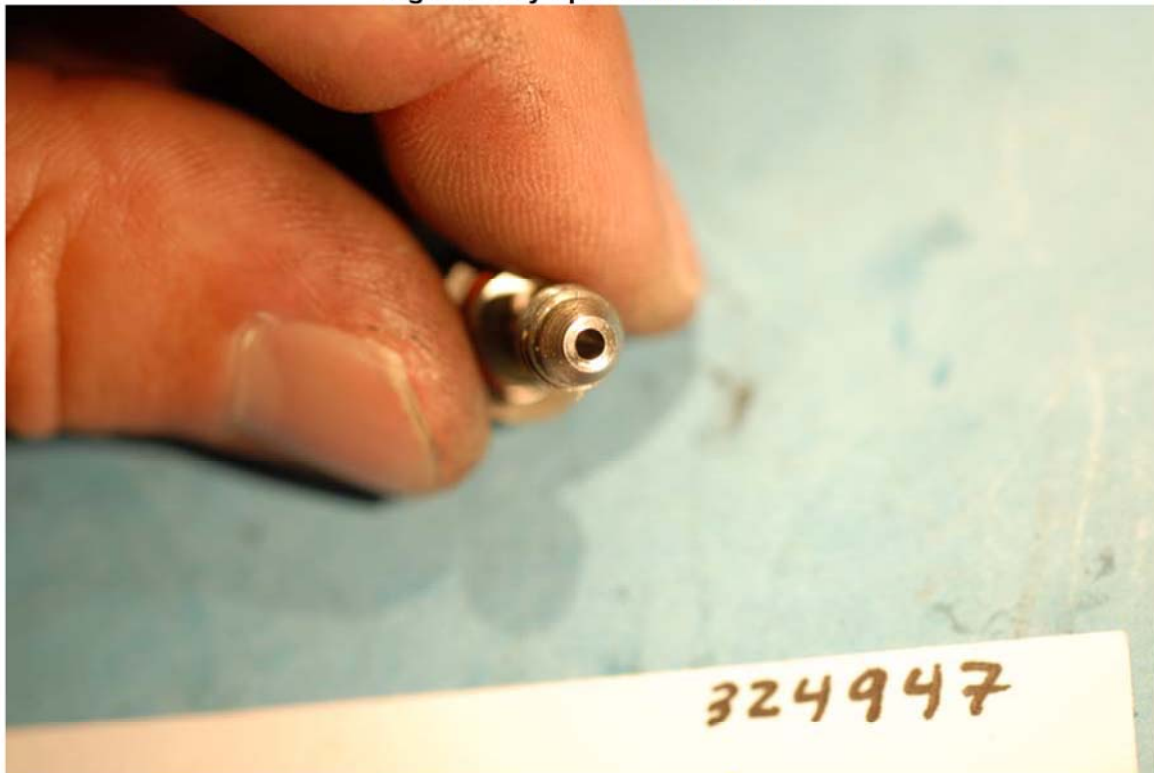
- 2.3.16. The PX and PY orifices were found to be normal.
- 2.3.17. The PX and PY lever pads had uniform circular contact witness marks from the corresponding orifices.

Figure 24 Py Orifice

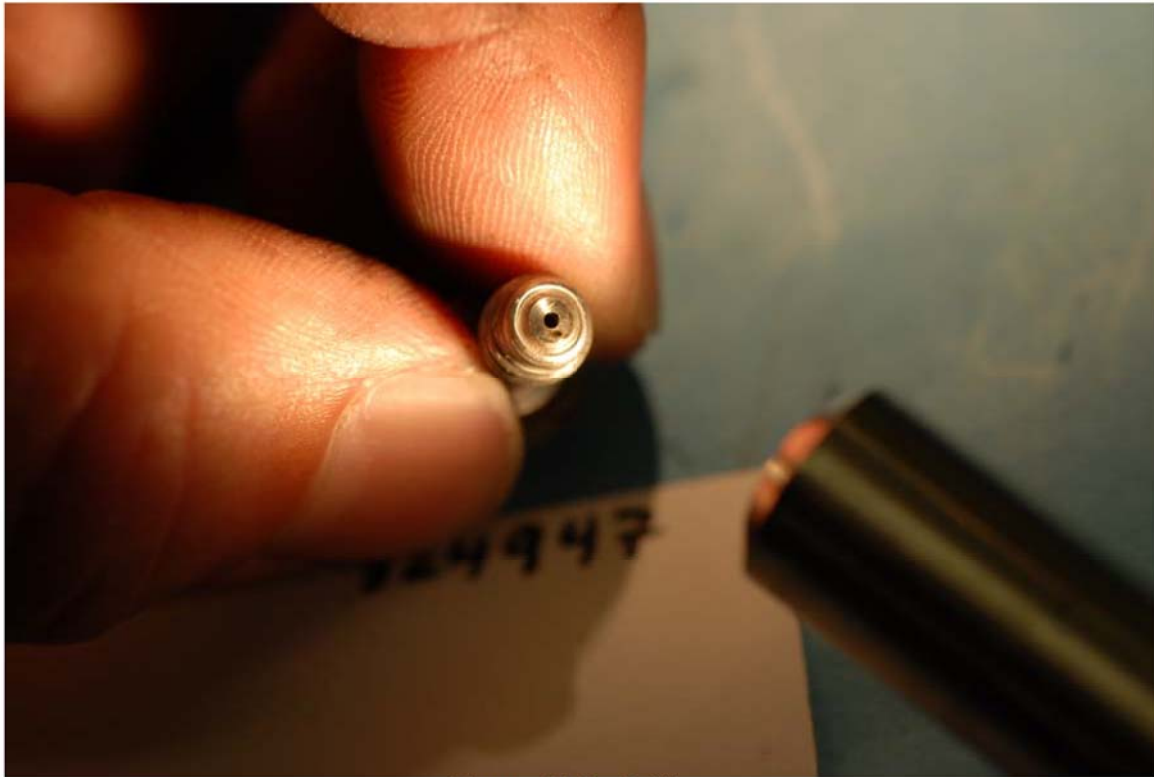
Figure 25 Px Orifice

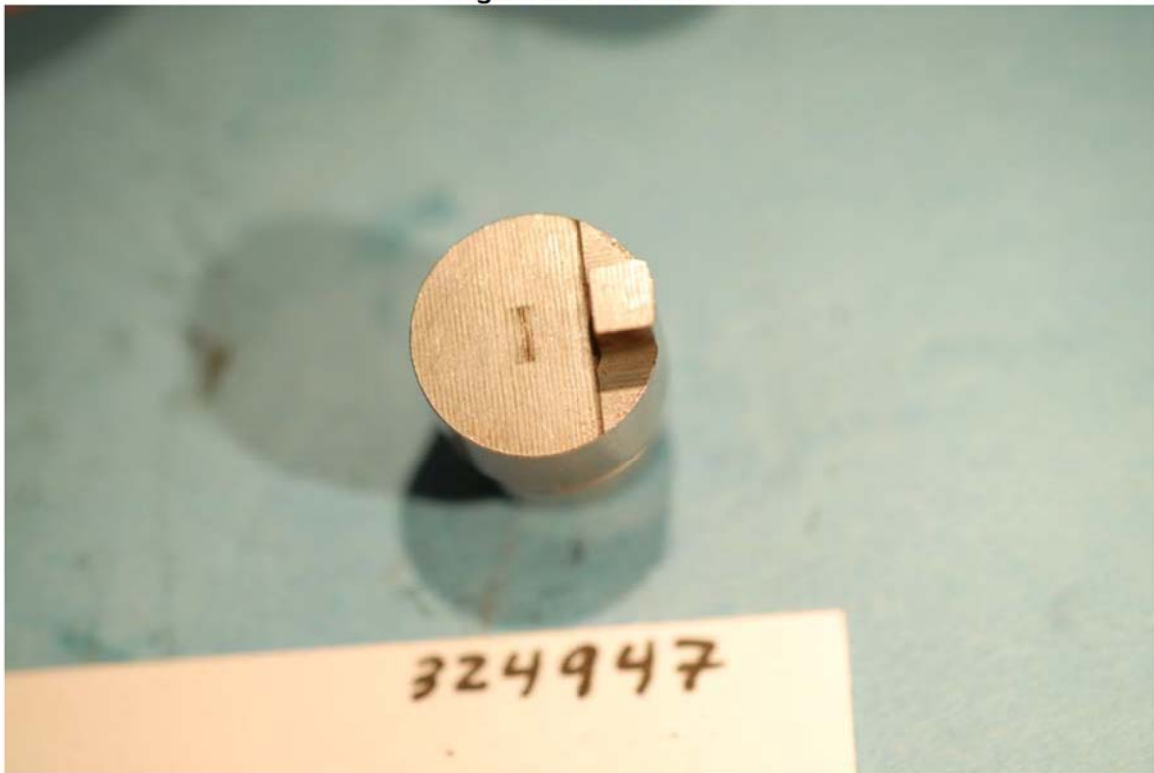
Figure 26 PMA Spool Bearing Cap
