THE CESSNA AIRCRAFT COMPANY  
PO BOX 7704  
WICHITA, KS 67277

MODEL NO: 650

REPORT NO: HY-GEN-606

ROLL SPOILER PCU  
INVESTIGATION 650-7063

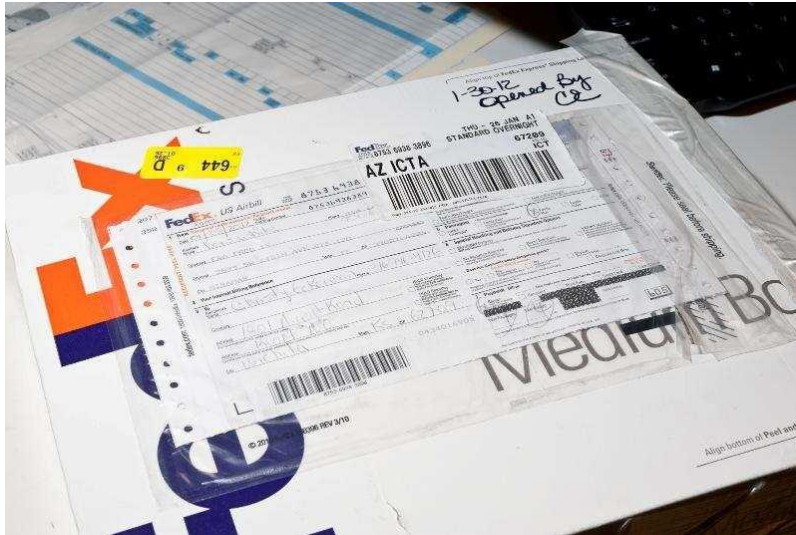
Packaging as received:

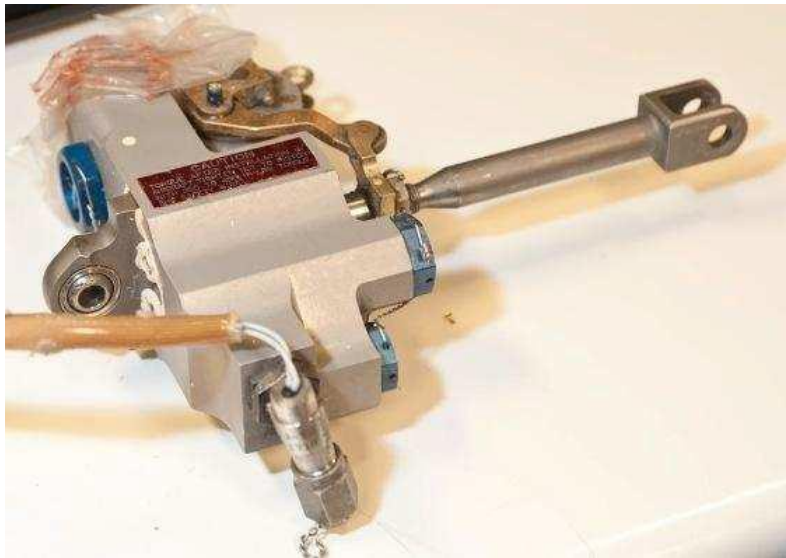
View of feedback link side as received:.

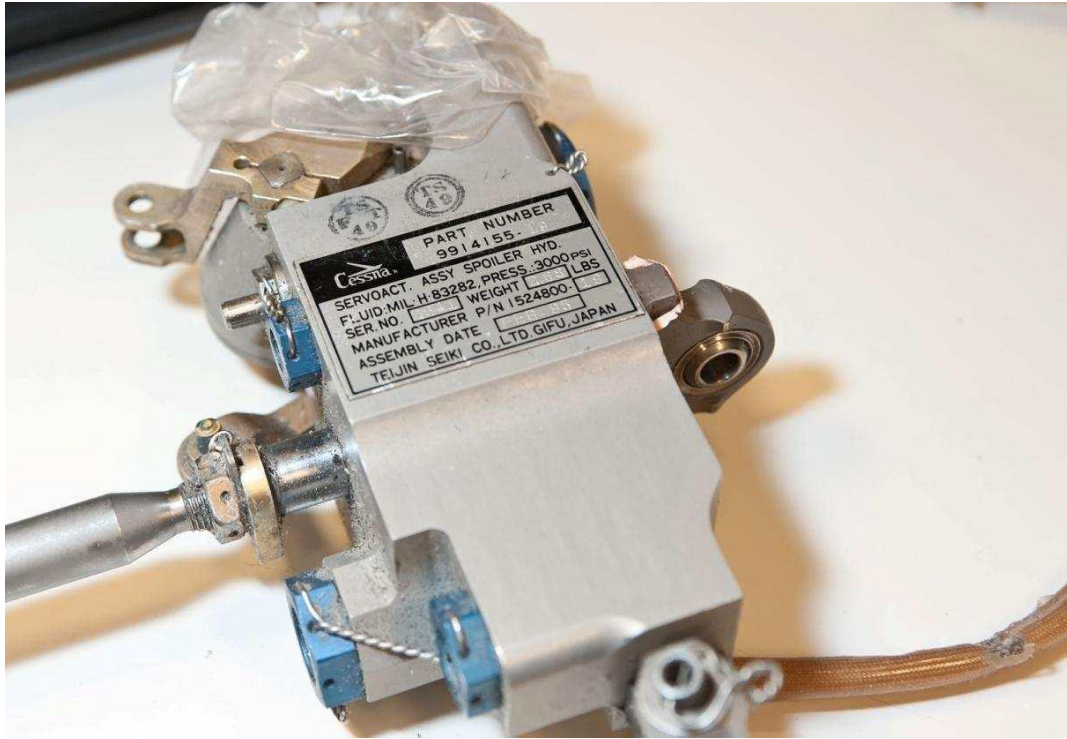
View of input link side as received:

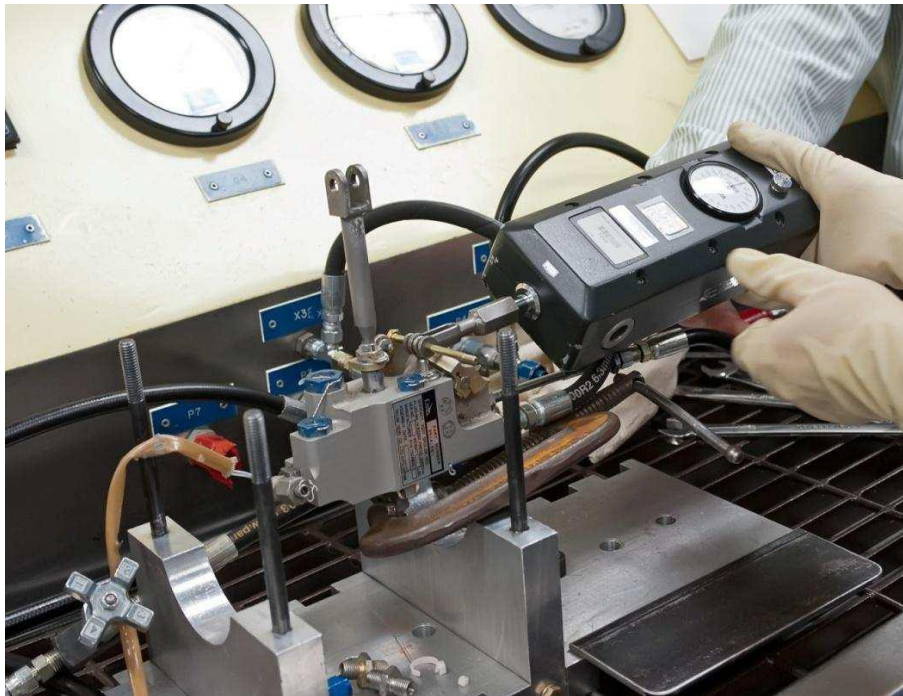
9914155-19 SN 2641 as installed for test at WCSC on 02-07-2012:

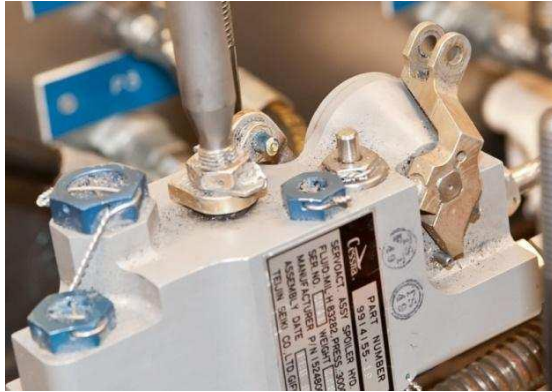
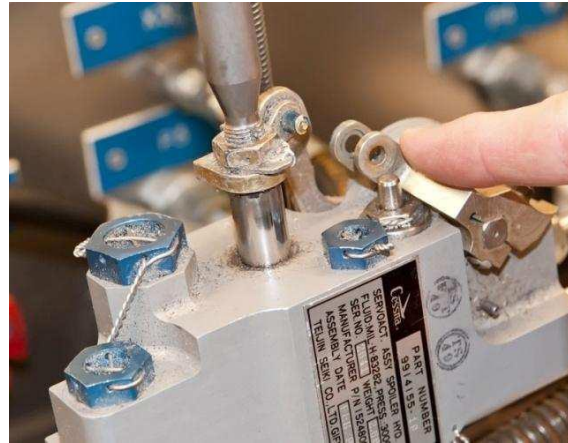
Input lever shown in normally stowed position and held in fully deployed position:

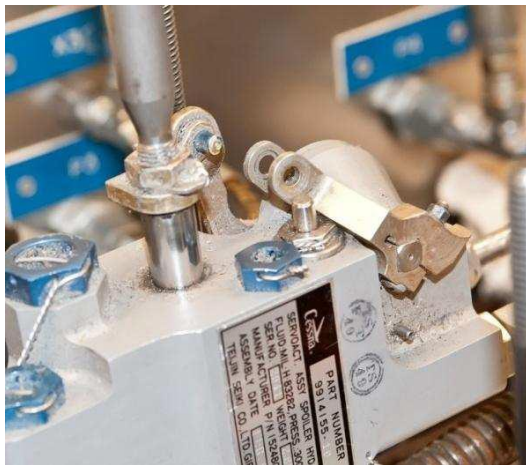
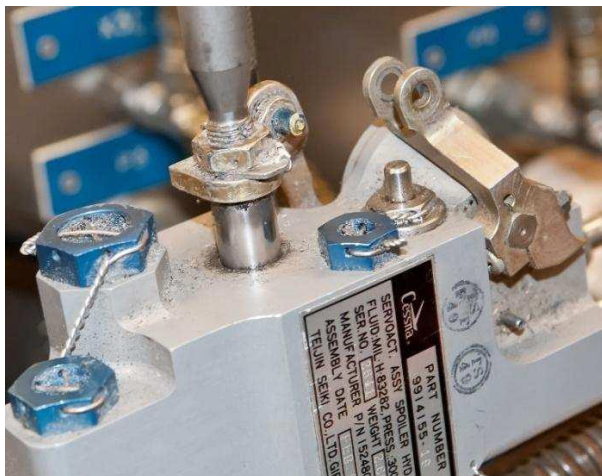
Input lever shown stuck in fully deployed position and stuck in mid position:

First input lever jam resulted in input lever stuck in full deploy position with lever against housing.

Second input lever jam resulted in input lever stuck at mid-stroke position.

In both cases pressure was reduced, input lever pushed toward stow position, and actuator retracted, following lever. It was not noted at what pressure motion resumed.

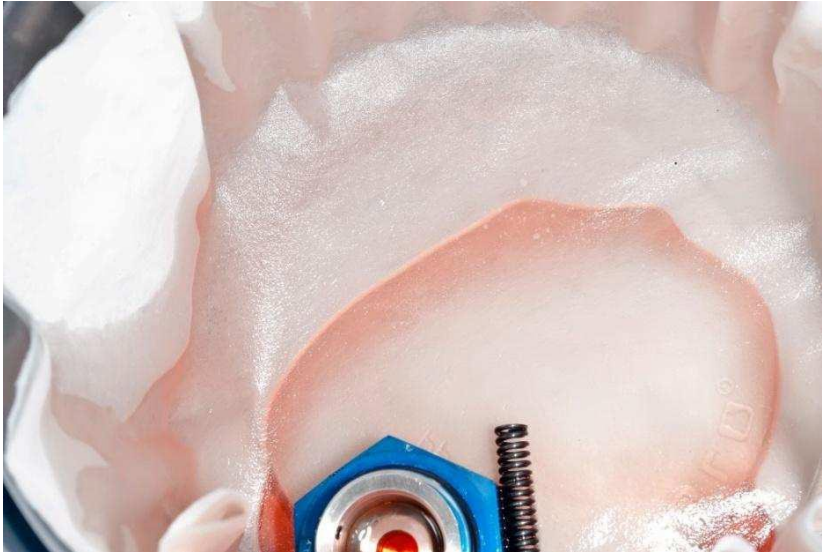
No large contaminants were found during disassembly or from examination of fluid captured during disassembly process as evaluated in Cessna Report 12-359-093 included in this report as section 4.

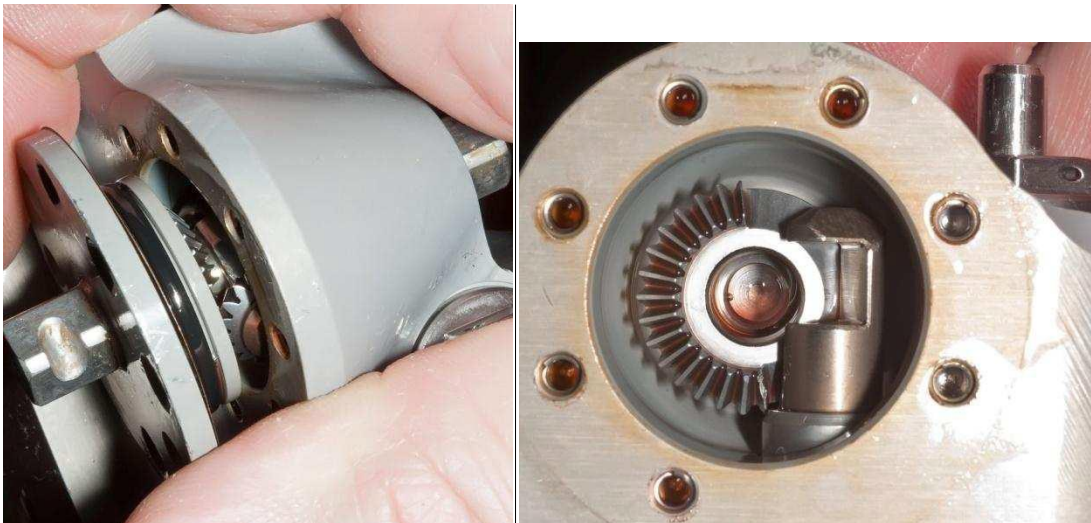
A little chip came out with fluid when medium blue plug was pulled (check valve).

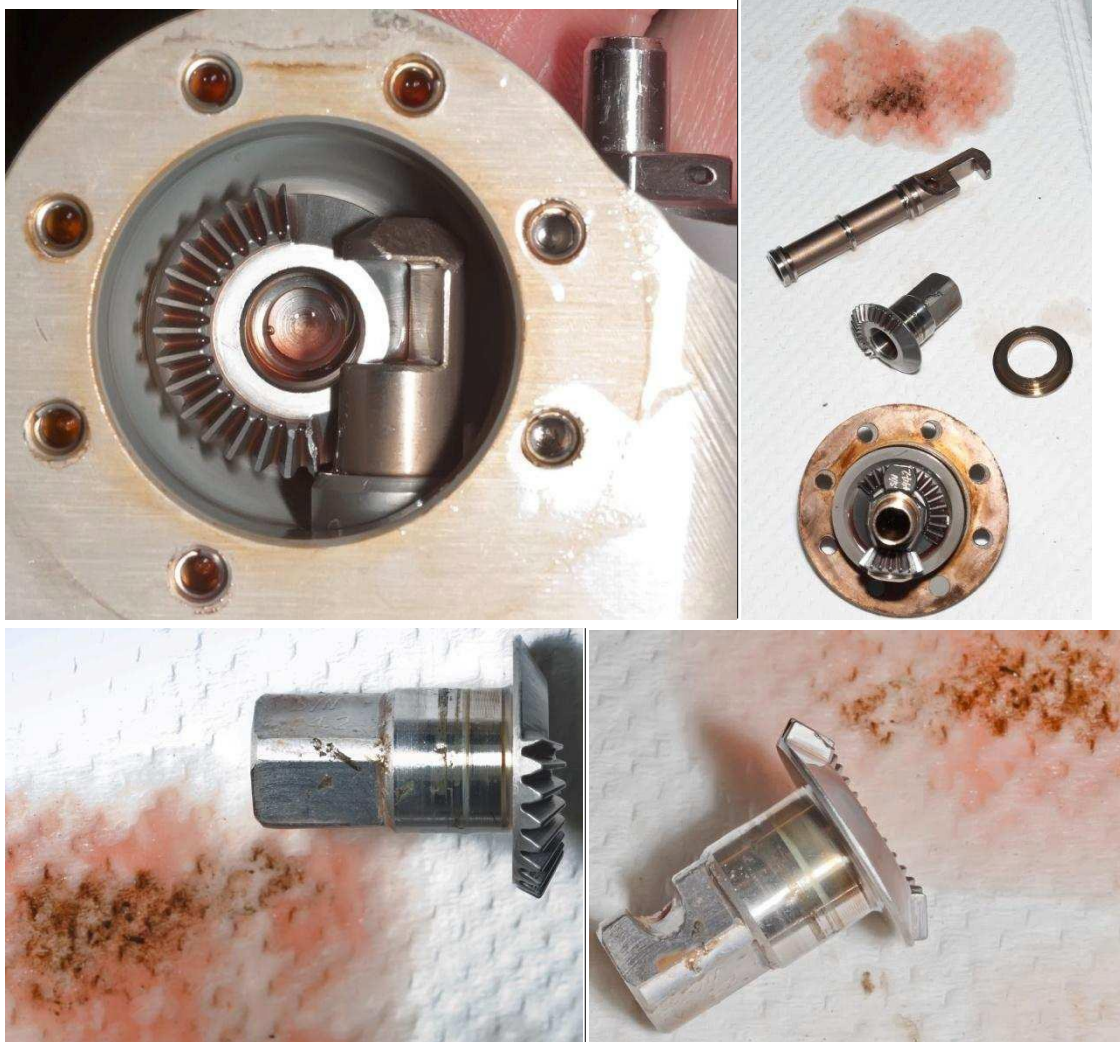
Damage seen on both input and feedback gears at extreme ends of travel, and at opposite ends (when installed damaged gear teeth would likely not be included in normal range of travel.)

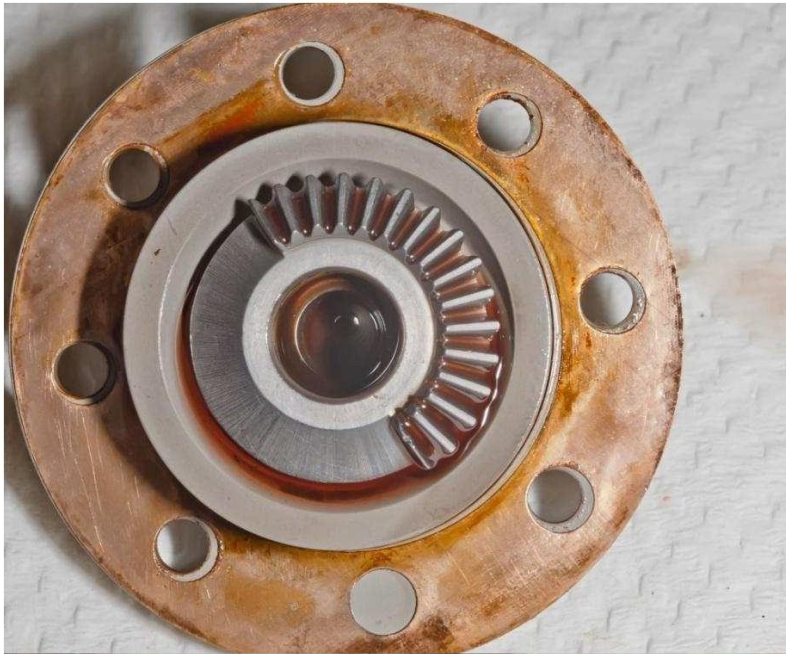
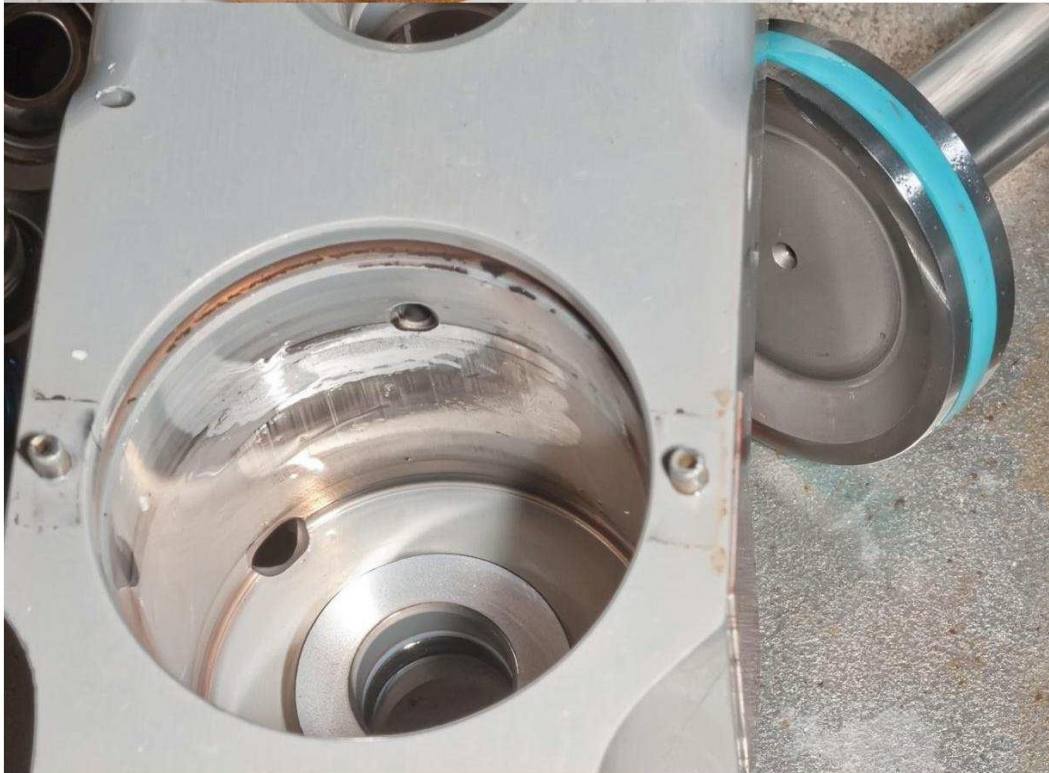
Visible contaminant was partially from external seals. It was not viewed as a likely source of valve malfunction at time of teardown.

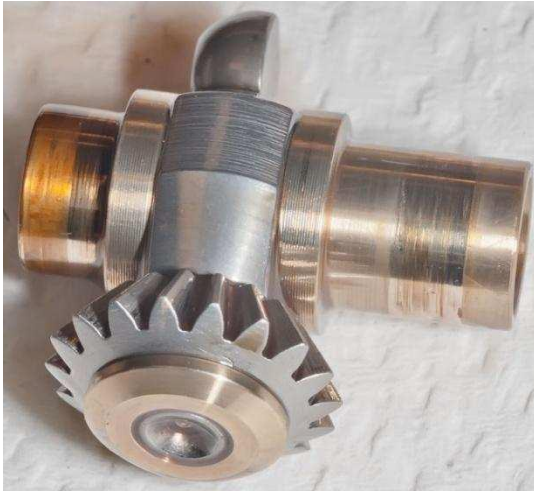
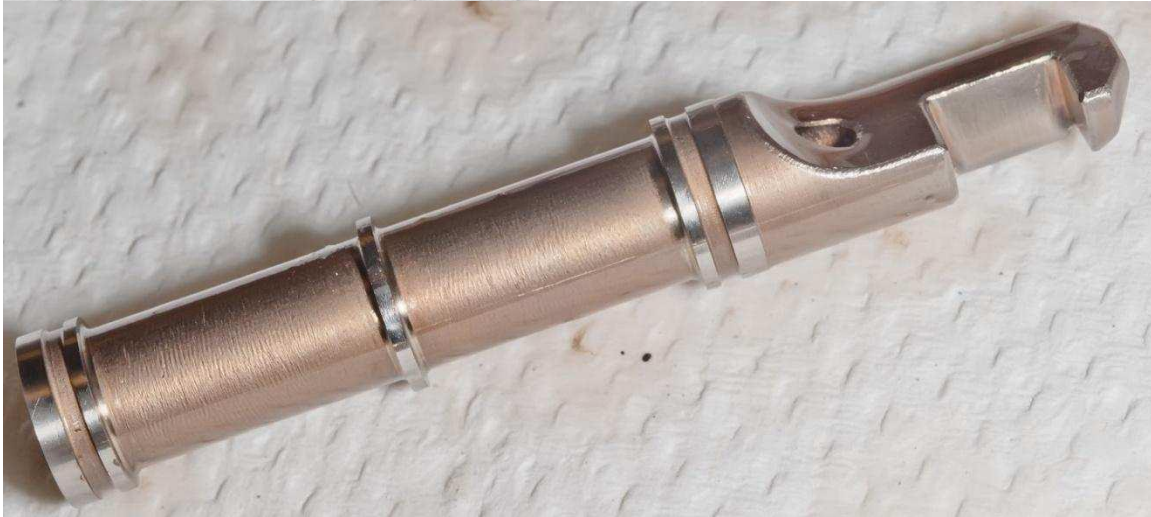
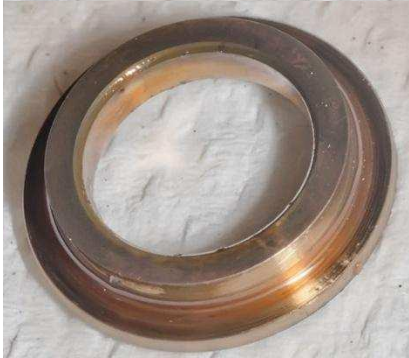
No visible damage to spool control summing gear or valve assembly.
