DOCKET NO. SA-539

NATIONAL TRANSPORTATION SAFETY BOARD
WASHINGTON, D.C.

AIRWORTHINESS GROUP ON-SCENE BALLOON CABLE EXAMINATION

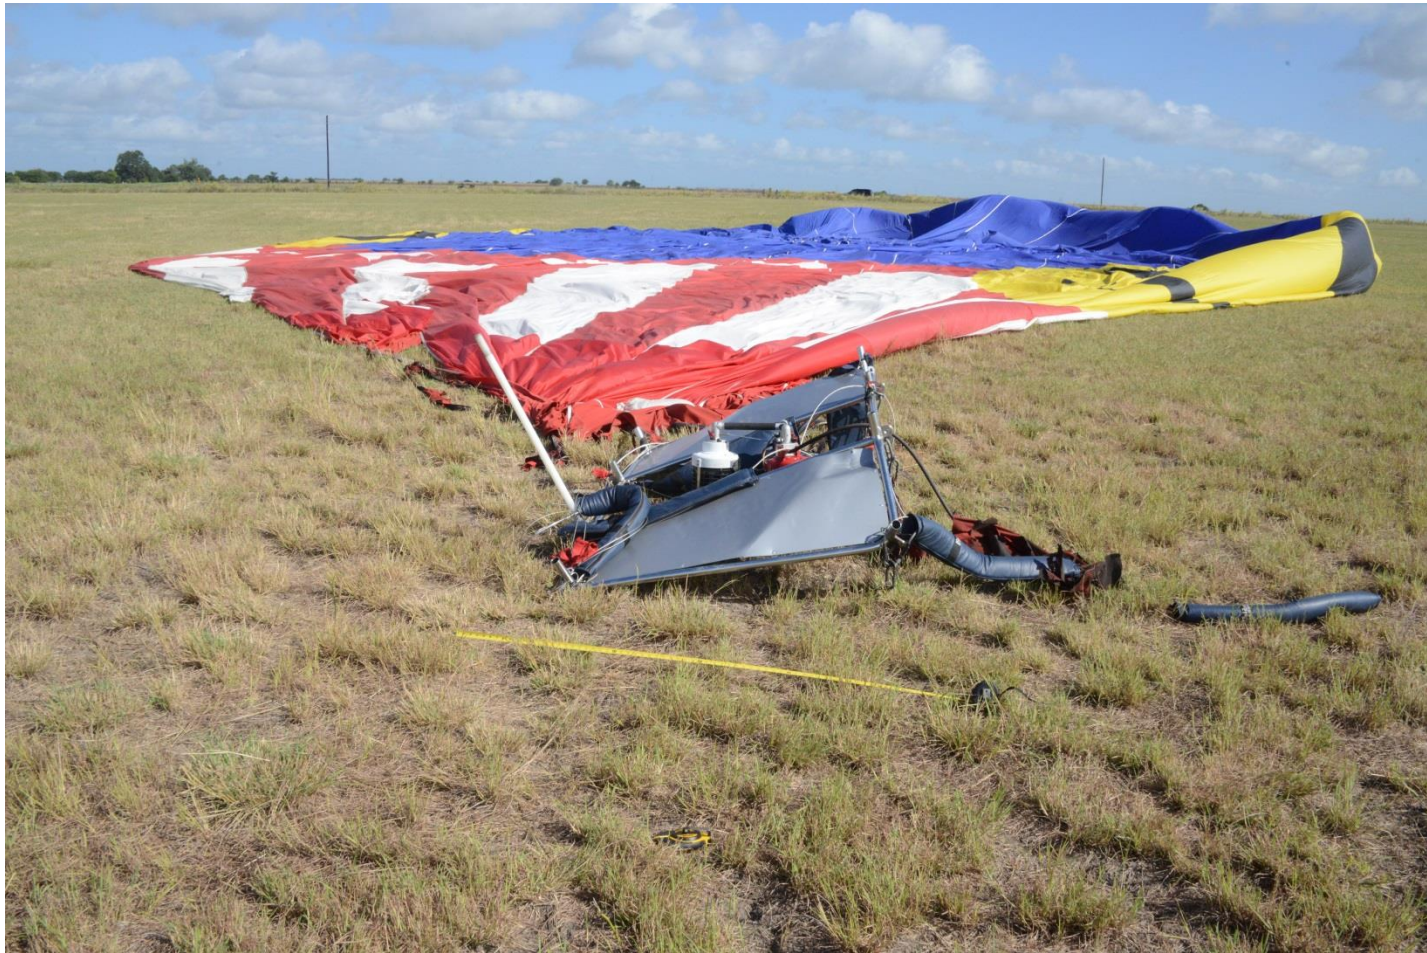
Envelope and attached burner frame

Removed Load Support Cables

1. The cable was intact.
2. The cable was intact.
3. The cable was intact.
4. The cable was intact.
5. The cable was intact.
6. The cable was intact.
7. The cable was intact.

8. The cable was separated and the separation exhibited discoloration and strand fusion.
9. The cable was separated and the cable exhibited discoloration, witness marks consistent with arcing, and the separation had a broomstraw appearance.

10. The cable was separated and the cable exhibited discoloration, witness marks consistent with arcing, and the separation had a broomstraw appearance.

11. The cable was separated and the cable exhibited discoloration, witness marks consistent with arcing, and the separation had a broomstraw appearance.

12. The cable was separated, the cable had witness marks consistent with arcing, the separation exhibited discoloration and strand fusion.
13. The cable was separated and the cable exhibited discoloration, witness marks consistent with arcing, and the separation exhibited strand fusion.

14. The cable was separated and the cable exhibited discoloration, witness marks consistent with arcing, and the separation exhibited strand fusion.
15. The cable was separated and the cable exhibited discoloration, witness marks consistent with arcing, and the separation exhibited strand fusion.

16. The cable was separated and the cable exhibited discoloration, witness marks consistent with arcing, and the separation exhibited strand fusion.
17. The cable was separated and the cable exhibited discoloration, witness marks consistent with arcing, and the separation exhibited strand fusion.

18. The cable was separated and the cable exhibited discoloration, witness marks consistent with arcing, and the separation had a broomstraw appearance.

19. The cable was separated and the cable exhibited discoloration, witness marks consistent with arcing, and the separation exhibited strand fusion.
20. The cable was separated and the cable exhibited discoloration, witness marks consistent with arcing, and the separation exhibited strand fusion.

21. The cable was separated and the cable exhibited discoloration, witness marks consistent with arcing, and the separation exhibited strand fusion.
22. The cable was intact.

23. The cable was intact.
24. The cable was intact.
25. The cable was intact.
26. The cable was intact.
27. The cable was intact.
28. The cable was intact.

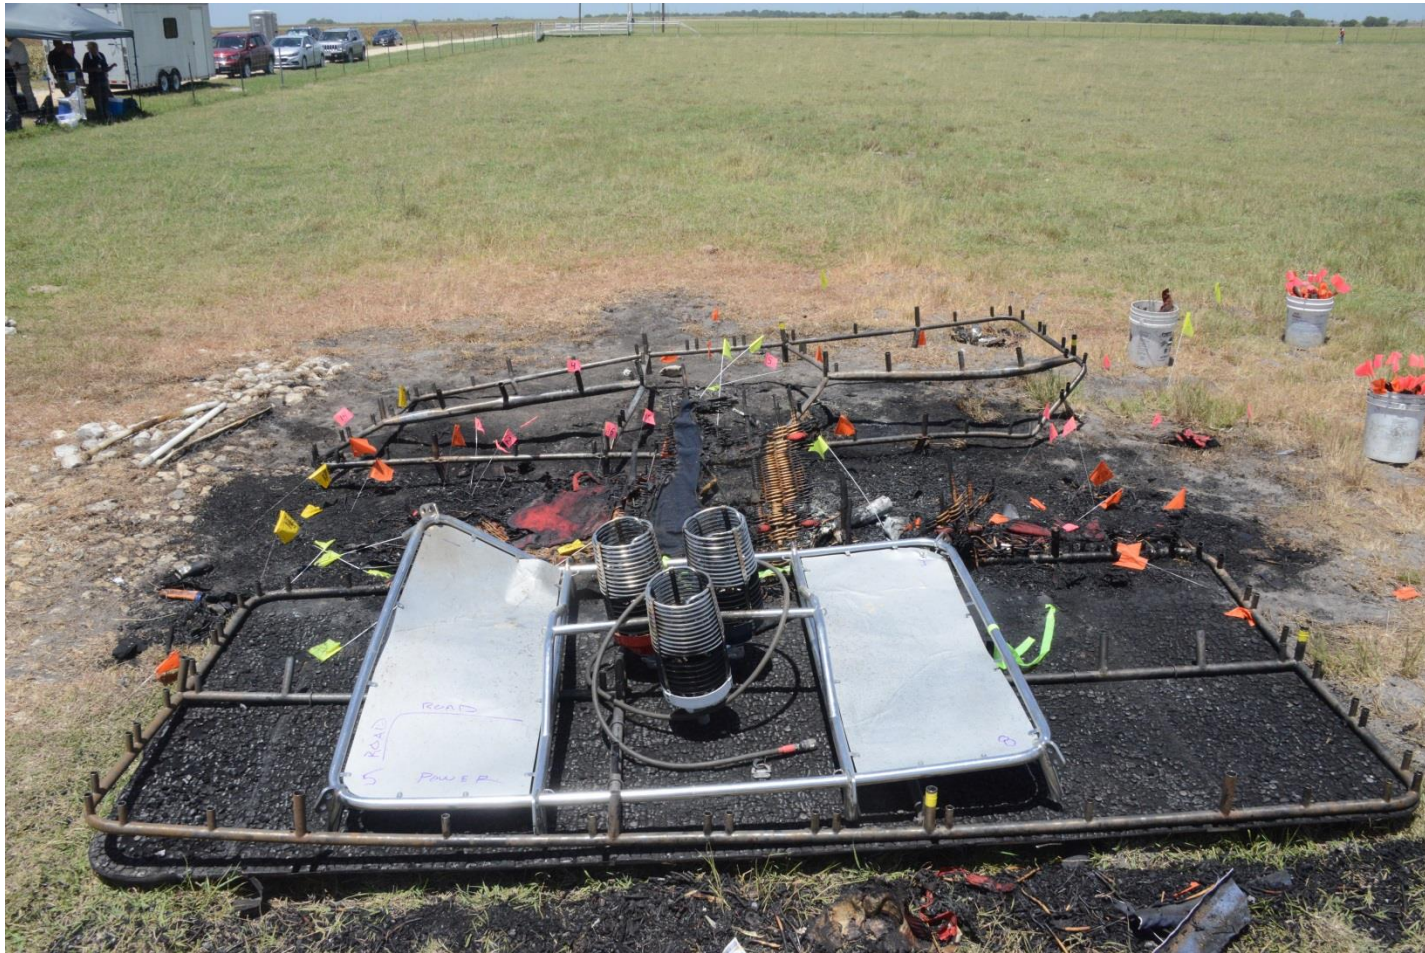
Burner frame placed on floor

Basket and Balloon Cable Ends at the Burner Support frame

1. Both carabiners, the two balloon load cable and basket cable eyelets exhibited material discoloration due to heat/fire. Both of the balloon load cables at the frame were severed. The 2 free ends of one balloon load cable eyelet had features consistent over stress failure. The other balloon load cable exhibited evidence of strand fusing. (What are the balloon load strap #'s?) Both basket attach cable ends had material discoloration due to heat/fire. One exhibited features consistent over stress failure and the other exhibited features consistent strand fusing and over stress failure.

2. Both balloon eyelets had material discoloration due to heat/fire and the other exhibited features consistent strand fusing. The basket attach cable had material discoloration due to heat/fire and the other exhibited features consistent strand fusing. The red carabiner exhibited evidence of arcing.

3. The eyelet with one balloon cable exhibited evidence of strand fusing. The other eyelet with the wrapped cable only had one free end visible and exhibited features consistent with over stress failure and strand fusing. The basket attach cable had material discoloration due to heat/fire and the other exhibited features consistent strand fusing.

4. Red shrink wrapped cables indicating the front right corner of the basket. All 4 free ends exhibited features consistent with overstress failure, exhibited multiple permanent curved deformations versus pure straight cable and wire fraying, evidence consistent with abrasion along their length and possible strand fusing. (What are the balloon load strap #'s? One of the basket attach cables exhibited features consistent over stress failure and the other exhibited features consistent evidence of strand fusing.

5. All 4 balloon load cables remained attached to the balloon at balloon load straps 22, 23, 24 & 25. Both basket attach cable ends had material discoloration due to heat/fire. One of the basket attach cables exhibited features consistent over stress failure and strand fusing the other exhibited evidence of strand fusing.

6. All 3 balloon load cables remained attached to the balloon at balloon load straps 26, 27 & 28. The basket attach cable end exhibited material discoloration due to heat/fire and exhibited evidence of strand fusing.

7. All 3 balloon load cables remained attached to the balloon at balloon load straps 1,2 & 3. The basket attach cable end exhibited material discoloration due to heat/fire and exhibited evidence of strand.

8. All 4 balloon load cables remained attached to the balloon at balloon load straps 4,5,6 & 7. Cables are frayed and abraded along their length. One basket attach cable end material discoloration due to heat/fire, features consistent over stress failure and possible evidence of strand fusing the other exhibited features consistent over stress failure.
