AIRWORTHINESS – EXAMINATION OF ENVELOPE AND BASKET LOAD CABLES

Airworthiness Group Examination of Envelope and Basket Cables

A. ACCIDENT DCA16MA204

Location: Lockhart, Texas
Date: July 30, 2016
Time: 0742 Local Time
Aircraft: Balony Kubicek BB85Z, registration N2469L

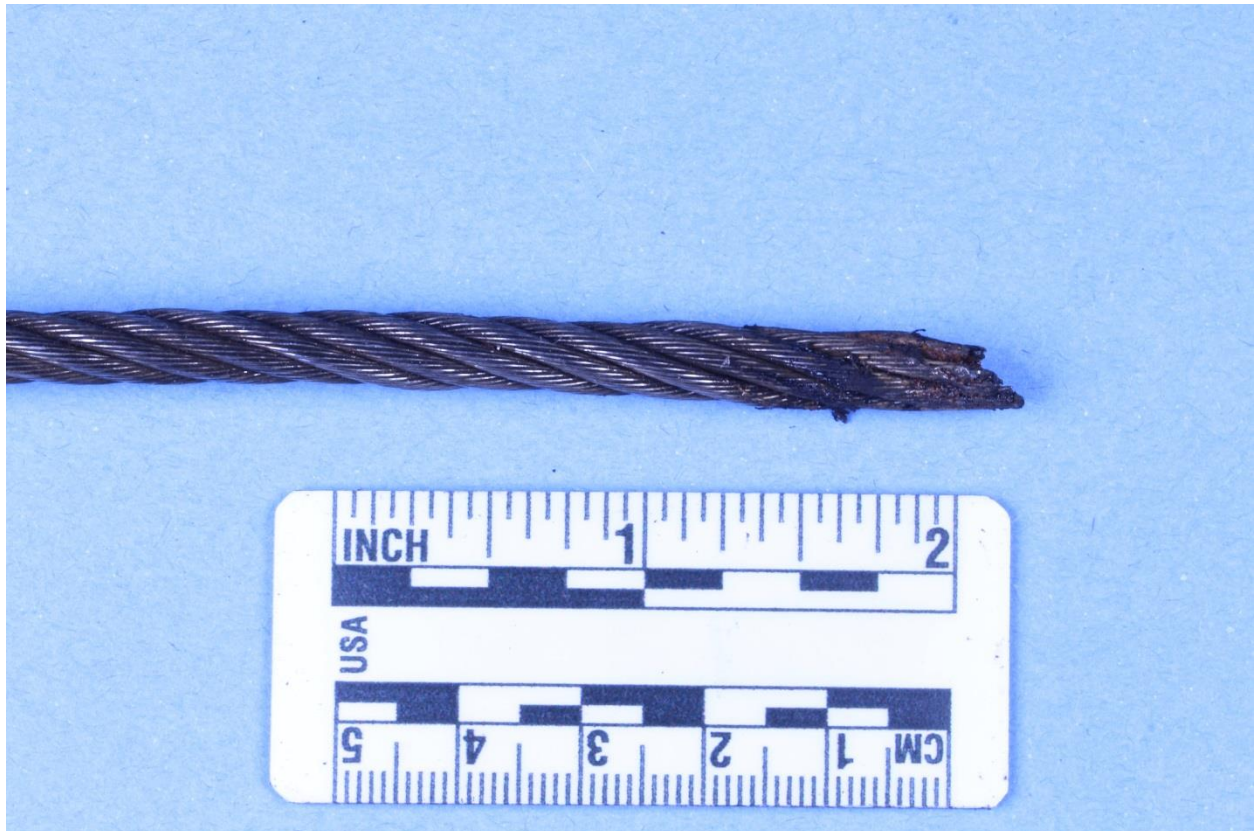
Eyelet to cable end (plastic sheath ended at cable end): 3' 7"
The severed end showed evidence of strand fusing (Figure 1)

Figure 1: Severed cable end exhibiting strand fusing (Burner Support Frame Corner 1)

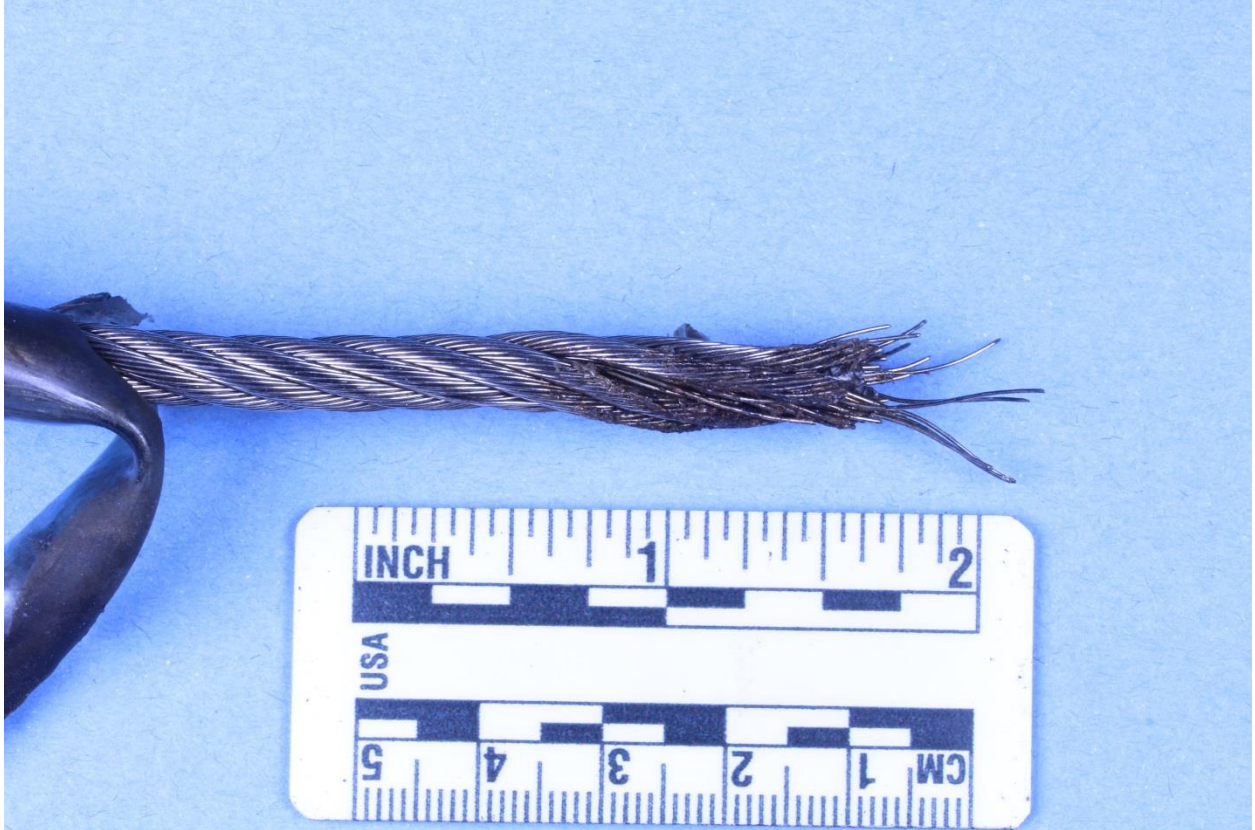
Eyelet to cable end (plastic sheath ended at cable end): 3' 7"
The severed end showed evidence of strand fusing (Figure 2)

Figure 2: Severed cable end exhibiting strand fusing (Burner Support Frame 1)

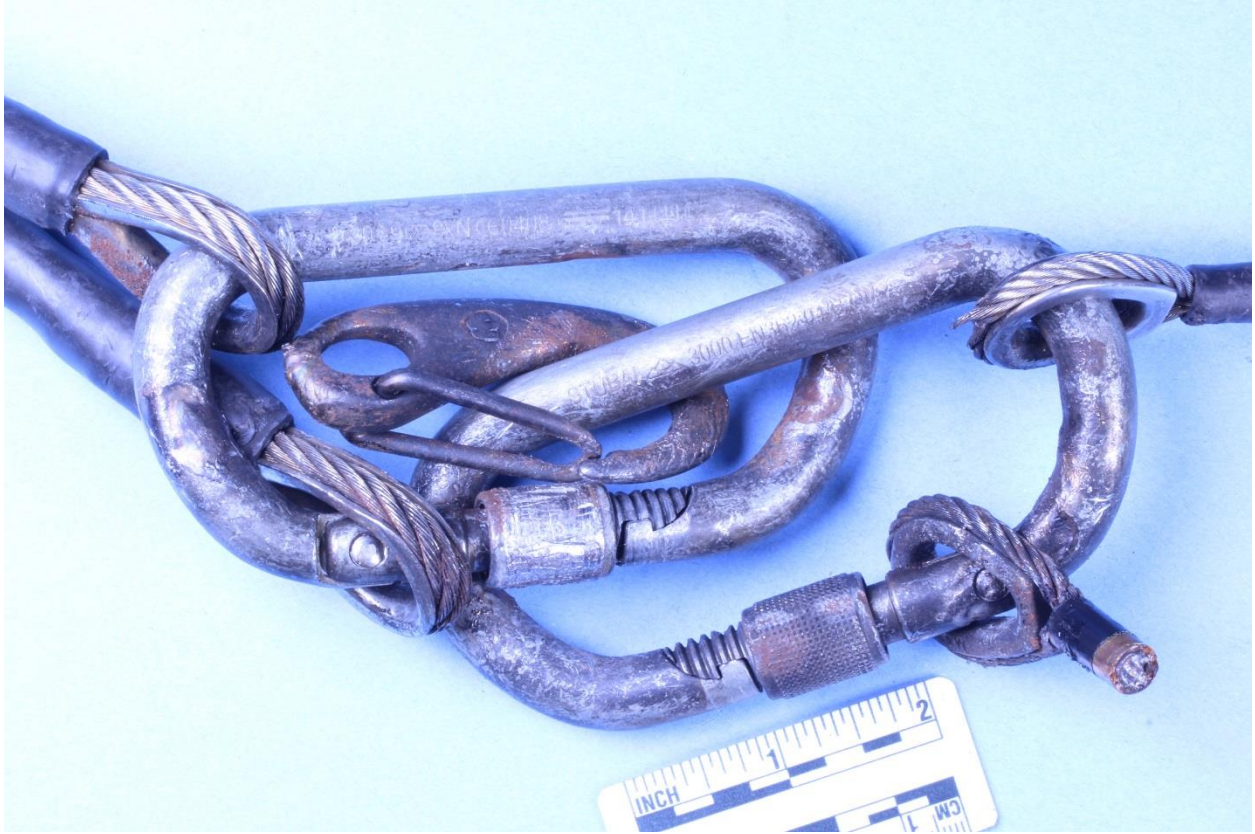
The two carabiners and the eyelets connected to them exhibited evidence of electrical arcing

Figure 3: Carabiners with electrical arcing damage (Burner Support Frame 1)

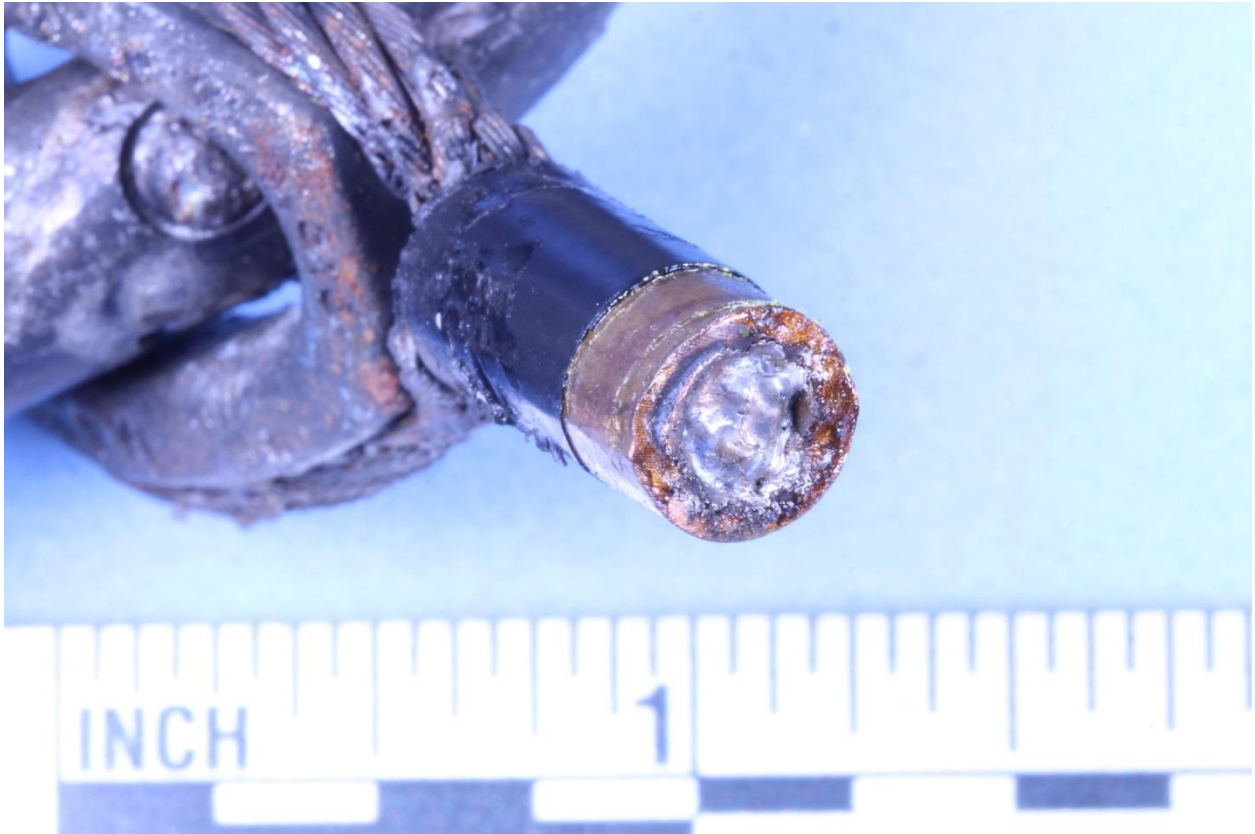
Cable was a fused stub (Figure 4), no measurement available.

Figure 4: Load cable fused and separated at eyelet (Burner Support Frame 1)

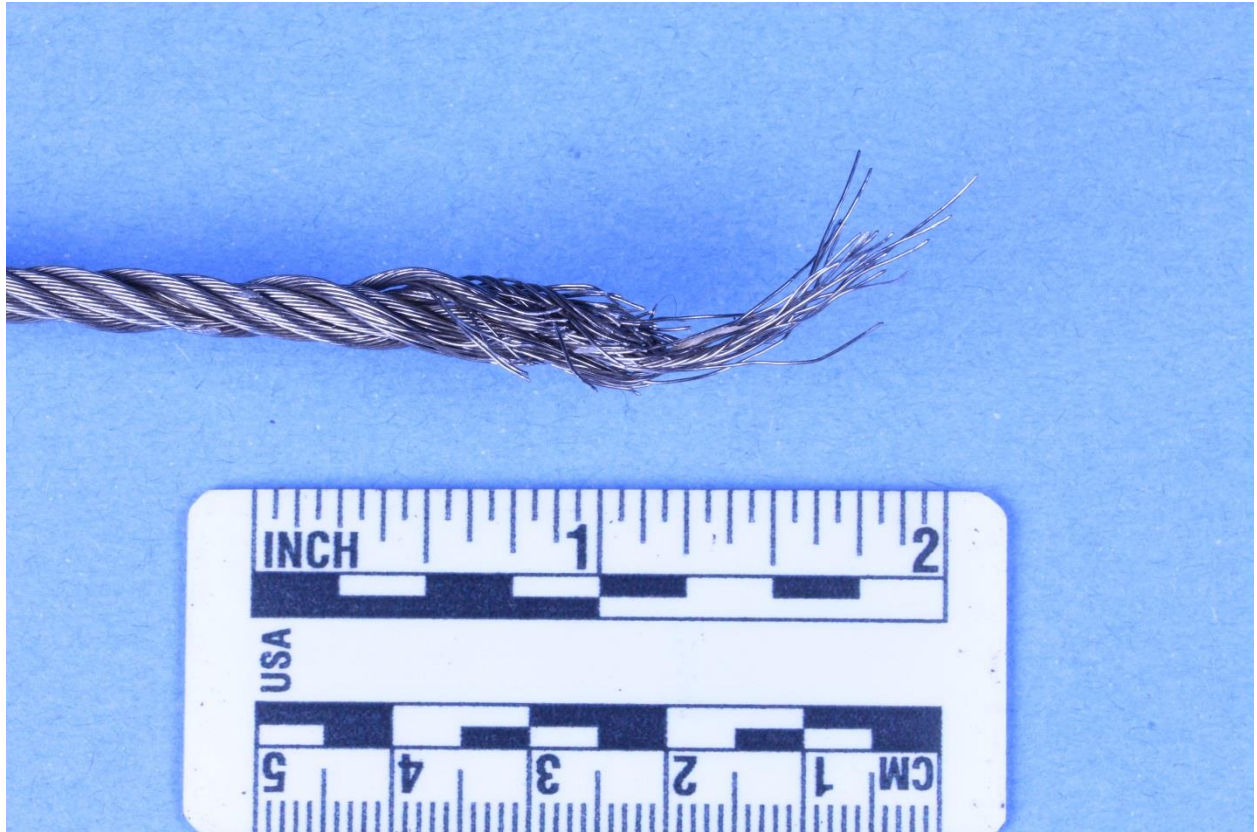
Overload evidence noted at cable end (Figure 5), with some abrasion on the cable noted.

Figure 5: Load cable exhibiting overload failure (Burner Support Frame 1)

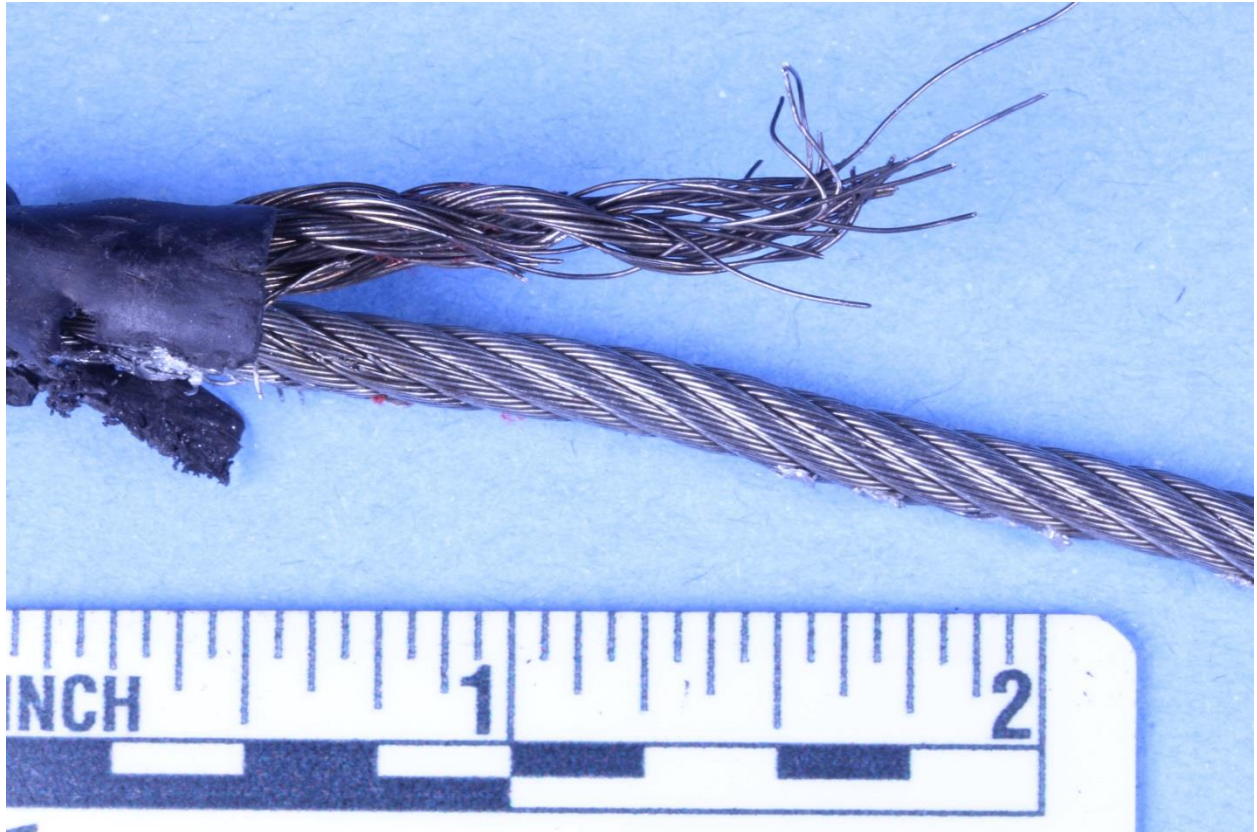
Overload evidence noted at cable end (Figure 6).

Figure 6: Load cable exhibiting overload failure (Burner Support Frame 1)

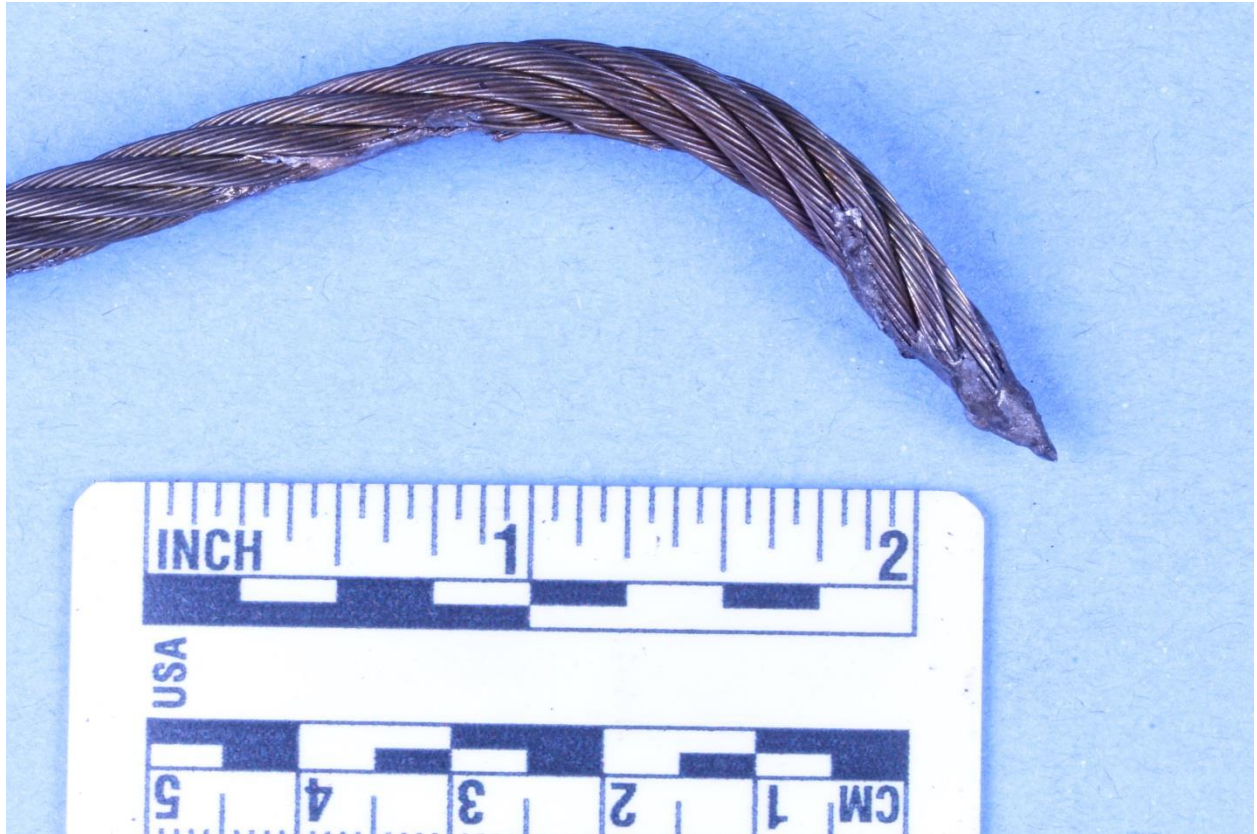
The severed end of the cable showed evidence of strand fusing (Figure 7).

Figure 7: Basket cable exhibiting strand fusing (Burner Support Frame 2)

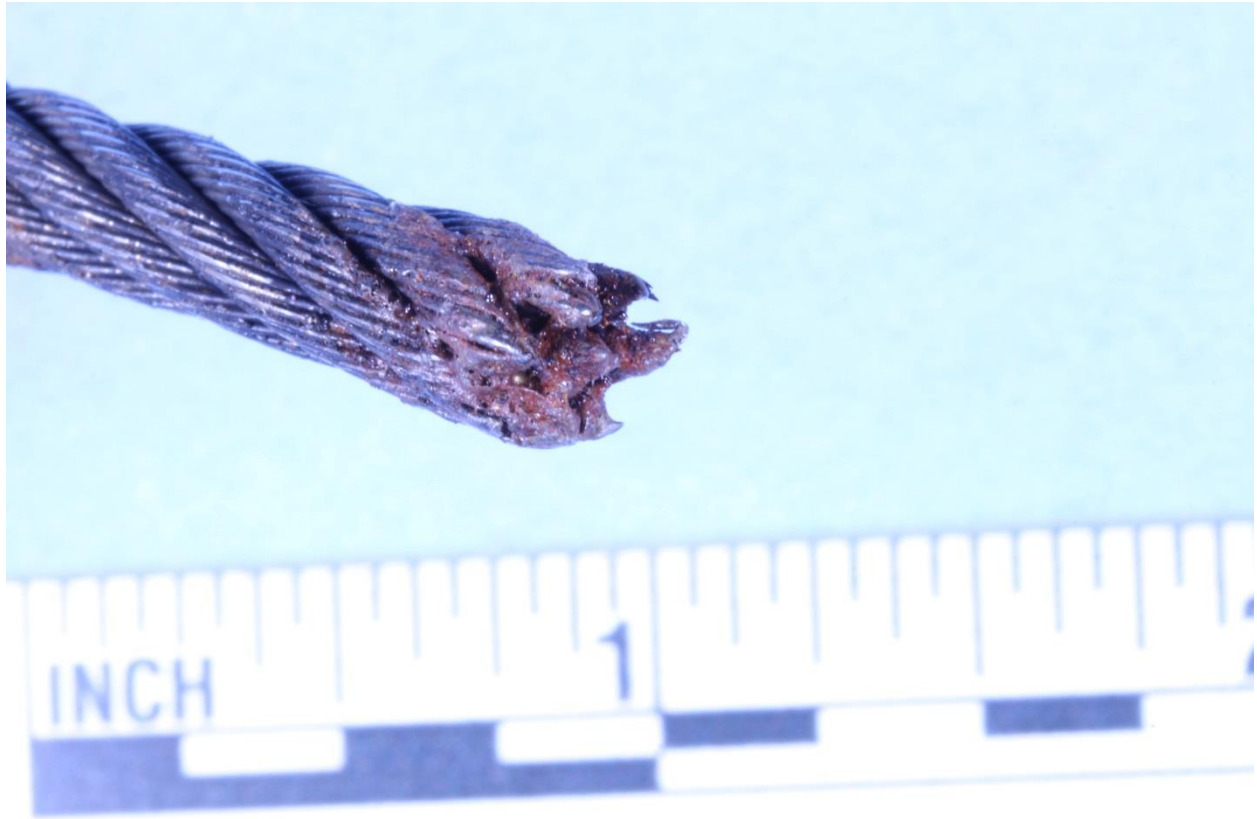
The cable end exhibited evidence of strand fusing (Figure 8) and arcing along the lower cable length.

Figure 8: Basket cable exhibiting strand fusing (Burner Support Frame 3)

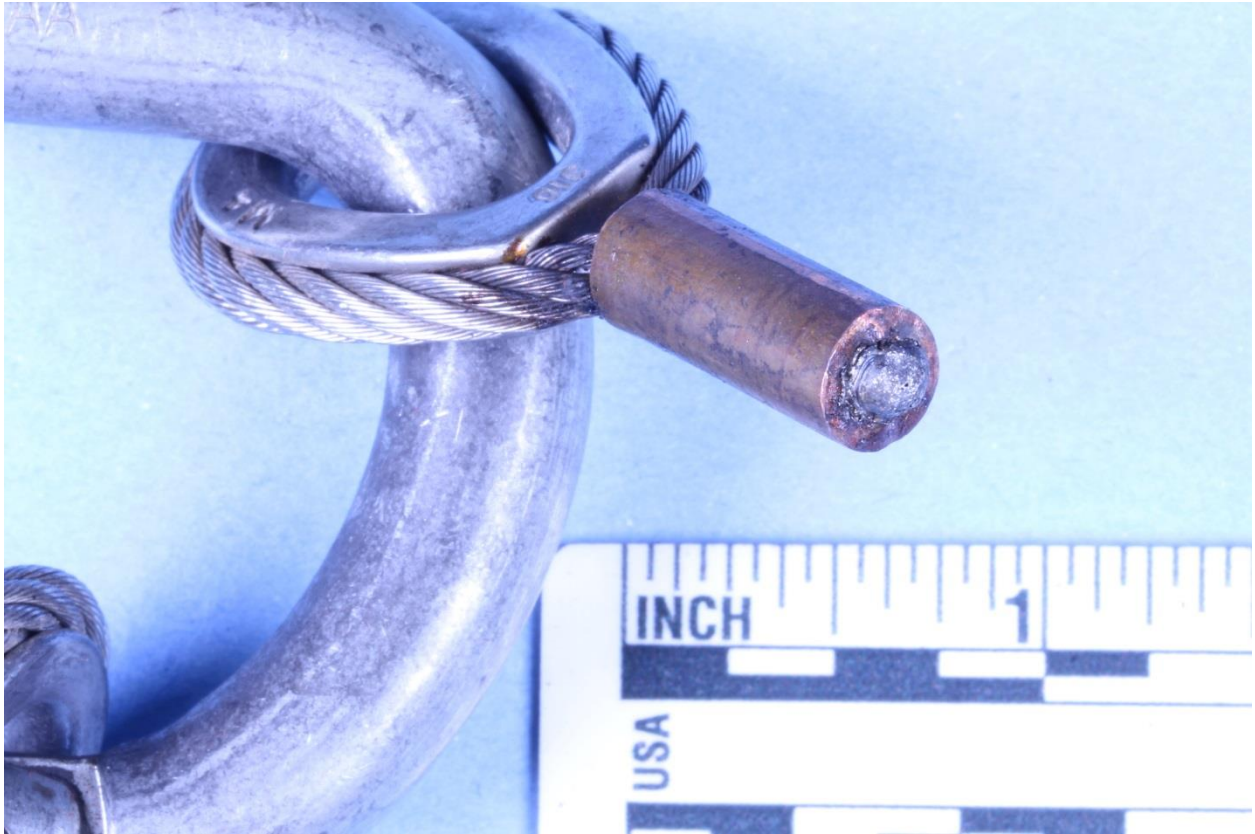
No measurement possible - No cable evident, fused at sheath end (Figure 9).

Figure 9: Load cable exhibiting strand fusing at the eyelet (Burner Support Frame 3)

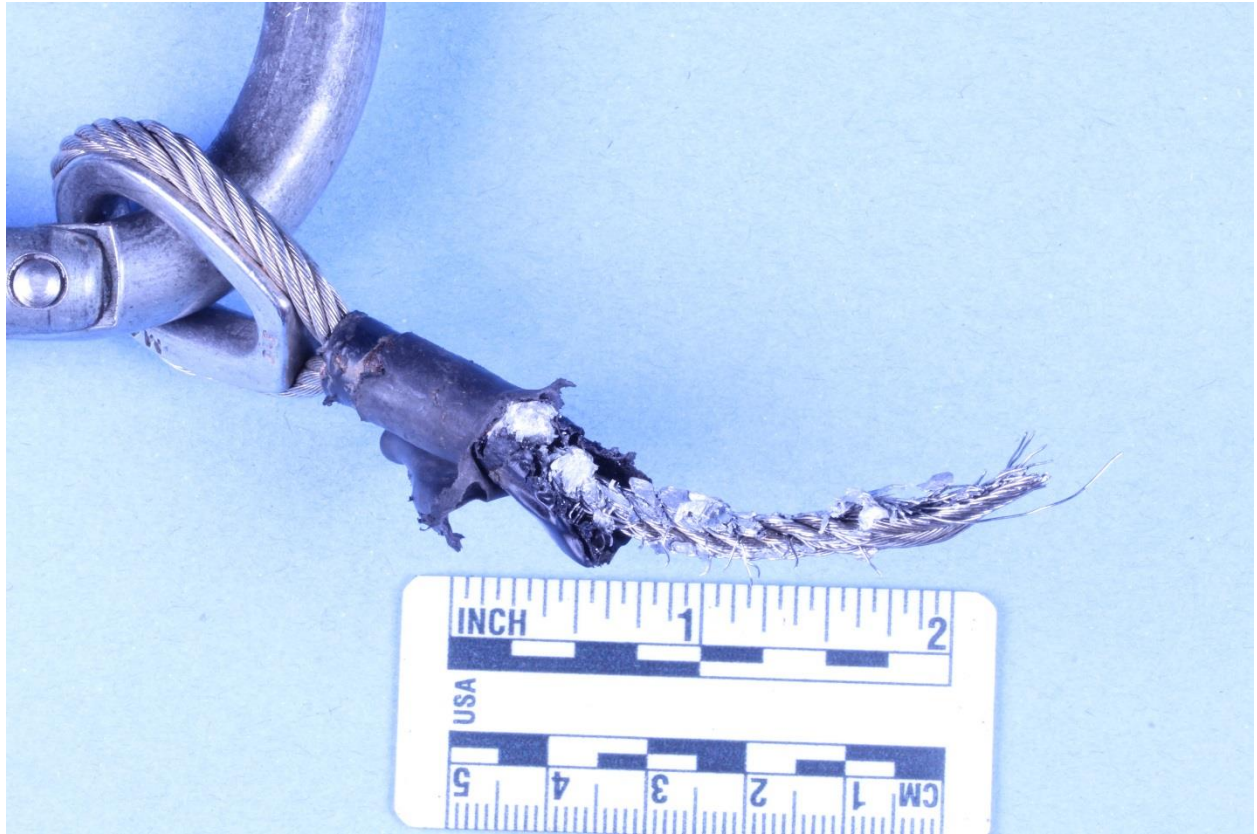
Cable end had evidence of overload, with a metallic substance abraded onto the cable (Figure 10).

Figure 10: Load cable exhibiting overload failure and abrasion (Burner Support Frame 3)

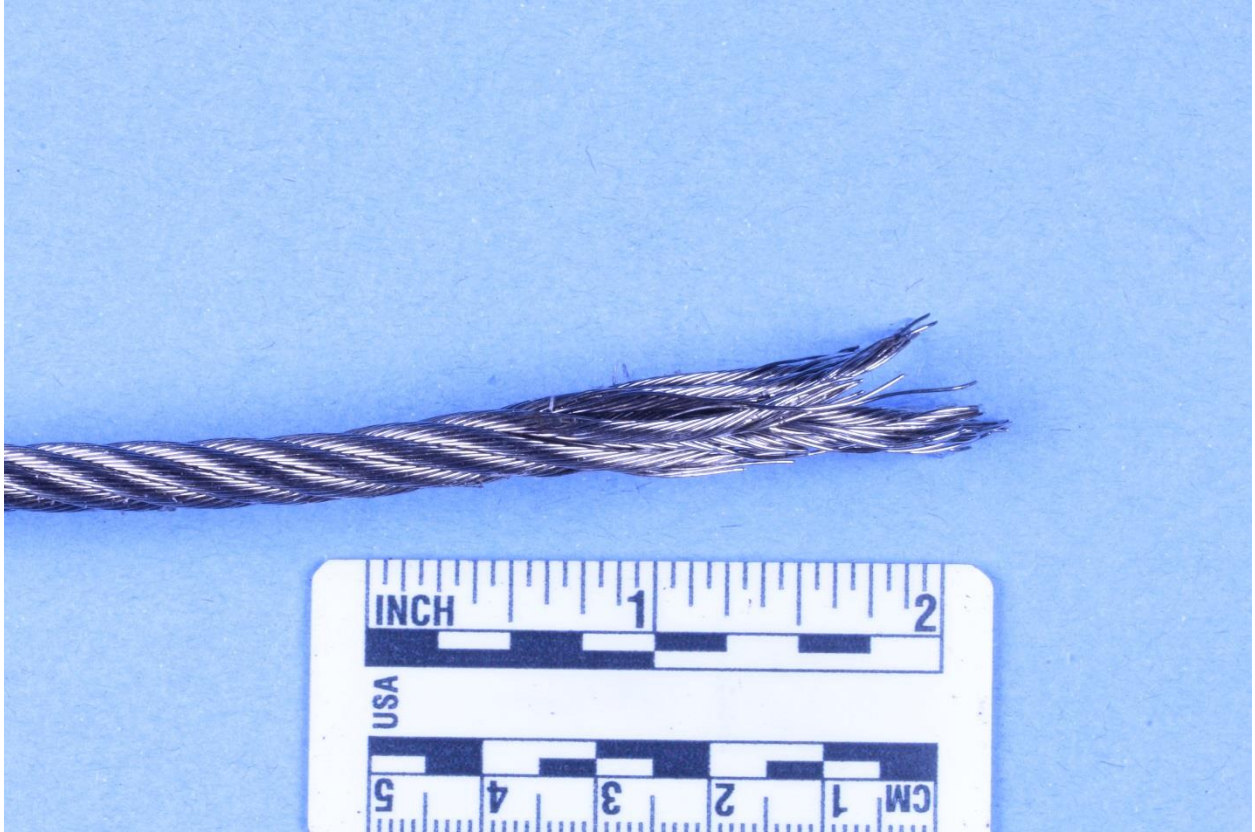
Severed end exhibited evidence of overload (Figure 11) and was coincident with end of plastic sheath.

Figure 11: Basket cable exhibiting overload (Burner Support Frame 4)

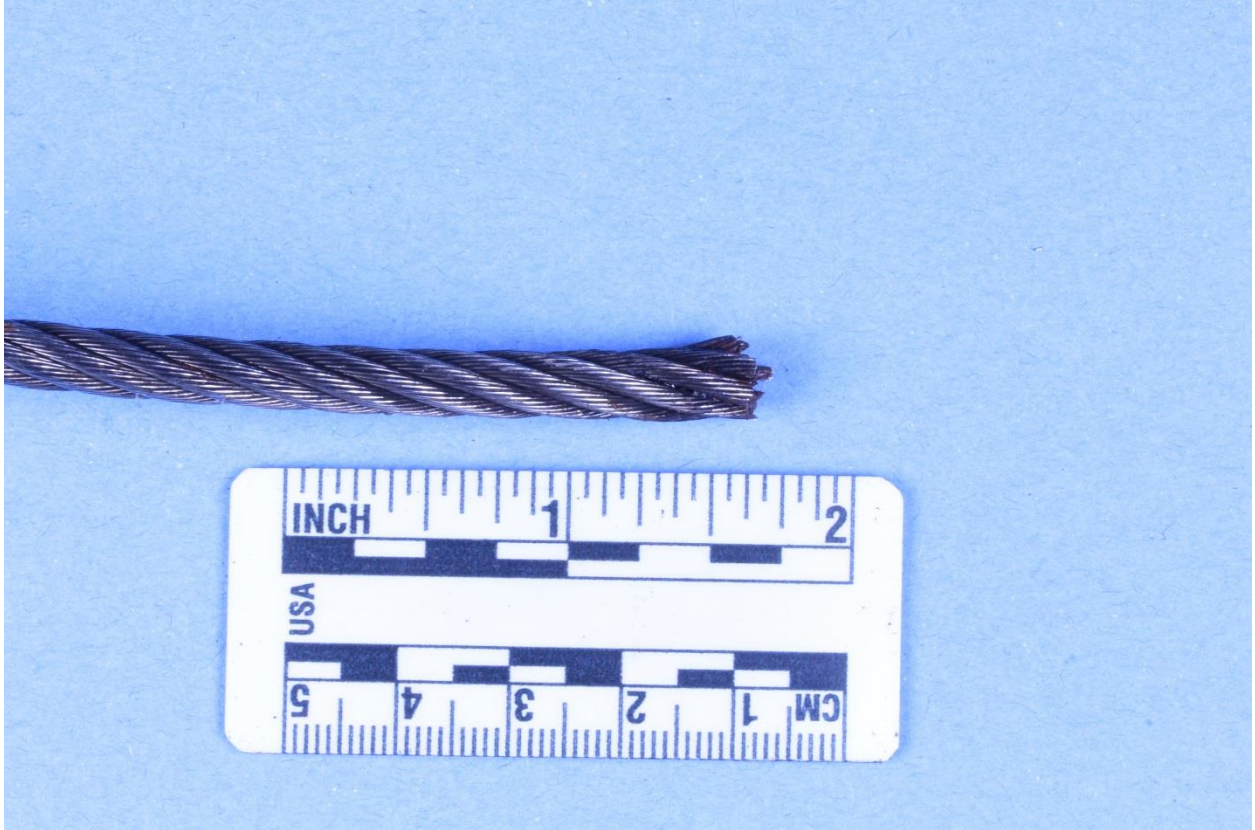
Severed end exhibited evidence of strand fusing (Figure 12). No plastic sheath was noted.

Figure 12: Basket cable exhibiting strand fusing (Burner Support Frame 4)

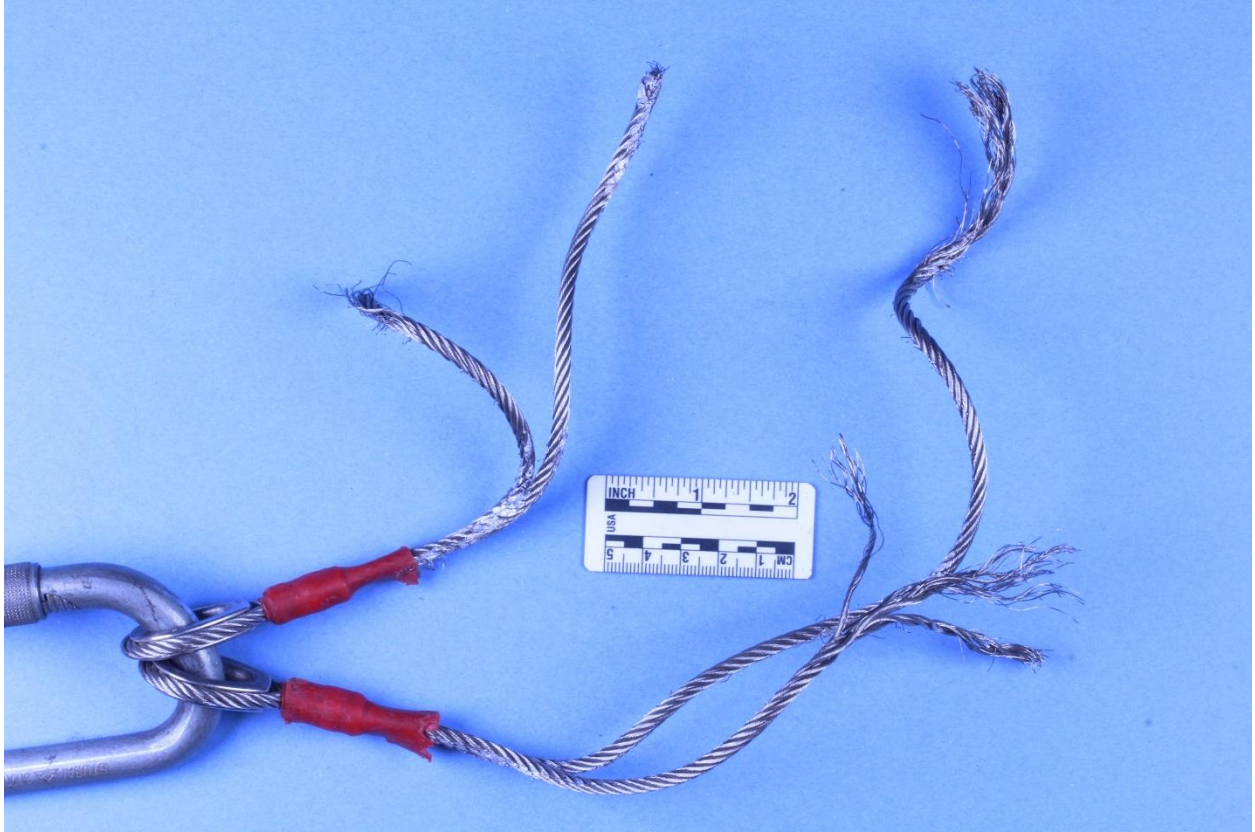
The severed ends of each of the four balloon load cables exhibited evidence of overstress (Figure 13). In addition, each of the cables had what was determined using a handheld XRF alloy analyzer to be aluminum, adhering to the outside the cables. An example of the adhering aluminum

Figure 13: Load cables exhibiting overload (Burner Support Frame 4)

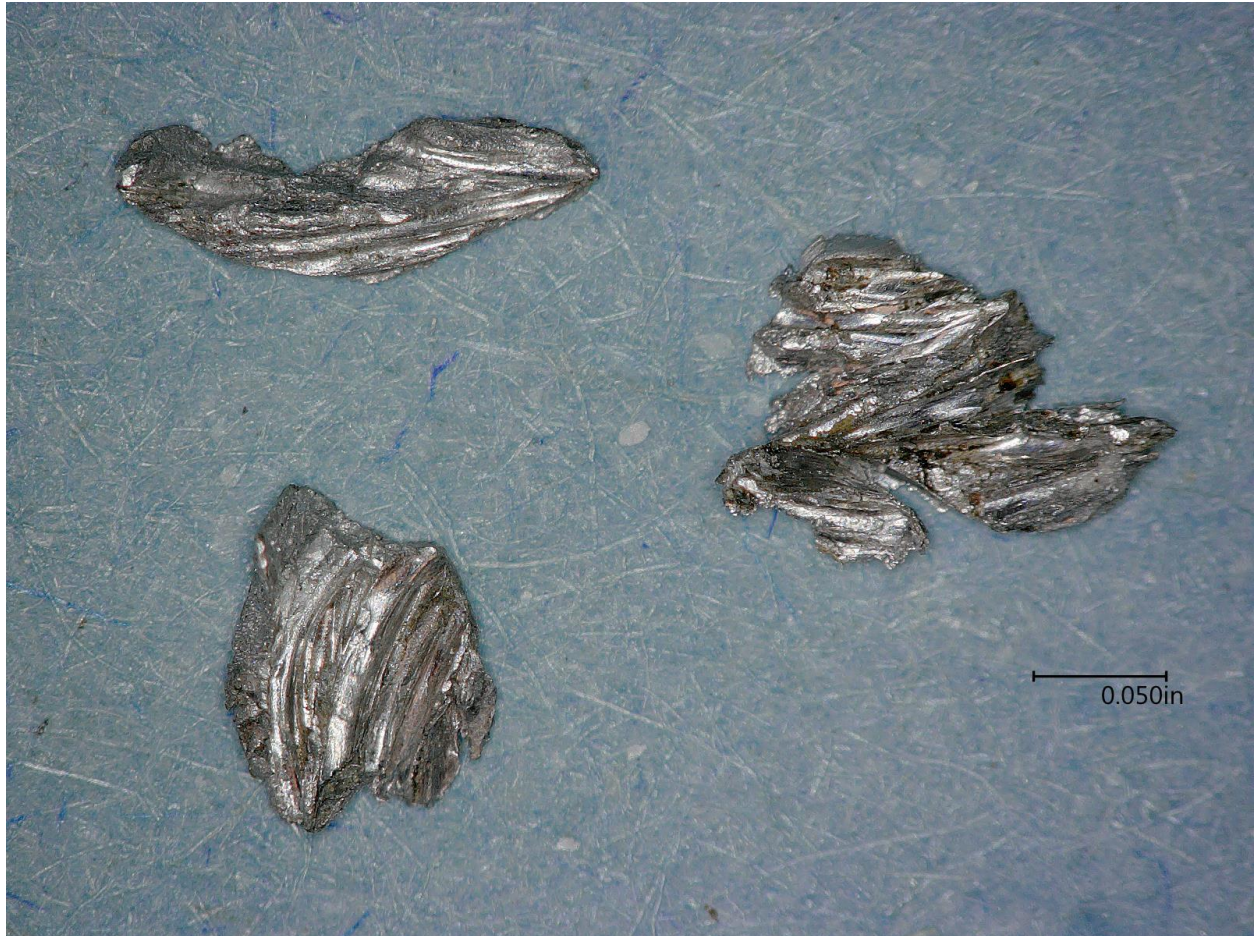
Figure 14: shavings of aluminum recovered from cable exterior (Burner Support Frame 4)

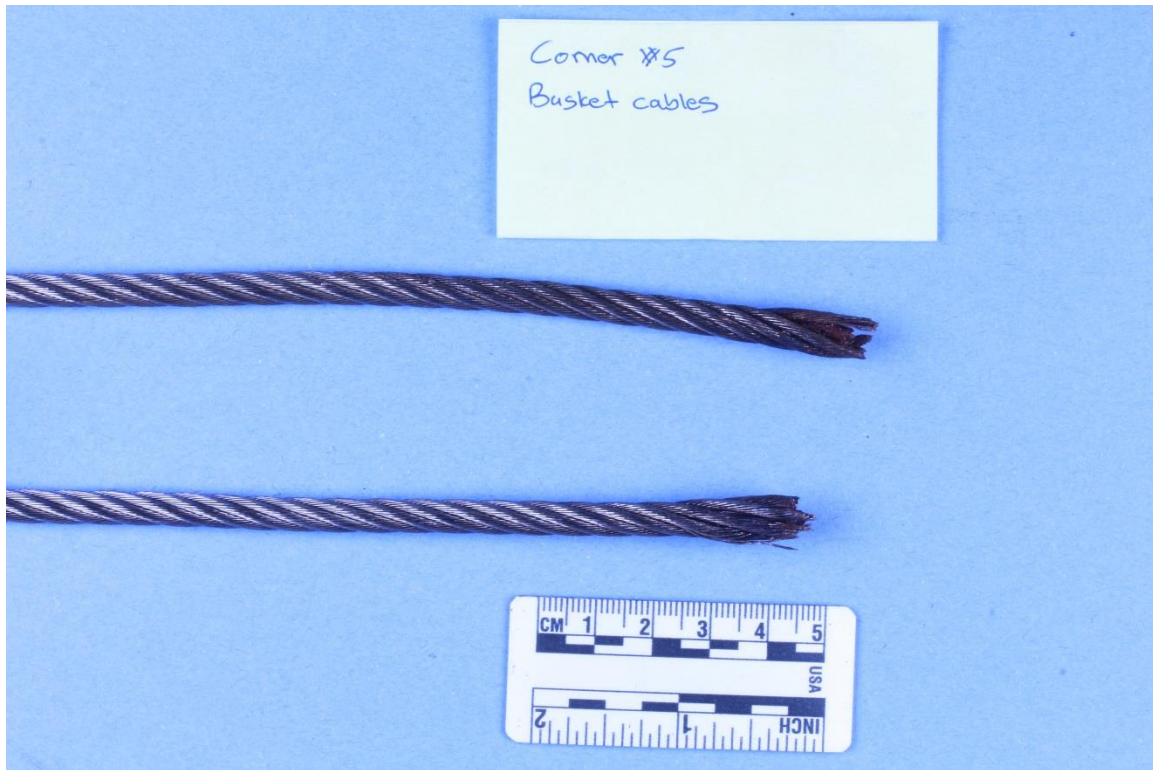
Both of the basket cable ends exhibited strand fusing (Figure 15).

Figure 15: Basket cables exhibiting strand fusing (Burner Support Frame 5)
