**DOCKET No.: SA-521**  
**EXHIBIT No. 1700**

**NATIONAL TRANSPORTATION SAFETY BOARD**  
**WASHINGTON, D.C.**

Correspondence about Reversed Elevator Damper

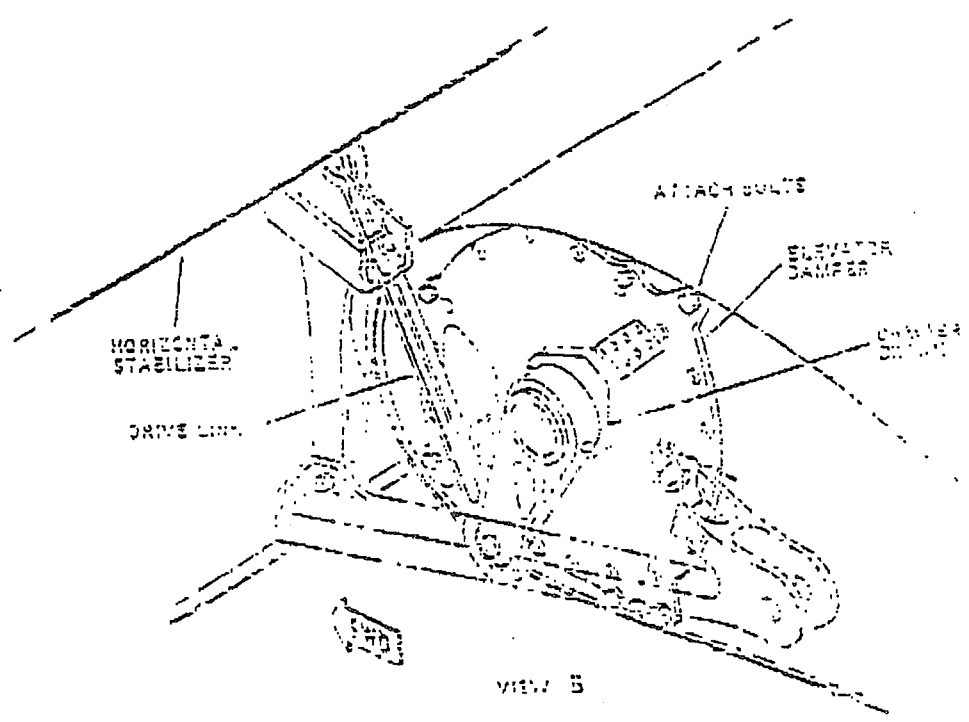
**Problem:** The elevator dampers have been installed on the wrong sides (left to right and right to left) from an outside vendor overhaul causing them to be hooked up wrong when the elevator is installed on the aircraft. This problem is undetectable when doing throw checks and will only be noticed when the aircraft is being flaired in flight, when it takes undo force to pull the stick back.

**DRIVE LINK AND DAMPER CRANK SHOULD BE DOWN AS SHOWN**

**Solution:** Verification of the correct elevator damper part number installed on the left and right elevator when received from an outside overhaul vendor. It is also possible to detect the problem if the procedures in the maintenance manual covering installation of the elevator dampers are followed.
