NATIONAL TRANSPORTATION SAFETY BOARD

Group Chairman's Factual Report

OPERATIONAL FACTORS

DCA16MA204

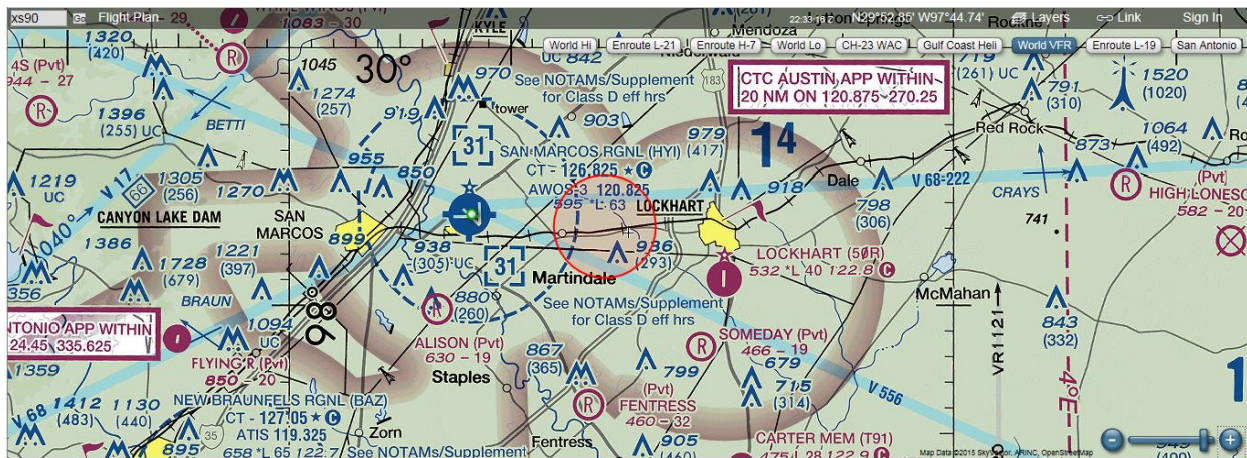
It is unknown if the accident pilot referenced a sectional chart during the accident flight (none was recovered). The power lines adjacent to the accident site were not depicted on the chart (see Figure 4).

Figure 4: Sectional Chart covering accident site.⁵² The red circle indicates the temporary flight restriction (TFR) over the accident site.

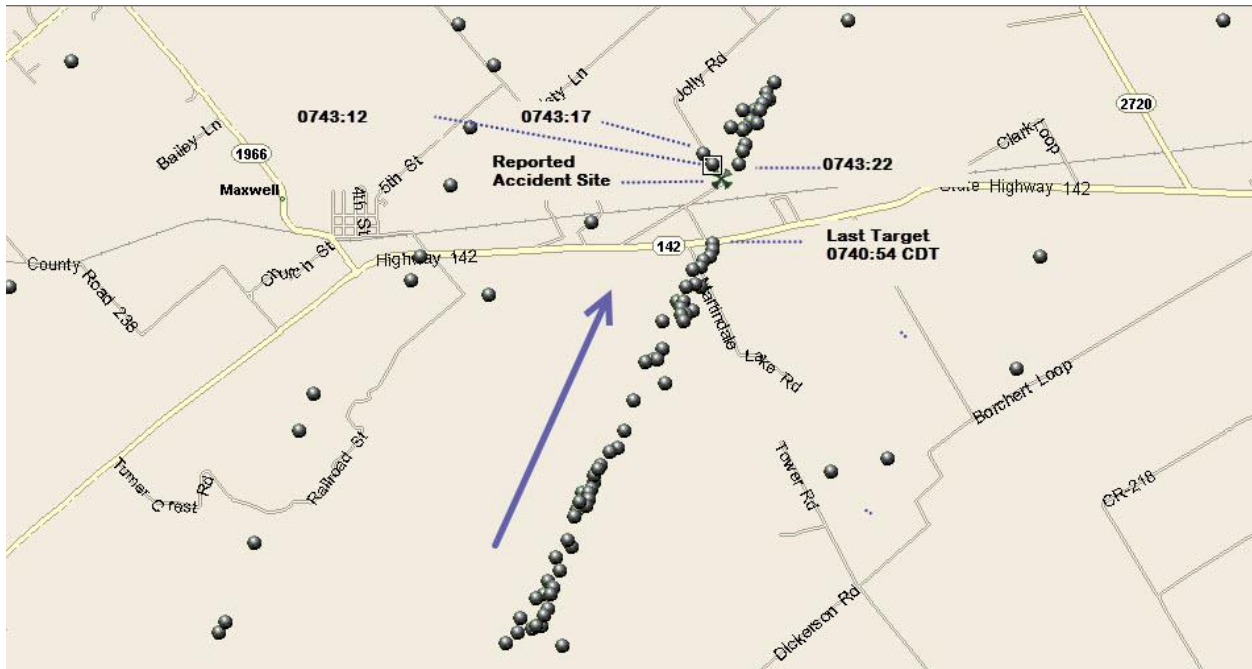
Figure 5: ATC primary radar data for the accident flight.

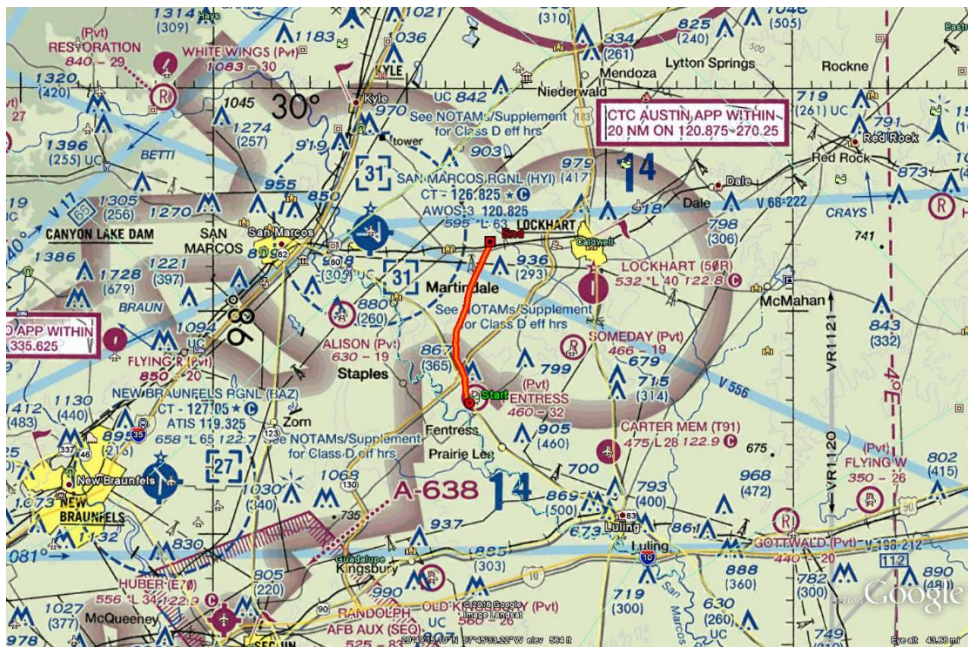
Figure 6: Sectional chart with accident balloon flight path overlay (orange line).⁵⁸
