**NATIONAL TRANSPORTATION SAFETY BOARD**

# **OPERATIONAL FACTORS**

**ANC17MA001**

Operator: Hageland Aviation Services, Inc.  
Location: Togiak, Alaska  
Date: October 2, 2016  
Time:<sup>1</sup> 1157 Alaska Daylight Time (ADT)  
Airplane: Cessna 208B Grand Caravan, N208SD

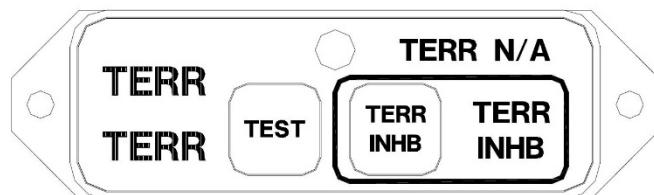
Figure 1 – TAWS control panel<sup>31</sup>

A post-accident examination of the inhibit switch on the control unit found the switch to be in the out, not-inhibited position. It is not known if this was the position of the switch prior to impact, or if forces of the impact caused it to move from the in, or inhibited position, to the out position. See Figure 1 below for a depiction of the TAWS control panel.

According to interviews with Hageland personnel, there was a company policy which allowed pilots to inhibit the TAWS aural and visual cautions and warnings if they occurred while the pilot was in VMC. The pilot could only inhibit the system if he could visually verify that the flight was not in danger of terrain conflicts. If the pilot did inhibit the alerts, there was no company guidance on when to un-inhibit (enable) them.
