NATIONAL TRANSPORTATION SAFETY BOARD

EXCERPTS FROM PG&E CAMERA
INSPECTION OF LINE 132, SEGMENT 180

Internal Pipeline Video Assessments

L-132 MP 38.49 to 40.05

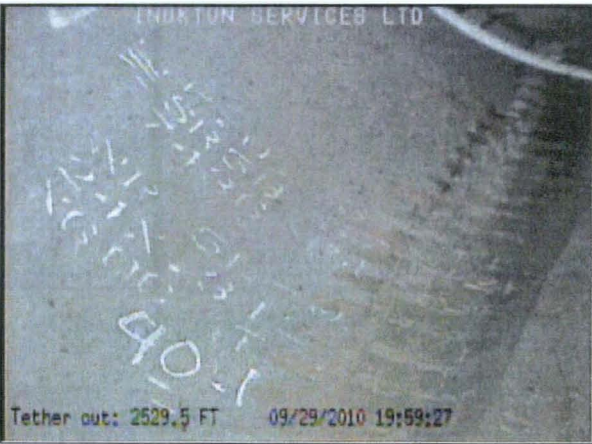
PIPE SEGMENT: 074

COMMENTS: (Spool with stencil - 40.1)

Stencil spool

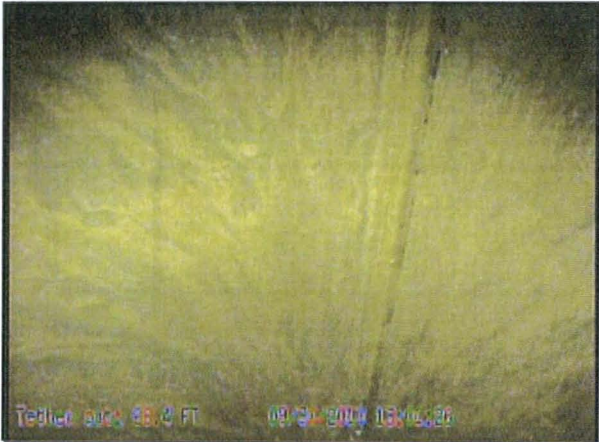
PIPE SEGMENT: 004

COMMENTS: Black spots on edge of LS @ 68' (linear).

Black line adjacent to the LS.

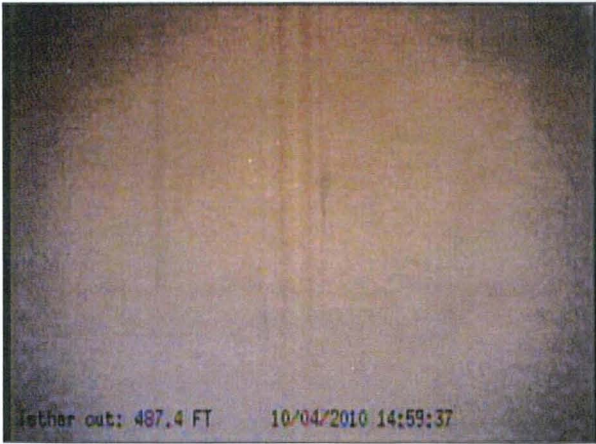
PIPE SEGMENT: 020

COMMENTS: Parallel lines @ both sides of LS intermittent, GW# 21 back welded and ground.

View of lines adjacent to LS

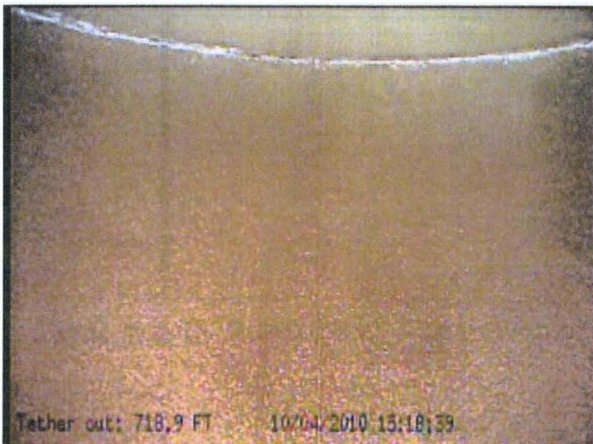
PIPE SEGMENT: 028

COMMENTS: Short spool between GW# 28 & 29, possible LS @ 06:00 position.

View of possible LS @ 06:00

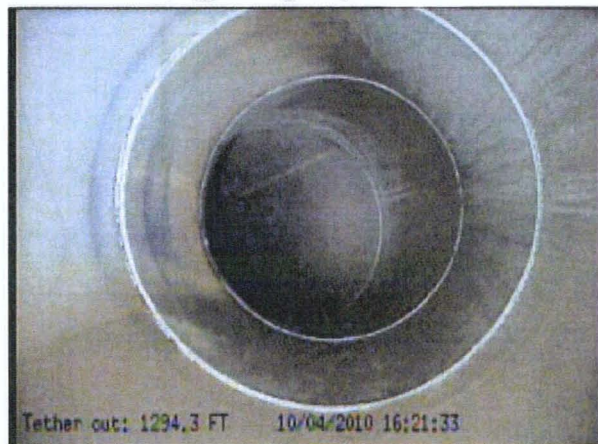
PIPE SEGMENT: 055

COMMENTS: Angle point Left, Double DSAW LS in spool.

View of double DSAW spool

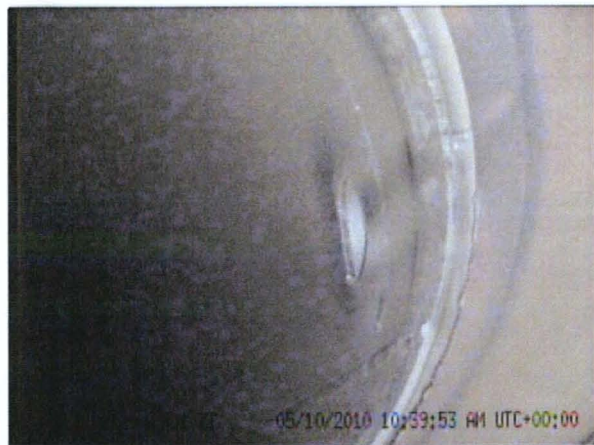
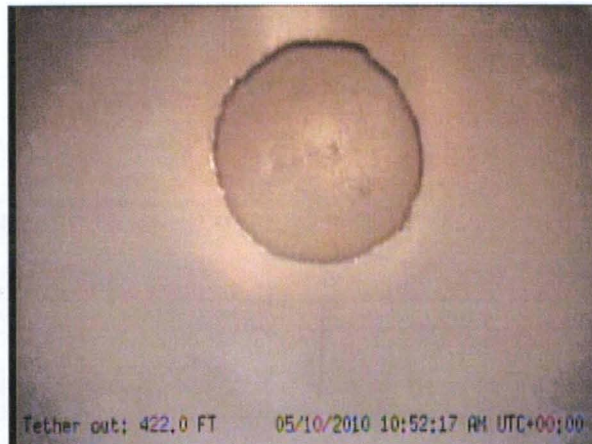
PIPE SEGMENT: 022

COMMENTS: Save-a-valve @ 421' (Pup @ end of elbow) / Sleeve @ GW-22

Save-a-valve @ 421' (Pup @ end of elbow)

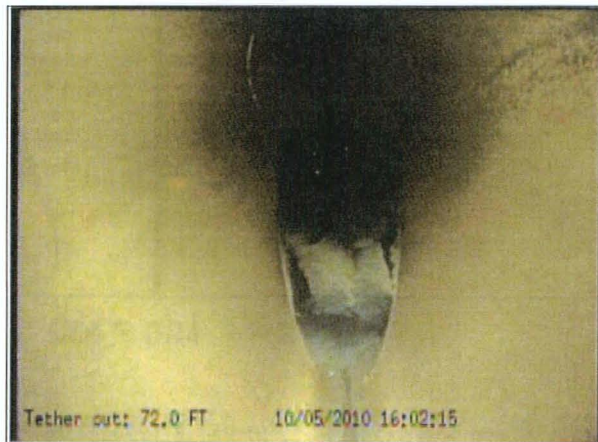
PIPE SEGMENT: 003

COMMENTS: Liquid Pool @ 75' to 82', angle point @ GW# 3

View of liquids @ 75'

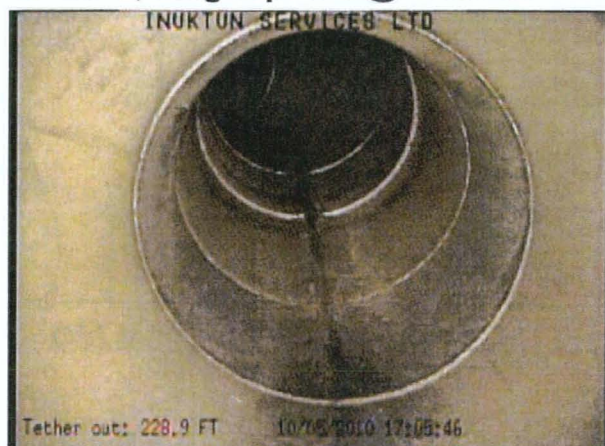
PIPE SEGMENT: 009

COMMENTS: Angle point down @ 197' , GW# 8.

View of spool assembly @ 228'

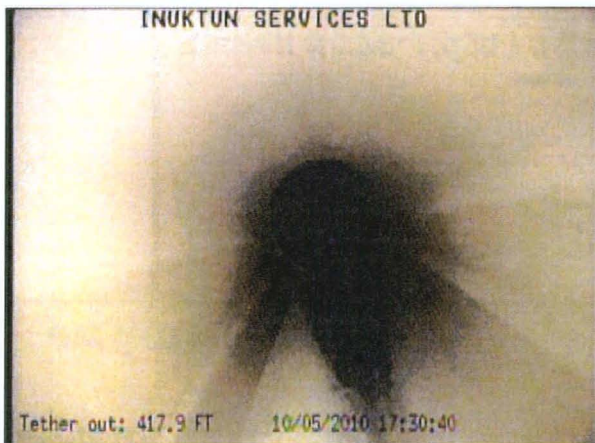
PIPE SEGMENT: 023

COMMENTS: Sag with liquid @ 433', GW# 23

View of low spot with fluid.

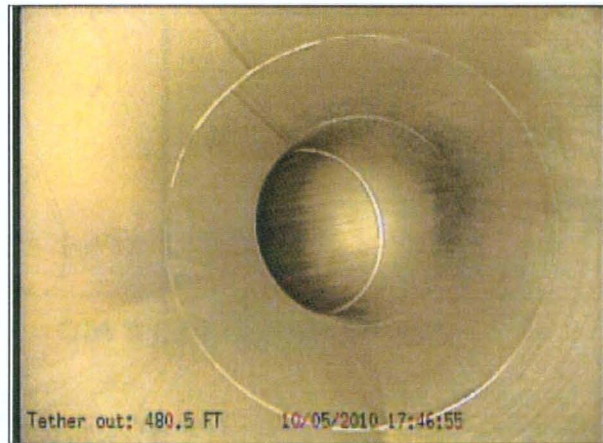
PIPE SEGMENT: 030

COMMENTS: Small spool.

View of small spool @ 480'.

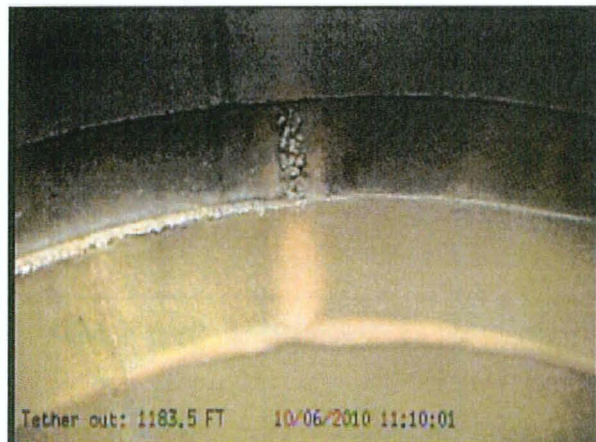
GPS: 44, @ GW# 50 - Sleeve

COMMENTS: Tie-In Sleeve @GW# 50, Split seam in sleeve, Entering GIS segment 183, Dent @ 1189 - 10:00 position.

View of Sleeve

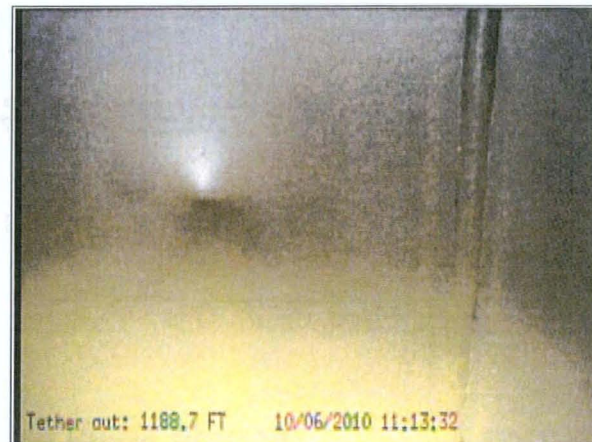
GPS: 45, @ 1189' - Dent

View of Dent

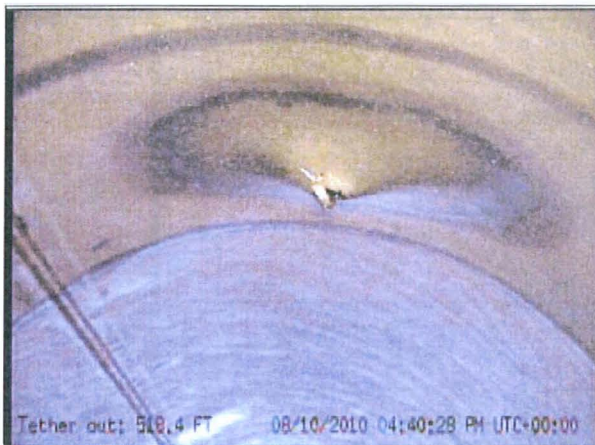
PIPE SEGMENT: 021

COMMENTS: Puncture with patch & sleeve @ 521.5', Possible weld bead ID emanating from indent.

View of puncture with patch & sleeve @ 521.5'
