Time Correlation Study

NTSB Accident Number
DCA08MR009

Location: Chatsworth, CA
Date: September 12, 2008
Time: 4:22 P.M. Pacific Daylight Time
Train(s) : Metrolink 111 commuter rail / Union Pacific LOF-6512

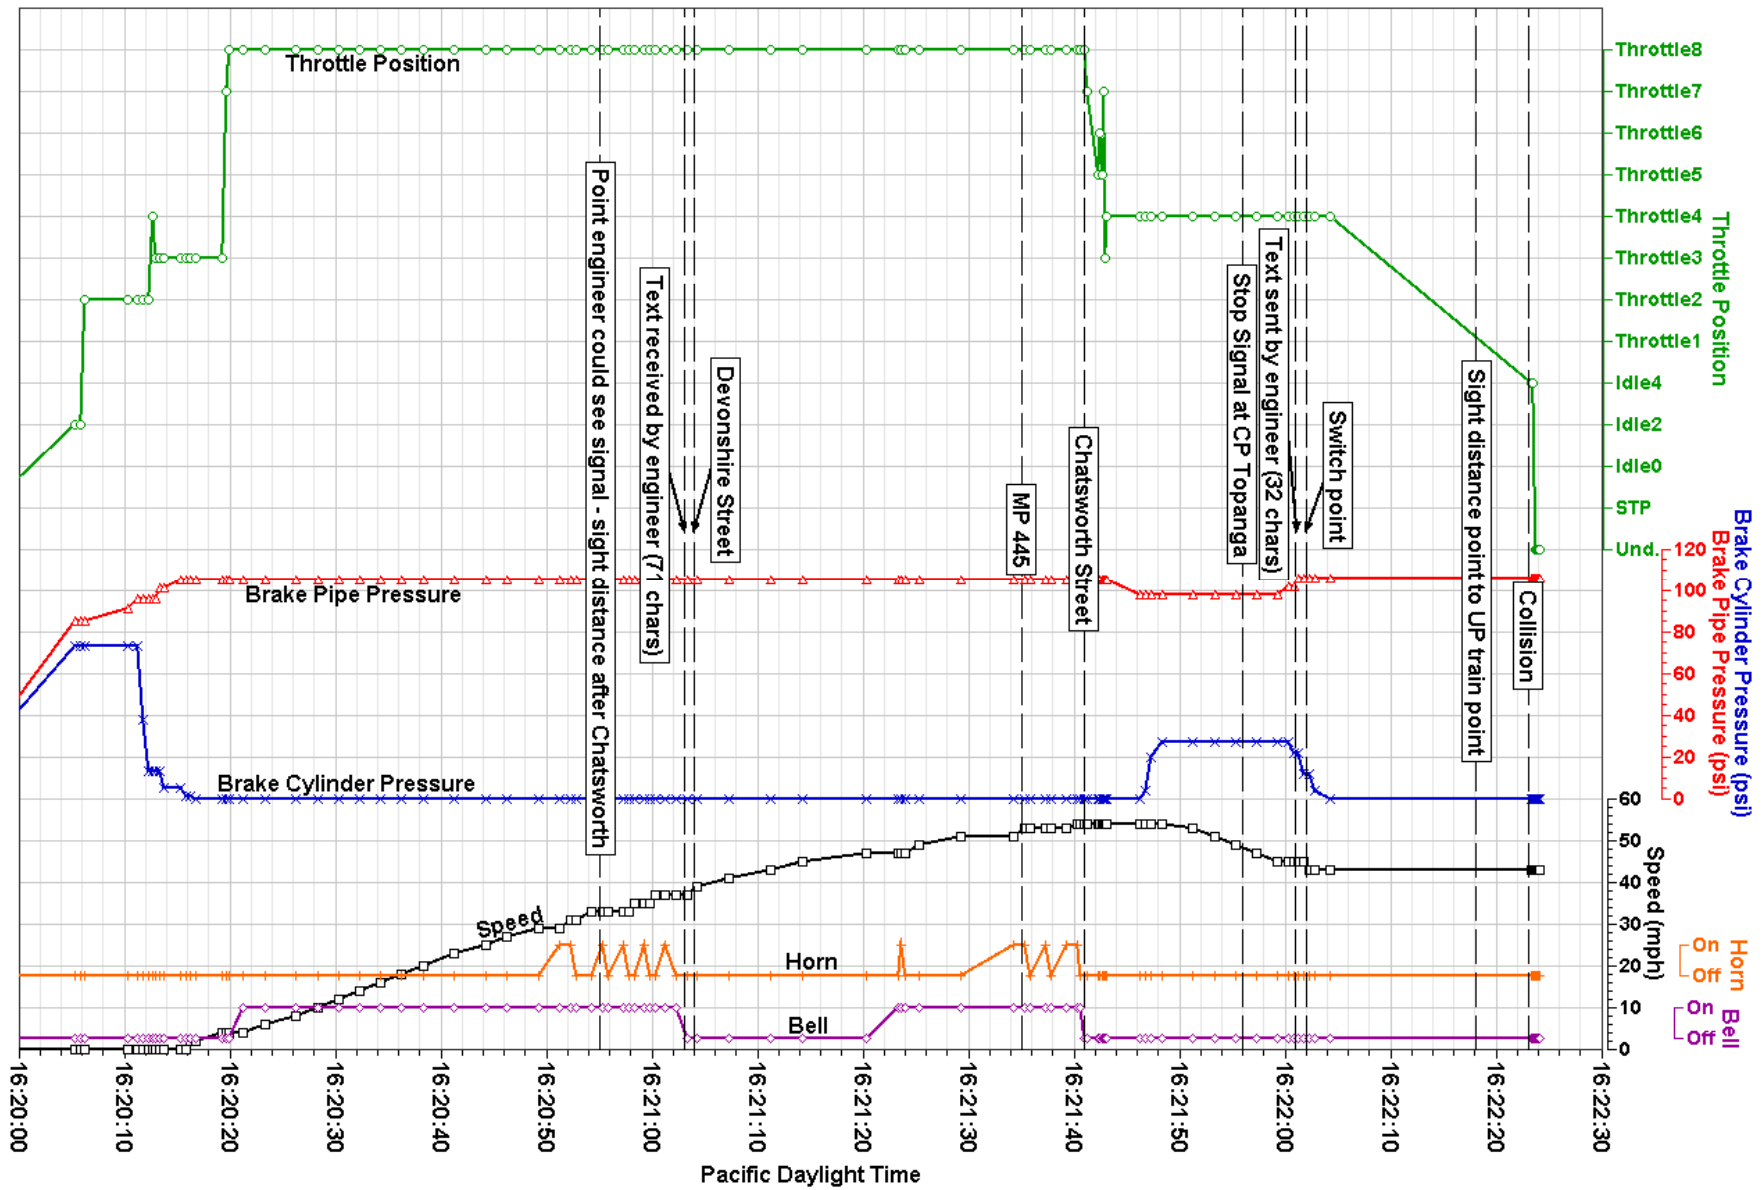
Figure 1: Correlation of Select Information

Figure 1 is a chart showing event recorder data from the Metrolink locomotive train, along with select events from the telephone records, and location references from the scene survey and sight distance tests.¹⁰
