NATIONAL TRANSPORTATION SAFETY BOARD
Investigative Hearing

Washington Metropolitan Area Transit Authority Metrorail train 302 that encountered heavy smoke in the tunnel between the L'Enfant Plaza Station and the Potomac River Bridge on January 12, 2015

Fire Investigation Factual Report

FIRE INVESTIGATION FACTUAL REPORTReport No. 15-039

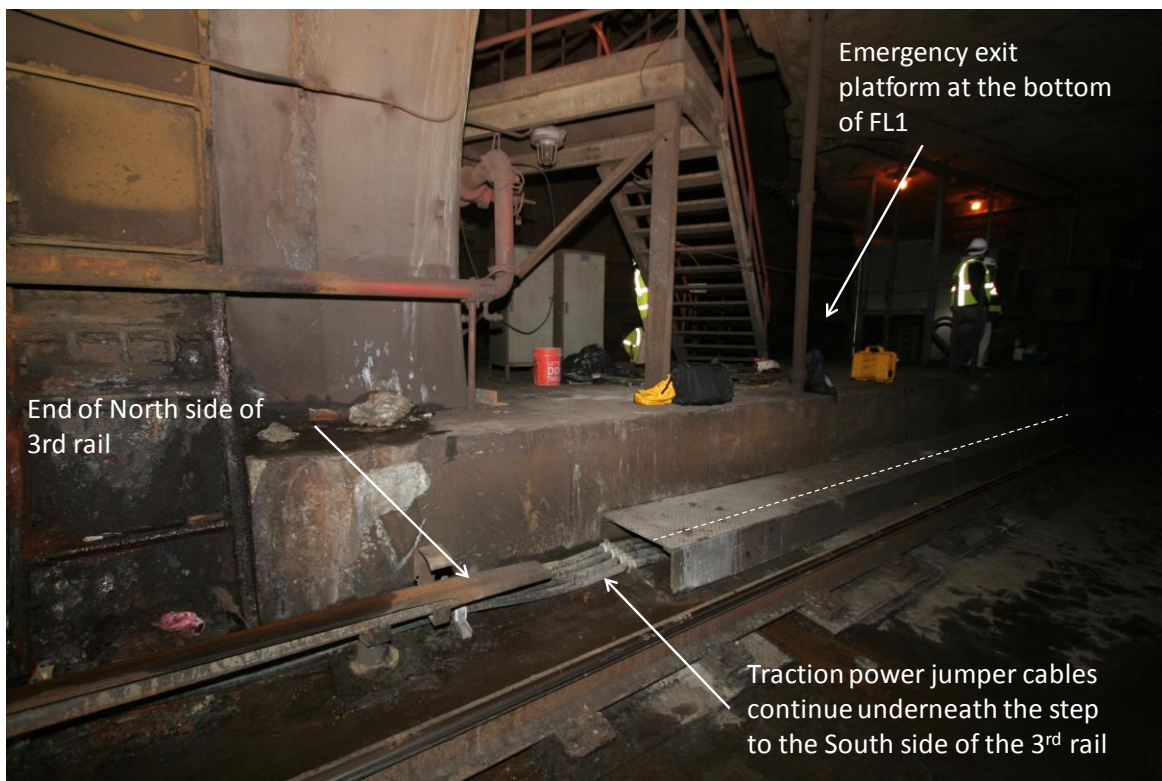
FL1 serves as a ventilation fan shaft as well as an emergency exit that can be used in the event a train has to be evacuated while inside the tunnel. At the base of the FL1 shaft there is also a drainage water pumping station. The fan shaft has four fans at the top that can operate in either supply or exhaust mode and can be controlled locally or remotely from the operations control center (OCC). The four fans each have a capacity of 50,000 cubic feet per minute (cfm) in exhaust and 35,000 cfm in supply. At the bottom of the fan shaft is the emergency exit platform where trains can pull up and disembark passengers from either track #1 or track #2 of the L-line. Passengers evacuating through the tunnel can also step up to the evacuation platform from the track bed at this location. Other than at the bottom of FL1, the bores for track #1 and track #2 are separate from each other. Because FL1 is intended as an emergency exit, there is a discontinuity in the 3rd rail along the length of the emergency exit platform so that passengers do not have to step over the 3rd rail when evacuating. This is the same for tracks #1 and #2 on either side of the platform. In order to maintain electrical continuity of the 3rd rail, jumper cables are used to bridge the gap (figure 2).

Figure 2: Emergency exit platform at the Intersection of L-line Track #2 and FL1.

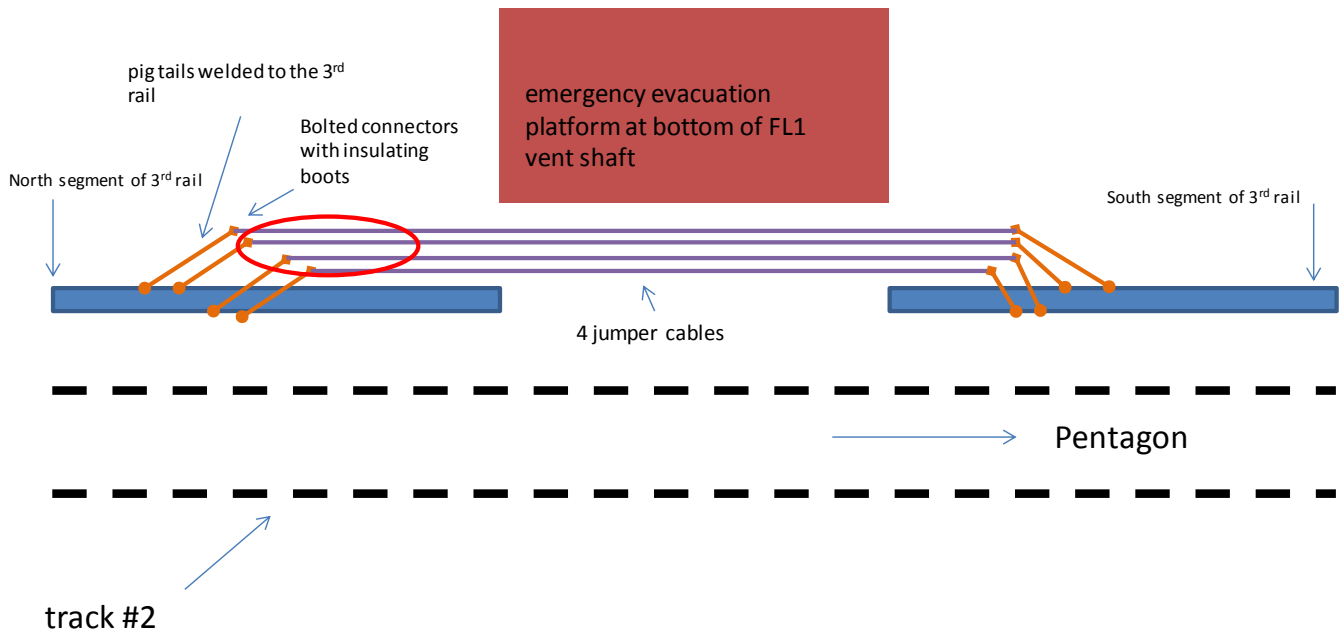
Diagram of jumper cable layout joining north and south segments of the 3rd rail at the incident site

There were four jumper cables that electrically joined the two sides of the 3rd rail (figure 3). Each jumper cable consisted of a long portion of relatively stiff cable (power feed cable) with portions of more flexible cable (pigtailed) connected at either end. Both of the types of cable were of equivalent electrical capacity. The connections between the power feed cable and pigtail cable were bolted connections. An insulating “boot” covered these connections. The connections between the pigtail cables and the 3rd rail were welded connections.

Figure 3: Diagram (plan view, not to scale) depicting jumper cable installation at the accident site. The area circled in red is where the majority of electrical arcing occurred.

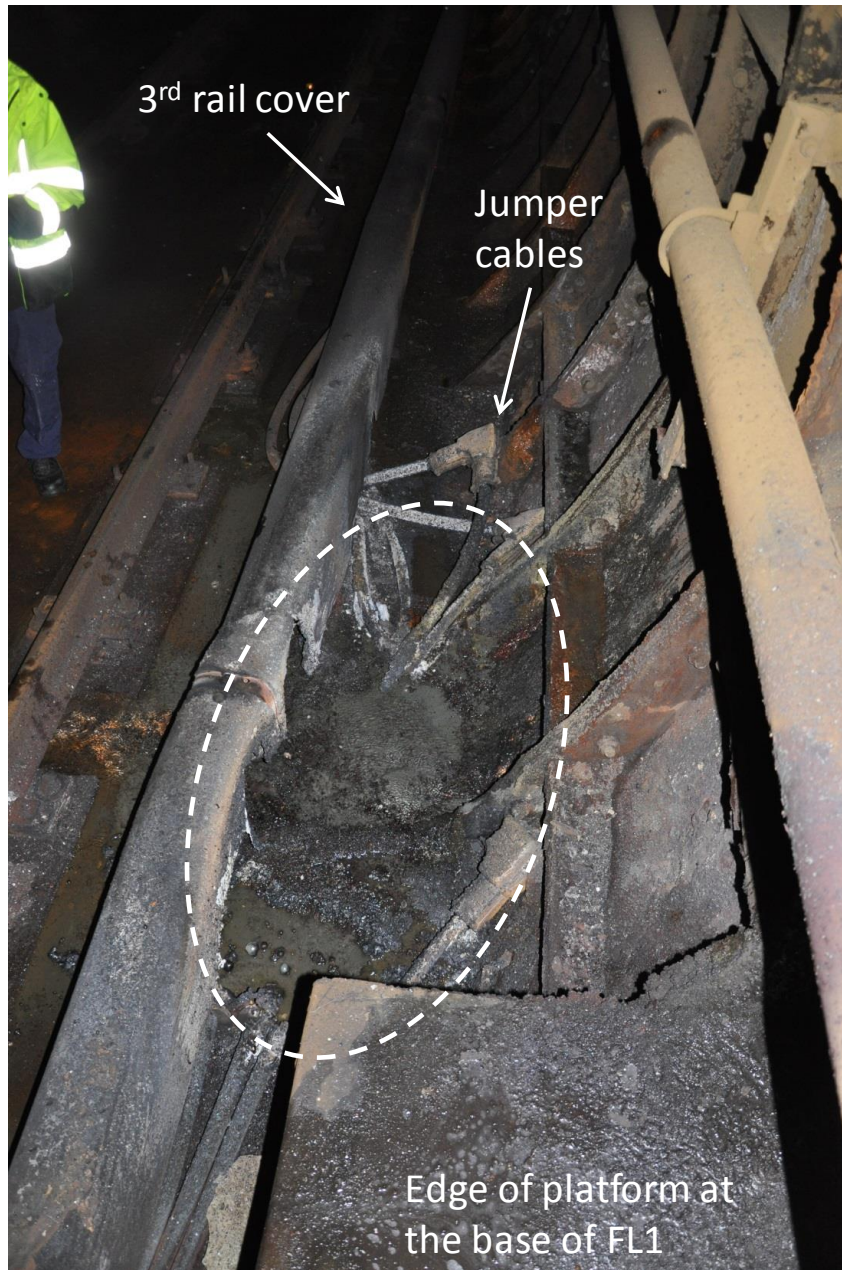
The accident site examination indicated that electrical arcing had taken place among the power jumper cables that bridge the gap in the 3rd rail. The arcing was concentrated among the jumper cables on the north side near their connection to the 3rd rail (figure 4). One area of electrical arcing against the 3rd rail was observed at the south side of the 3rd rail (figure 5).

Figure 4: The majority of the electrical arcing and thermal damage was concentrated among the jumper cables. The area circled had missing portions of cable.

The majority of the arcing and thermal damage took place on the north portion of the jumper cables in the area where the jumper cable connector boots were resting against the tunnel wall casing (Figures 4,6). The tunnel wall casing in this area was constructed of a ribbed, plate steel design with bolted connections among segments. One of the steel plates near floor level had evidence of copper splatter on it and seemed to be eroded or punctured. This area of splatter was directly behind the area where a cable connection appeared to have previously been. The connector and boot that would have been in this location were no longer present. One more of the cable connections in this same area was partially consumed. There appeared to be segments of cable missing from all four of the jumper cables. The ends of the severed cables had a melted and beaded appearance consistent with conductors that had gone through electrical arcing. Beyond the severed ends of the cable conductors the insulating sheathing had been burned back and thermally damaged. This damage to the insulation varied in the degree of how far back it extended from the exposed conductor. These damaged sets of jumper cables were retained for further examination and documentation at the NTSB laboratory.

The general area where the electrical arcing took place was wet. Pools of standing water existed where the cables had been laying. Water was freely flowing from an area of the tunnel casing where electrical arcing damage was observed. Water was also seen dripping from the tunnel casing above the location of the electrical arcing. The rusty appearance of the tunnel casing was consistent with prolonged exposure to moisture and corrosion.

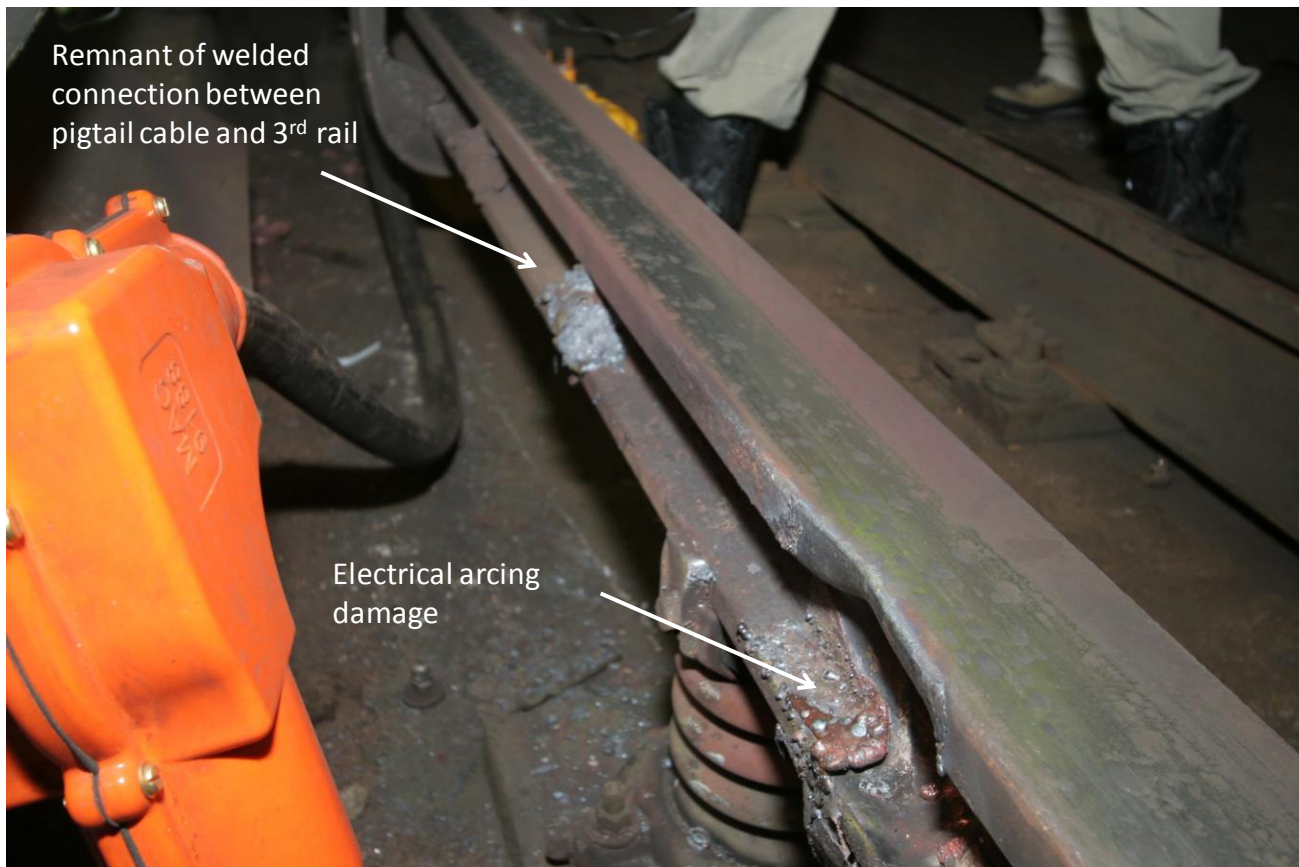
Figure 5: Electrical arcing damage to 3rd rail on south end.

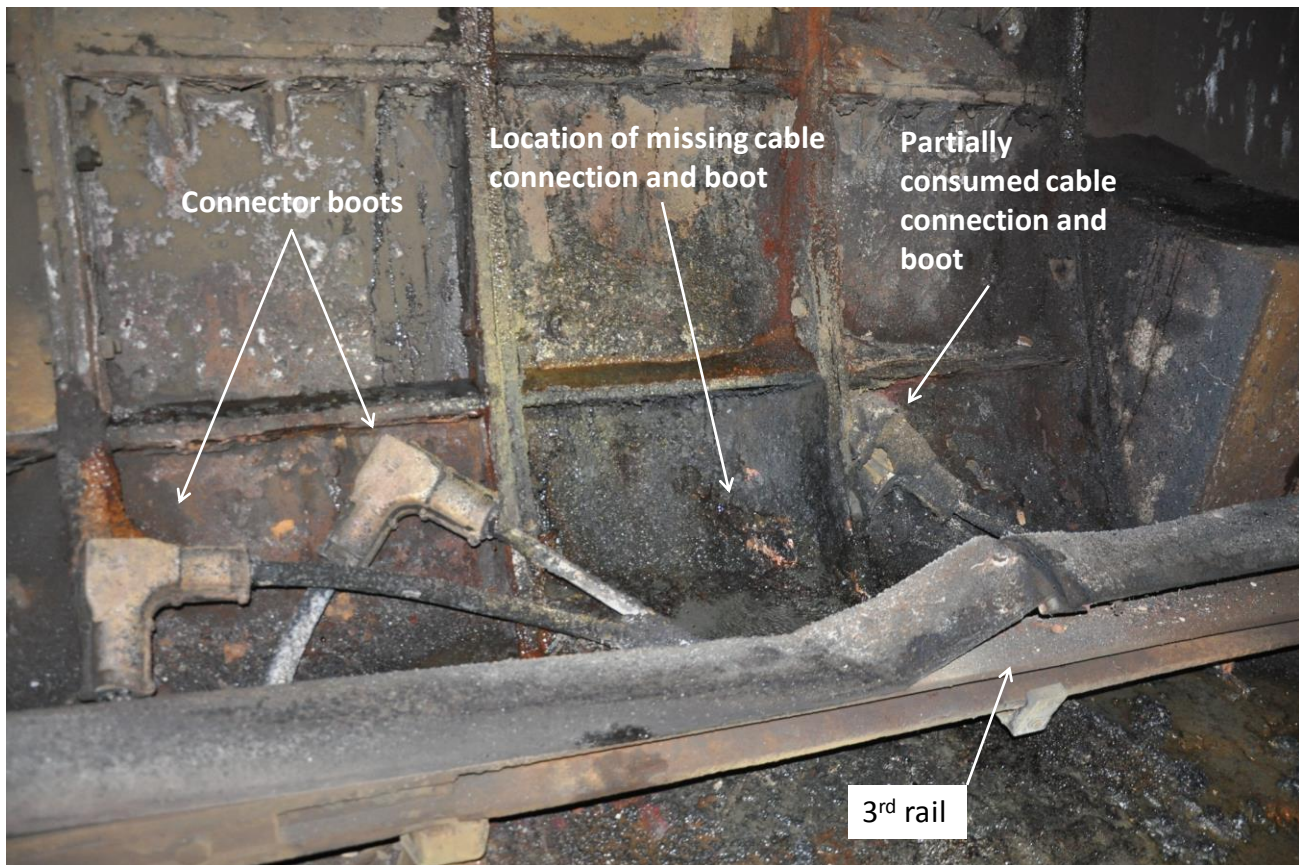
Figure 6: Damaged jumper cables resting against tunnel casing

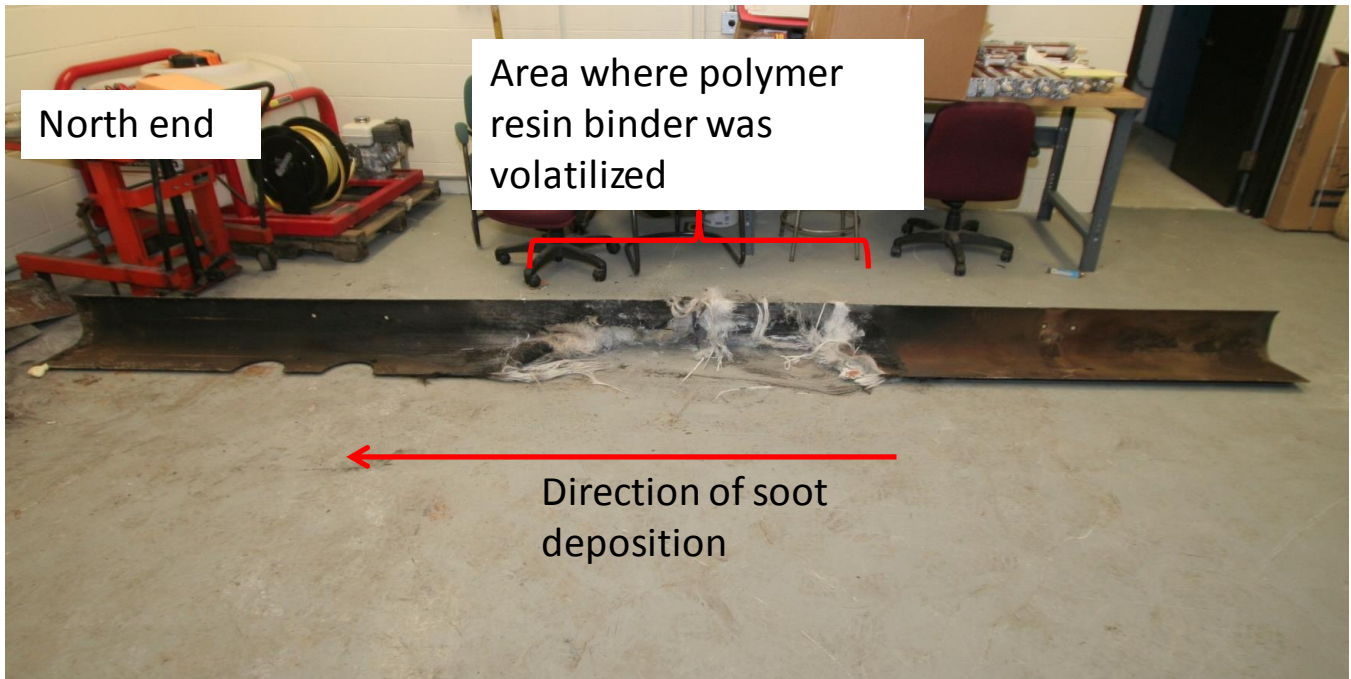
There was a portion of 3rd rail in front of the location of the electrical arcing. This portion of the 3rd rail was covered by a fiberglass rail cover. The rail cover was thermally damaged exhibiting an area in which the polymer resin binder had completely volatilized leaving just the glass matrix behind. (figure 7). A horizontal soot trail and gradient of thermal damage along the interior face of the rail cover was consistent with air flow in the tunnel drifting towards the north (L'Enfant Plaza direction). This portion of the rail cover along with two more adjoining portions towards the north were retained for further examination at the NTSB laboratory. No evidence of any electrical arcing against the 3rd rail was observed on this north segment of the rail.

Figure 7: Thermal damage to the 3rd rail cover

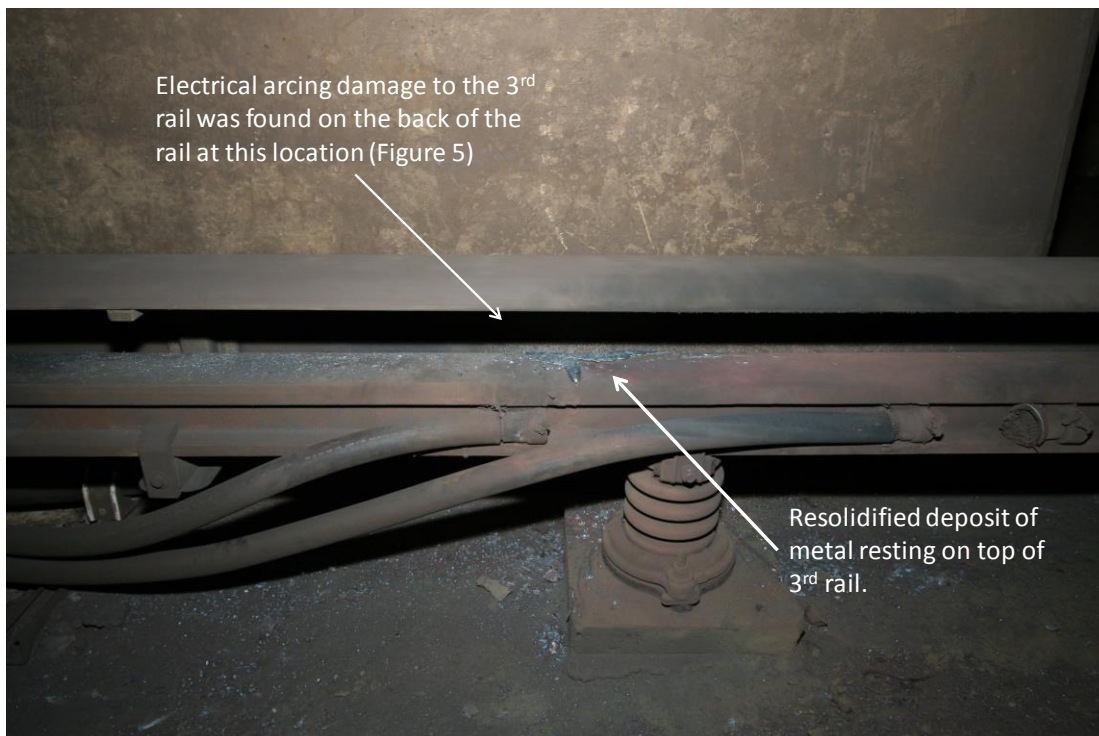
On the segment of the 3rd rail south of the emergency exit platform, a deposit of re-solidified metal was observed laying on the top surface of the 3rd rail (figure 8). On the surface of the 3rd rail facing the tunnel casing, directly below where the deposit was found, an area of damage from electrical arcing was observed (figure 5). The deposit was analyzed by x-ray fluorescence spectroscopy and found to consist mostly of iron with traces of copper.

Figure 8: Resolidified metal deposit on South end of the 3rd rail.

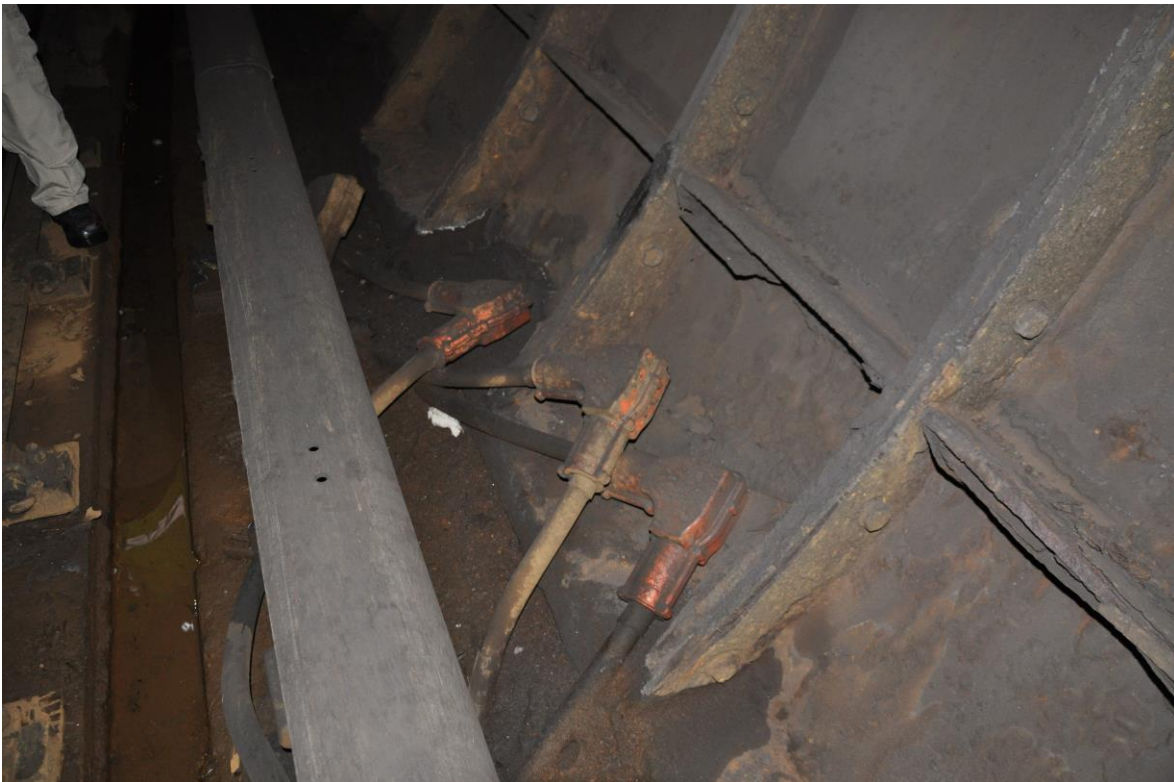
Track #1 of the L-line had a similar jumper cable installation used to bridge the gap in the 3rd rail due to the emergency exit platform (figure 9). The environment where the cable connections and insulating boots were laying was not as wet as what was observed in Track #2. There was however moisture and water puddles along the track bed. The jumper cables were coated in a moist, mud-like debris (figure 10).

Figure 9: Jumper cable connections and boots on Track #1 of L-line at the North end of FL1.

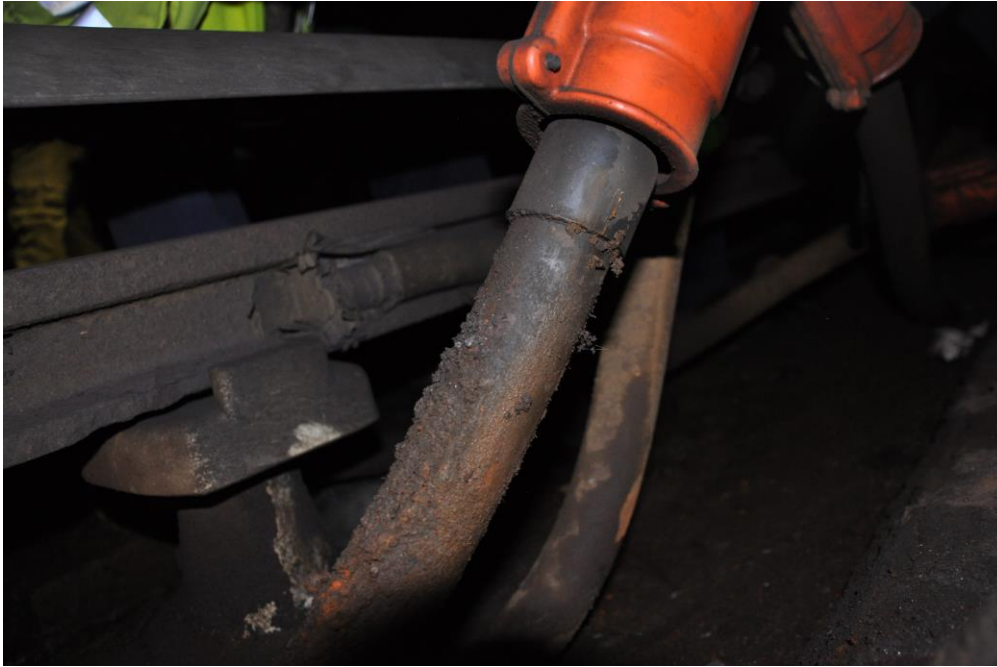
Figure 10: Jumper cable with moist debris adhering to the insulation surface.

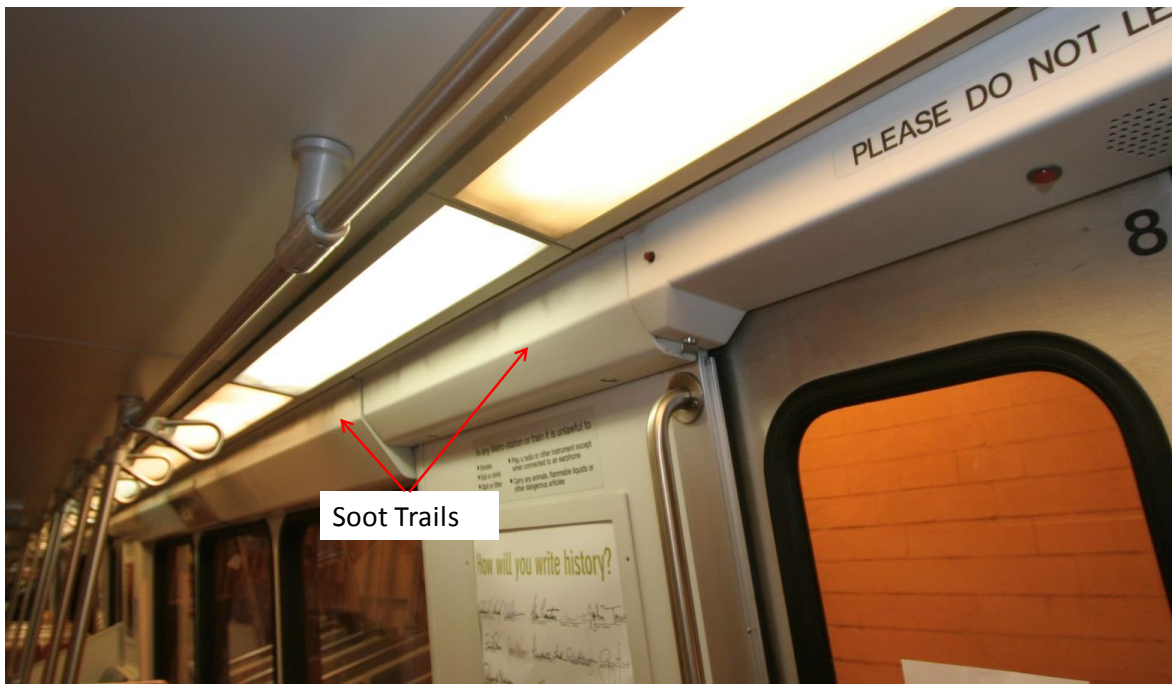
had a similar level of soot accumulation on the horizontal surfaces as the previous two cars. In this car, soot trails were observed at the vents near the ceiling on both sides of the car in the area between the forward and middle sets of doors. The 6th and last car (3031) also had soot on the horizontal surfaces similar to that seen in the 3rd through 5th cars. In this car, unlike the previous cars, the soot trails coming out of the vents at the ceiling appeared continuous along the length of the car on both sides (where there were vents). All the filters from the ventilation systems of the cars in this train consist were retained for further examination at the NTSB laboratory.

Figure 12: Soot trails seen at the ceiling vents.
