NATIONAL TRANSPORTATION SAFETY BOARD
Investigative Hearing

Washington Metropolitan Area Transit Authority Metrorail train 302 that encountered heavy smoke in the tunnel between the L'Enfant Plaza Station and the Potomac River Bridge on January 12, 2015

Mechanical Group Factual Report

Smoke and Arcing at L'Enfant Plaza Subway Station

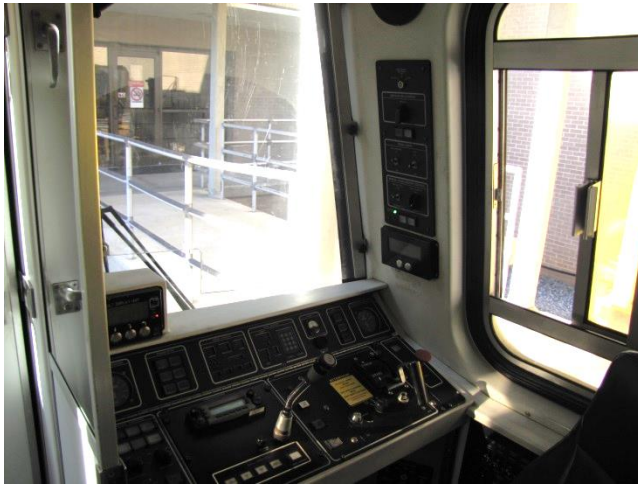
WMATA 10-year veteran, was asked to shut down the train's HVAC systems in a manner consistent with receiving permission from the operations control center during a smoke event. With the train stopped and the console keyed on, the test operator used a key to turn the environmental control (EC) switch off which is located on a panel on the right wall of the operator's cab. See figures 1 and 2.

Figure 1-Operator console of railcar 3031

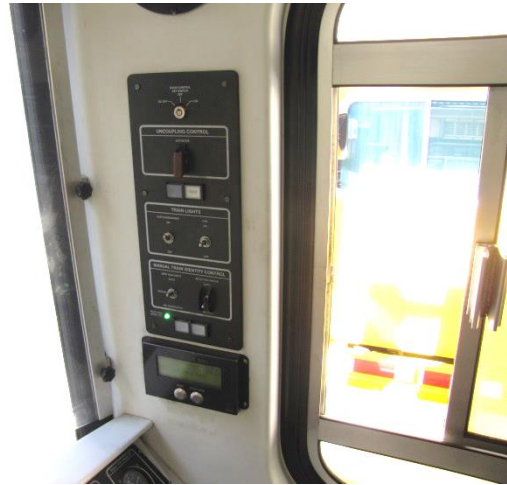
Figure 2-Environmental control (EC) switch

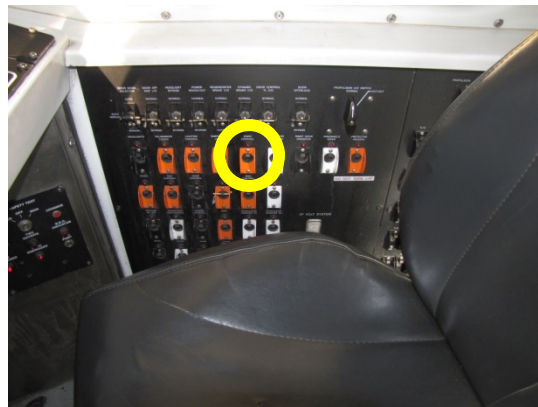
The test operator then opened an environmental control circuit breaker. See figure 3. At this time railcar 3031's environmental systems shut down. The team verified that all other environmental systems remained operational. That is, they did not shut down with the action performed by the test operator.

Figure 3-Circuit breaker panel of railcar 3031 with the environmental control circled
