Washington Metropolitan Area Transit Authority Metrorail train 302 that encountered heavy smoke in the tunnel between the L'Enfant Plaza Station and the Potomac River Bridge on January 12, 2015

<b>GROUP</b>	<b>C</b>
<b>EXHIBIT</b>	
13

Tunnel Leak Inspection Report 2012,  
L'Enfant Plaza to L'Enfant Plaza Portal

WASHINGTON METROPOLITAN AREA TRANSIT AUTHORITY  
**TUNNEL LEAK INSPECTION REPORT**  
 F03 L'Enfant Plaza to L'Enfant Plaza Portal OB (3,800 Ft)

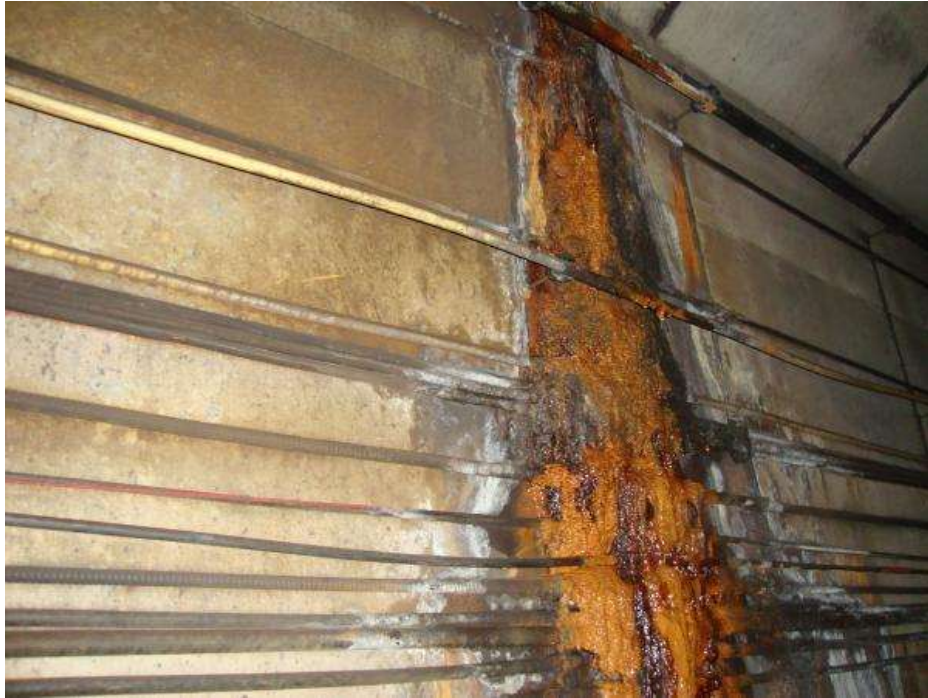
Photo 1  
L2 88+30

CHAIN MARKER	TUNNEL AREA 3R CRN SW INV	COMPONENTS AFFECTED						Location & DRAIN SIZE	CATEGORY 1, 2 OR 3	REMARKS
		W	L	HW	SW	R	FL			
88+30								1	Leaking on running rail (see attached file for e-mail sent 3-26-11) This condition has been corrected (2012)	
88+80	X							3	cold jt.	
92+40	X							2	cold jt.

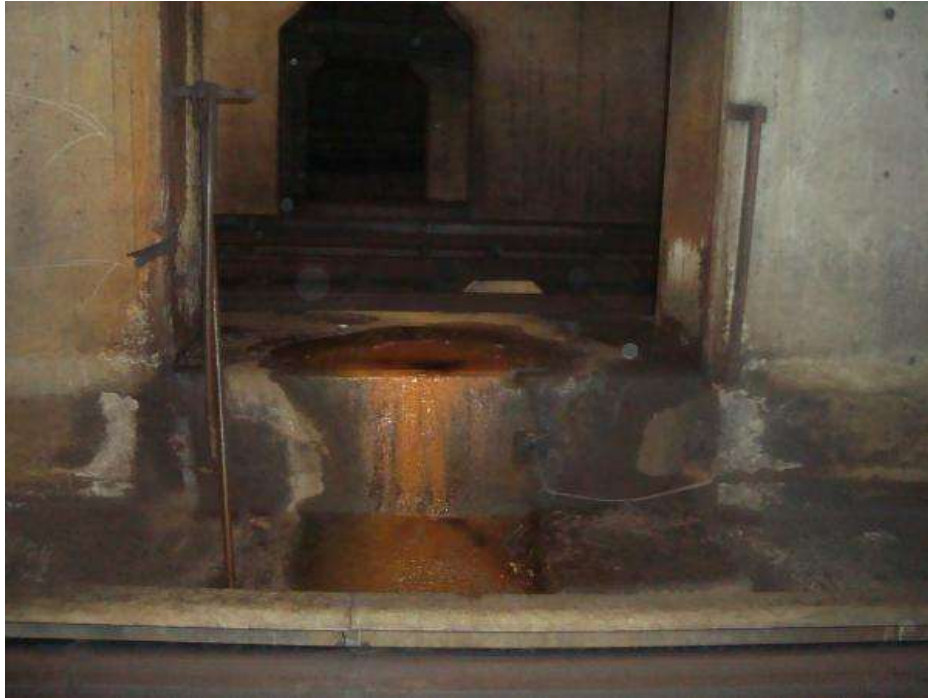
Photo 5  
Overall of area of leak.

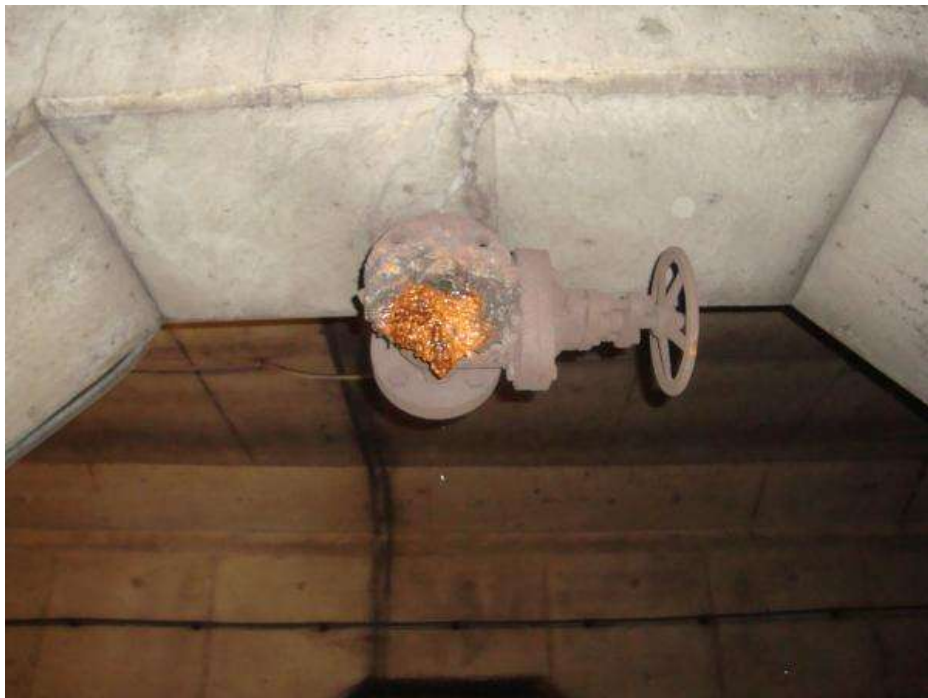
Photo 6  
Pipe that is the source of leak and rusting components.

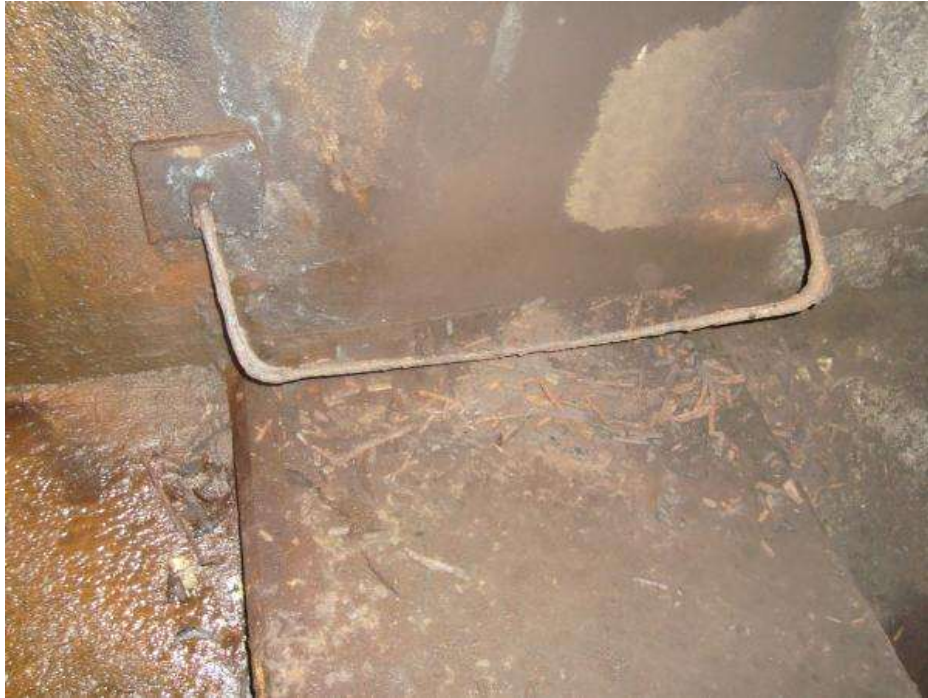
Photo 7

Foot/grab bar that is unsafe for use.

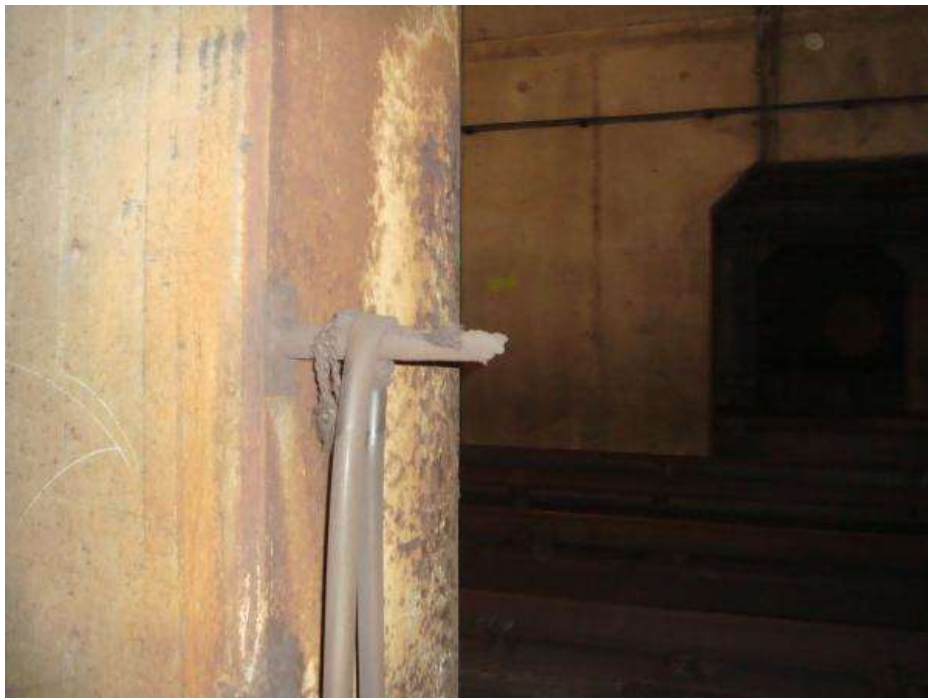
Photo 8

Safety rail that has rusted away.

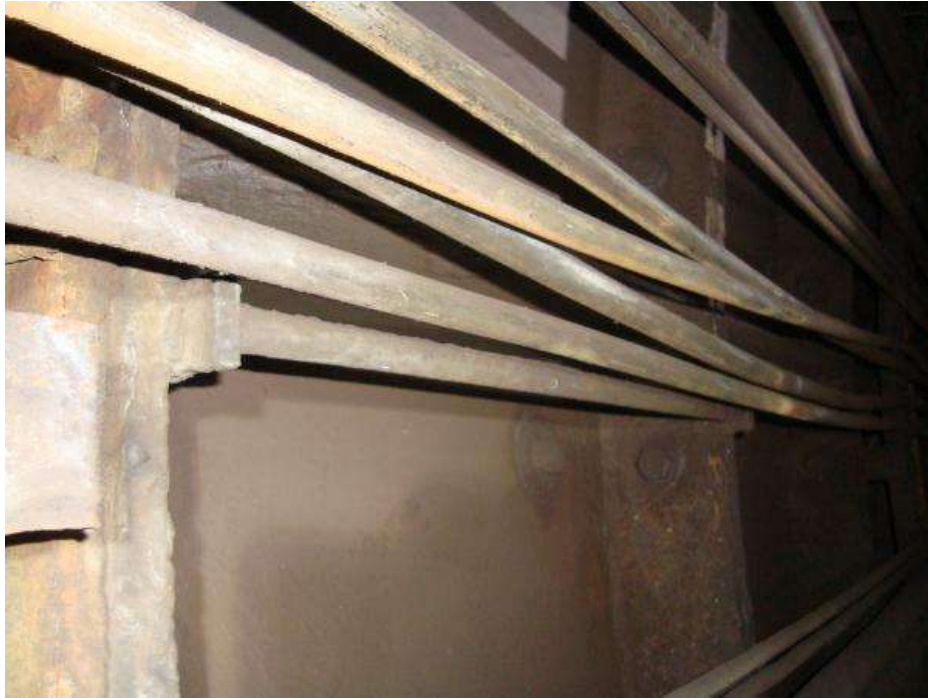
Photo 9

Grab bar that is intertwined with cables.
