NATIONAL TRANSPORTATION SAFETY BOARD
Investigative Hearing

Washington Metropolitan Area Transit Authority Metrorail train 302 that encountered heavy smoke in the tunnel between the L'Enfant Plaza Station and the Potomac River Bridge on January 12, 2015

GROUP	C
EXHIBIT	
14

**Biennial Tunnel Structural Maintenance
Inspection Report 2014,
L'Enfant Plaza to L'Enfant Portal**

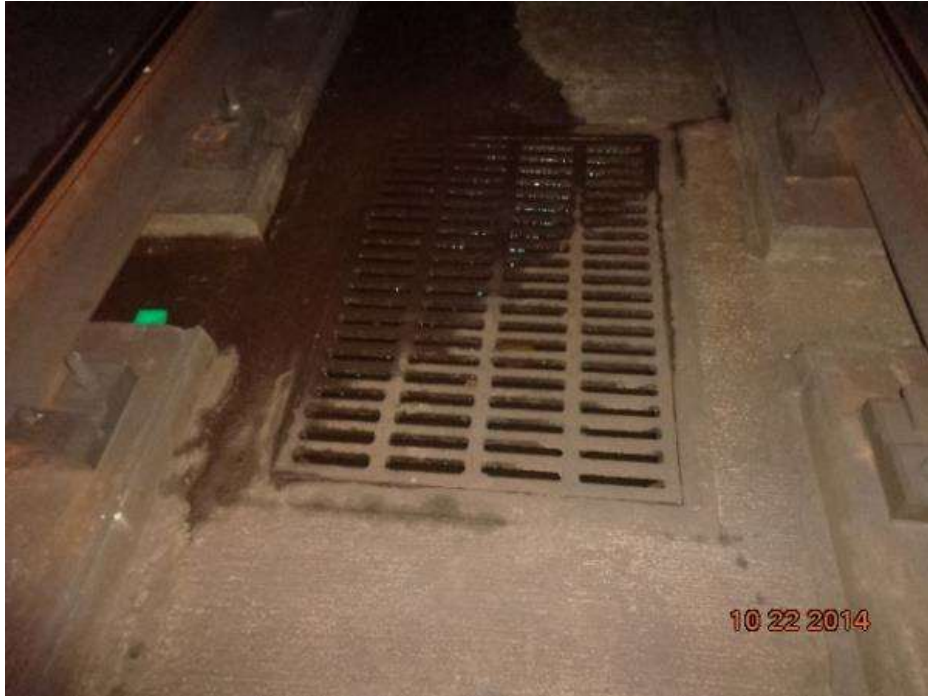
Photo 1

3) Invert Slabs	6	
4) Drains / Troughs	4	- Main drain at the center of track bed is clogged at CM 90+60
5) Safety Walk	5	- L2 57+30, delam 12"x 12" on center of safety walk. - CM L2 56+15 nose plates missing on the top and center steps, nose plate raised 1 inch on the lower step and the top step is spalled (10"x8"x2") See Photo(s): 11, 12, 13, 14, 15

CHAIN MARKER	LOCATION	NO.	REMARKS
L2 88+20	CRWN	4	Leak at joint is dripping on to the rail and hardware See Photo(s): 2, 3
L2 90+60	Invert	4	Large drain at center of track is clogged See Photo(s): 1

Large drain in center of track bed is clogged at CM L2 90+60

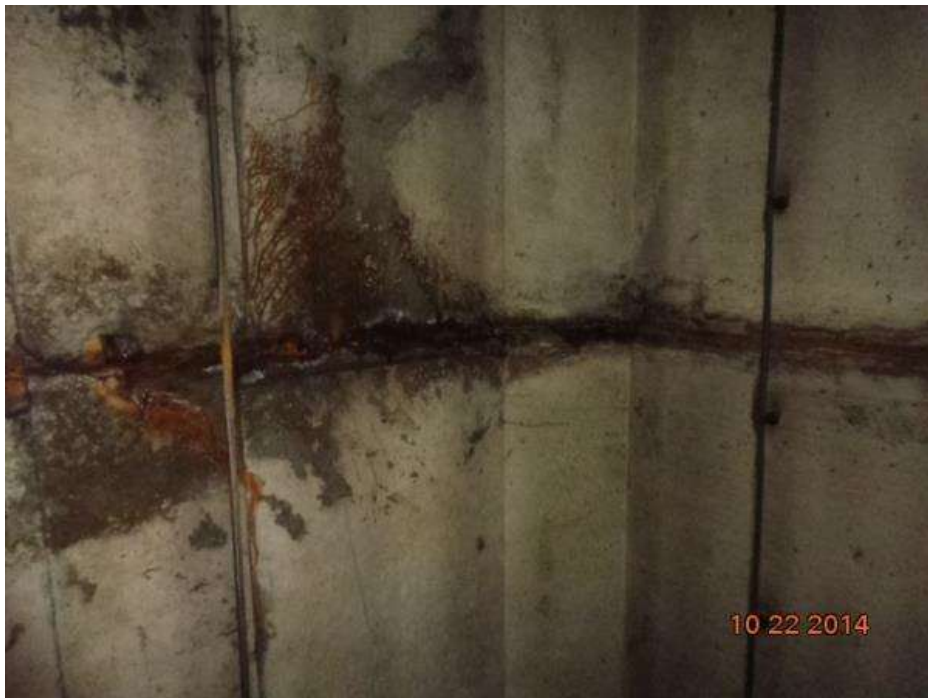
Photo 2

Leak in crown at construction joint, CM L2 88+20

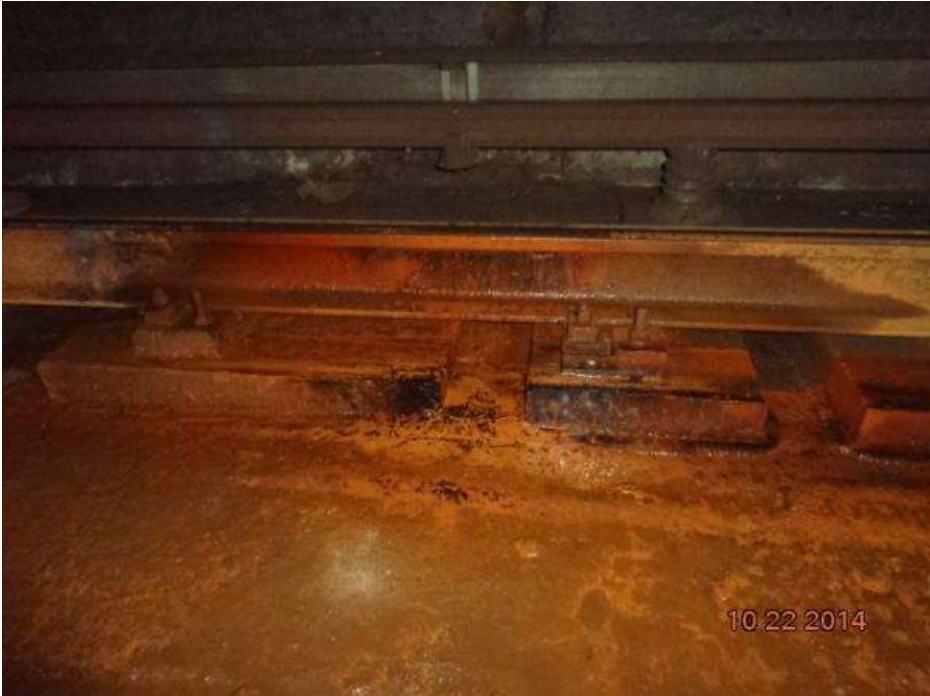
Photo 3

Crown leak at CM L2 88+20 is leaking onto the running rail.

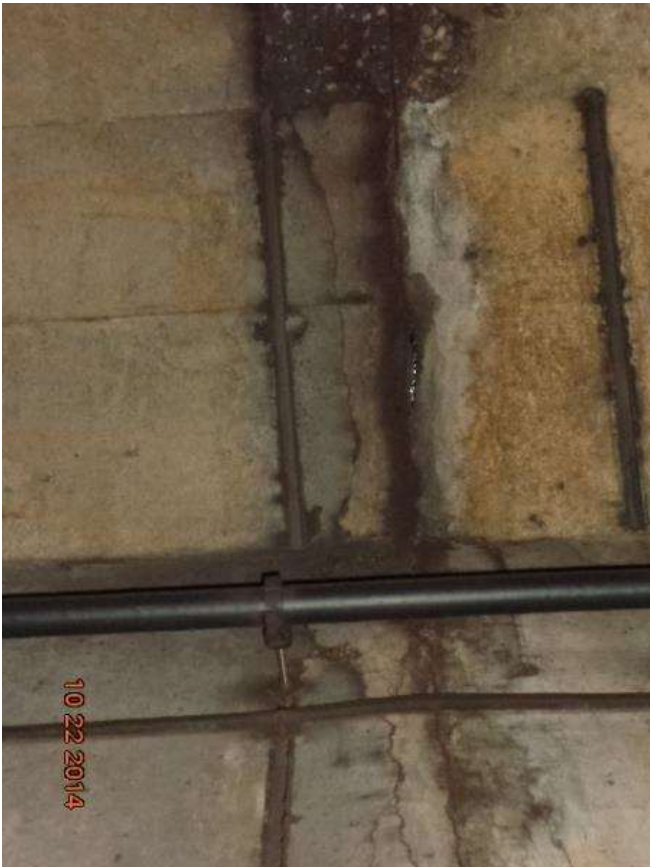
Photo 4

ITEM	NO.	REMARKS
<u>TUNNEL</u>		- Leak in the crown at joint is leaking on to the rail and hardware at CM L2 88+20
1) Tunnel Liner	6	
a. Concrete	5	- CM# 85+40 Overhead spall at joint (approx. 2-1/2"x 10"x 1"). There is also vertical cracking open to .030" on the East wall at the joint. See Photo(s): 4, 5, 6, 7, 8

Cracking in the East wall near the construction joint at CM L2 85+40

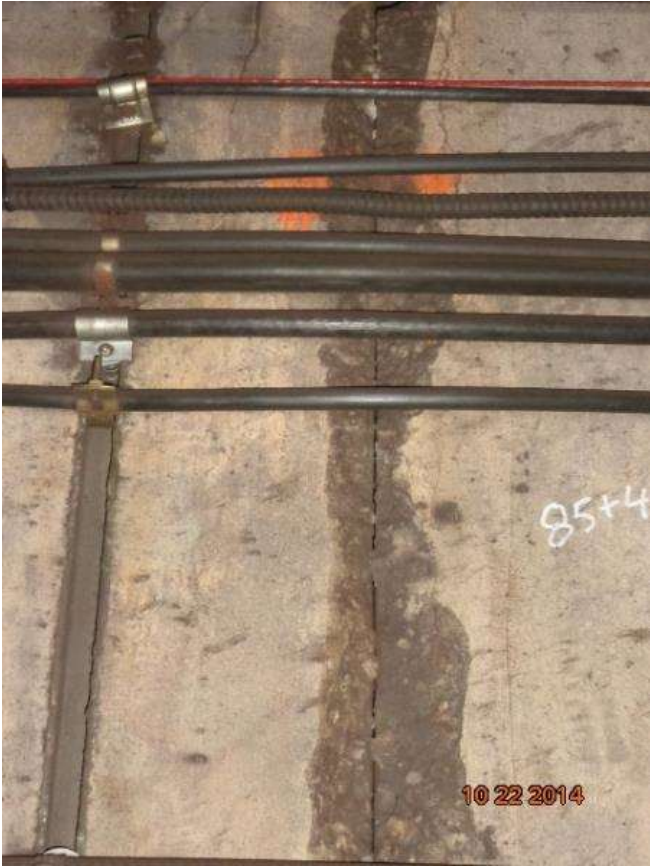
Photo 5

Spalling in the East wall at the construction joint at CM L2 85+40

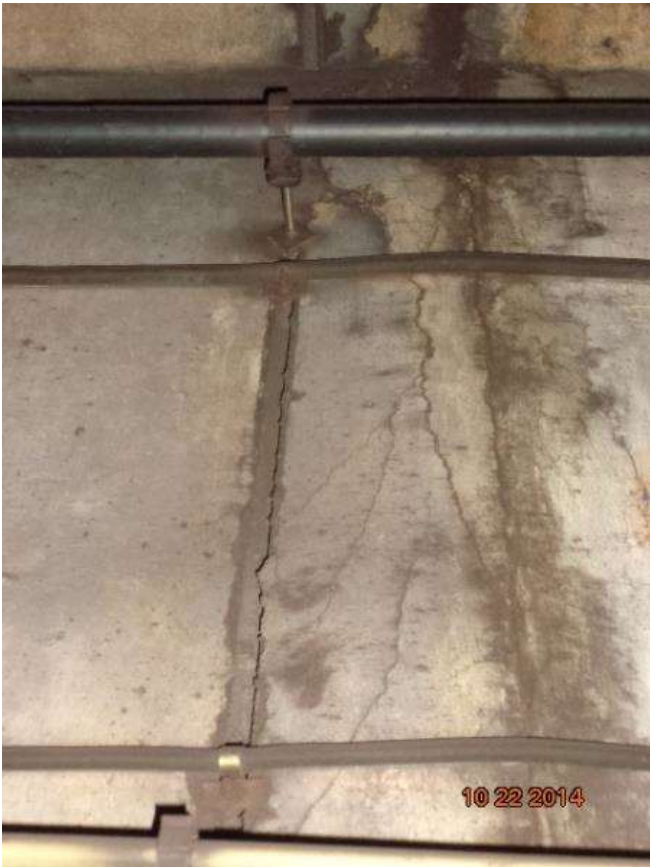
Photo 6

Cracking in the East wall near the construction joint at CM L2 85+40

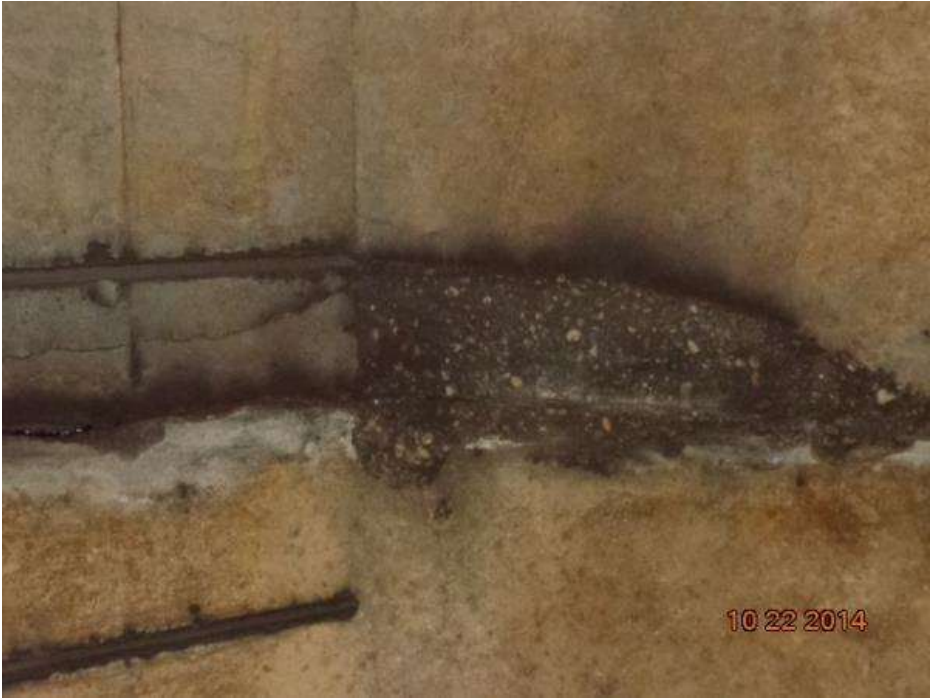
Photo 7

Spalling in the ceiling at the construction joint at CM L2 85+40

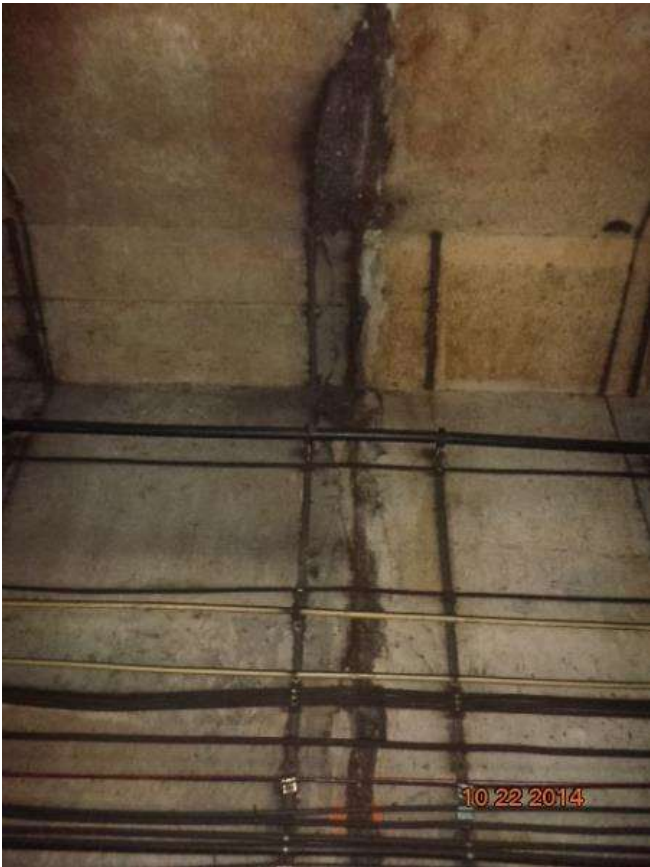
Photo 8

Overall of construction joint at CM L2
85+40

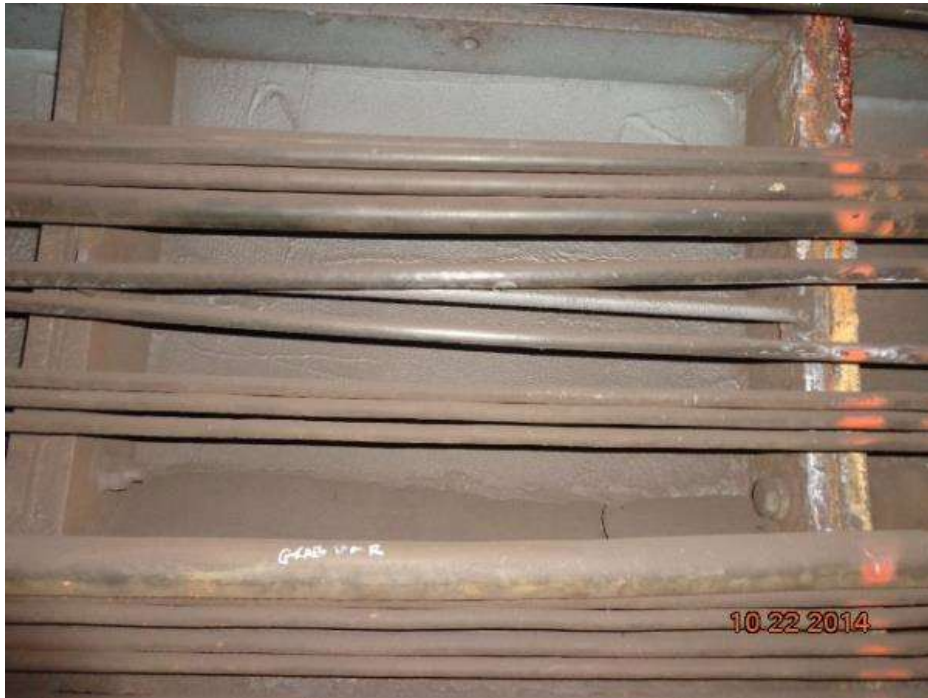
b. Steel / Iron Plates and / or Bolts	6	
c. Grab Rails, Handrails and Fasteners	5	L2 70+00 grab bar covered by wires. Grab rail needs to be extended past wires.CM# 84+60 See Photo(s): 9, 10

Photo 9
Grab bar covered by wires at L2 70+00

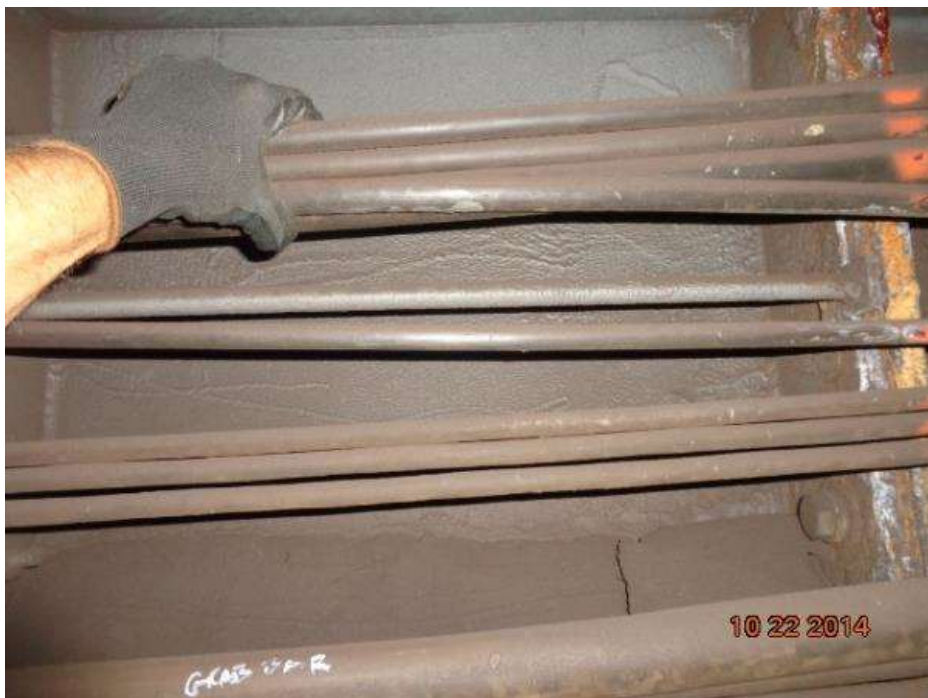
Photo 10
Grab bar covered by wires at L2 70+00

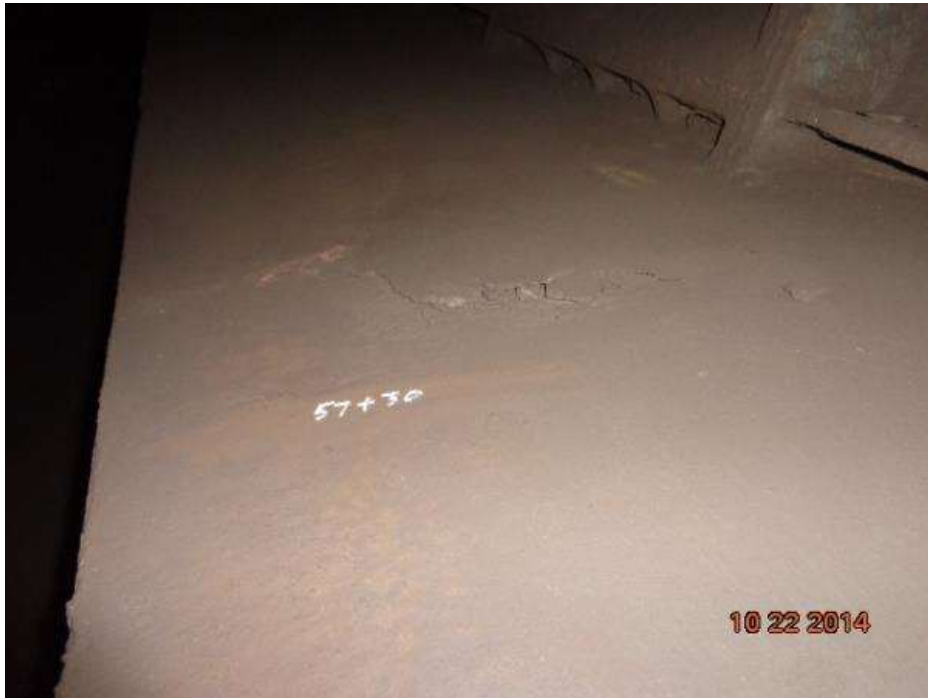
Photo 11

Spall/Delam on safety walk at CM L2 57+30

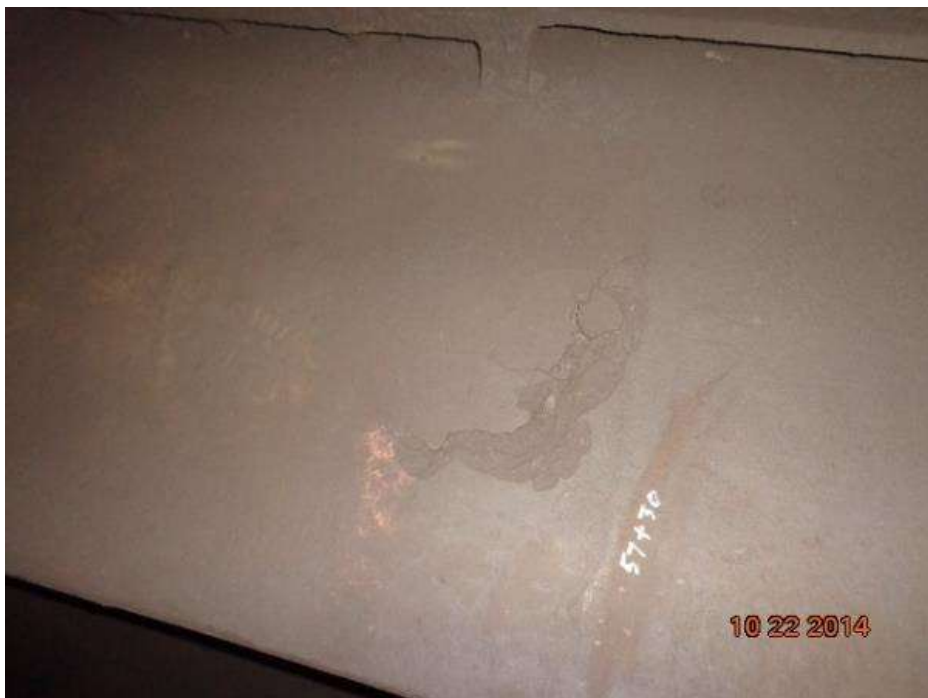
Photo 12

Spall/Delam on safety walk at CM L2 57+30

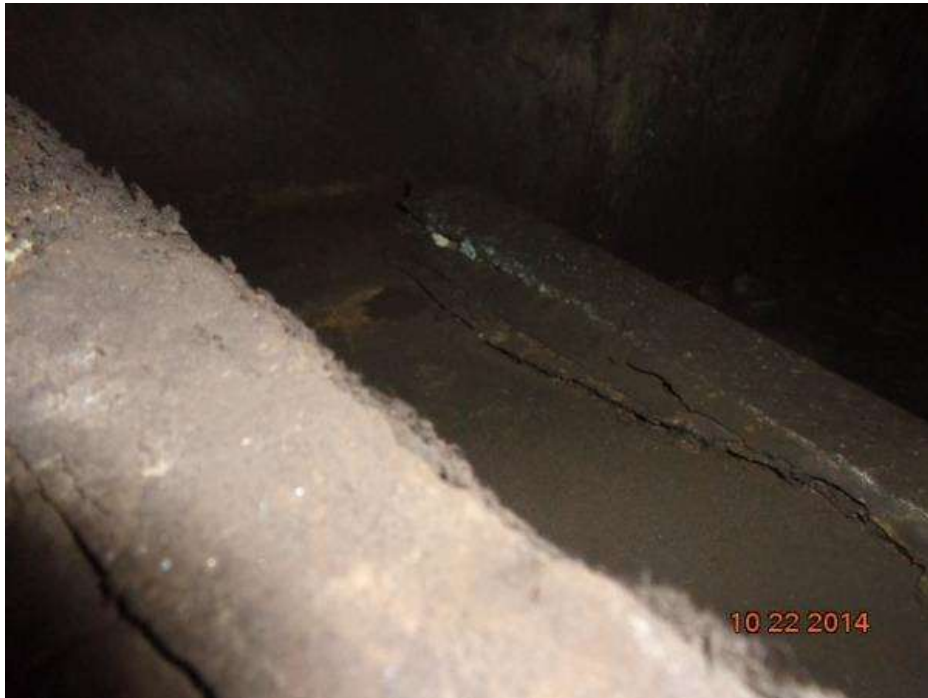
Photo 13

Nose plate raised 1 inch on the bottom step CM L2 56+15

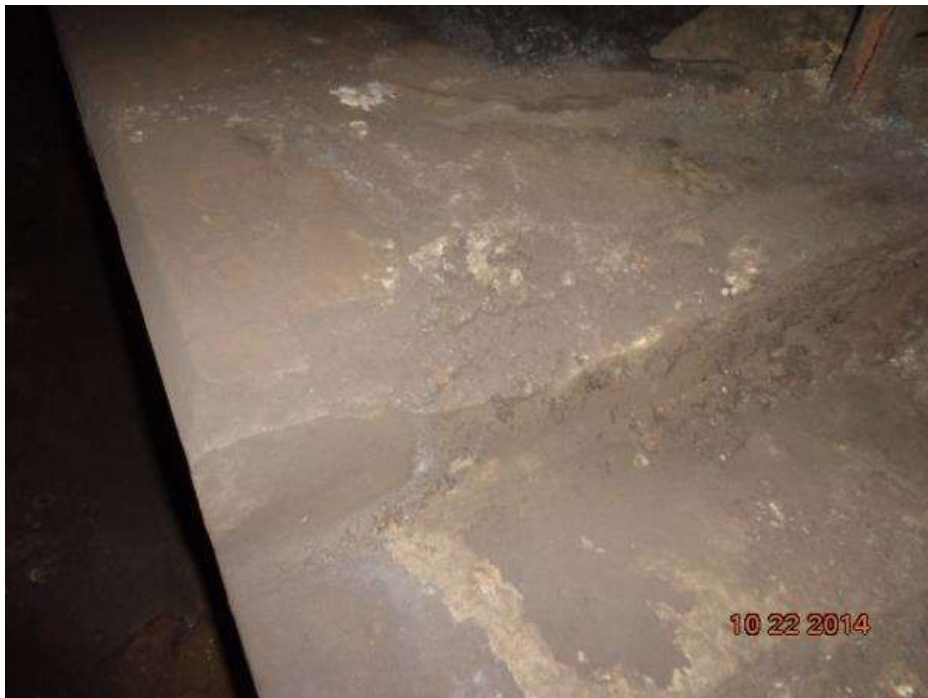
Photo 14

Top step spalled at CM L2 56+15

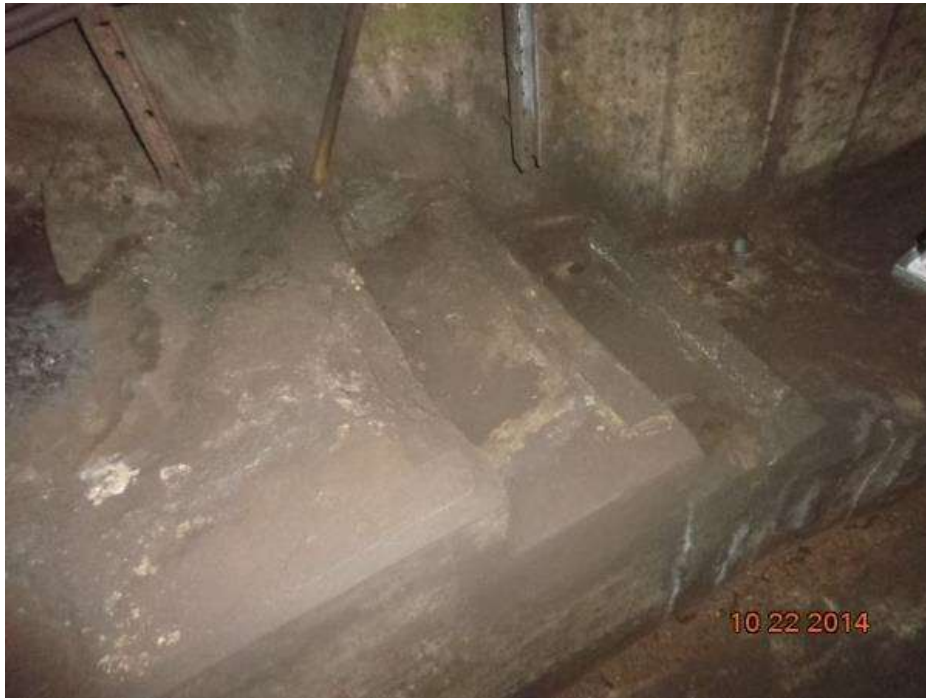
Photo 15

Nose plates missing at the top and center step CM L2 56+15
