**Report of Preconstruction Condition
Survey Services**

**ADJACENT PROPERTIES TO
THE WHARF – PHASE I
WASHINGTON, DC**

ECS PROJECT NO. 37:1306

OCTOBER 6, 2014

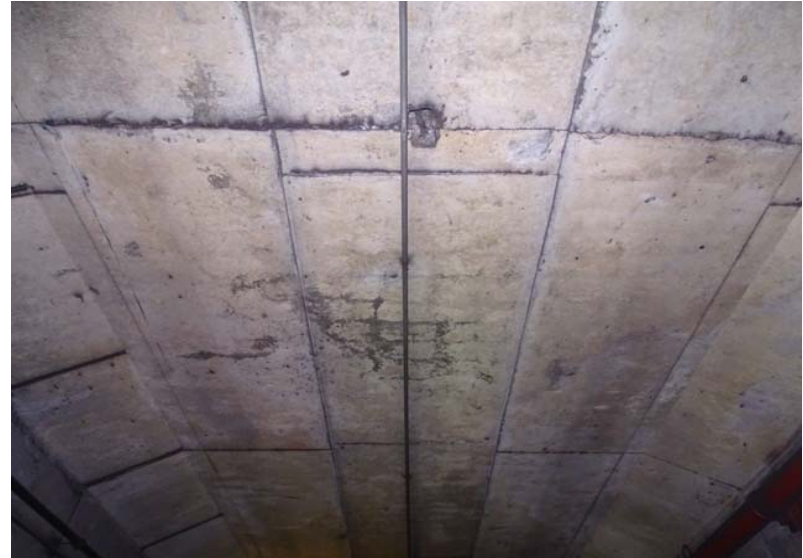
Photograph No. 93
Station 72+20 - crack on the east wall.

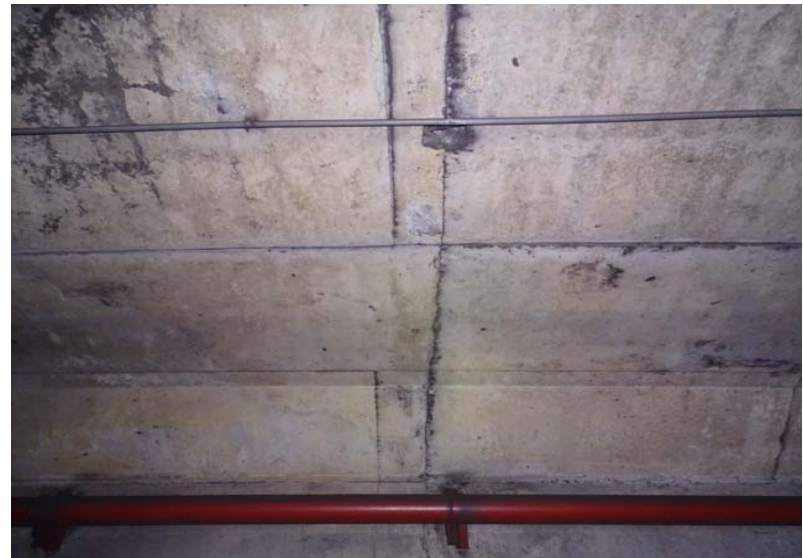
Photograph No. 96
Station 72+20 - crack on the ceiling, looking west.

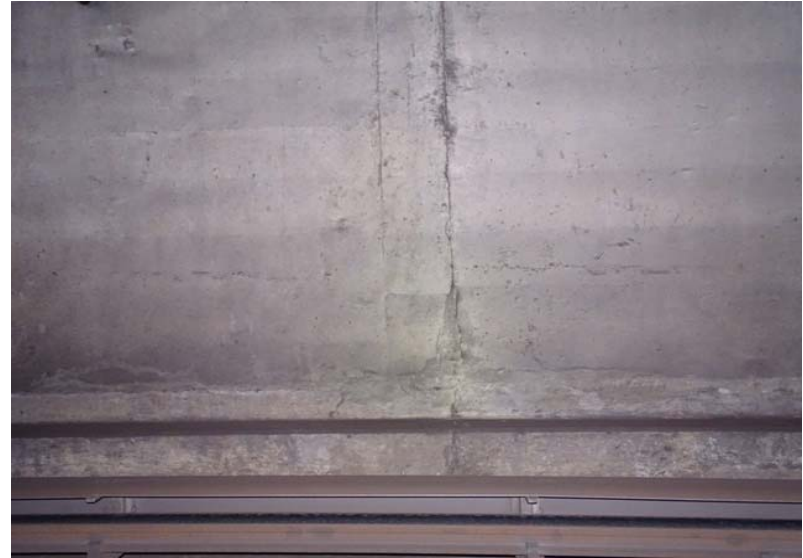
Photograph No. 98
Station 72+20 - crack on the west wall.

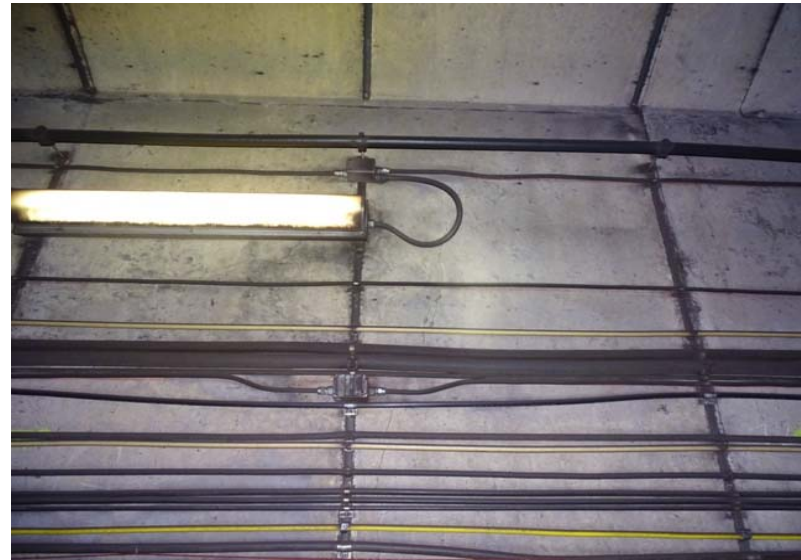
Photograph No. 102
Station 72+40 - crack on the east wall.

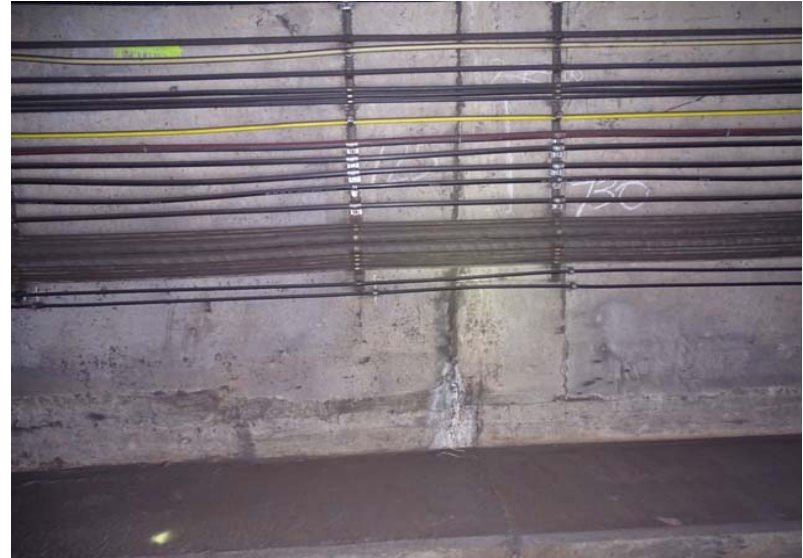
Photograph No. 114
Station 72+60 - crack and stain on the east wall.

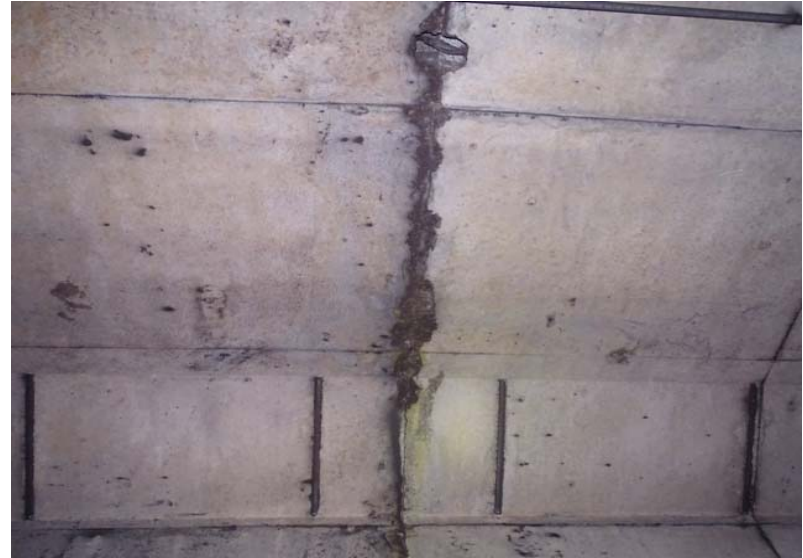
Photograph No. 154
Station 73+60 - damaged concrete on the ceiling, looking east.

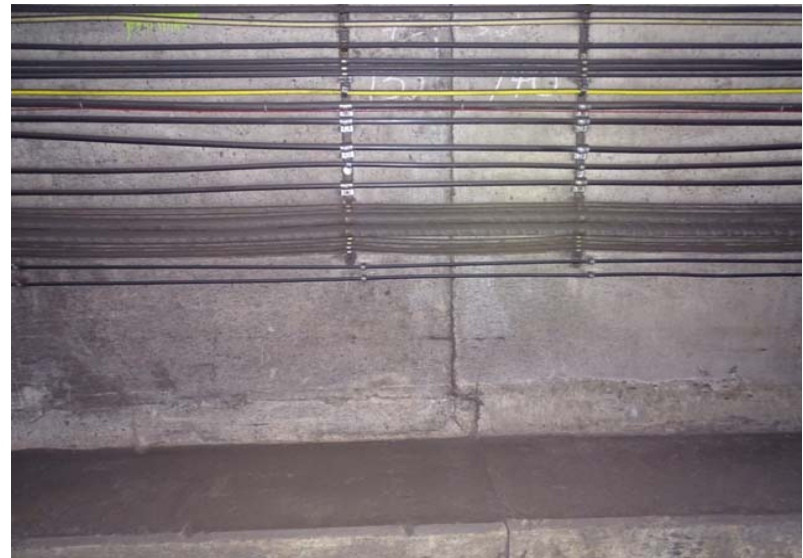
Photograph No. 155
Station 73+60 - damaged concrete at a construction joint on the east wall.

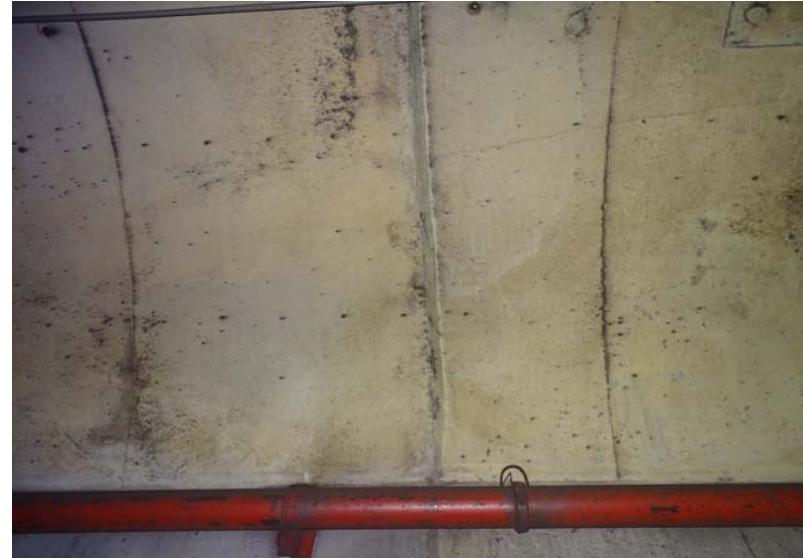
Photograph No. 186
Station 74+40 - crack and previous repair at the joint.

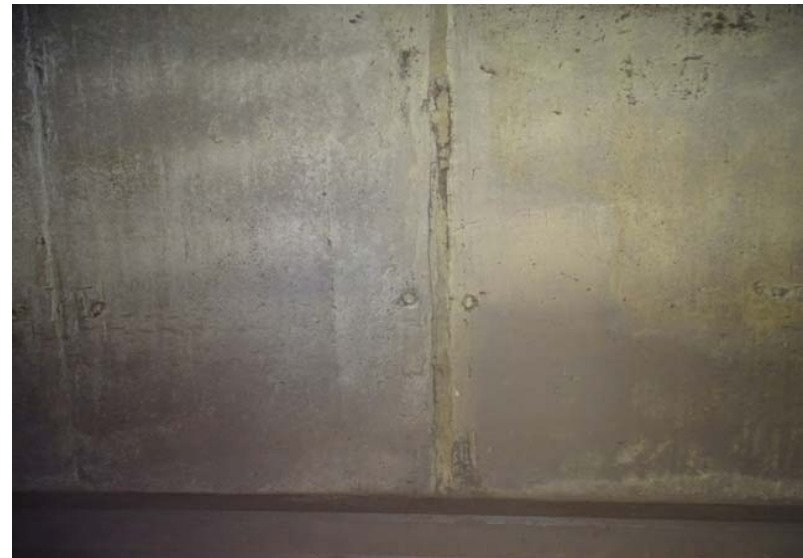
Photograph No. 187
Station 74+40 - previous repair at the joint.

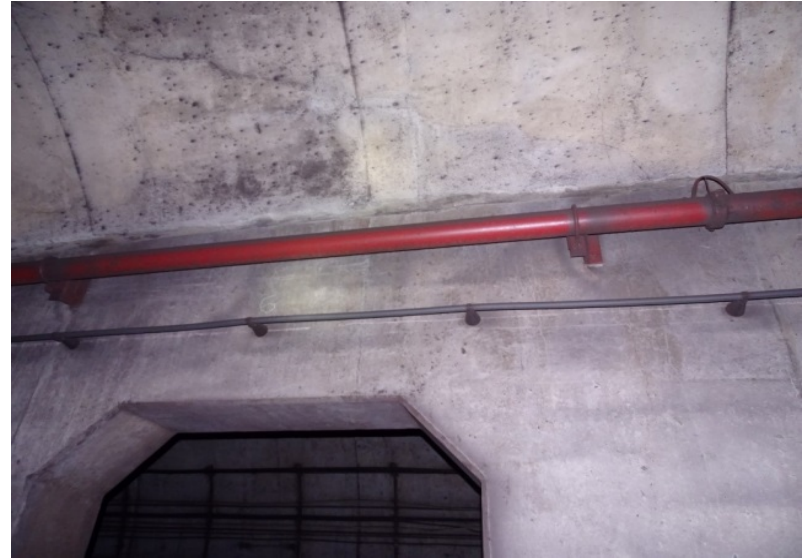
Photograph No. 270
Station 76+41 - crack above west arch.

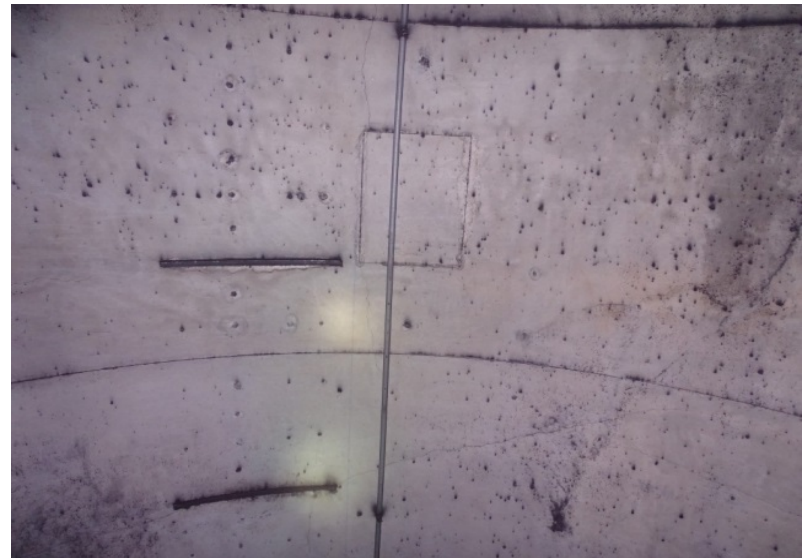
Photograph No. 271
Station 76+45 - vertical crack in east wall.

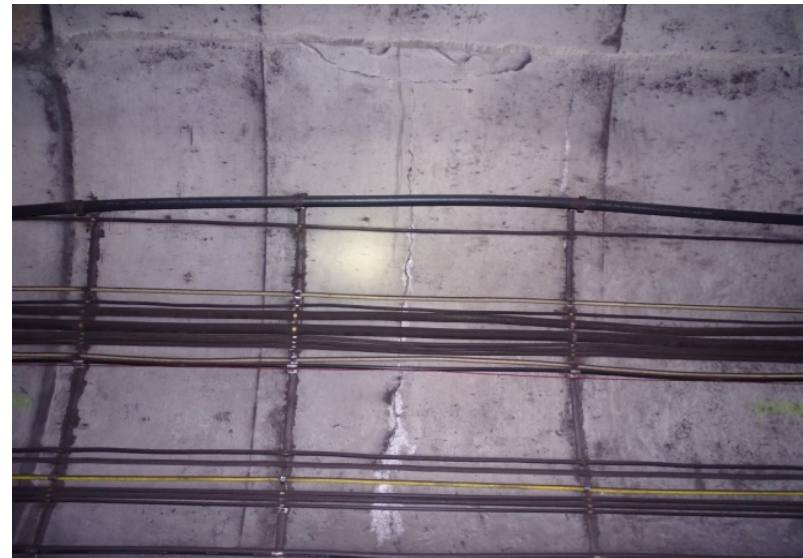
Photograph No. 332
Station 77+85 - vertical crack and efflorescence on east wall.

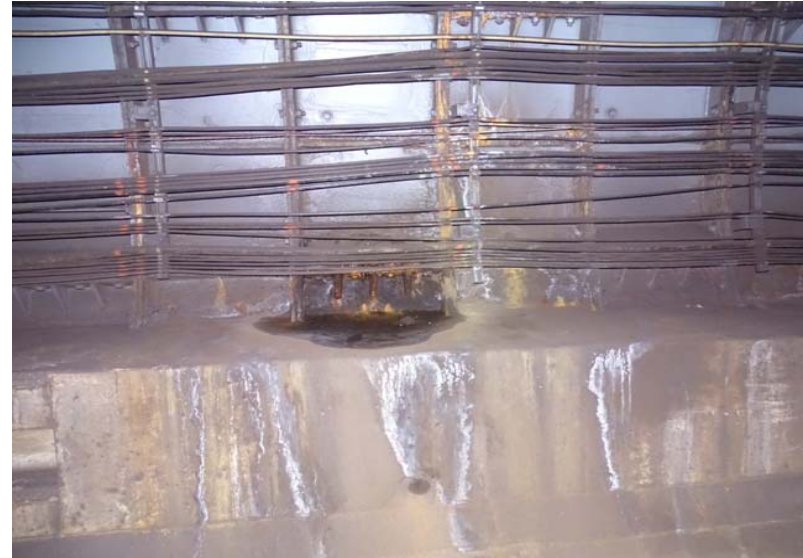
Photograph No. 14
Station 69+90 - active leak, stains, and efflorescence on the west wall.

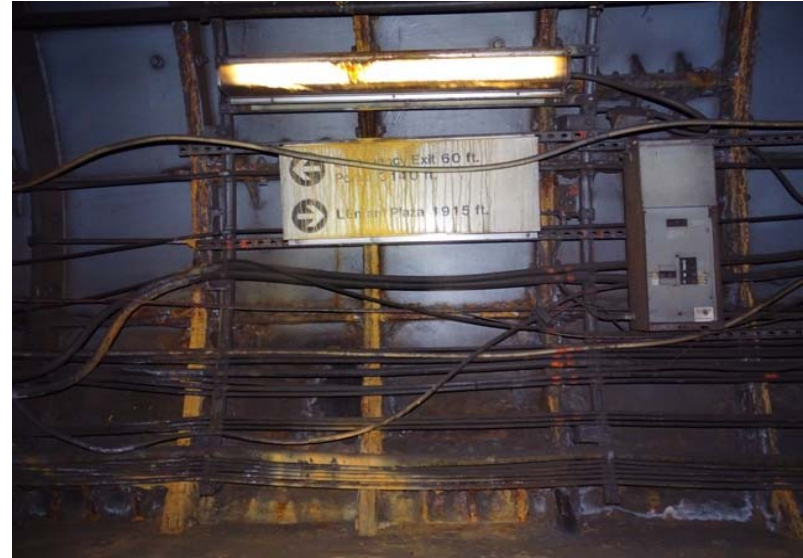
Photograph No. 34
Station 70+30 - stains and corrosion on the west wall.

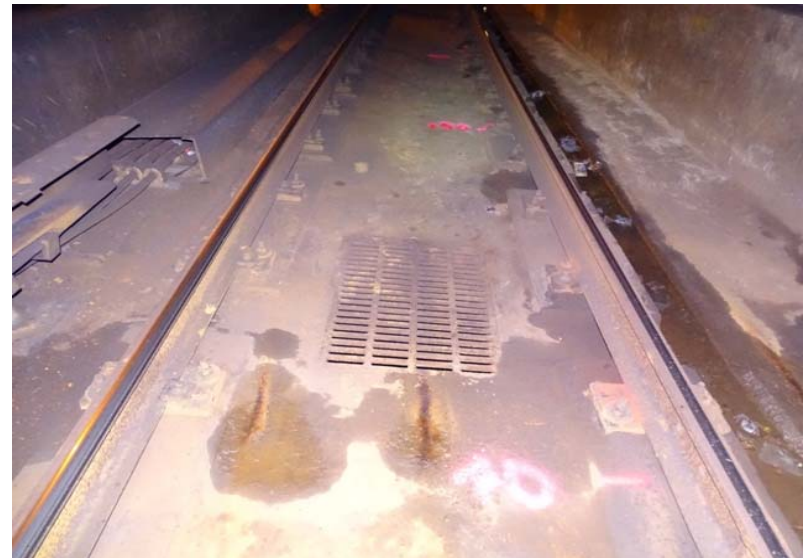
Photograph No. 35
Station 70+30 - active leak, stains, and corrosion on the west wall.

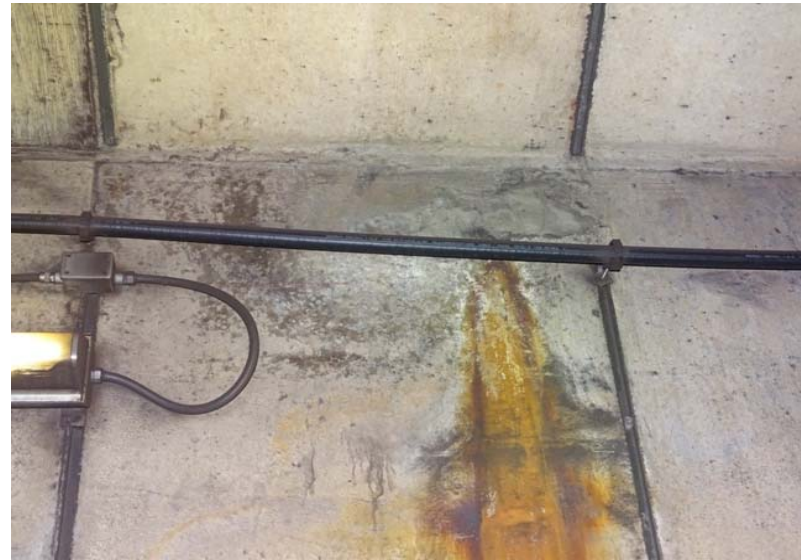
Photograph No. 90
Station 71+20 - stain and previous concrete repair on west wall.

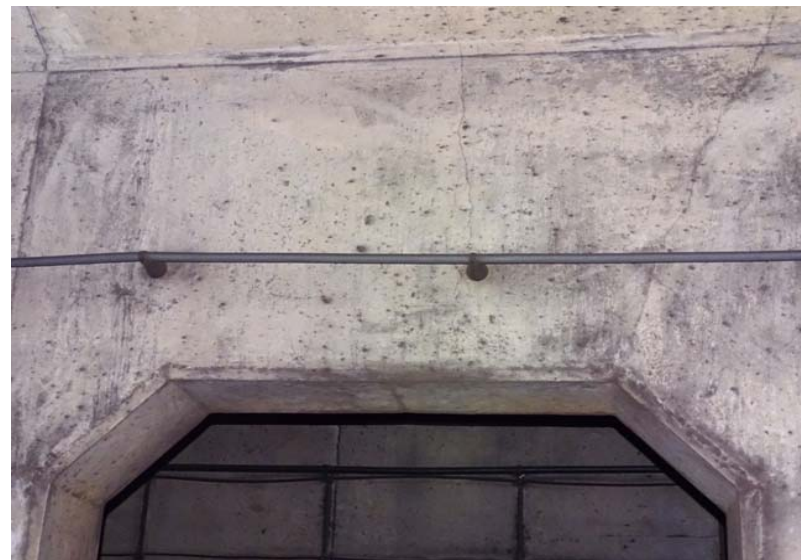
Photograph No. 240
Station 73+40 - cracks above east arch.

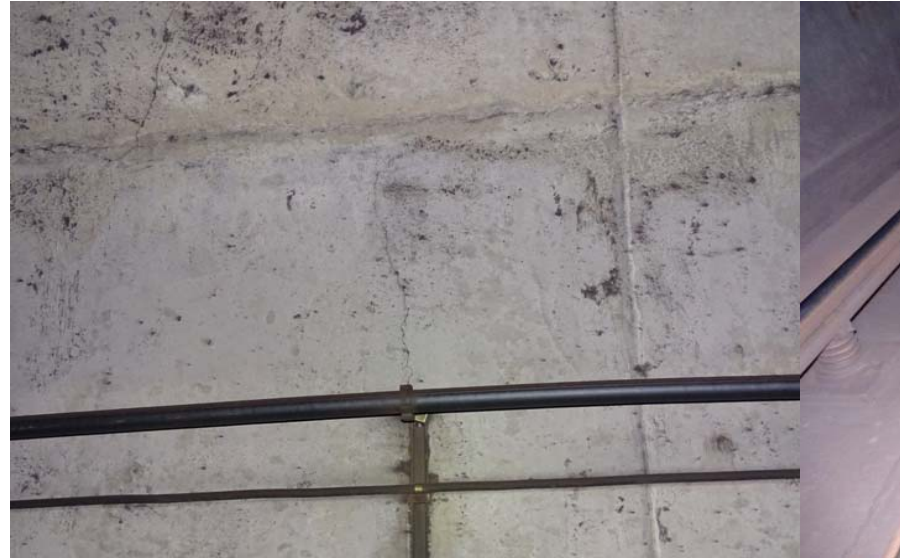
Photograph No. 345
Station 74+90 - crack on west wall.

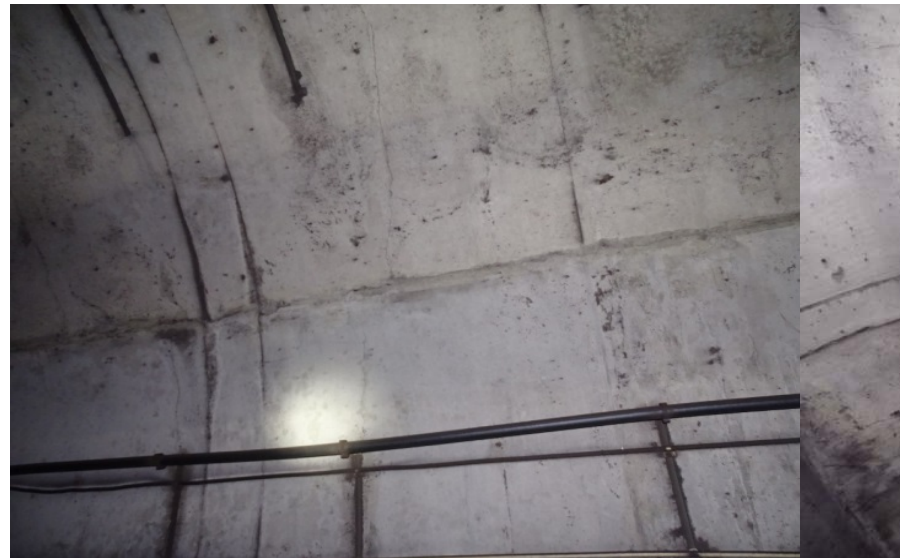
Photograph No. 355
Station 75+07 - crack on ceiling.

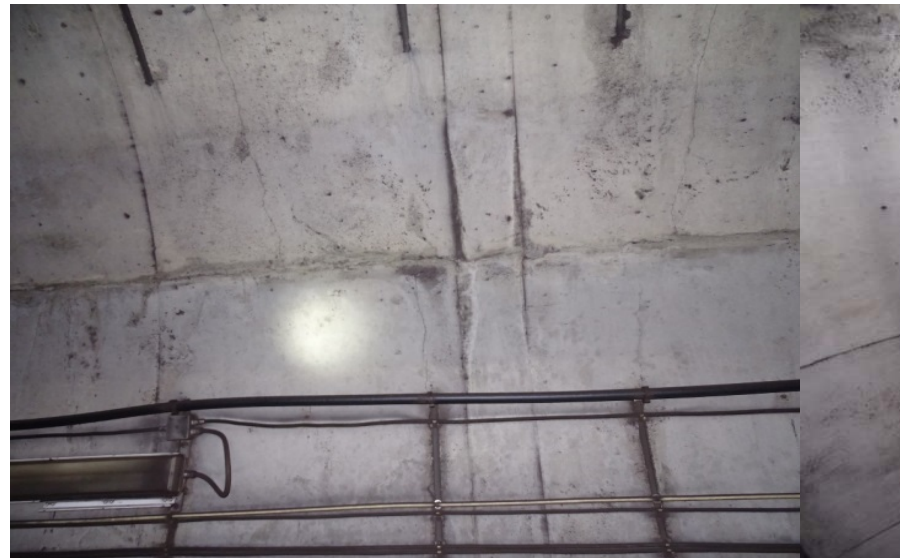
Photograph No. 363
Station 75+15 - crack in ceiling.
