NATIONAL TRANSPORTATION SAFETY BOARD
Investigative Hearing

Washington Metropolitan Area Transit Authority Metrorail train 302 that encountered heavy smoke in the tunnel between the L'Enfant Plaza Station and the Potomac River Bridge on January 12, 2015

GROUP	C
EXHIBIT	
3

Summary Report For PSRS Adjustments at One Judiciary Square

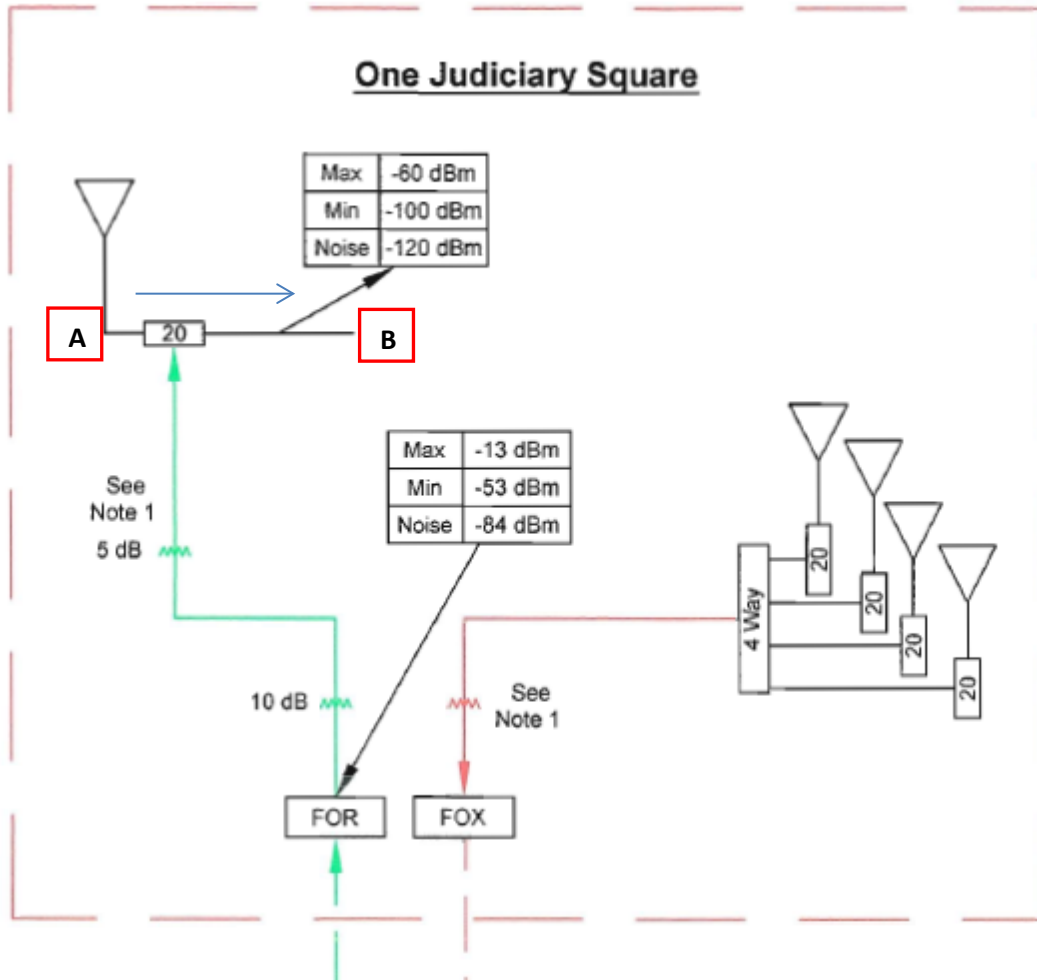
DRAWING 1

TEST 4: WMATA determined that the UPLINK levels into the new configuration may be at or close to the threshold of operation for both the 4.1 equipment and the P25 site equipment. The existing drawings show a total of 35 dB attenuation at point B on Drawing 1. It then gets added to the off-Air feed antenna (<1 dB via coupler) to radio systems.

RESULTS: OUC's contractor verified that he saw no increase to the overall noise floor before and after the attenuators were removed. The below ground noise floor level may still be below the noise floor coming of the above ground feed point A on Drawing 1

Original Configuration shown for UPLINK (snapshot from 2009 contract document)

RESULTS: WMATA removed a total of 18 dB of attenuation both the 10 dB and 5 dB attenuators (shown) and an additional 3 dB (not shown) before heading out to conduct radio checks.

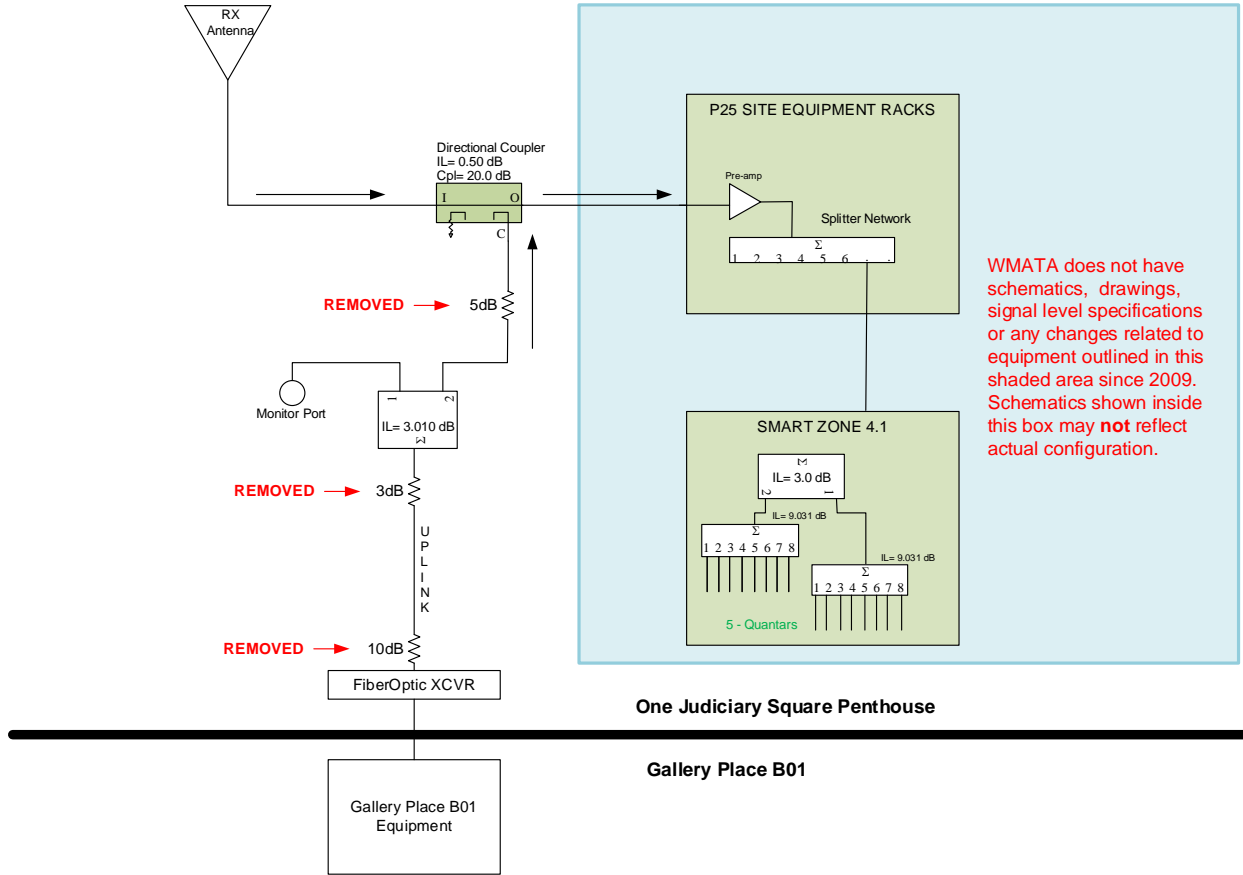
DRAWING 2

RESULTS: Original Configuration and path for the below ground UL signal have been modified (OUC contractors) after the 20 dB coupler to incorporate P25 Prime site equipment and continue cut-over support on the existing 4.1 equipment at One Judiciary Square

Configuration sketched from One Judiciary Square visit for UPLINK (Jan 14, 2015)

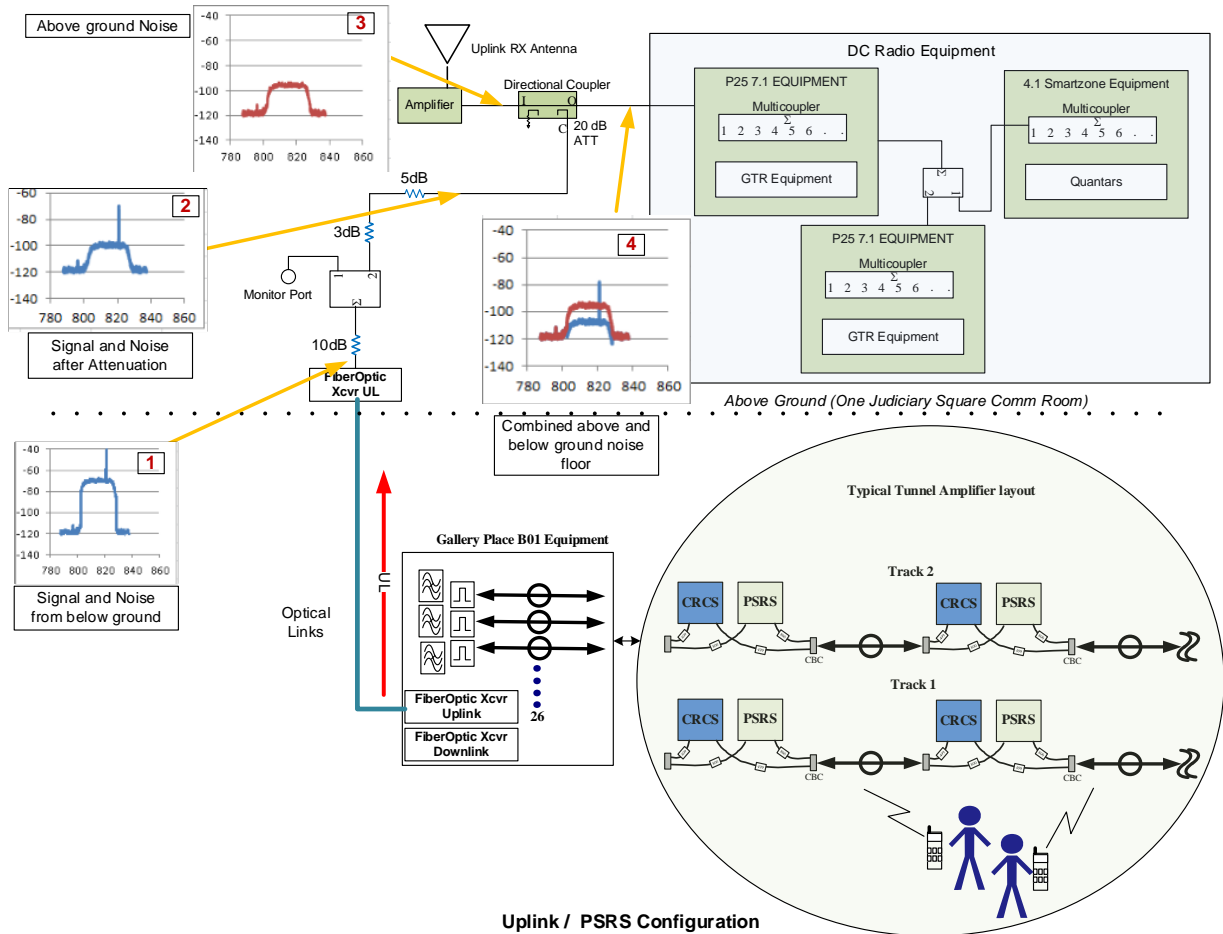
Description of Uplink :

This waveform shows a typical signal and noise coming from the combined output of the below ground that is fed from one Gallery Place B01 equipment room. The signal is usually higher than the noise floor in order to be detected and processed.

Waveform 2 is identical to waveform 1 but at a reduced level. Both the signal and noise are equally attenuated through a 10-dB pad, 3-dB splitter, 3-dB pad and another 5-dB pad prior to entering the 20-dB coupler. A total of 21-dB attenuation drop in level.

Waveform 3 illustrates what the above ground noise floor would look like after it enters the antenna and is amplified through the Tower Top Amplifier (TTA).

Waveform 4 illustrates the combined signals of the above and below ground. This combination of signals gets done using a directional coupler. In this case the below ground signal it is further attenuated by 20 dB on the coupled port since the coupler used is 20 dB. The above ground path passes through the coupler with less than < 2 dB attenuation.

At the output port leaving the coupler, if the above ground noise is much higher than the below ground noise, signals on the below ground must now need to exceed the dominant noise floor before it gets detected and processed. WMATA suspects that this may have been the case where the above ground signal increased and overshadowed the below ground signal and noise therefore causing poor radio communications. Further test and measurements are required to make a better determination.

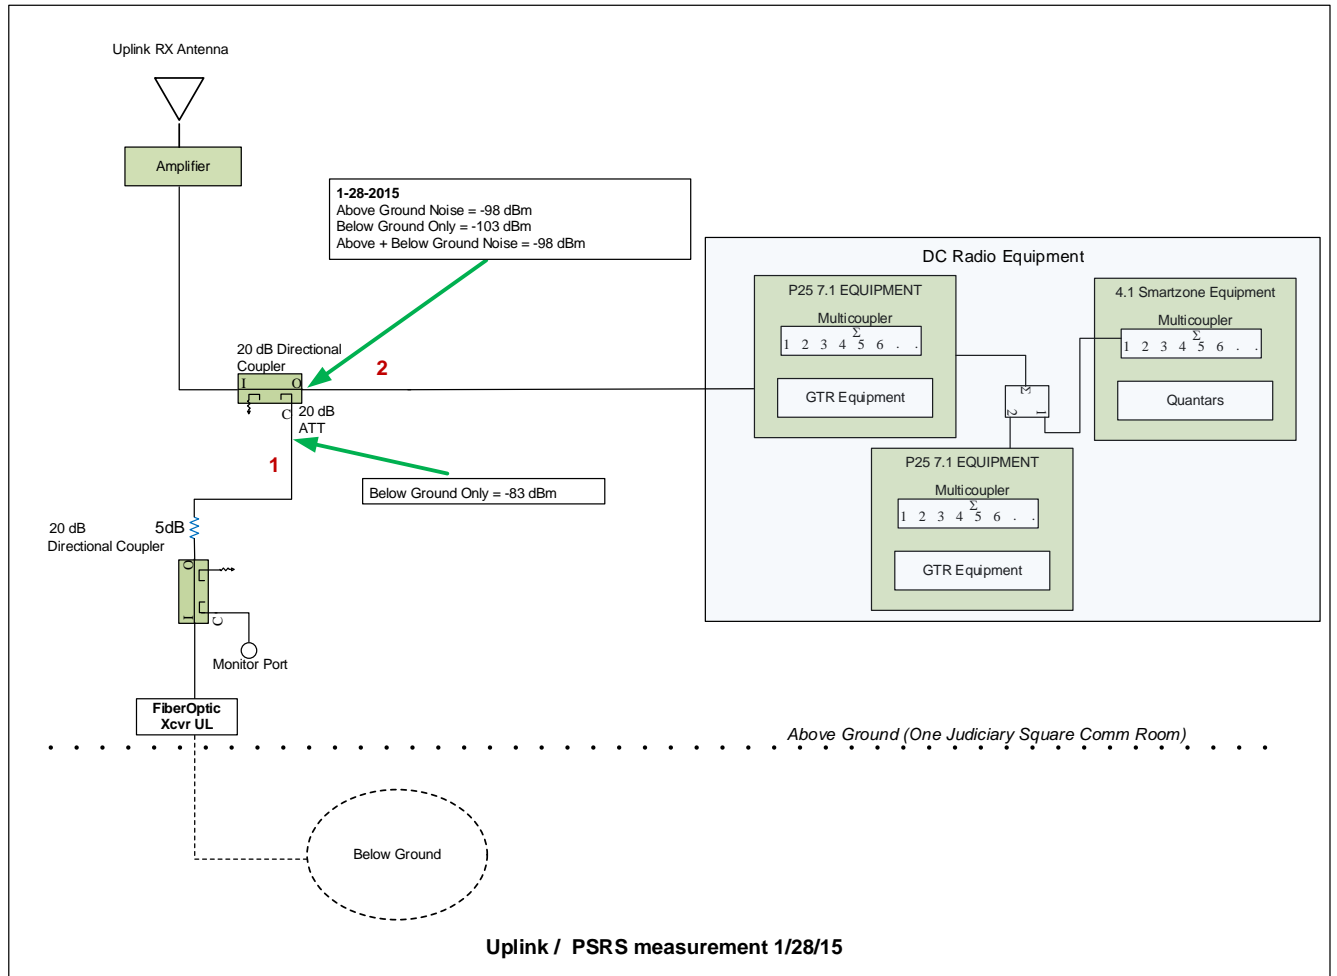
Measurement on 1/28/15 after final adjustments

Final results are indicated on the drawing below. The measurements taken on Jan 28th 2015 shows that the below ground noise had no impact to the above ground floor after exiting the directional coupler. The above ground noise floor is the dominant of the two, averaging around -98 dBm with the below ground coming in around -103 dBm. In order to achieve a -103 dBm on the below ground noise floor, WMATA was able to bring the signal up an additional 4 dB by re-

The wide difference seen between the levels on the above and below ground floors on 1-14-15 is still left unknown. It can only be explained with an increase in the above ground side. Since above ground floor noise floor measurements are not available from OUC since 2009, WMATA cannot determine how much it increased.

configuring the coupler at the monitor port. This brought the level up for a total of 22 dB (18 dB increase on 1-14-15 and additional 4 dB on 1-28-15) to balance the above and below ground floor.

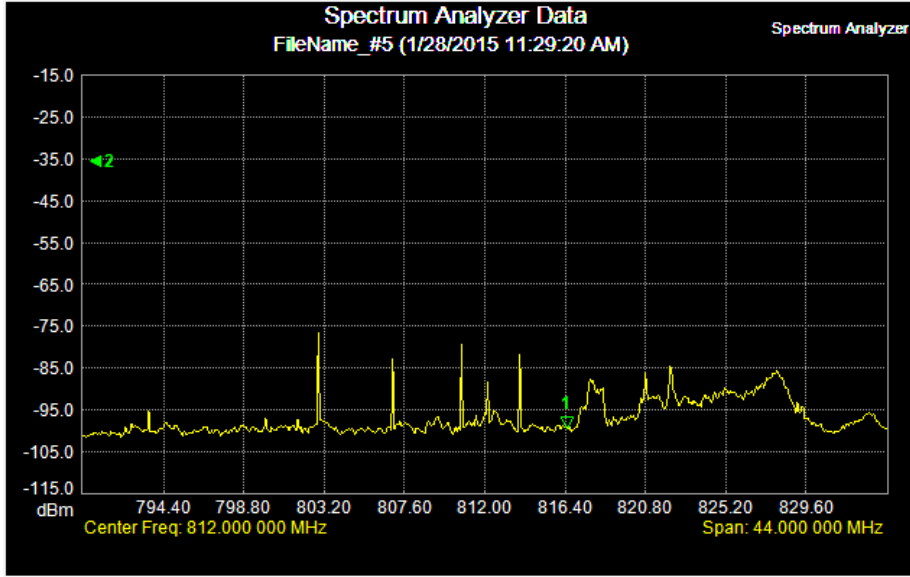
Above Ground Only - Output of Coupler

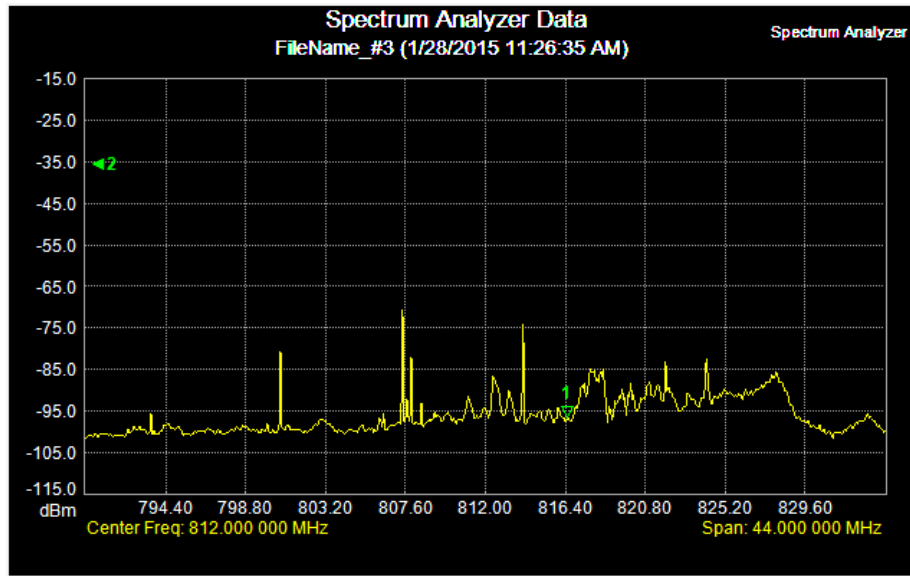
Above and Below Ground Combined - Output of Coupler

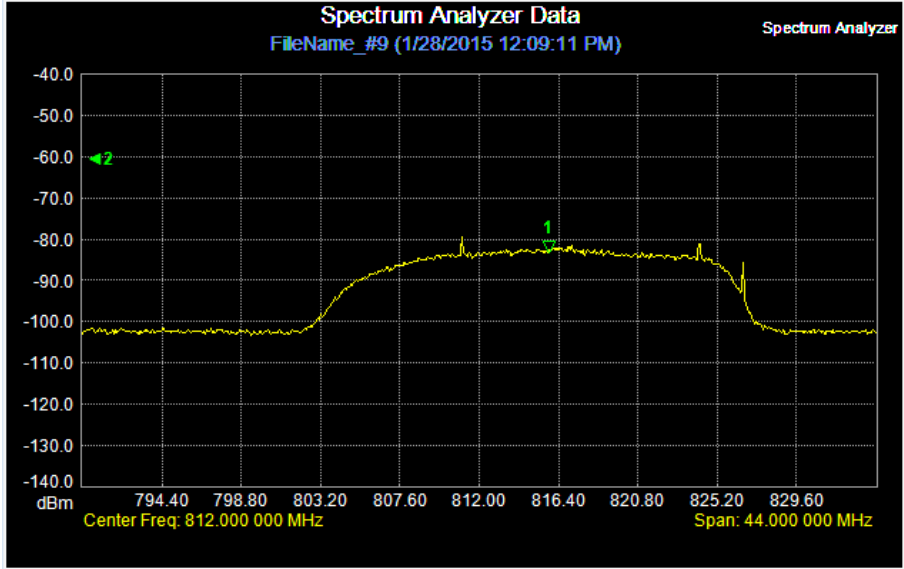
Below Ground Only – Coupled Port Before 20 dB loss
