**NATIONAL TRANSPORTATION SAFETY BOARD
Office of Research and Engineering
Vehicle Recorder Division
Washington, DC 20594**

**GROUP CHAIRMAN'S FACTUAL REPORT OF INVESTIGATION
External Imagery Factual Report
DCA15MA019**

Location: Koehn Dry Lake, CA
Date: October 31, 2014
Vehicle: Model 339 SpaceShipTwo
Registration: N339SS
Operator: Scaled Composites, LLC.
NTSB Number: DCA15MA019

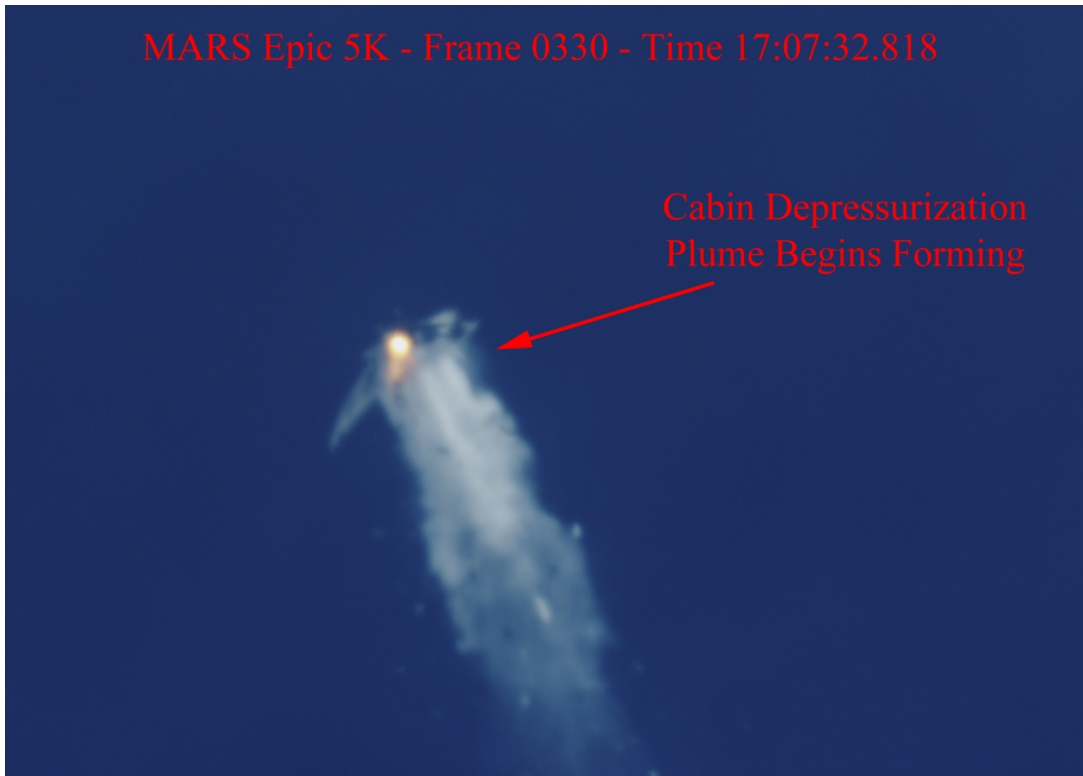
Figure 20.

Figure 20 shows the lighter colored cabin depressurization gas plume beginning to form. The left and right booms are obscured by the main nitrous plume which is more white in color.

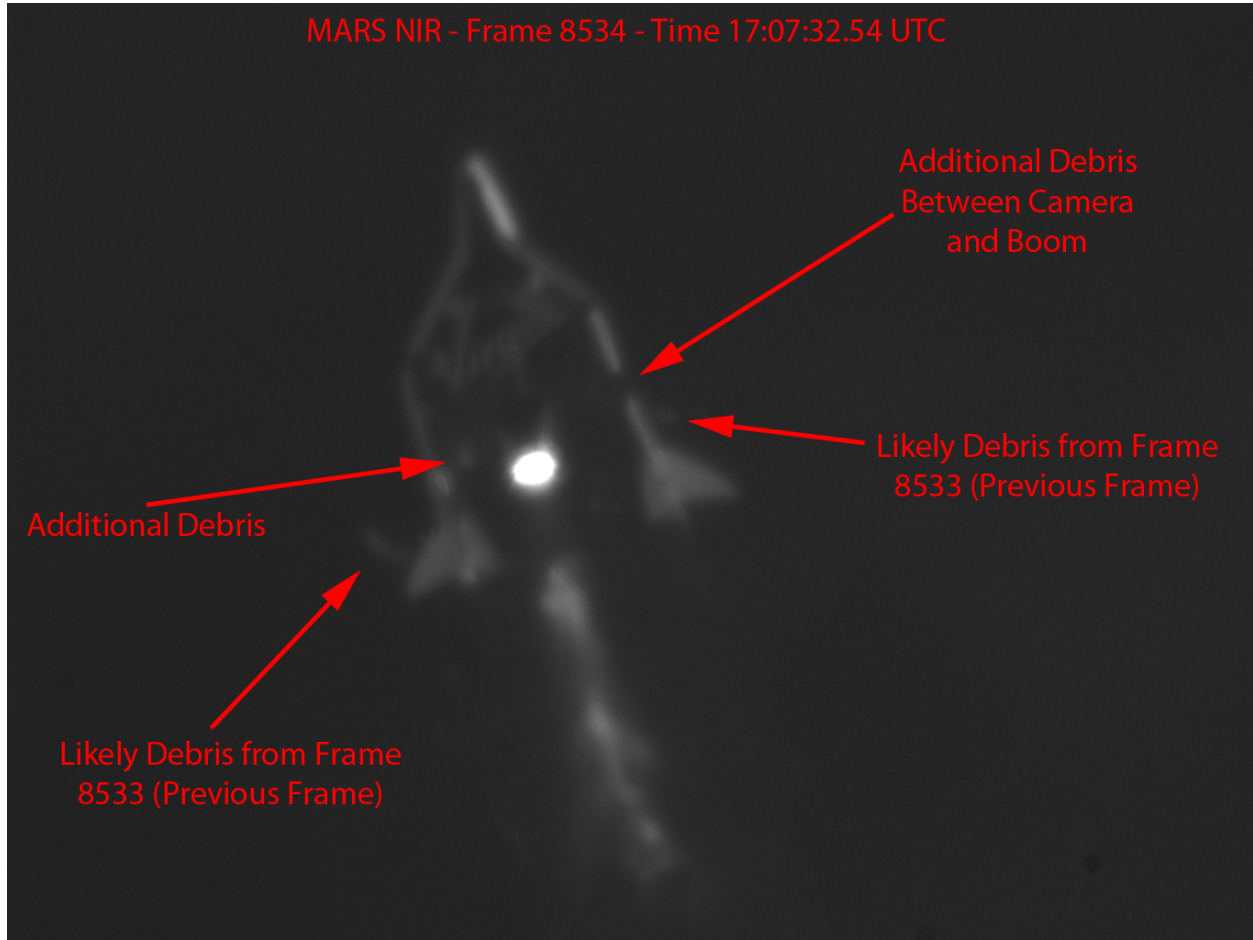
Figure 24 shows additional unidentified debris separating from the vehicle. The likely debris noted in figure 22 propagates from the vehicle, trailing the additional debris.

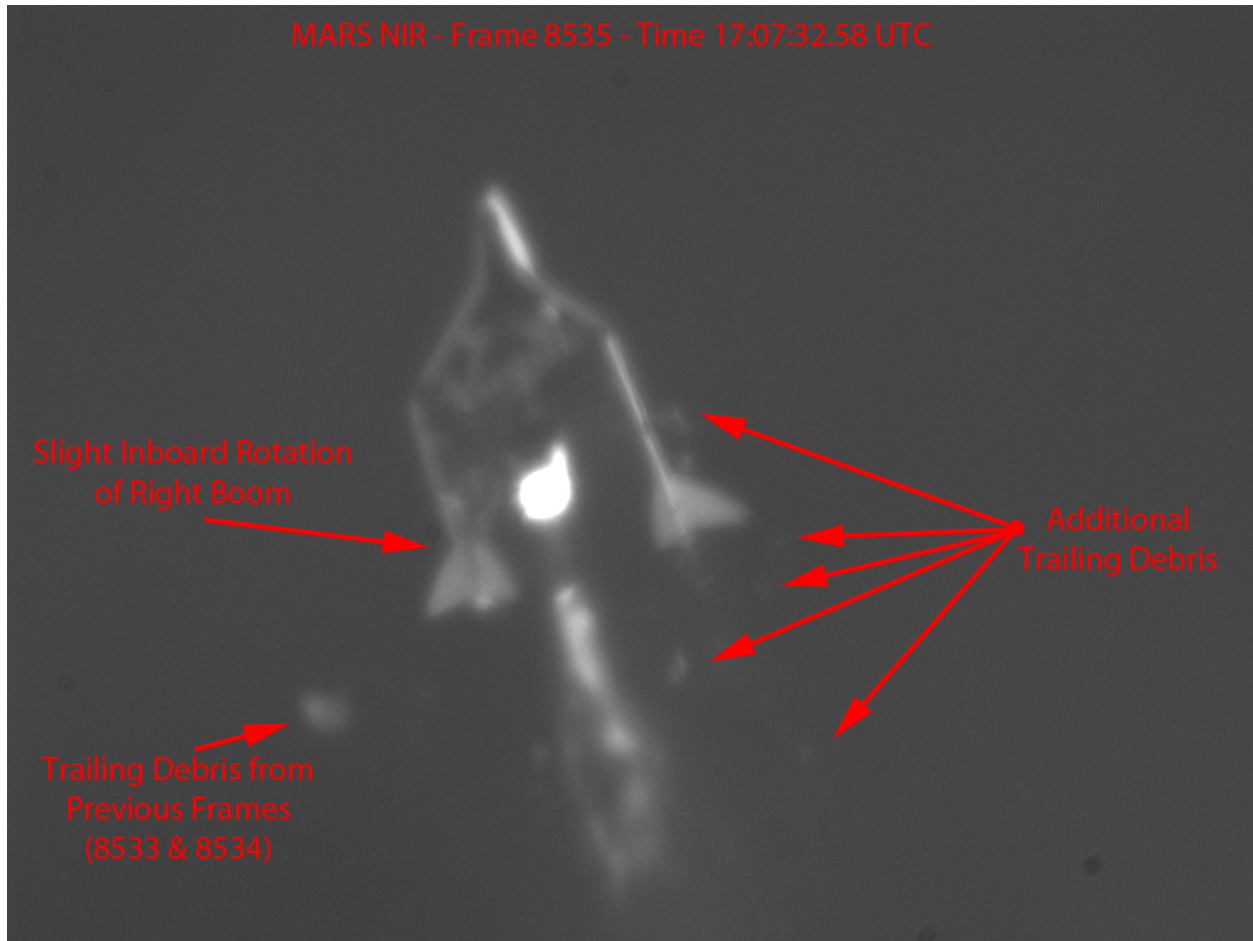
Figure 25 shows additional debris propagation, likely indicated in previous frames. The right boom exhibits a slight inboard rotation toward the center of the vehicle demonstrated by additional surface area of the right vertical stabilizer facing the camera location.

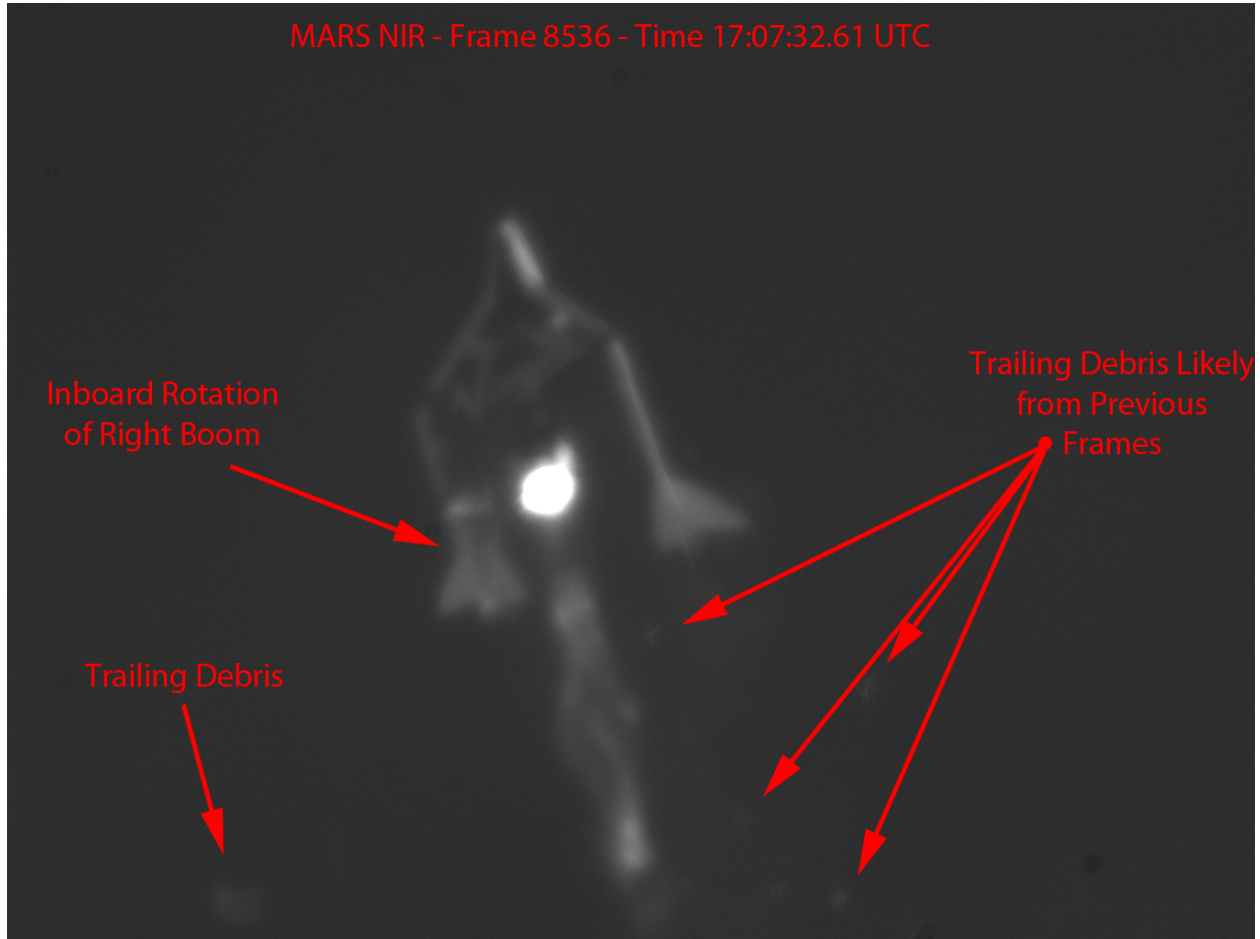
Figure 26 shows a continued inboard rotation of the right boom. Trailing debris also seen propagates from the vehicle.

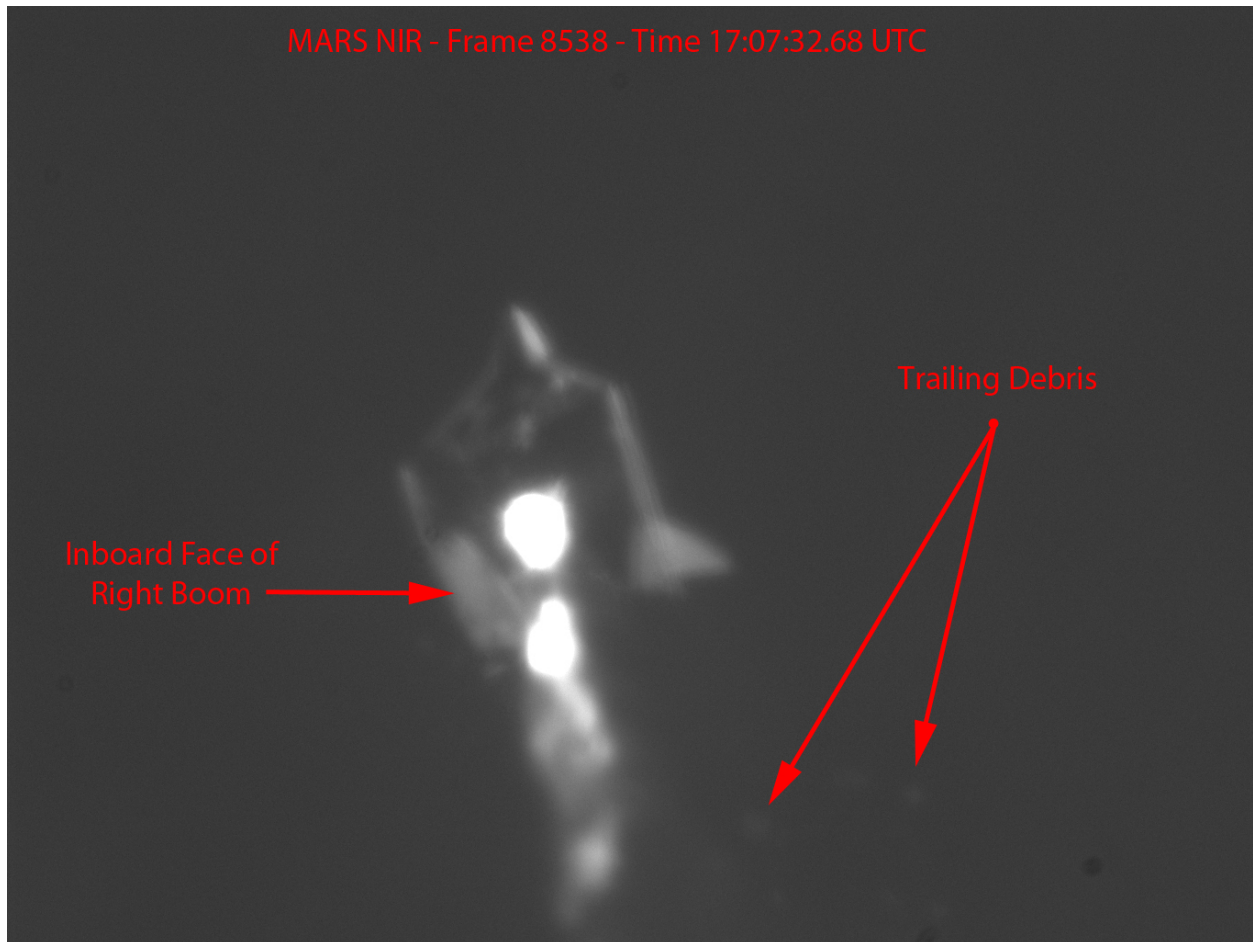
Figure 27 displays a significant inboard rotation of the right boom. The inboard face of the right boom is more apparent to the imager's field of view. Some additional unidentified trailing debris is noted near the bottom of the frame.

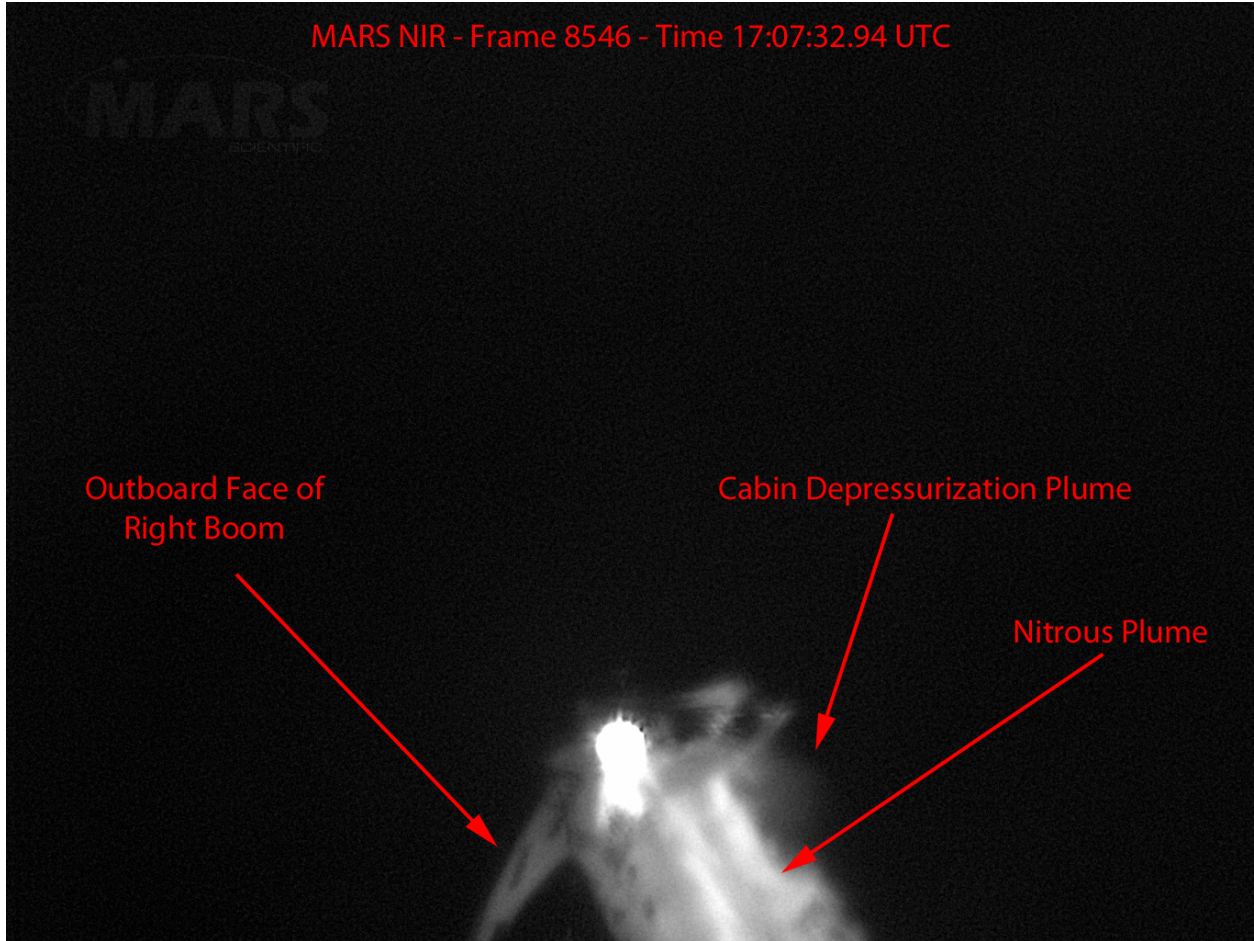
Figure 28 shows the vehicle has continued to pitch up in a manner inconsistent with the expected flight profile. The nitrous plume is still visible trailing the aft portion of the main fuselage structure. The outboard face of the right boom is near the bottom left portion of the frame. A second, smaller and lighter in color, gas plume is visible forming near the main cabin area of the vehicle. The group determined this secondary gas plume was associated with cabin depressurization.

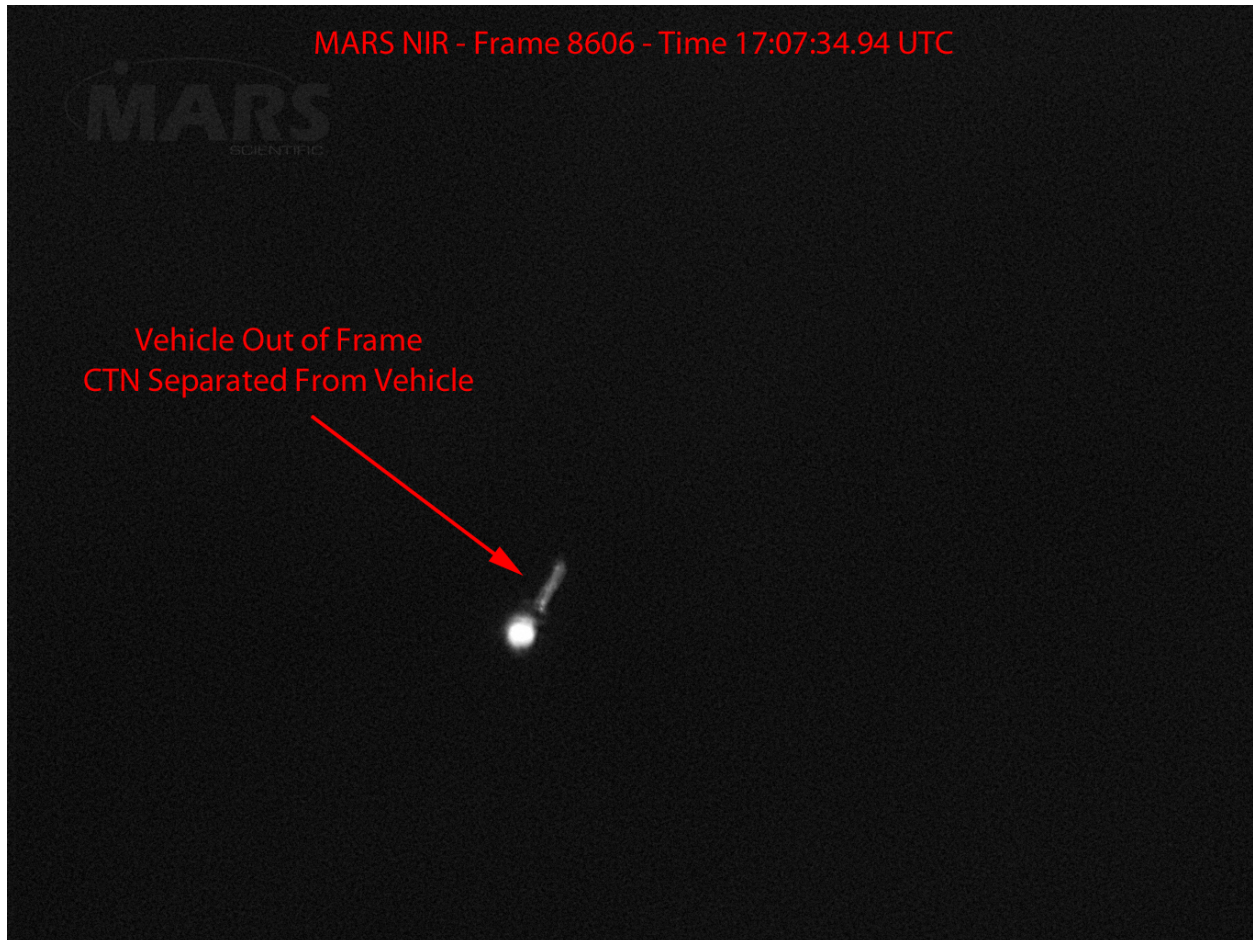
In Figure 29, the main fuselage of the vehicle was momentarily lost from the imager's frame. The CTN is separated from the vehicle. An area of higher heat energy is near the nozzle end of the CTN.

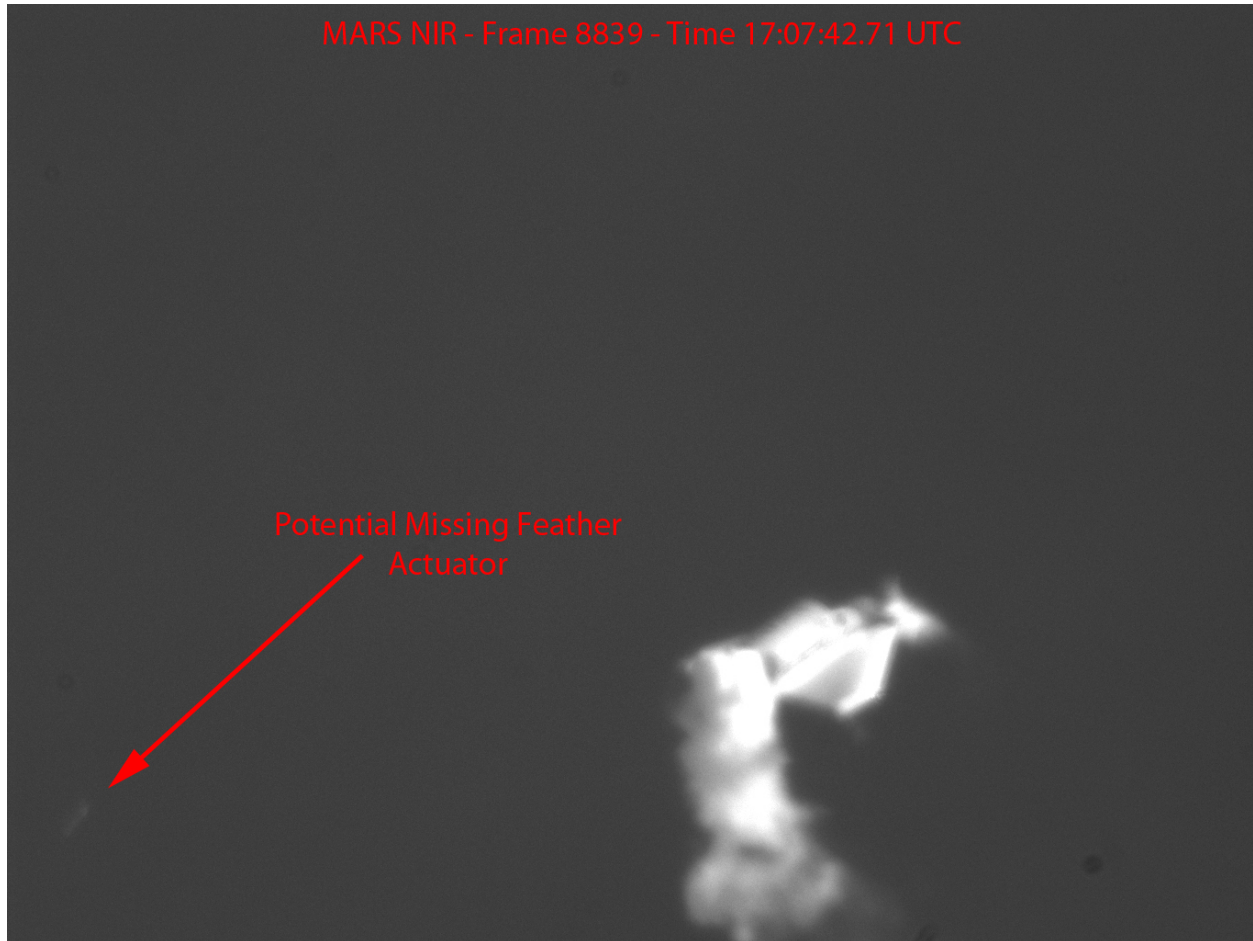
Figure 30 shows the main fuselage of the vehicle back within the imager's frame. The main fuselage is missing the nose section containing the crew cabin. An object consistent with the size and shape of a feather actuator is in the lower left portion of the frame. During the on-scene portion of the investigation, a feather actuator was absent from the wreckage sites. Later, on December 12, 2014, the missing feather actuator was located.

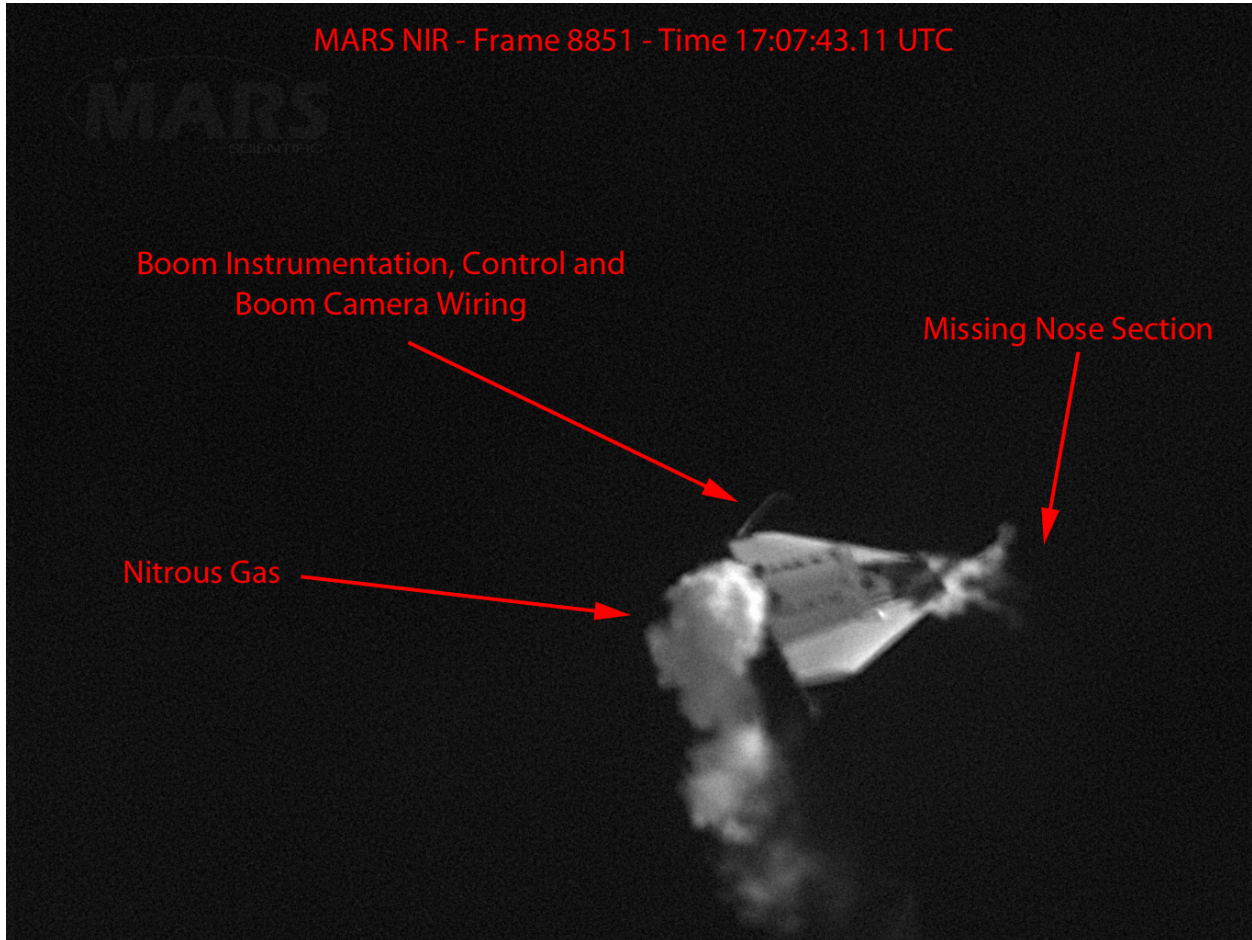
Figure 31 shows the main fuselage section of SpaceShipTwo. Nitrous gas is seen escaping in large volume from the rear of the main fuselage. Some smaller areas of plumed gas are near the forward portion of the main fuselage. The main fuselage is missing the nose section. Wiring and/or flight control cables are trailing the left wingtip. Some additional wiring and/or flight control cables are trailing the right wingtip.

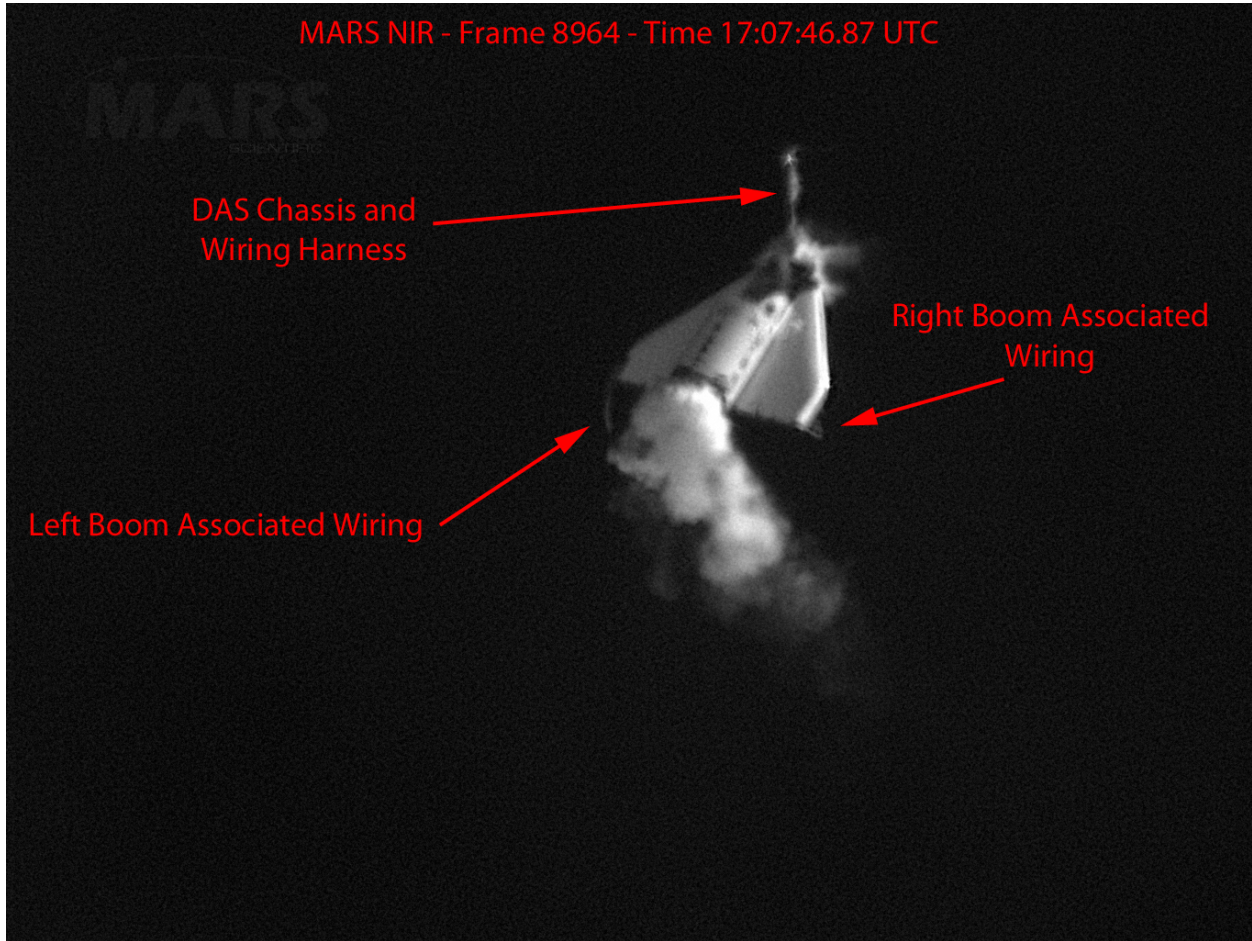
Figure 32 shows wiring and/or cables associated with the left and right booms trailing the main fuselage structure. An object consistent with the SODAS³⁵ chassis and associated wiring harness is attached to the forward portion of the main fuselage structure. The motion of the recorded image series indicates the vehicle had entered an inverted flat spin and the SODAS chassis was being held to the vehicle by its wiring harness until impact.

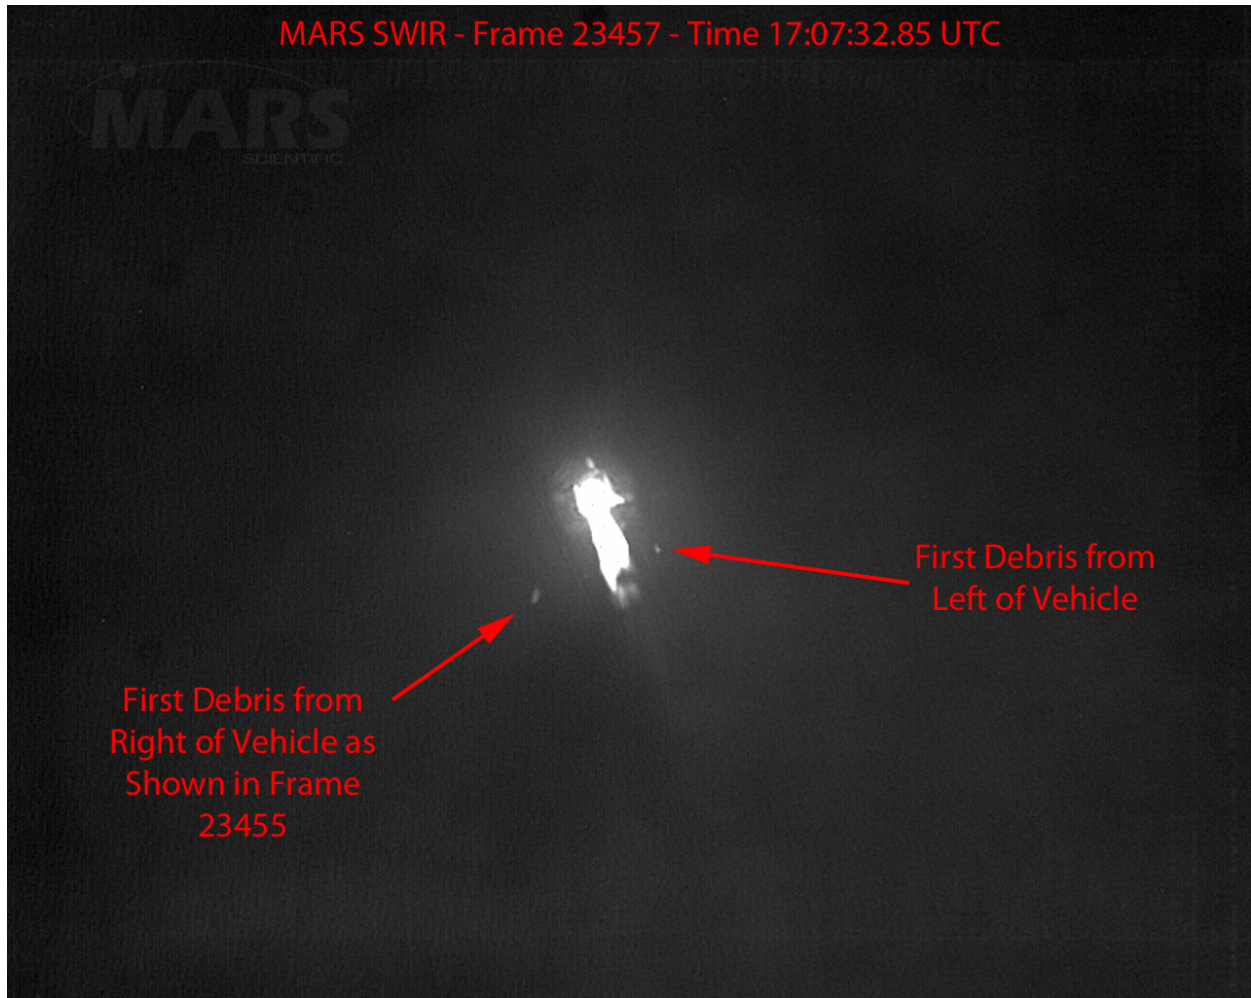
Figure 34 shows unidentified debris from the right side of the vehicle propagating from the previous frame. Additionally, the first evidence of unidentified debris from the left side of the vehicle is visible.

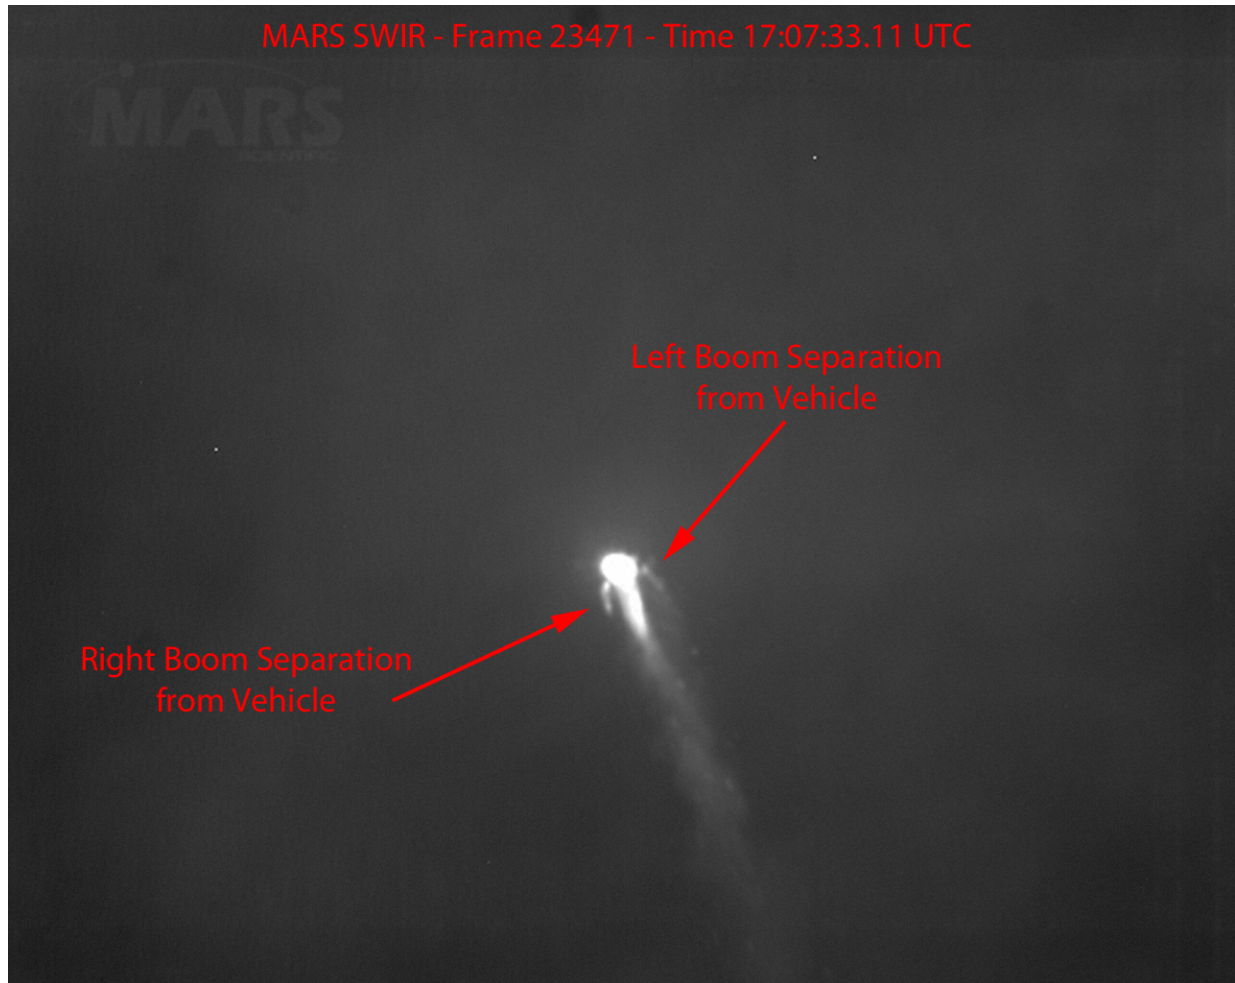
Figure 35 shows the moment just after separation of the left and right booms from the vehicle.

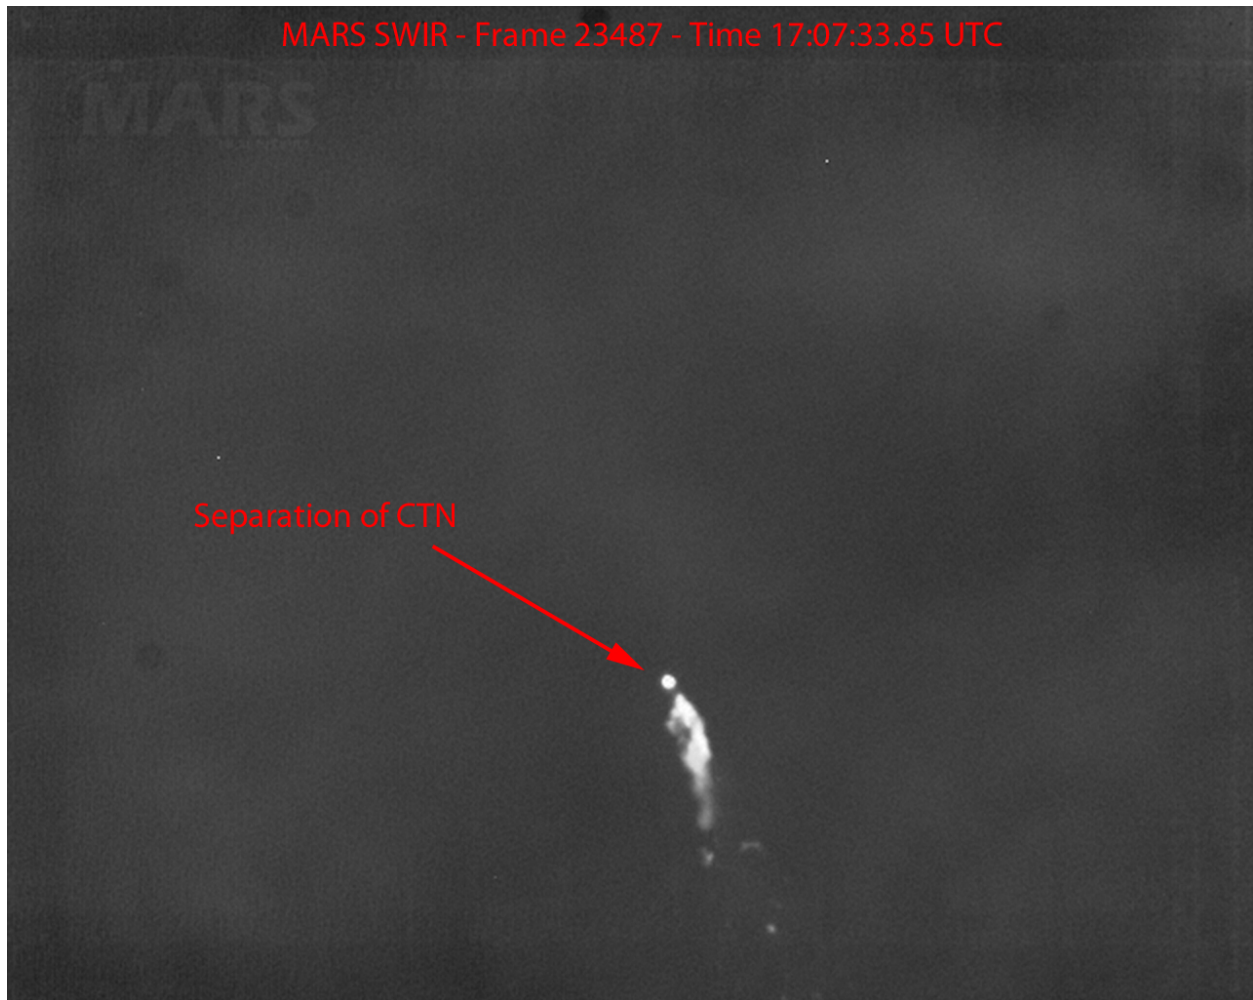
Figure 36 shows separation of the CTN from the vehicle. An area of heat energy facing the imager implies the nozzle is facing toward the MARS ground station.

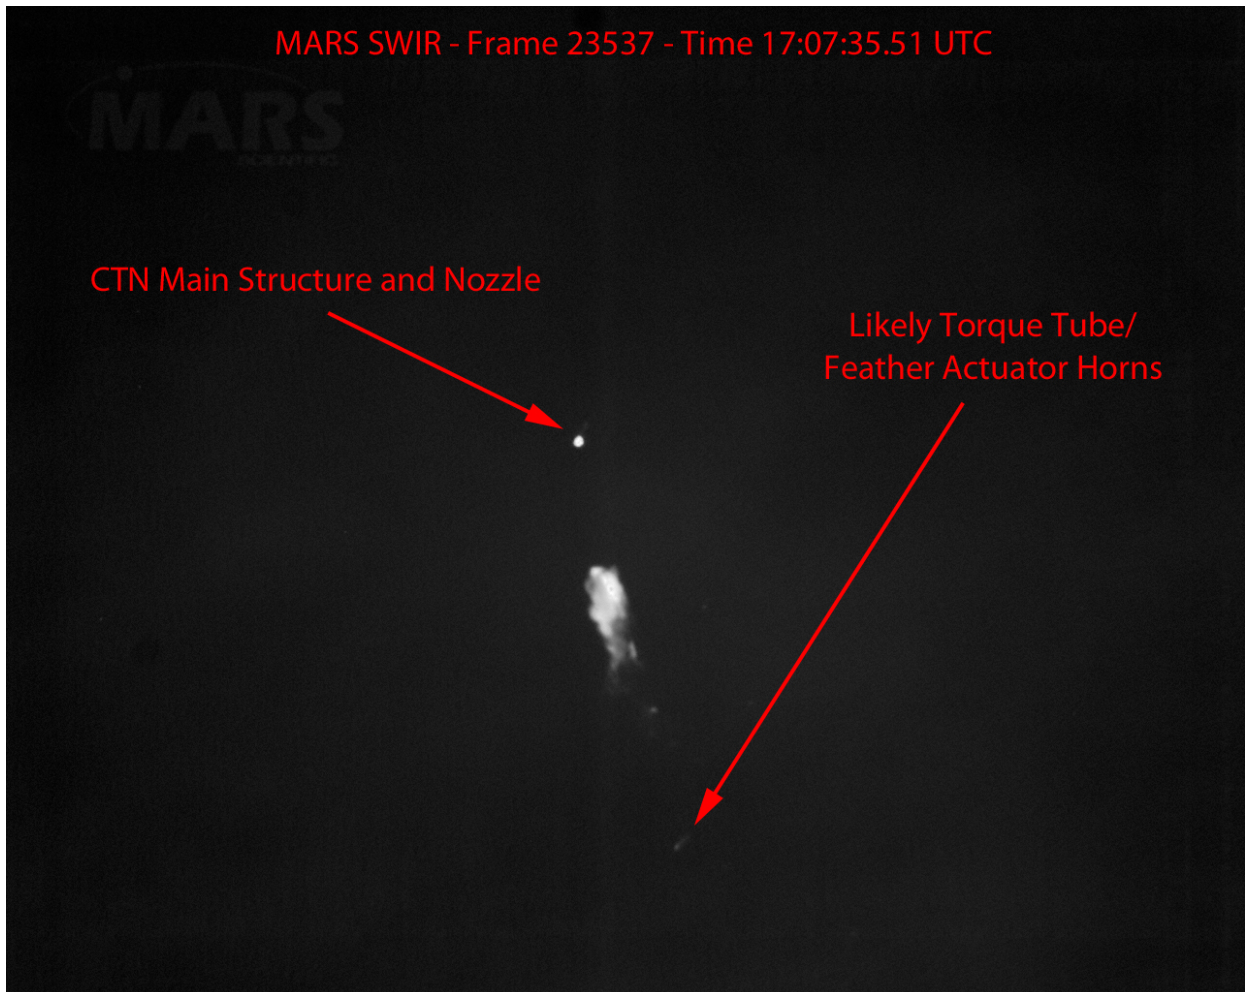
Figure 37 shows the CTN has become further removed from the main fuselage area. An object consistent with the torque tube and attached feather actuator horns is in the lower portion of the frame.

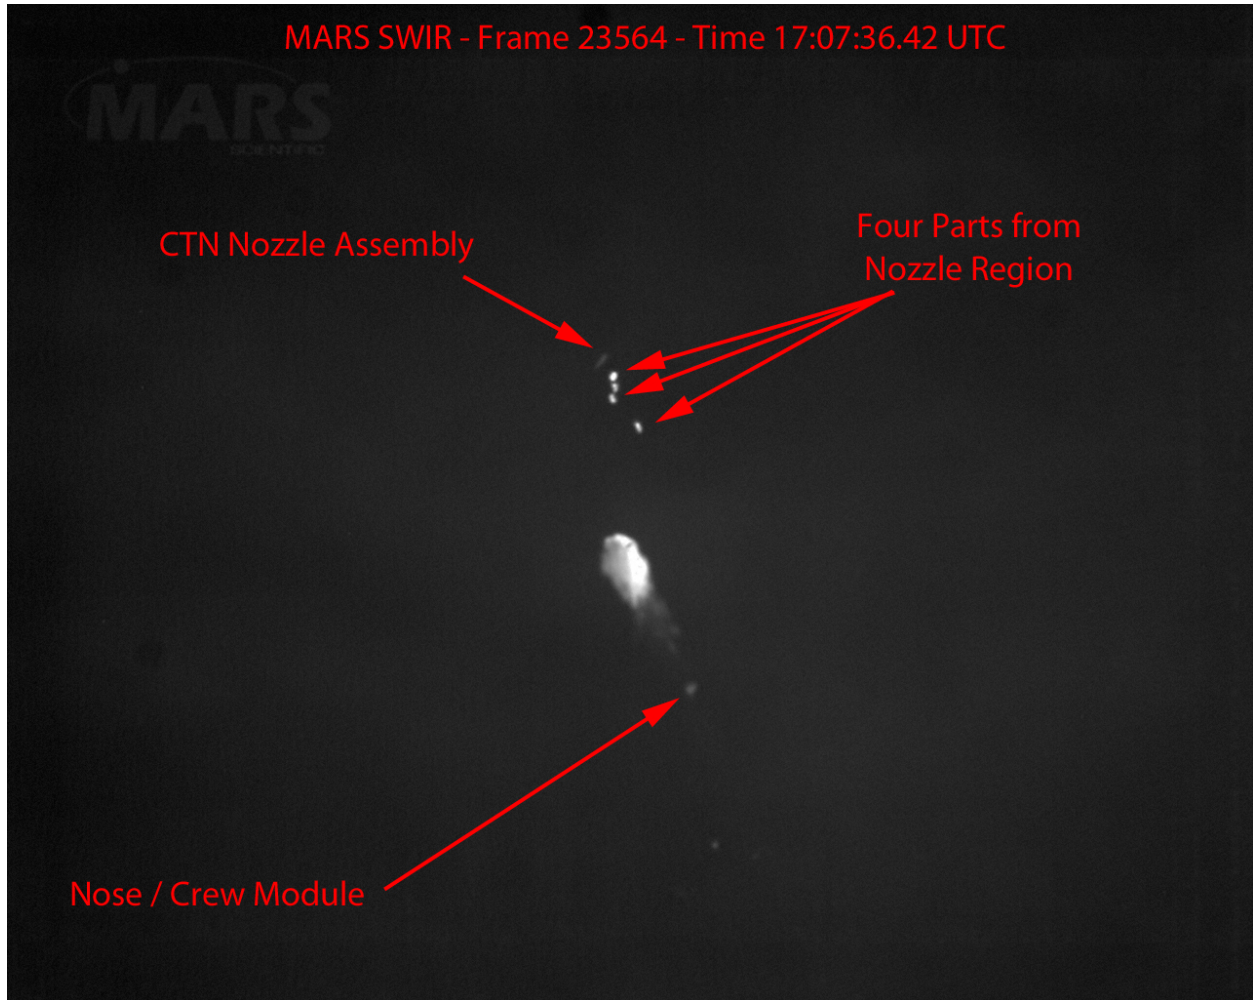
Figure 38 shows the CTN assembly has shed four identifiable parts containing a higher heat energy. The nose section containing the crew module is separated from the main fuselage structure.

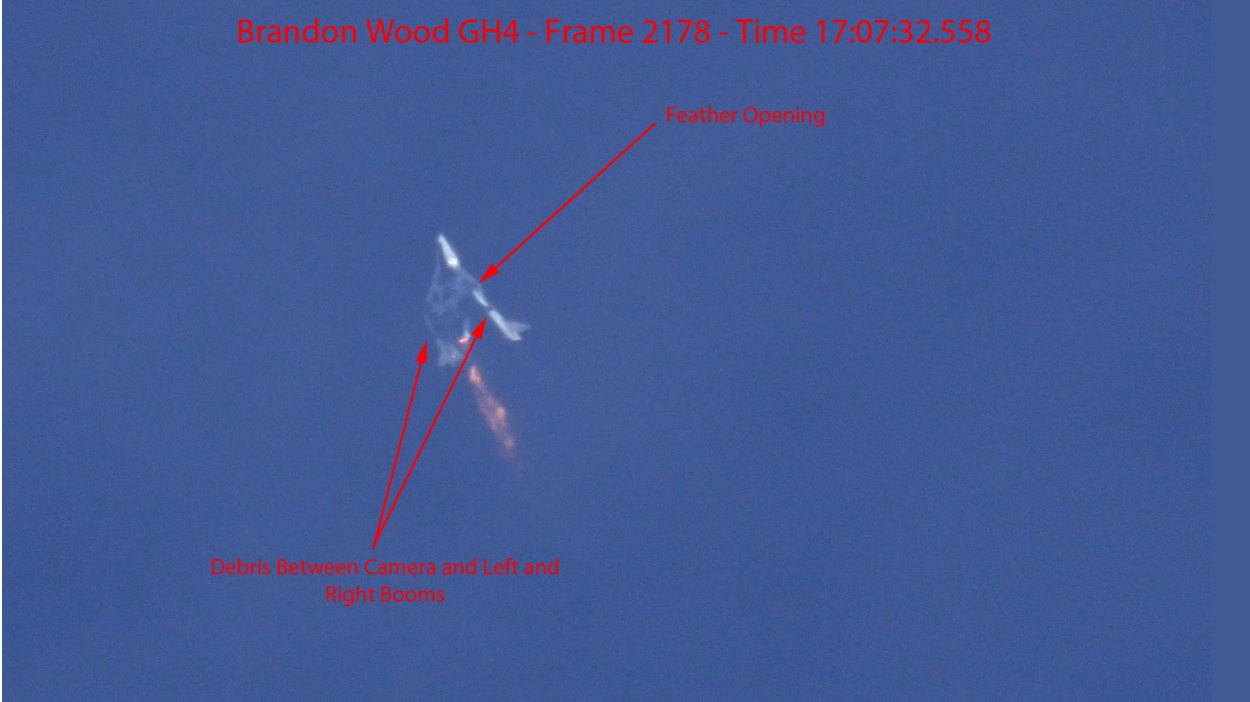
Figure 40 shows evidence of unidentified debris between the camera and the left and right booms. Additionally, the feather tusks are further displaced from the main wing.

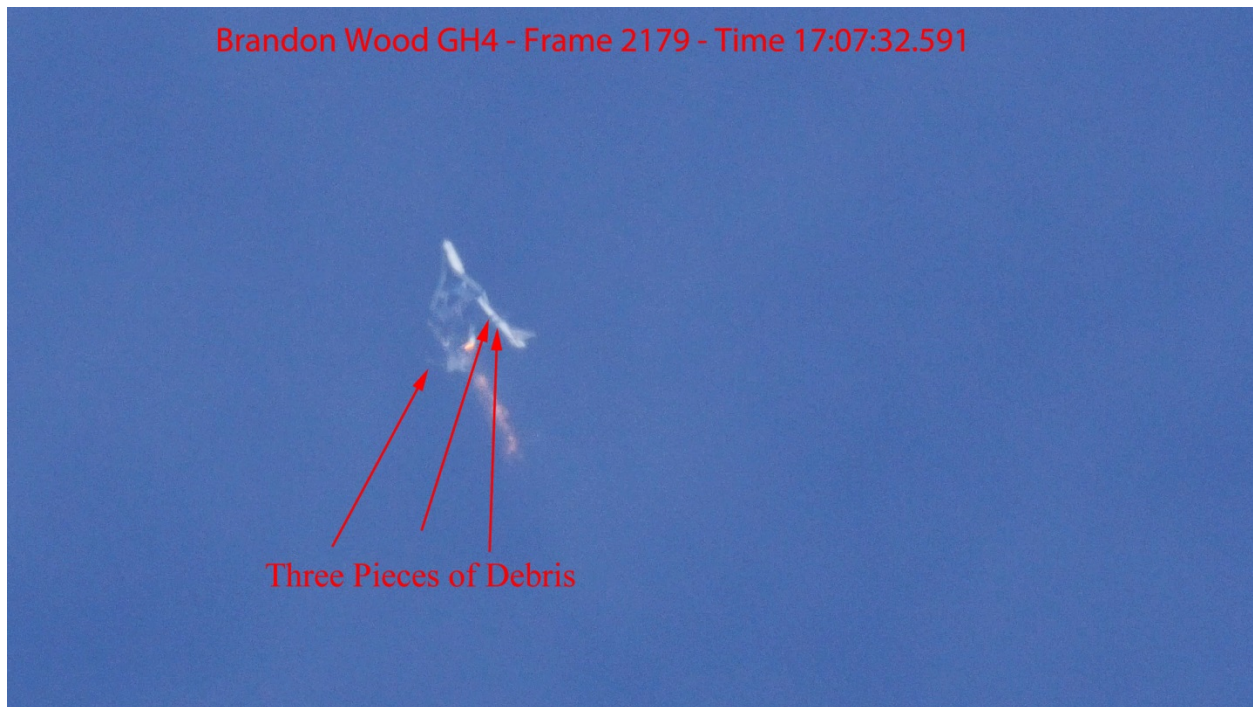
Figure 41 shows three pieces of unidentified debris have separated from the vehicle and have come between the left and right booms and the camera.

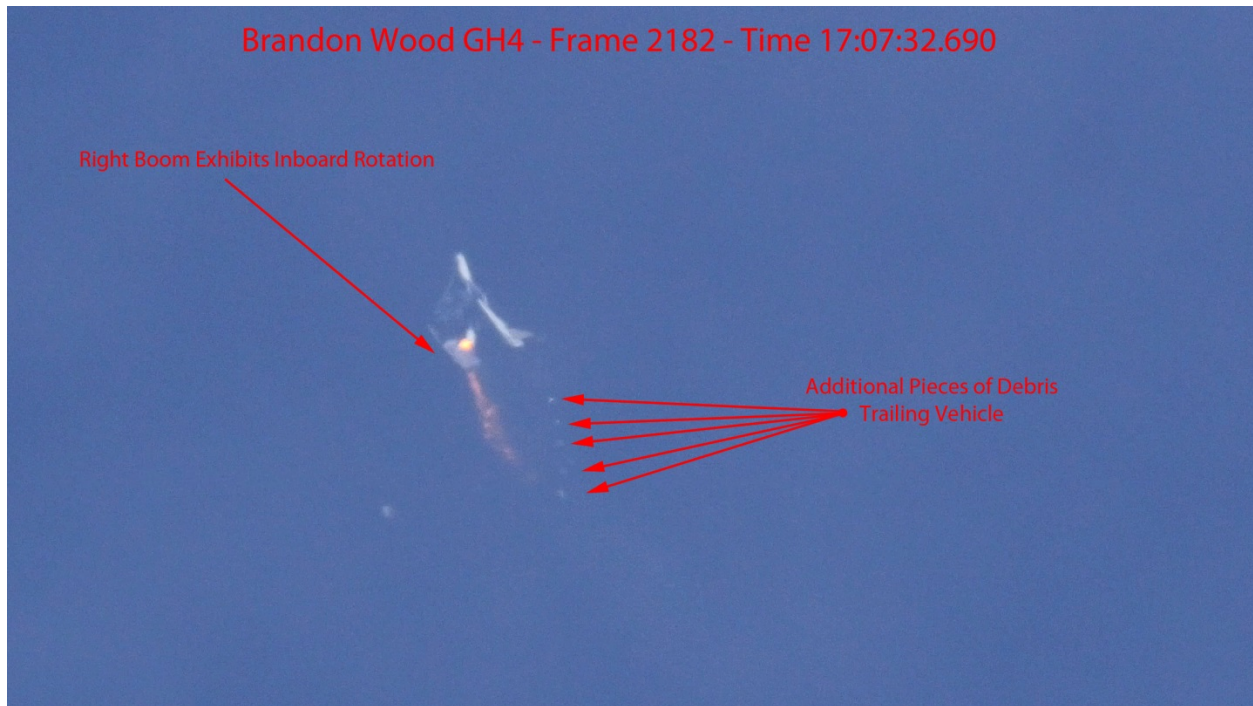
Figure 42 shows additional trailing debris propagating in the flight path of the vehicle. The right boom exhibits an inboard rotation toward the centerline of the vehicle.

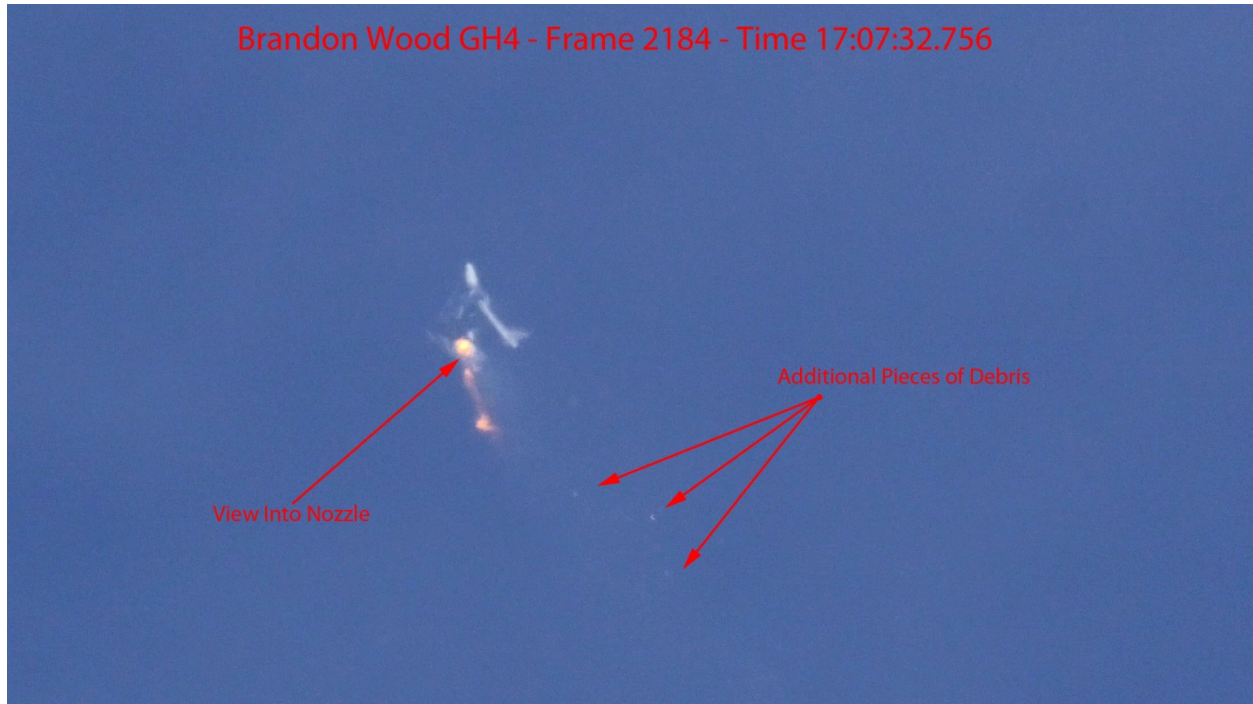
Figure 43 shows the rocket motor nozzle oriented more directly toward the camera's lens indicating the vehicle is pitched up in an unusual manner. Additional unknown debris is trailing in the vehicle's flightpath.
