**NATIONAL TRANSPORTATION SAFETY BOARD
Office of Research and Engineering
Vehicle Recorder Division
Washington, DC 20594**

**GROUP CHAIRMAN'S FACTUAL REPORT OF INVESTIGATION
External Imagery Factual Report
DCA15MA019**

Location: Koehn Dry Lake, CA
Date: October 31, 2014
Vehicle: Model 339 SpaceShipTwo
Registration: N339SS
Operator: Scaled Composites, LLC.
NTSB Number: DCA15MA019

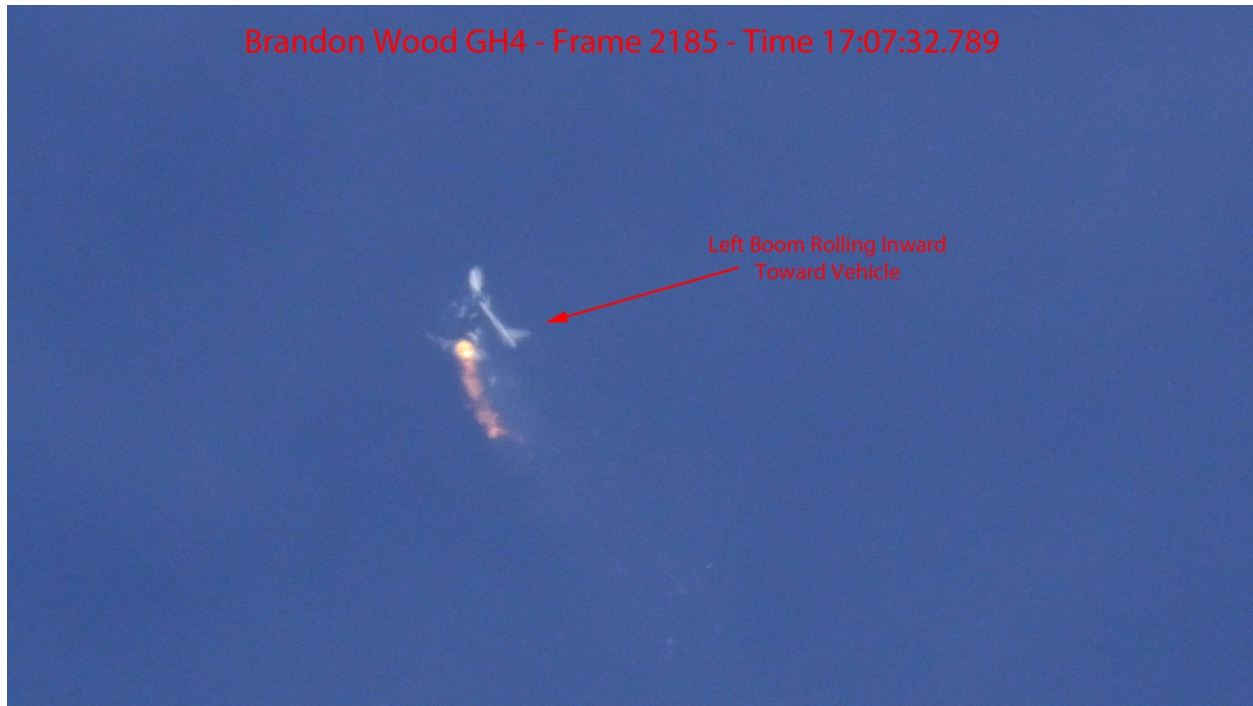
Figure 44 shows the left boom has begun to rotate inboard toward the vehicle. The right boom is obscured behind the main fuselage.

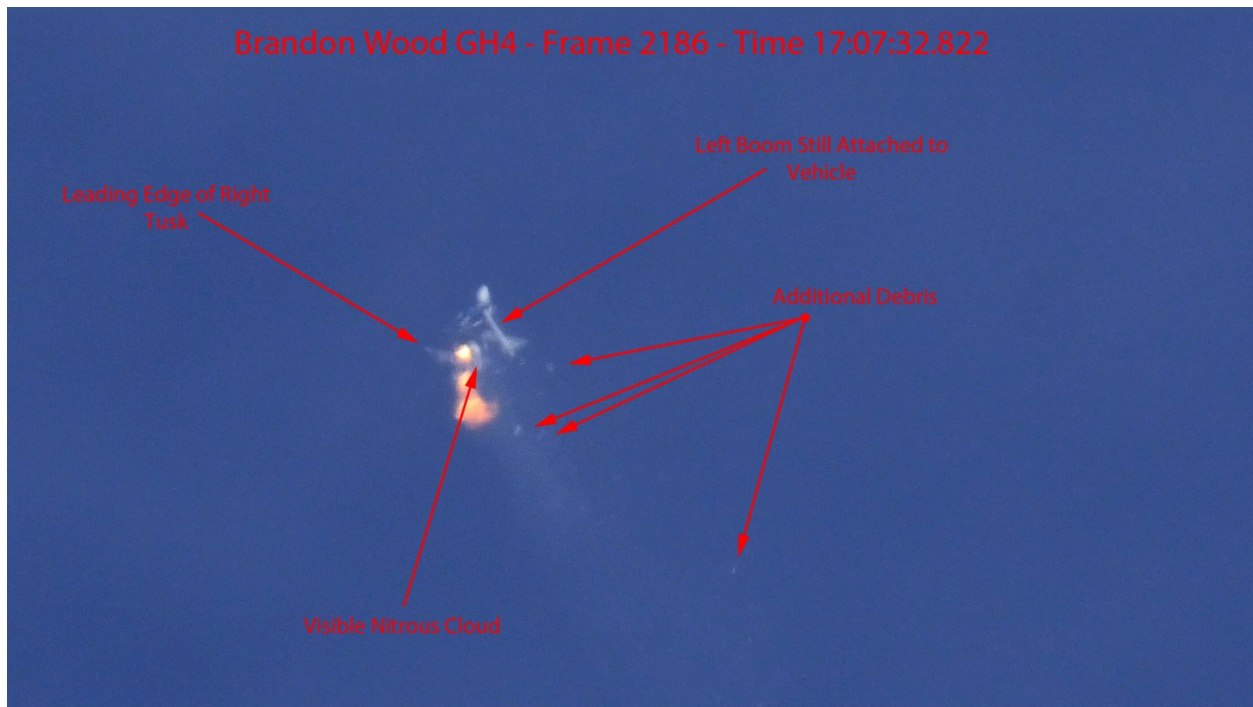
Figure 45 shows a nitrous plume has become visible. The leading edge of the right feather tusk is on the right side of the vehicle. The left boom is still attached to the main fuselage structure. Additional unidentified debris is trailing the vehicle behind the vehicle's flightpath.

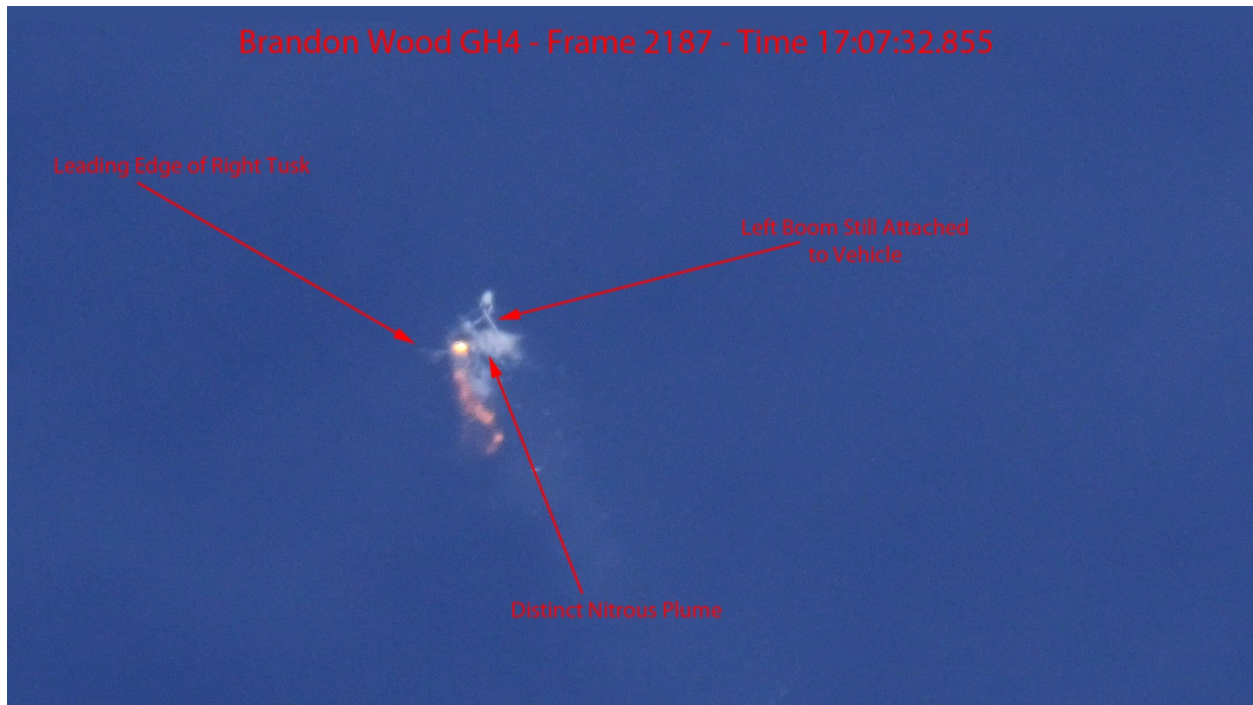
Figure 46 shows a distinct nitrous plume. The leading edge of the right feather tusk is on the right side of the main fuselage. The left boom appears to still be attached to the vehicle.

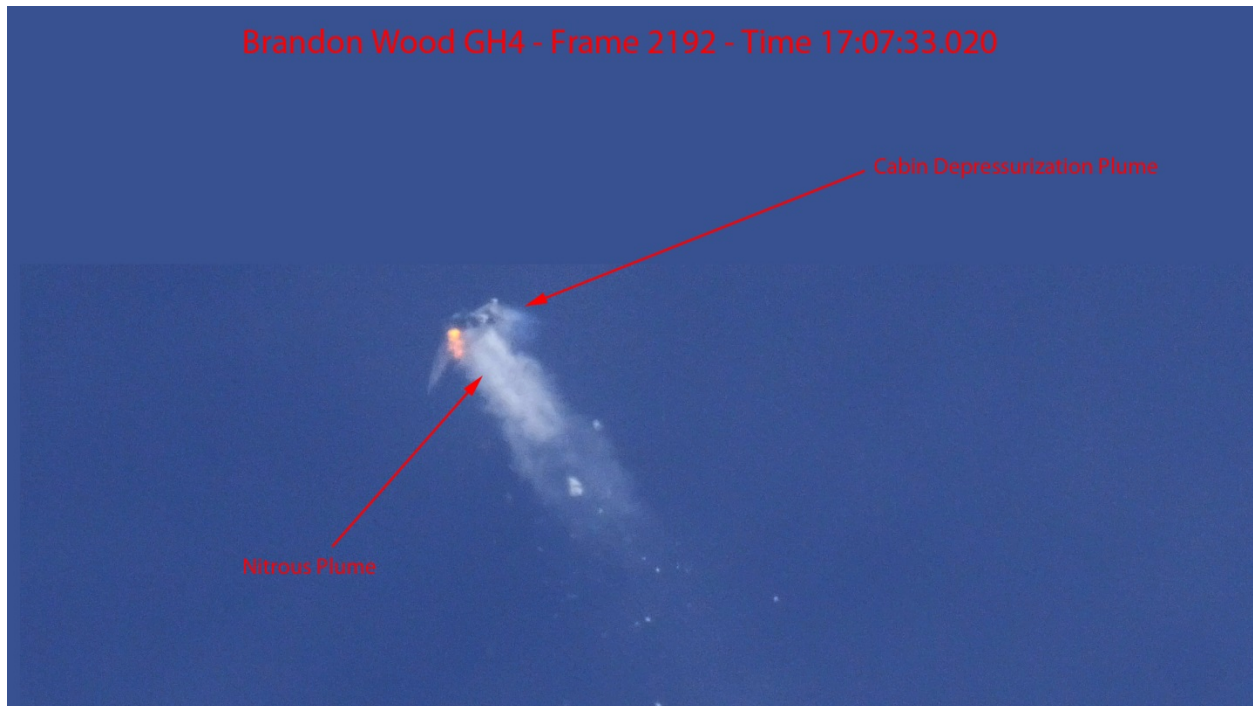
Figure 47 shows a secondary gas plume in the area near the main cabin, a result of a compromise in the cabin structure and indicative of cabin depressurization. The main nitrous plume has continued to grow larger in size. Additional unidentified debris is trailing in the vehicle's flightpath.

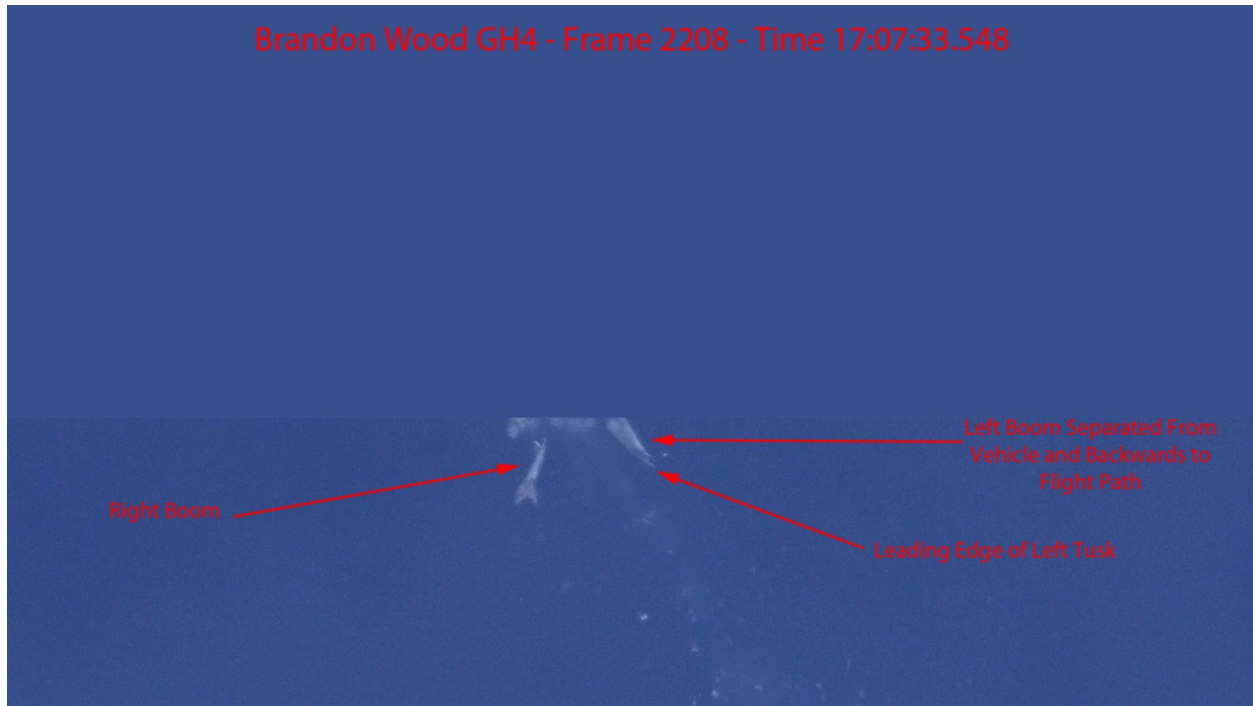
Figure 48 shows the first recorded images from the Wood camera exhibiting left and right boom separation. The main fuselage of the vehicle is mostly out of the camera's frame.

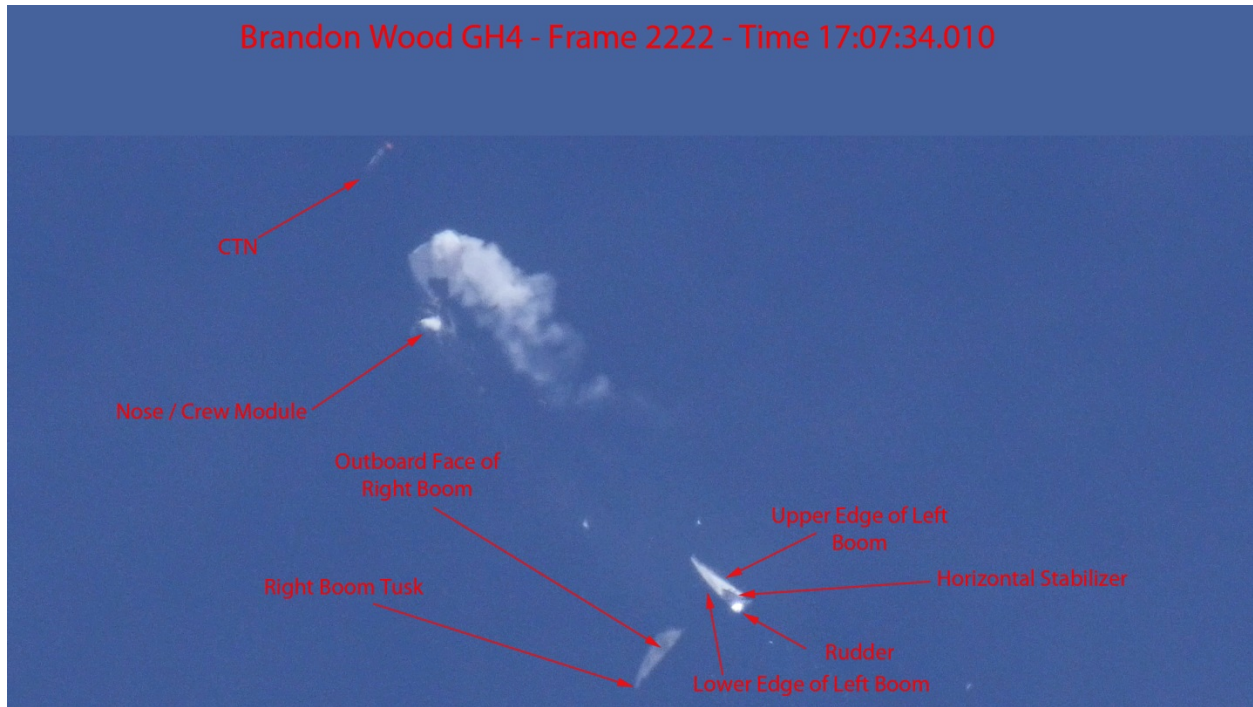
Figure 49 shows separation of the CTN from the main fuselage area. The nose section containing the crew module is clearly separated from the fuselage. The outboard right boom is separated from the vehicle with the outboard face toward the camera and trailing in the flightpath. The left boom is rotated inverted. The outboard portion of the left boom is with the left horizontal stabilizer attached.

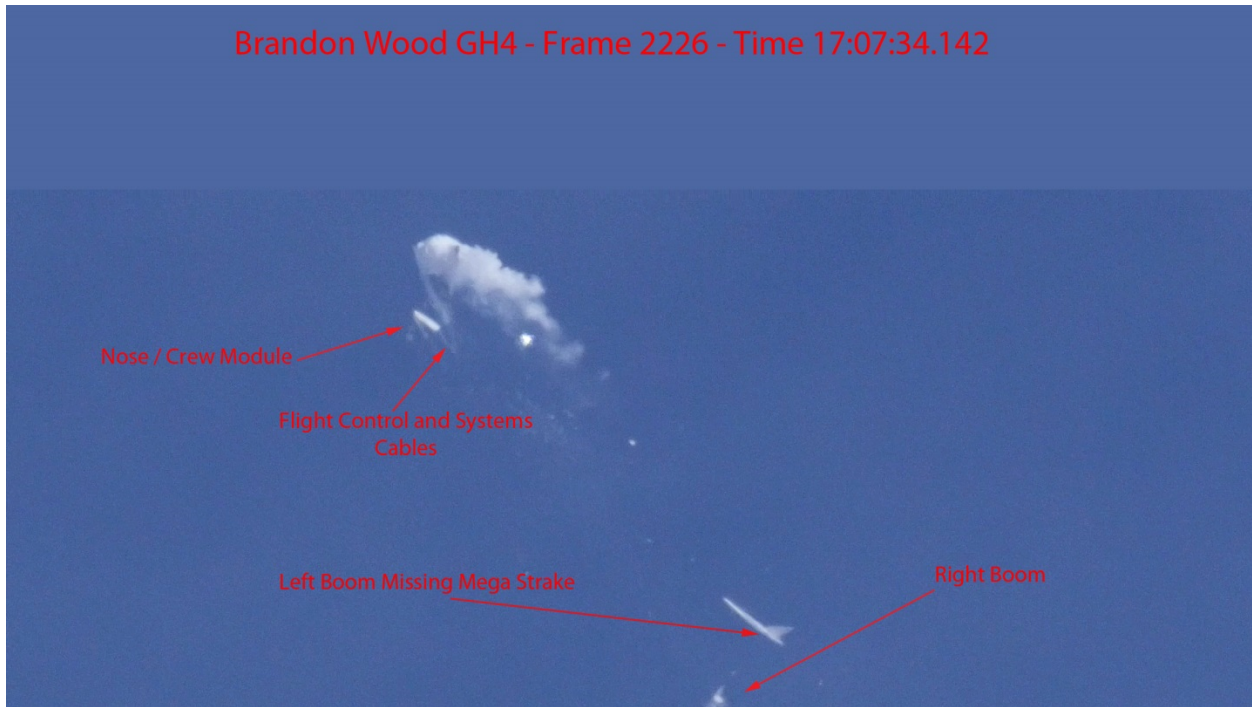
Figure 50 shows the nose section containing the crew module separated from the vehicle. Flight control and/or systems cables are trailing the nose section's structure. The left boom is containing the left horizontal stabilizer and missing the left mega strake. The right boom is partially out of the camera's frame.

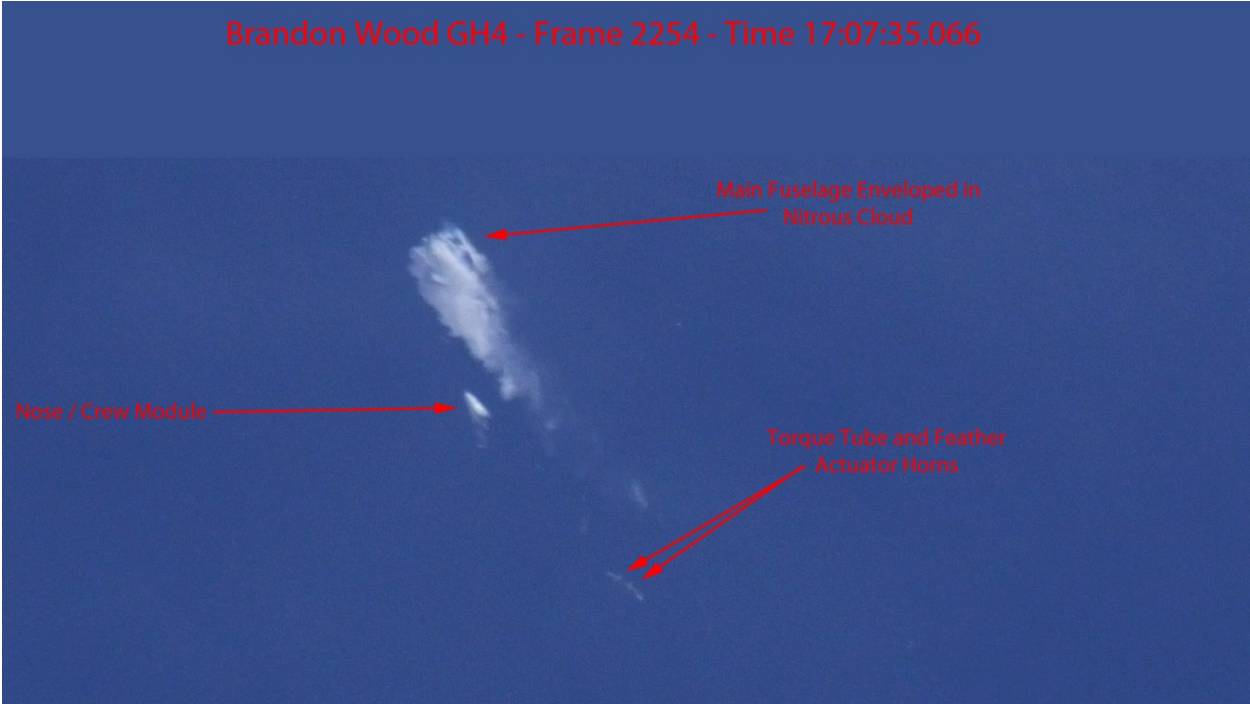
Figure 51 shows the main fuselage enveloped in a plume of nitrous. The nose and crew module is still in the camera's frame and separated from the vehicle. The torque tube is behind the main fuselage area containing the two feather actuator horns.

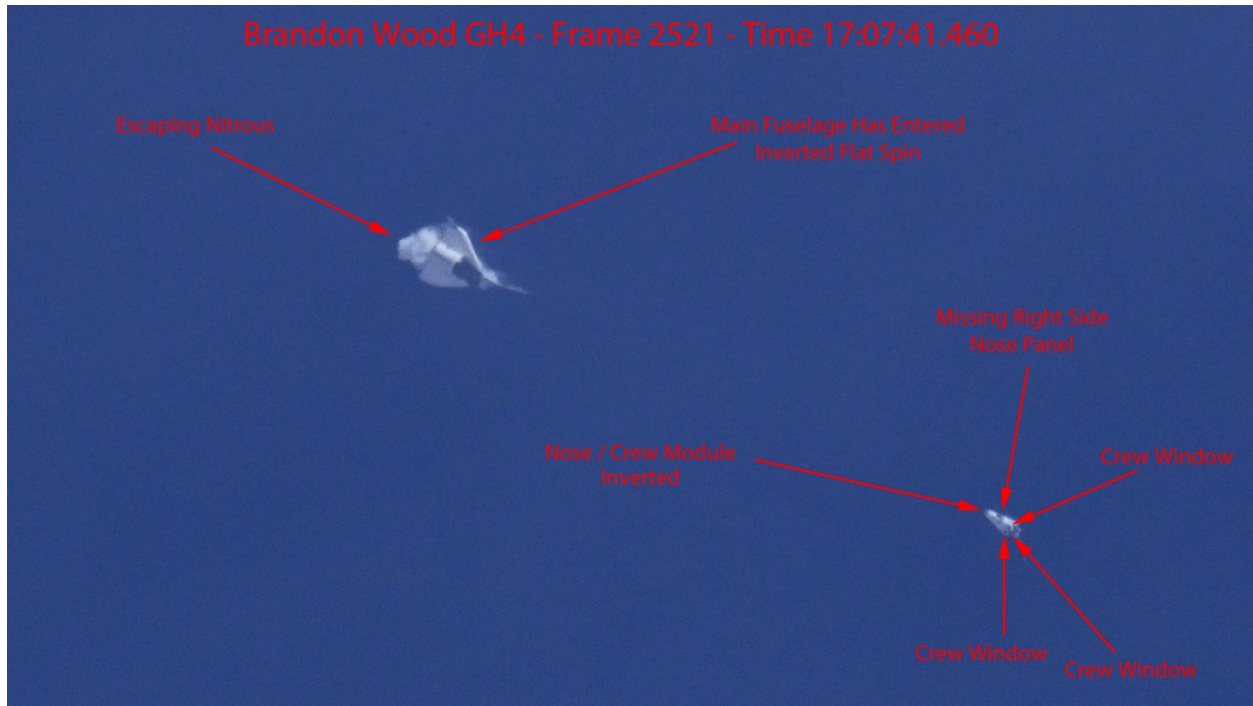
Figure 52 shows the fuselage inverted and in a flat spin. The SODAS chassis is attached to the main fuselage structure affixed by the associated wiring harness. The nose section is trailing the aircraft's flightpath. The nose section shows an upper right nose panel section is absent from the nose structure. Three crew windows are visible.

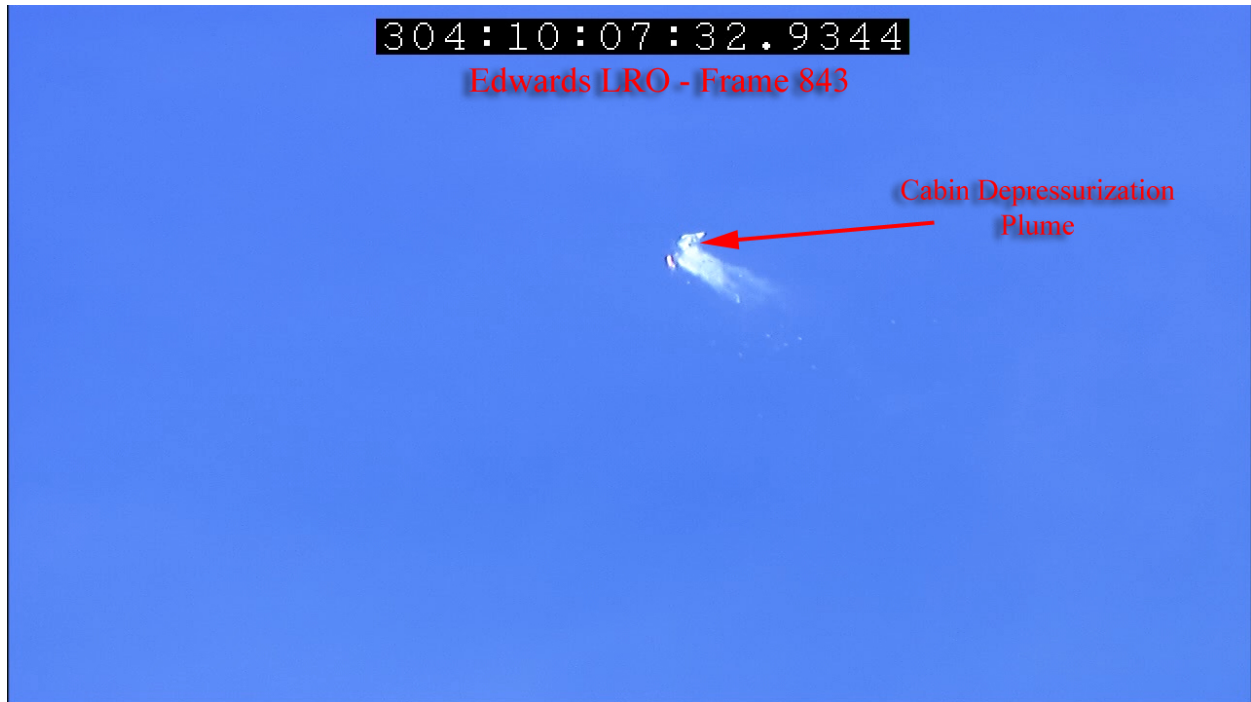
Figure 54 shows a secondary gas plume forming near the forward part of the main fuselage. This gas plume is likely associated with cabin depressurization.

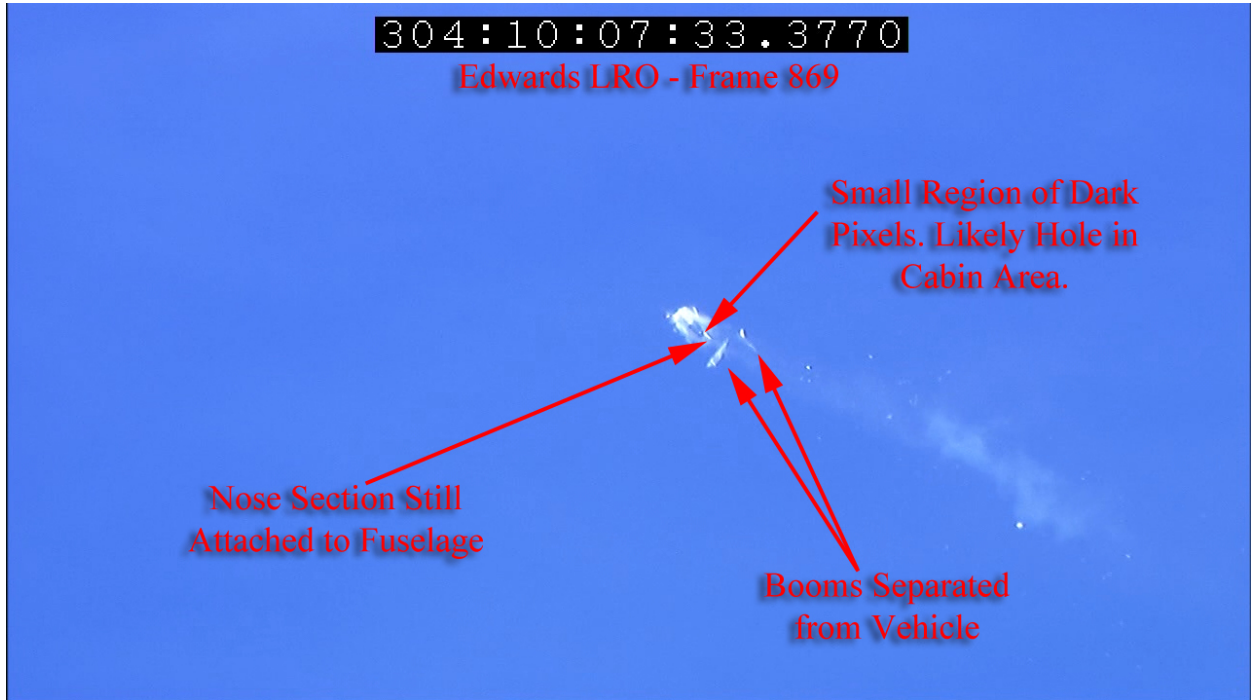
Figure 55 shows the nose section still attached to the main fuselage. A small region of dark pixels located on the upper part of the fuselage indicates a compromise in the fuselage structure. By this moment, the booms are separated from the vehicle.

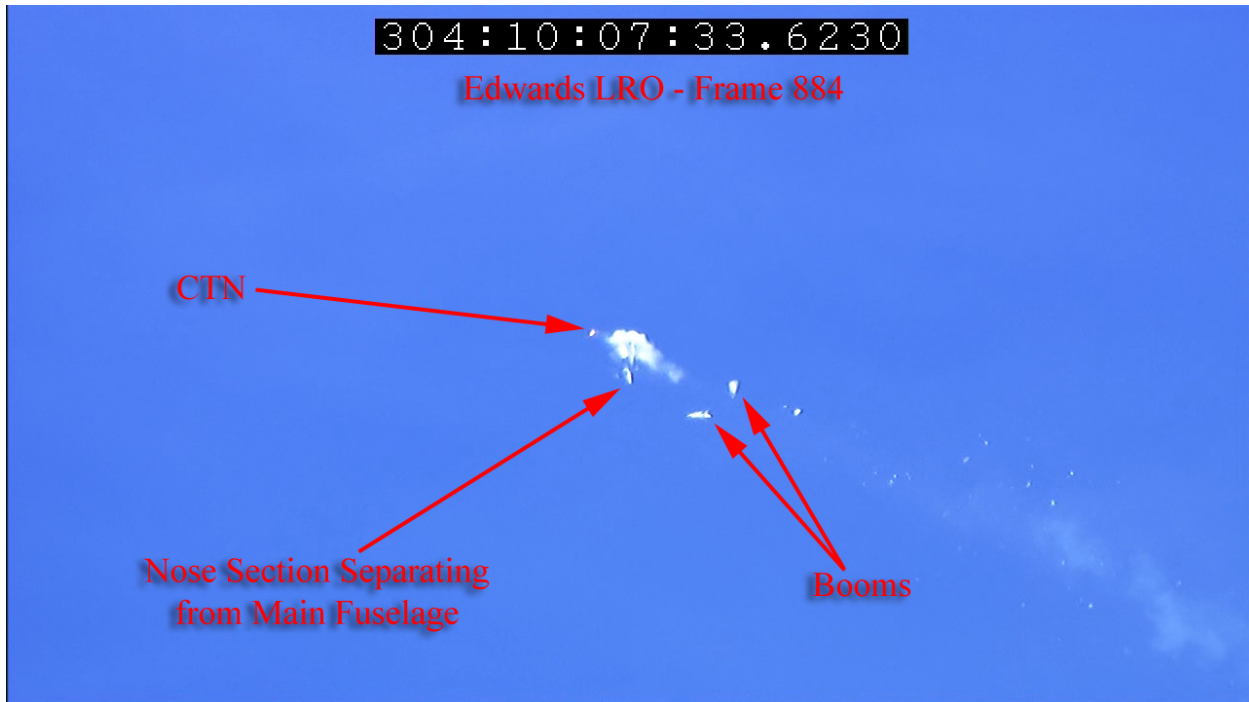
Figure 56 shows the CTN separated from the vehicle. The nose section is separating from the vehicle's main fuselage. The left and right booms are separated from the vehicle and further displaced from the image in figure 53.

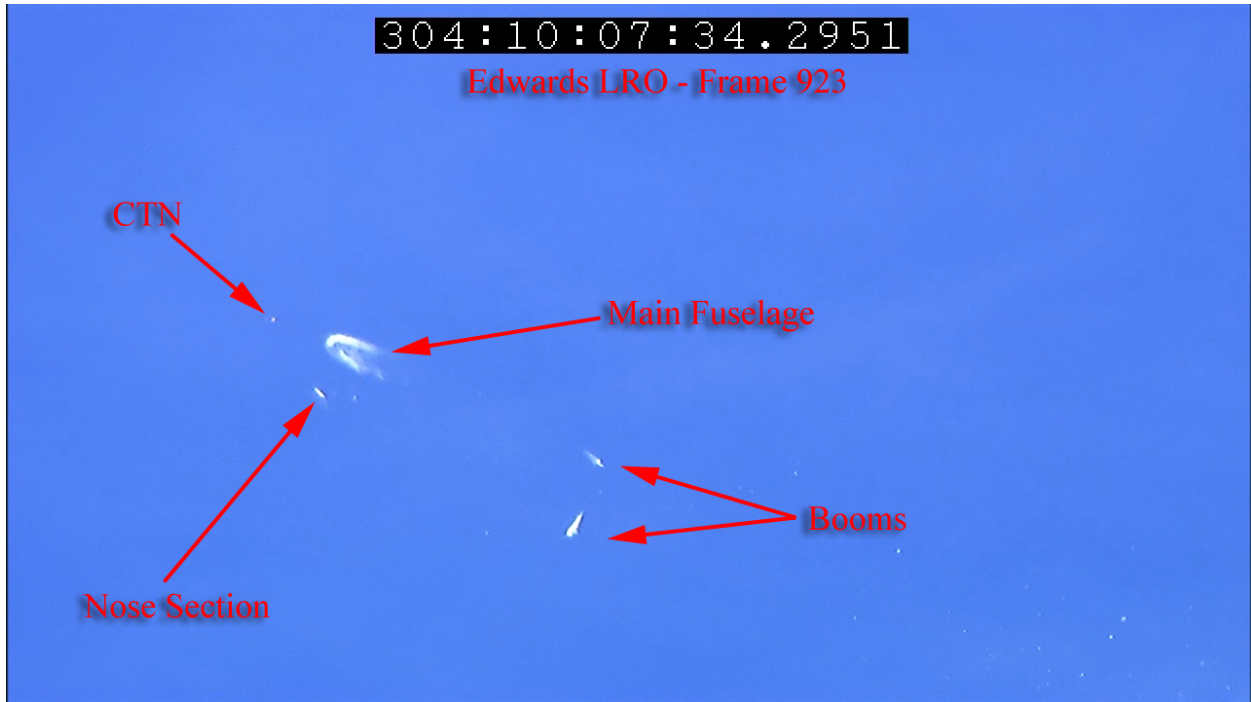
Figure 57 shows the vehicle broken into multiple large parts. The CTN is separated above the main fuselage. The nose section has completely separated from the main fuselage. The left and right booms are trailing the vehicle along the flightpath. Additional debris is behind the vehicle.

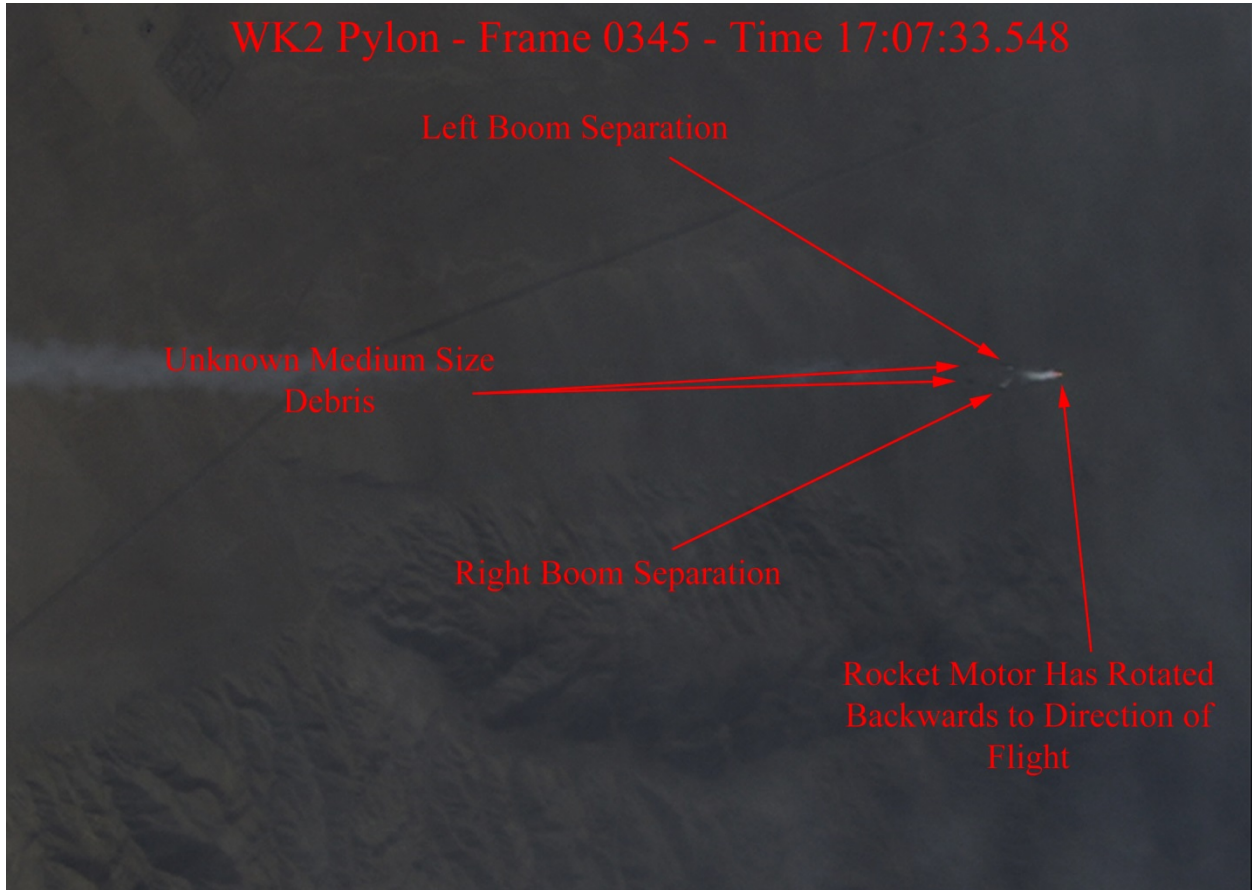
Figure 59 shows medium size debris trailing the vehicle. The left and right booms are separated from the vehicle. The rocket motor is rotated backwards to the direction of flight.

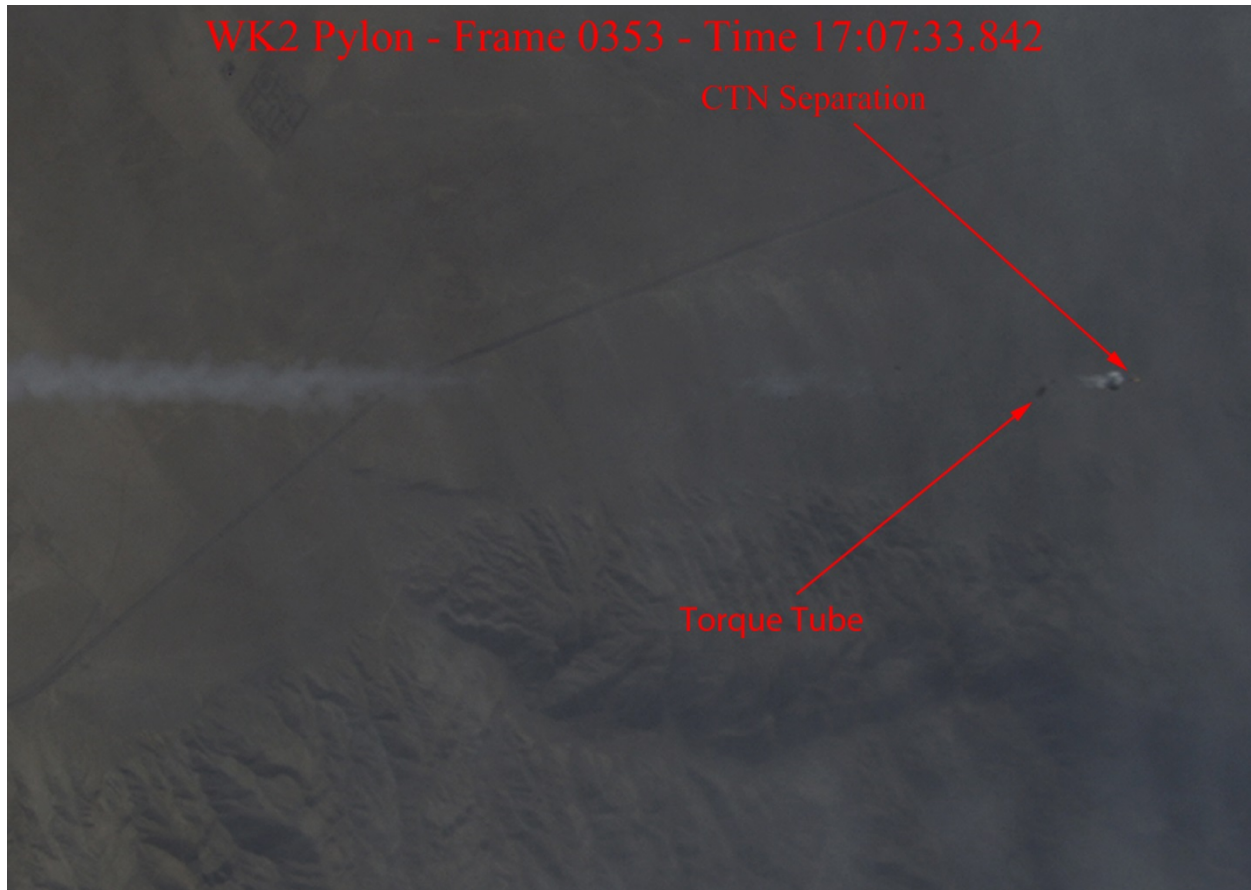
Figure 60 shows separation of the CTN from the main fuselage structure. A large dark part consistent in size and shape of the torque tube is trailing the vehicle's flightpath.

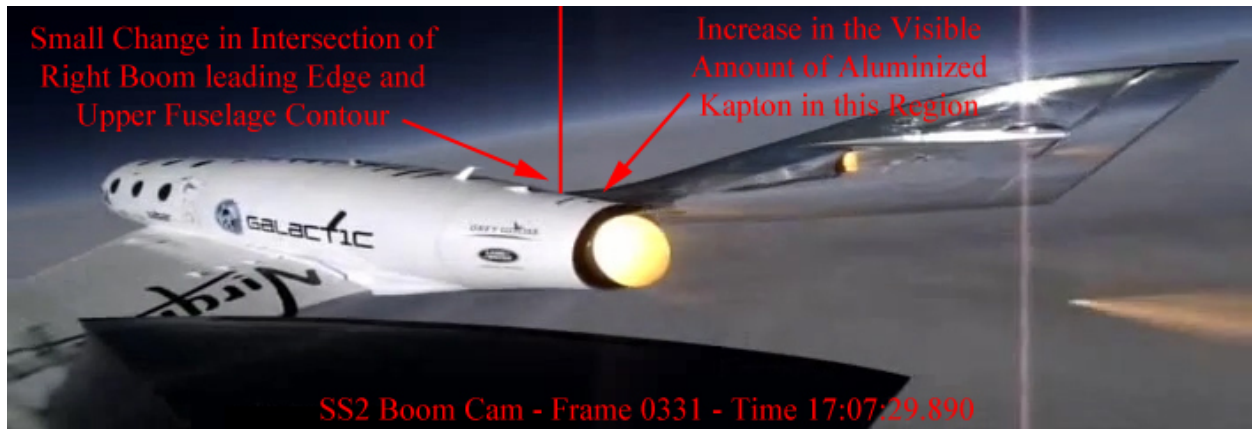
Figure 63 contains the first evidence indicating feather position movement. The vertical line from figure 62 was transposed onto figure 63. A slight change in relative position between the right boom leading edge and the upper contour of the fuselage was noted. Additionally, a region on the inner surface of the right boom covered in aluminized Kapton is observed having a slightly larger surface area indicating that the feather had slightly changed position. Slight feather movement was observed in frame 0330 (not shown) using the same techniques (Time 17:07:29.857) but was unable to be clearly presented in a graphics format.

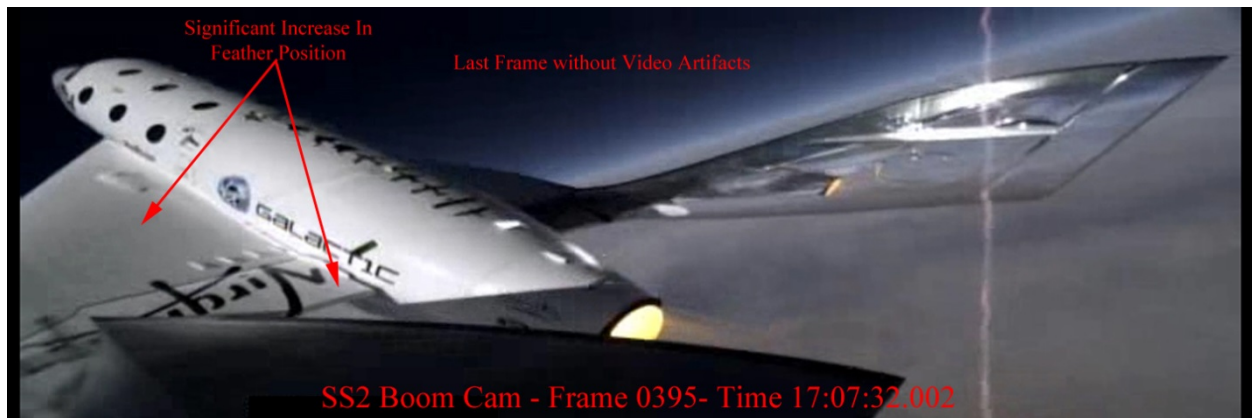
Figure 66 is the last exported frame from the recording that was clear and did not contain video artifacts likely associated with the abrupt removal of power to the camera system. A significant increase in feather position is noted.

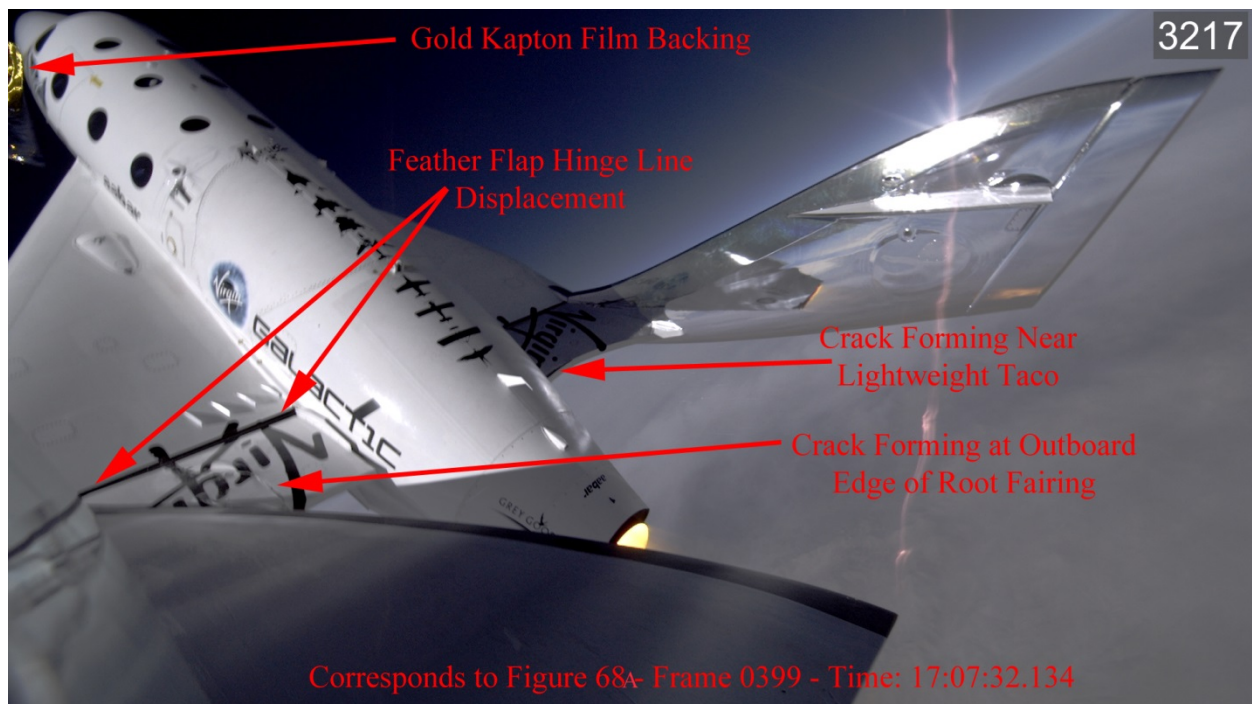
Figure 68b. Recovered HD still image.

Figure 68b is the corresponding still frame exported from the boom camera hard drive containing high definition imagery. Figure 68b shows greater detail of the cracks forming on the outboard root fairings and the lightweight “taco” area. The high definition file also shows the Kapton foil failing in the upper left hand corner of the frame, the area near the leading edge of the left boom structure.

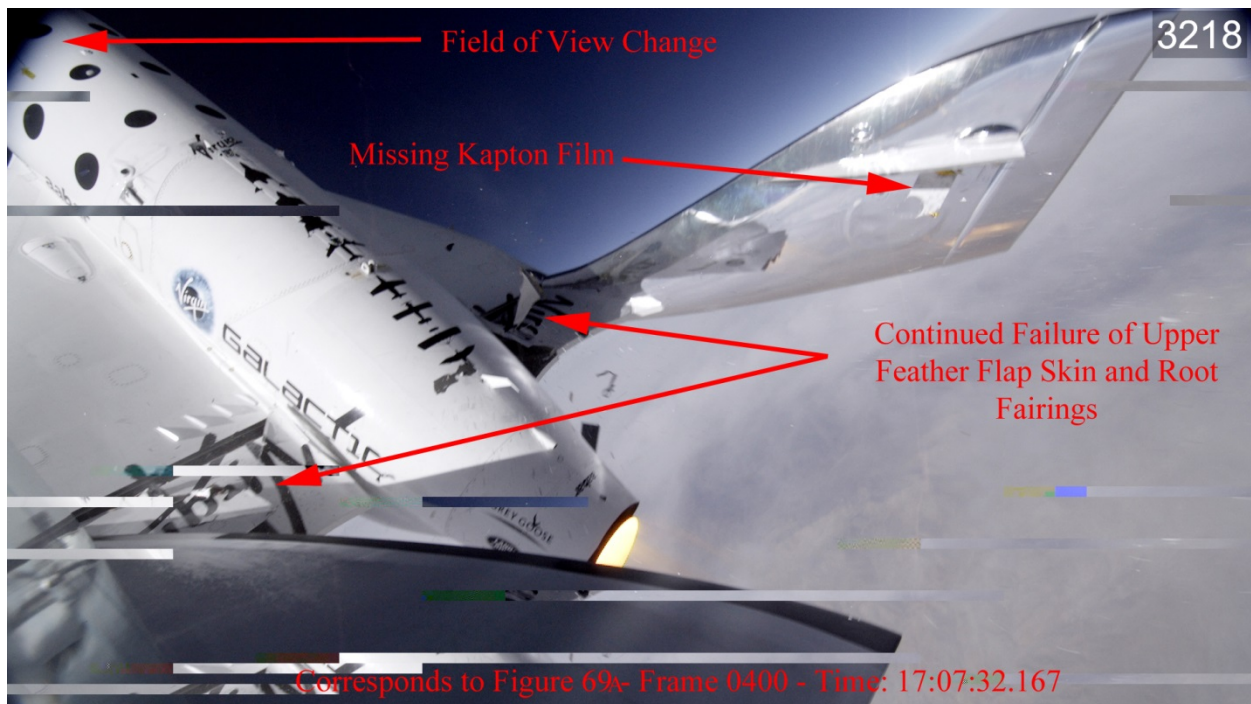
Figure 69b.

Figure 69b is the corresponding still frame exported from the boom camera hard drive containing high definition imagery. The high definition file shows a portion of missing Kapton on the right boom structure and the continued failure of the upper feather flap skin and root fairings. Video artifacting has become present on the recovered high definition file.

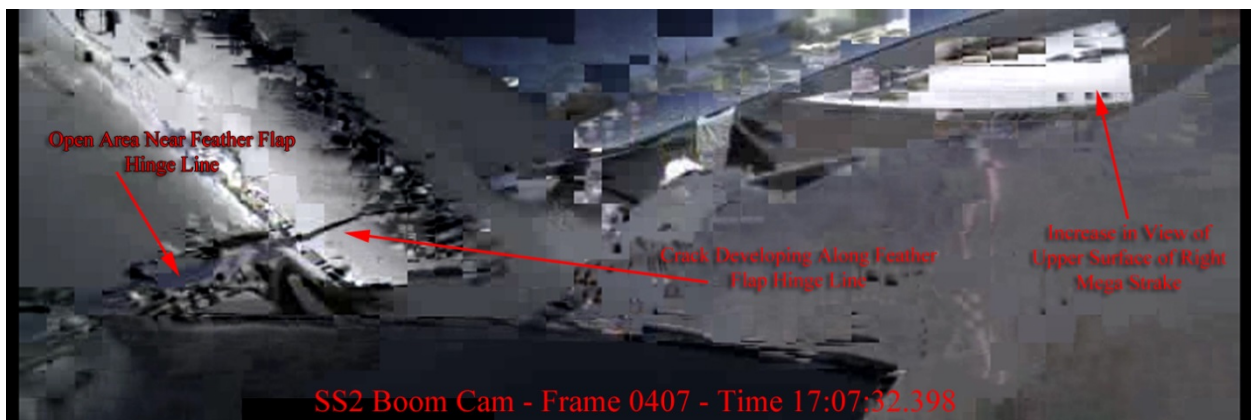
Figure 72 shows an increase in the visibility of the upper surface of the right mega strake indicating further rotation of the right boom inboard toward the centerline of the vehicle. An open area is visible near the feather flap hinge line consistent with the color of the surrounding background near the left hand portion of the frame. Additionally, a crack has begun to propagate from the feather flap hinge line into the fuselage near the tail cone section of the vehicle.

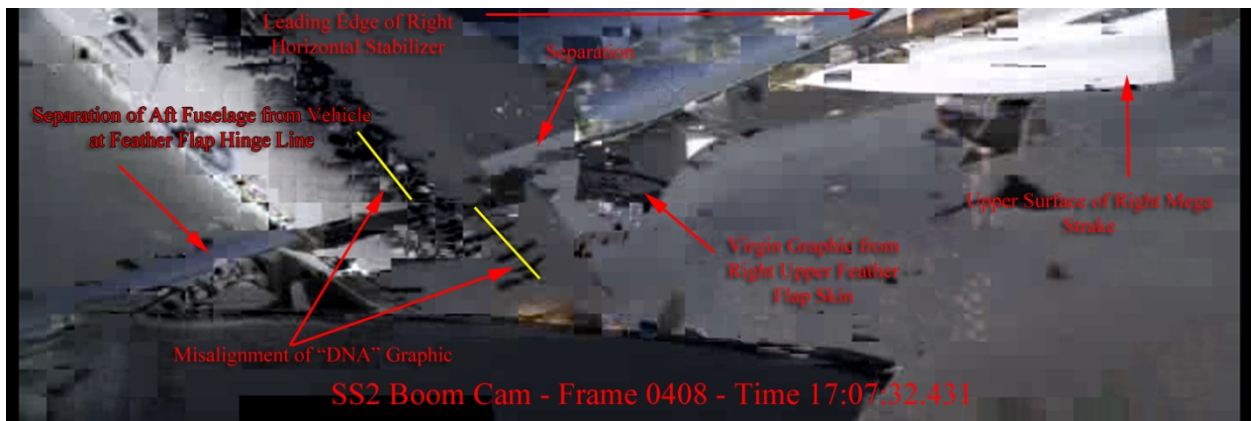
Figure 73 shows separation of the aft fuselage in the region of the tailcone. The crack along the feather flap hinge line has greatly increased in displacement. Background is visible between separated portions of the vehicle. The tailcone has begun to twist along the region of displacement, indicated by the “Virgin DNA” graphic becoming clearly misaligned (yellow line). Separation along the feather flap hinge line on the right side of the vehicle is also apparent, with background visible in the region of displacement. The right boom has mostly separated from the vehicle’s main structure and has continued to roll inboard with the upper surface of the right megastrake becoming more apparent to the camera’s field of view. The Virgin logo on the right side of the vehicle near the feather flap hinge line is attached to the right boom structure and separated from the vehicle.
