[Docket No. ; Amendment 39-4222; AD 81-11-02 R1]

**Airworthiness Directives; Piper Model PA-28R-200, PA-28R-201 and Model PA-28RT-201 Airplanes.**

**81-11-02 R1 PIPER AIRCRAFT CORPORATION:** Amendment 39-4111 as amended by amendment 39-4222.

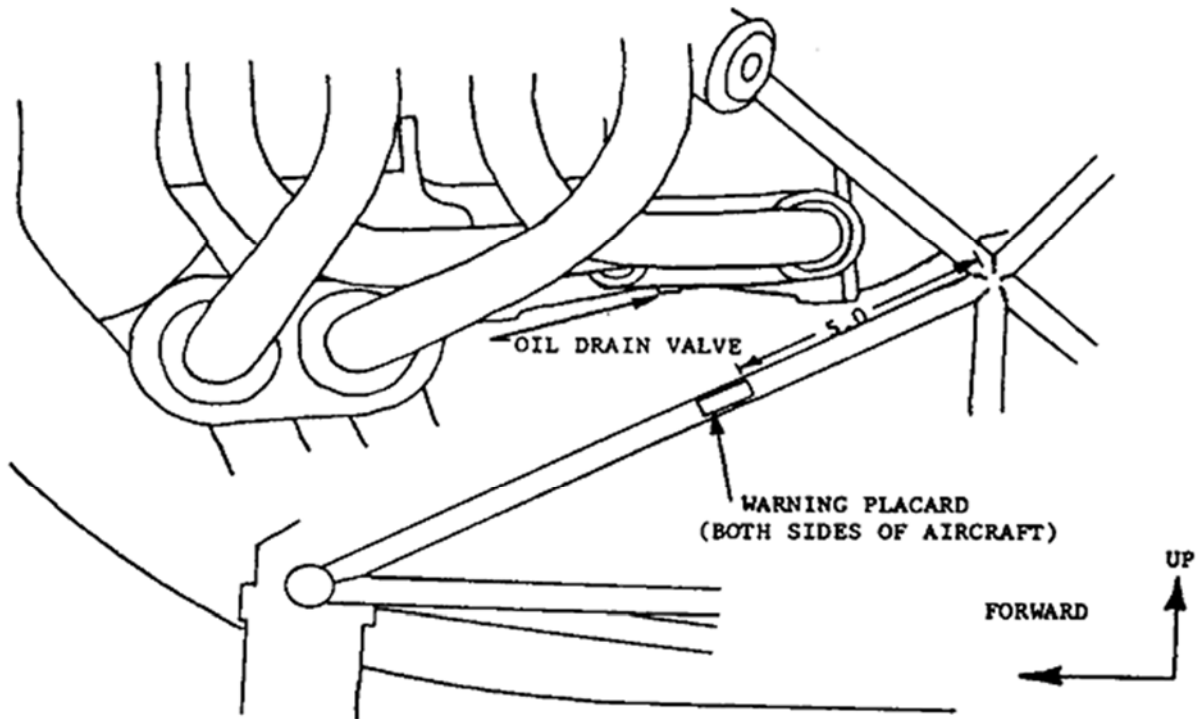
FIGURE 1  
AD 81-11-02

Compliance is required within the next 50 hours time in service or at the next oil change, whichever comes first, after the effective date of this AD unless already accomplished. To prevent possible loss of oil due to installation of an incorrect engine oil quick drain valve, accomplish the following:

(a) Install two warning placards, one on each side, on the lower engine mount beneath the intake and exhaust tubes, in accordance with Figure 1. Use Piper Part No. 87369-26V which reads:

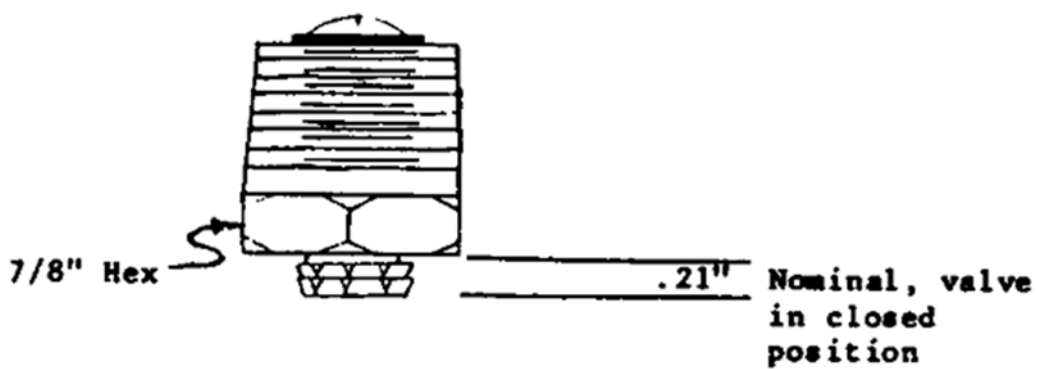
FIGURE 2  
AD 81-11-02

(1) Inspect the oil quick drain valve and insure that Piper Part No. 492-172V is installed and correctly safety wired. The correct valve can be identified by comparison with Figure 2. Also, the Number 1H50-1 may be visible on the hex.

(2) If an incorrect valve is installed, replace with Piper Part No. 492-172V, and safety wire, using .032 safety wire.
