# 2011-10-09

## CESSNA AIRCRAFT COMPANY

Amendment 39-16690

**Airworthiness Directives; Cessna Aircraft Company Models 150, 152, 170, 172, 175, 177, 180, 182, 185, 188, 190, 195, 206, 207, 210, T303, 336, and 337 Airplanes**

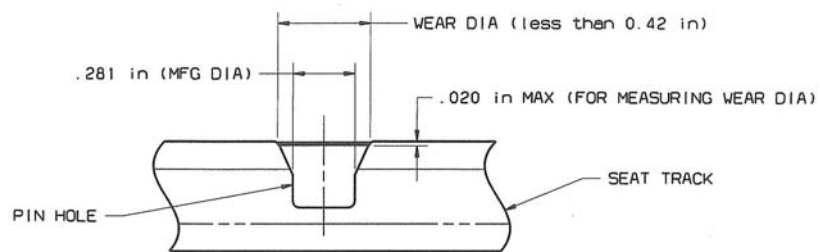
Figure 1. Diameter of seat pin locking engagement hole

(3) Inspect the diameter of each seat locking pin engagement hole in the pilot and copilot seat rails for excessive wear. Due to wear on the rail surface at the hole opening, we allow this

measurement 0.020 of an inch below the surface of the rail. You must take this measurement somewhere between the surface of the rail or no more than 0.020 of an inch below the surface of the rail.

We disagree with this comment. The measurement dimensions in figure 1 adequately address the measurements necessary for this AD. Additional measurements will not provide any additional benefit.

(i) If the diameter of any of the holes is 0.42 of an inch or more (see figure 1), before further flight, replace the rail.

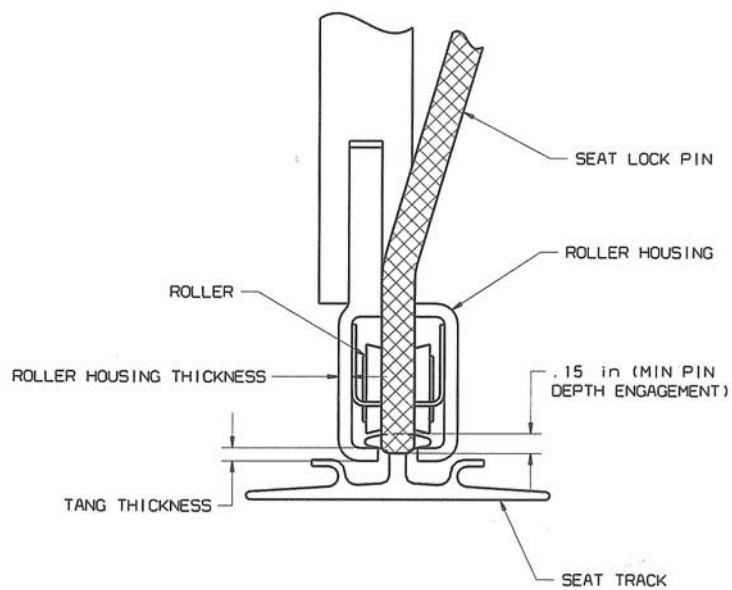
Figure 2. Seat locking pin depth engagement

(10) Lift up the forward edge of each seat to eliminate vertical play of the seat locking pin in the engagement hole, and from this position, inspect the depth of engagement of each seat locking pin (see figure 2). If the rail is worn, this depth is measured from the worn surface, not the manufactured surface.

(i) If engagement of any of the seat locking pins measures less than 0.15 of an inch, before further flight, replace or repair any seat components necessary to achieve a seat pin engagement of a minimum of 0.15 of an inch.

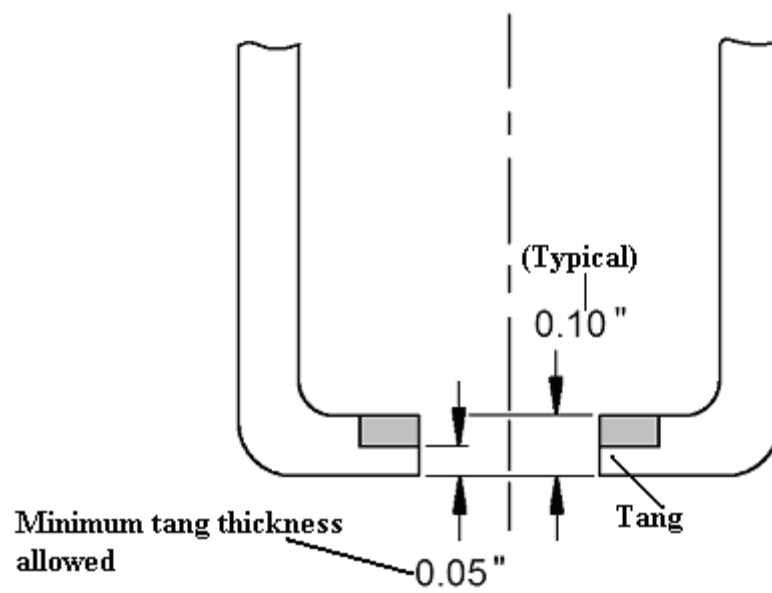
Figure 3. Closeup of seat roller housing  
and tang thickness

(5) Inspect the thickness of the tang (see figure 2 and figure 3). Due to wear of the tang chafing against the seat rail, measure the tang thickness where the tang inner edges contact the seat rail.

(i) If the tang thickness measures less than 0.05 of an inch, before further flight replace the roller housing.

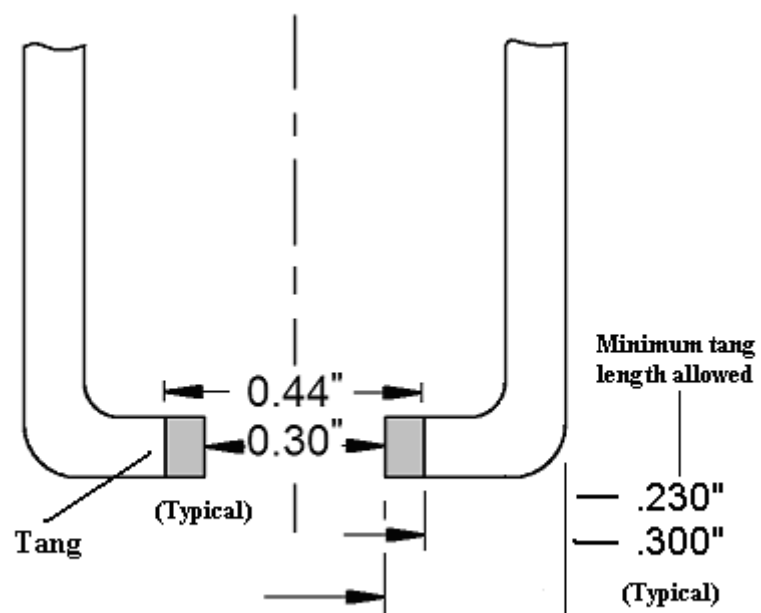
Figure 4. Closeup of seat roller housing and tang gap width

(6) Due to wear or deformation of the tangs, inspect the tang length from the inner edge of the tang to the outer edge (the bend area) of the roller housing (see figure 4).

We have changed the callouts in figure 4 to measure the tang length from outside of the roller housing instead of from inside of the roller housing. We have also changed the description of the tang measurement in figure 4 to more accurately describe the measurement.

(i) The minimum measurement allowed for the remaining tang length is 0.230 inches remaining on either of the tangs, from the inner edge of the tang to the outer edge (the bend area) of the roller housing. If the measurement is less than 0.230 inches on either of the tangs, before further flight, replace the roller housing.
