FAA Inspector Report – Mr. Wesley Dollahite, Denver FSDO

On Friday July 12, 2019 I drove from Denver to Sidney, Ne, to help with an accident involving Queen Air, N62069, S/N 62-3866 that during departure had a left hand wing explosion. Met with a team from Bemidji Aviation including the Director of Maintenance and Director of Ops, as I walked into the FBO they taxied onto the ramp.

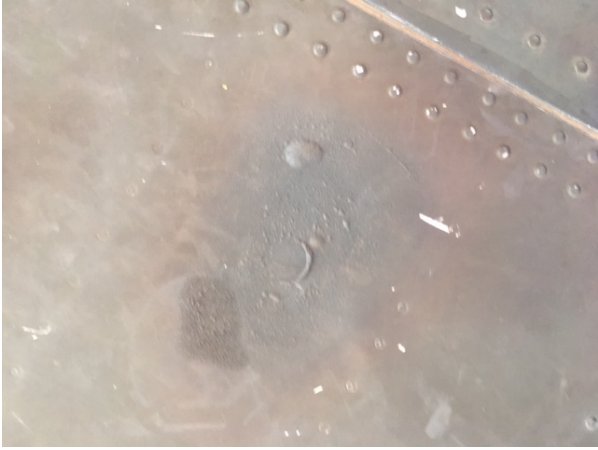
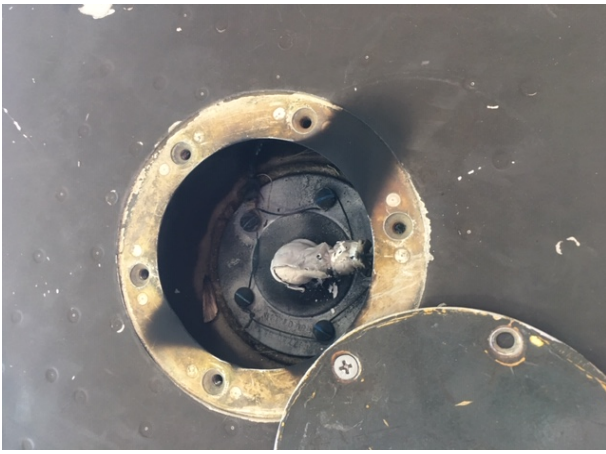
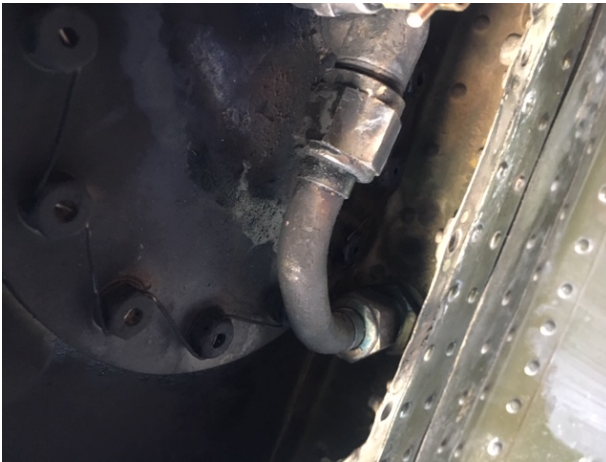
We were led to a hanger on the airport that held several aircraft including the Queen air. It had been defueled by a mechanic from Bemidji a couple days before so no fuel leaks were present. DOM preceded to open up all wing panels so that we could have a good visual inspection. During this visual heavy fire damage was seen in the wing root area, including sooting from several areas, burned wiring, melted insulation and a couple areas of burned paint on the outside of the wing.

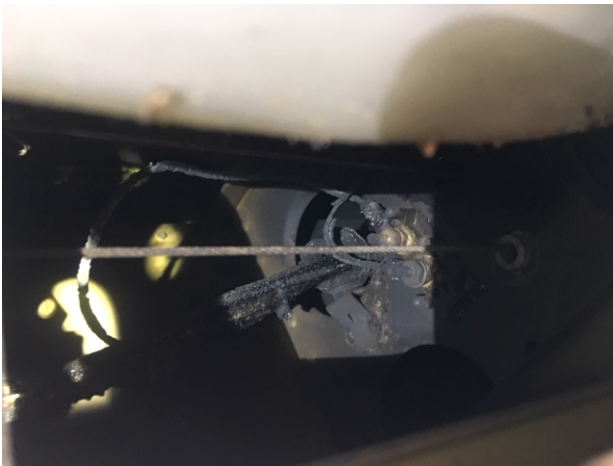
As the inspection happened the discussion arose about what the pilot had stated after returning to the ramp. This is when the statement of the erroneous stall warning activation started to point us at a grounding of the wiring and possible arcing that would have caused the ignition of the fuel. We then started tracing wiring as much as possible and found an area where two clamps were clamped to a rib for the wing wiring to run through. Power was hooked back up and the stall warning continued to sound and the Nav light circuit breaker was popped and could not be reset. This aircraft is not equipped with wingtip strobes so no wiring was present for the packs. Not being able to see what was going on with the wiring clearly we decided to move the aircraft outside and prepare the aircraft for fueling.

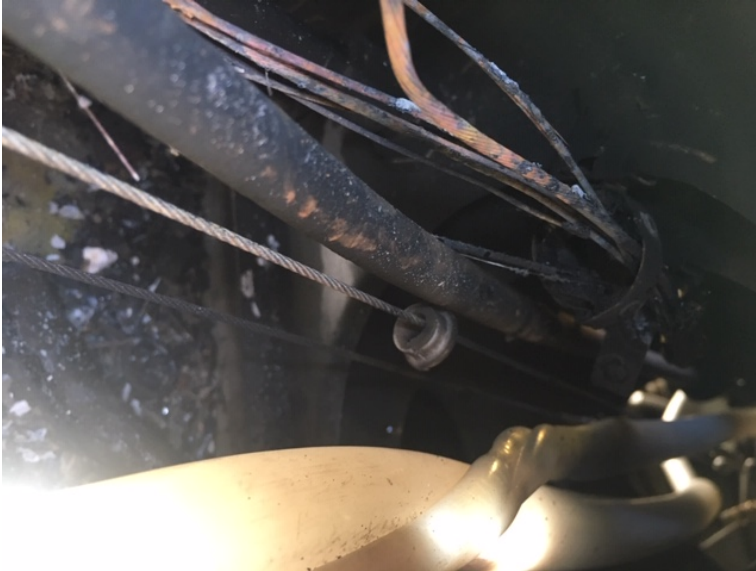
wing wiring harness was able to be seen more readily. Harness was found to be pinched between a clamp and a wing rib. Harness was moved outward from the clamp and shiny metal to metal contact areas were seen. This seemed to be the area where the inboard fire started. Wiring harness insulation was heavily damaged so there was no easy way to separate the wiring to see if the stall warning would stop sounding.

In this area were two clamps, wiring can be seen passing thru one clamp, other clamp was missed by wiring and pinched against the rib. This is also the area where the paint was bubbled and burned on top of the wing.

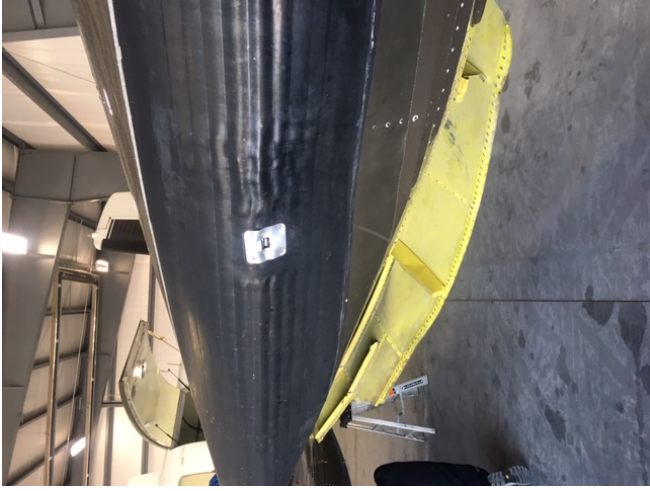
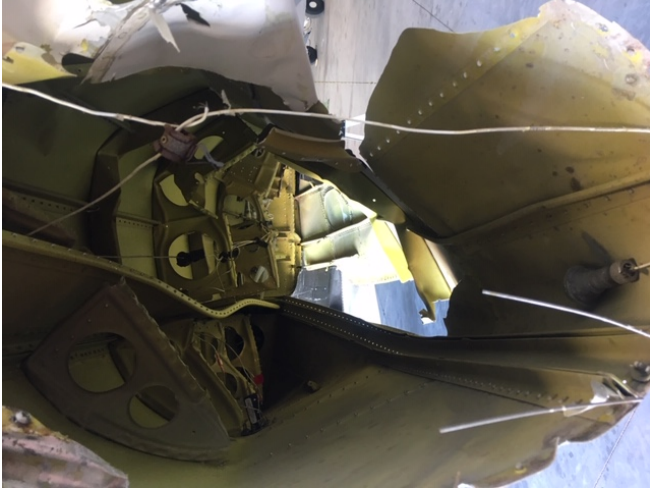
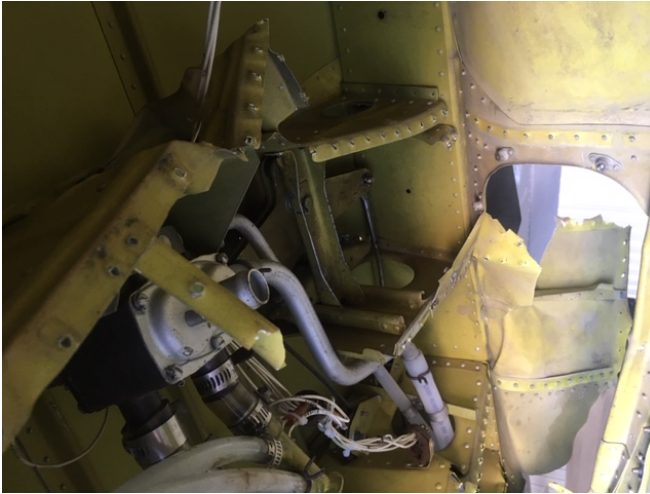
So between the fuel leaking from the sending unit and the wiring being pinched and arcing the cheese seemed to line up. Flames from the inboard fire ignited the vapors in the wing causing the wing tip to explode.
