U.S. Department
of Transportation
**Federal Aviation
Administration**

Damage Report - Incident Number ERA13IA313

MARC CABIBBO ASI FSDO-AEA-11 Accident June 30, 2013 @ 12:15 EDT
FAA IIC Marc H. Cabibbo received a call from AEA-RO communications center reporting a helicopter down on the Hudson River near 79 street boat basin New York, NY. FAA Inspectors Marc Cabibbo and James Ciccone responded and were present at the accident site at 1335 hours EDT. The aircraft was at that time secured at the 79street dock, stable on its emergency pop out floats. There were no injuries in connections with this event. The circumstances are as follows:

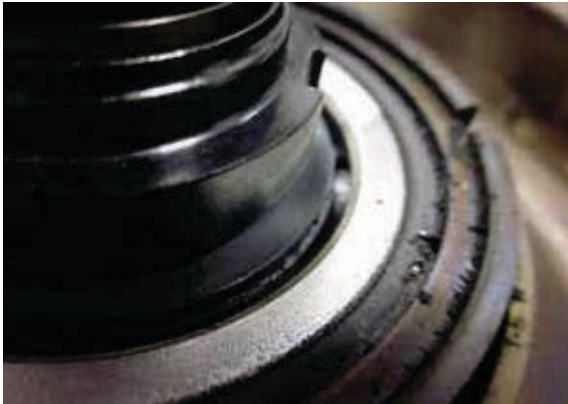
Figure 2, #2 Bearing installed

The compressor module was the first removed from the shipping container and reviewed. The #2 bearing in the compressor was noted at the operator's maintenance facility as being seized. During an inspection of the #2 bearing there was a noted lack of oil and high temperature signatures (Figures 2, 4 & 5). The bearing had debris on it, the ball bearings were damaged, showed coking, no cracks noted. The bearing appeared to have more heat damage on the forward side of the bearing (Figure 4) compared to the aft side (Figure 5). The races showed signs of high temperature as well (Figures 3 & 5). The

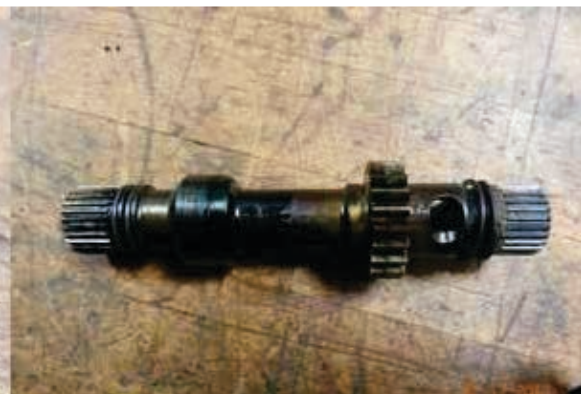
Figure 7, Spur Adapter gear shaft

gearbox and compressor had not been separated while the current owner/ operator had owned the aircraft/power plant. The Spur adapter gear shaft (Figure 6) was inspected during the tear down and showed signs of high temperature as well. **The #2 bearing with races and shims and the Spur adapter gear shaft were taken by NTSB for further evaluation.**

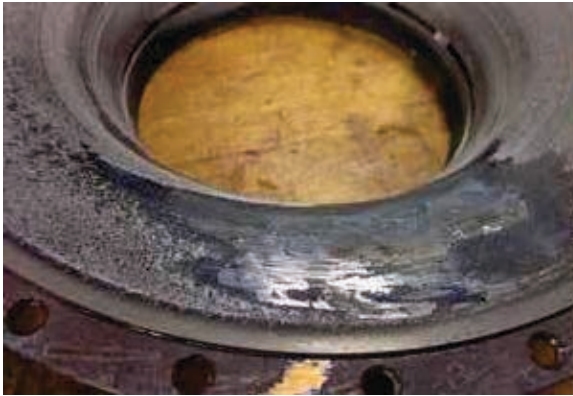
Figure 8, Impeller housing, inside

The Impeller was also inspected. During the tear down to get to the Impeller, it was difficult to separate the Impeller from the housing. The housing showed signs of high temperature, most evident in the 12 and 6 o'clock positions (Figures 8, 9, 10, 11, 12, 13 & 14). Once the Impeller was removed, there was evidence that the Impeller had rubbed on the housing (Figure 12).

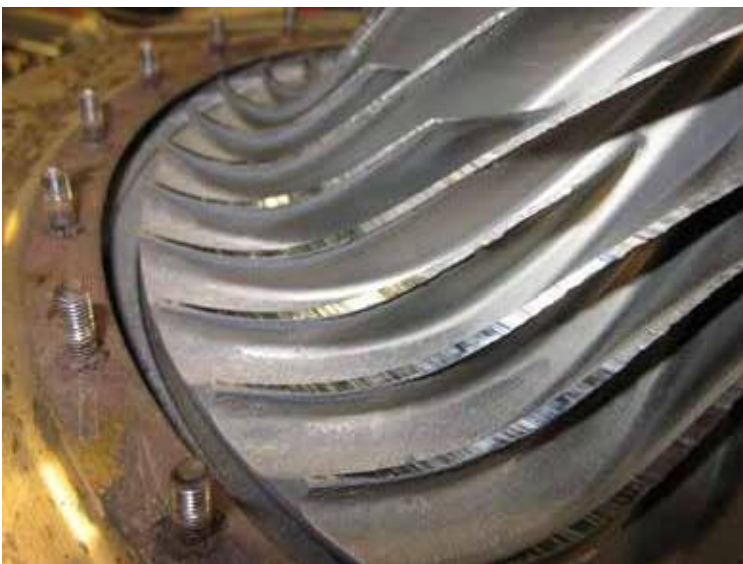
Figure 12, Impeller, rub marks shown

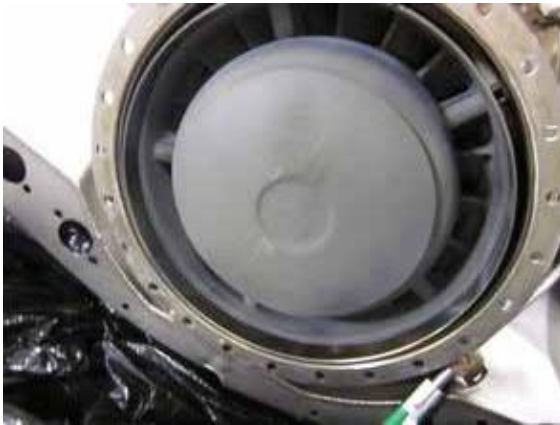
Figure 15, Combustion liner

This module was able to spin freely and did not show major signs of damage. The combustion liner had a rough coating that was not normal (Figure 15). It was not disassembled. Over haul was conducted by KTS during 11/2012. In preparation for overhaul the turbine module was separated by the owner/operator and shipped to KTS. The gearbox and compressor modules were not sent to KTS at that time.

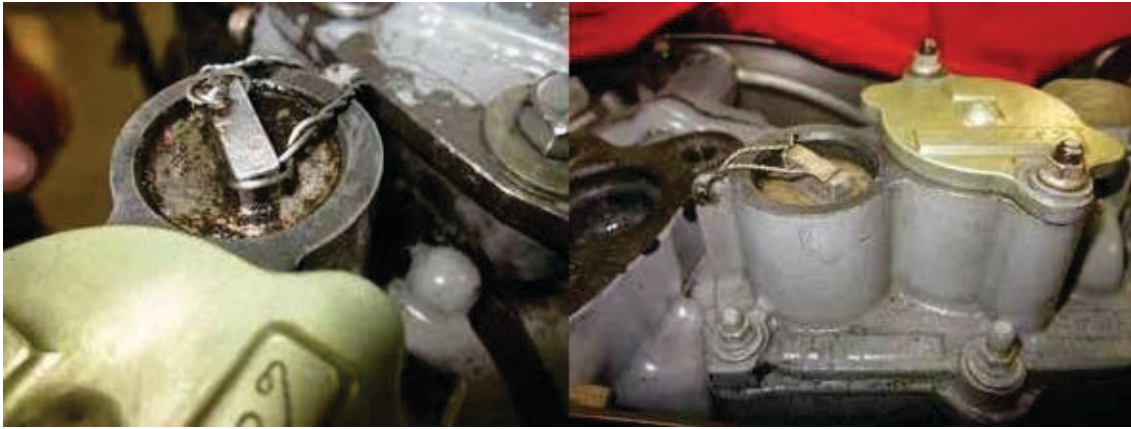
Figure 16, Oil Pressure Regulator (N405MR) Figure 17, Regulator set to nominal setting

The module was disassembled as well on 7/11/13. During an over view of the gearbox it was noted that the oil pressure regulator had a setting to decrease oil pressure (Figure 16). The technician performing the tear down pointed this out to the observers. The regulator is set to nominal at approximately 5 ½ turns after bottoming out (Figure 17). The regulator is screwed in until in bottoms out and is turned out approximately 5 ½. After which, the regulator is adjusted during power plant testing to regulate the correct pressure. The technician attempted to bottom the regulator adjustment cap, in the housing, but was unsuccessful at doing so. When screwed all the way in, he was able to dislodge the plunger that is accessible from the bottom of the regulator housing.

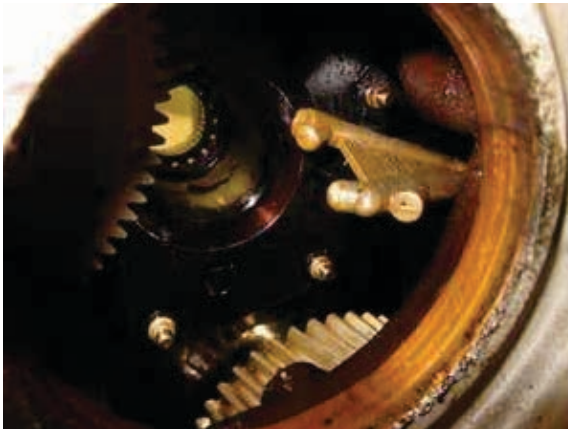
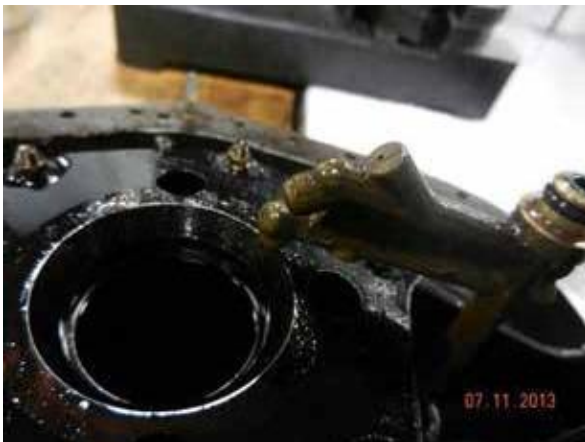
Figure 18, Piccolo Tube

Prior to separating the gearbox halves an oil flow test was accomplished. During the test it was noted that the piccolo tube (Figure 18 & 20), that supplies oil to the #2 bearing, only produced a few drops of oil. The oil should have squirted out of the tube. No visible clogs were noted. Other holes in the piccolo tube produced oil. The oil filter screen for the piccolo tube appeared to be heavily coated (Figure 19). **The piccolo tube and filter screen were taken by the NTSB for further evaluation.**

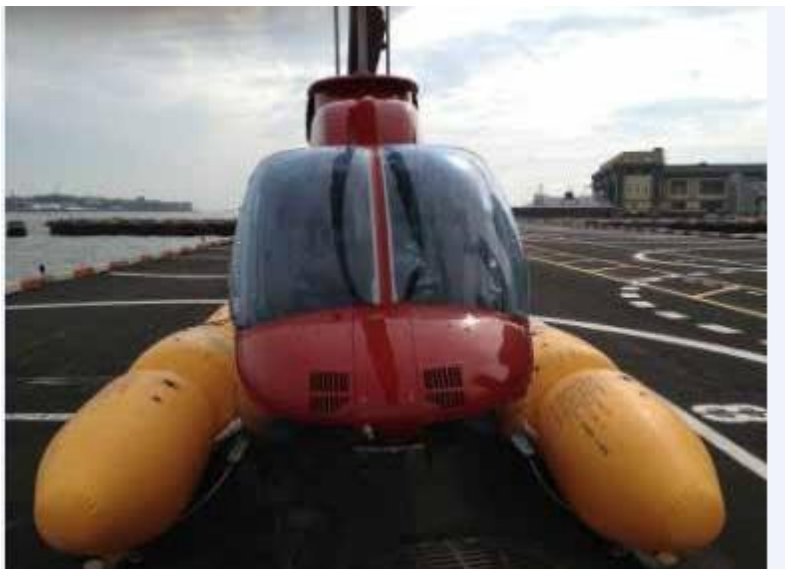
The aircraft was equipped Light weight Pop out floatation system on High Skid gear. The forward cross tube showed deflection on the right side. The float bags remained inflated and secured to the skid tubes.

Forward landing gear cross tube deflected

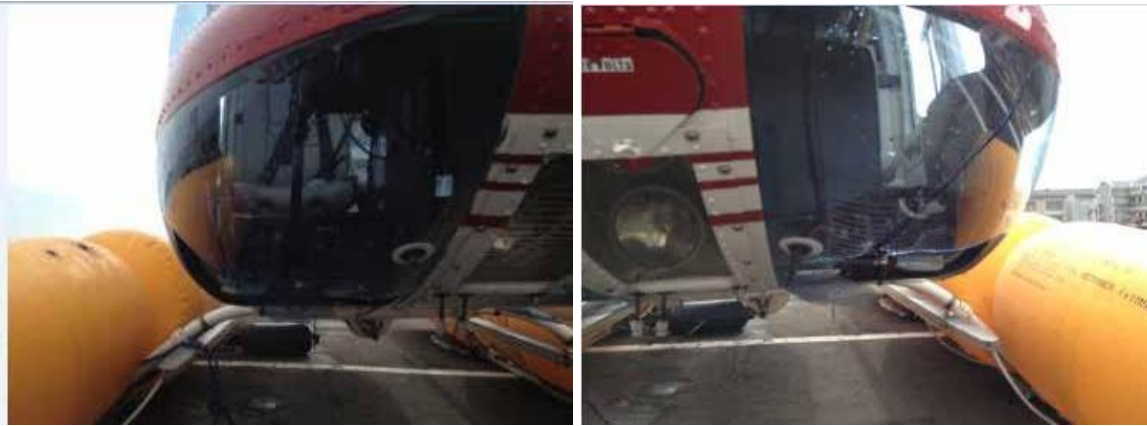
Left and Right Chin Bubble windows

The fuselage/main cabin was intact with damage to the left and right lower chin bubble windows, damage to the Transmission cowling. The Intermediate fuselage showed no signs of oil canning.

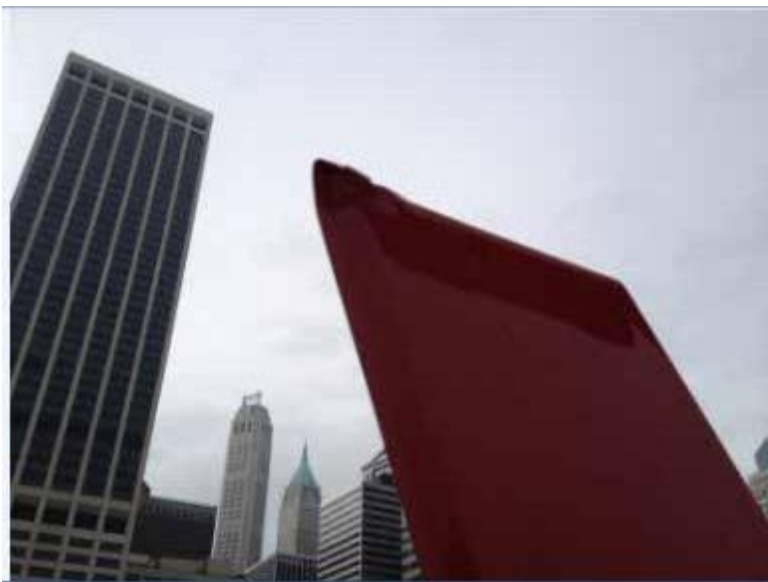
Left vertical Stabilator

The Tailboom and Tail rotor was intact with damage to the tail rotor blade due to sudden stoppage contact with the water. The left vertical stabilator had contact damage from the main rotor blade flexing downward during impact. Tailboom attachment area and Intercostal area showed no signs of deformation.

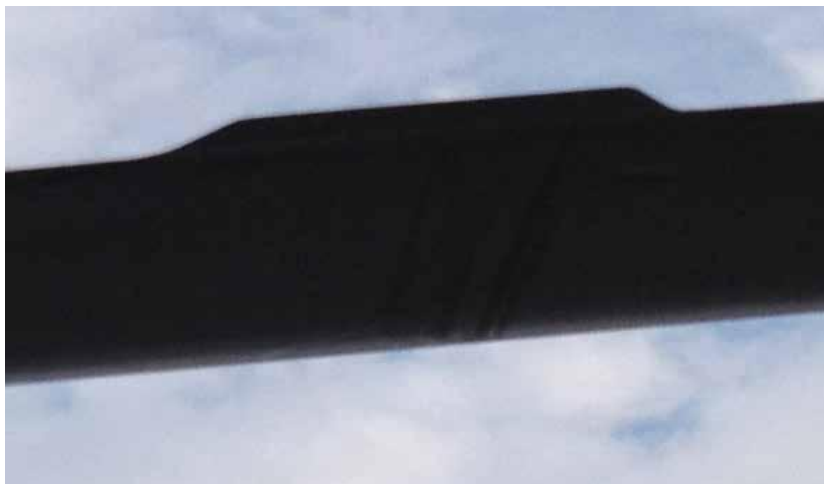
White Main Rotor Blade

The Main Rotor system was intact and did not appear to have an abnormal set, the White main rotor blade had slight contact marks in line with the contact damage to the left stabilator.
