## Inspectors Statement

My Name is Cornelius J. Baker, I am an Aviation Safety Inspector assigned to the West Columbia Flight Standards District Office. I am writing this statement on August 18, 2016 from notes and pictures taken during a visit to Champion Aerospace, LLC.

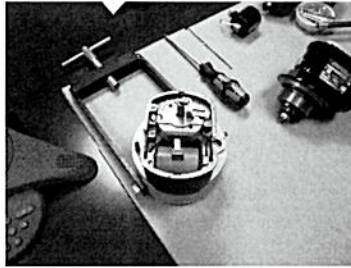
On August 16, 2016 I drove to the Champion Aerospace facility in Liberty South Carolina. Meet with Joe Logie, Technical Support Manager and Alan Woods, Manager Piston & Airframe Products. The right magneto housing with coil installed, model 4201 serial number 1011091 was removed from the sealed evidence bag. The broken piece of the cover was removed.

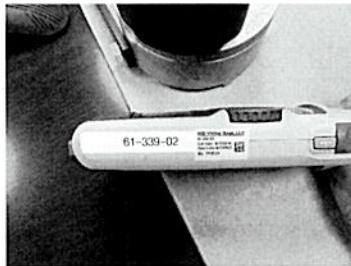
The coil was tested with a Fluke 376 True RMS Clamp meter last calibrated on June 17, 2016.

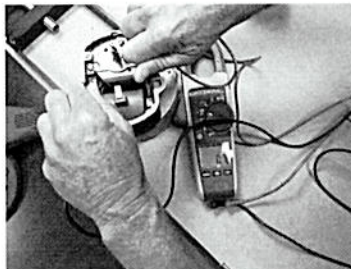
The initial readings were taken at room temperature. The primary windings were tested first and read .7 Ohms.

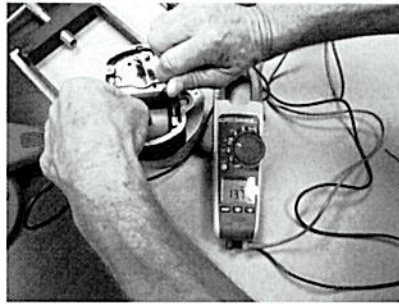
Secondary windings were then tested and read 13.71k Ohms.

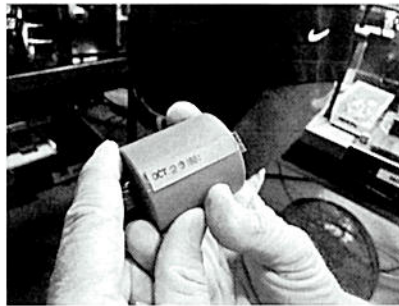
After the initial cold testing was completed the coil was removed from the housing. It had a manufacture date of October 26, 1981 ink stamped on the bottom.

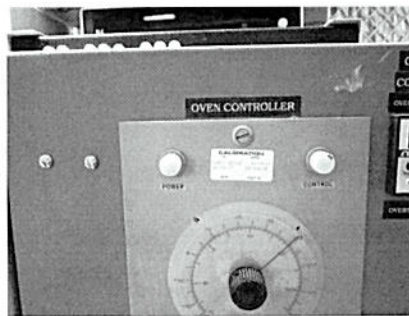
The coil was then placed in a calibrated oven at 201 degrees for 2 hours.

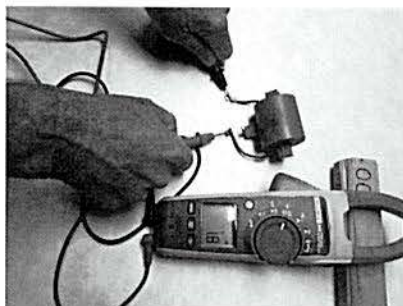
After the 2 hours the primary windings were again tested and read 1.8 Ohms.

The upper limit of the primary coil windings were .6 Ohms higher than the limit of 1.2 Ohms that is published in the maintenance manual. There is no published resistance reading for a "hot" coil that we could compare it to.

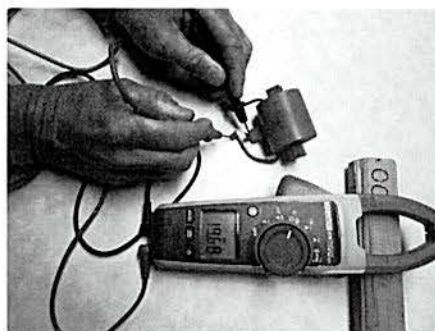
Then the secondary windings were tested and read 19.68k Ohms.
