N50690 Accident Report

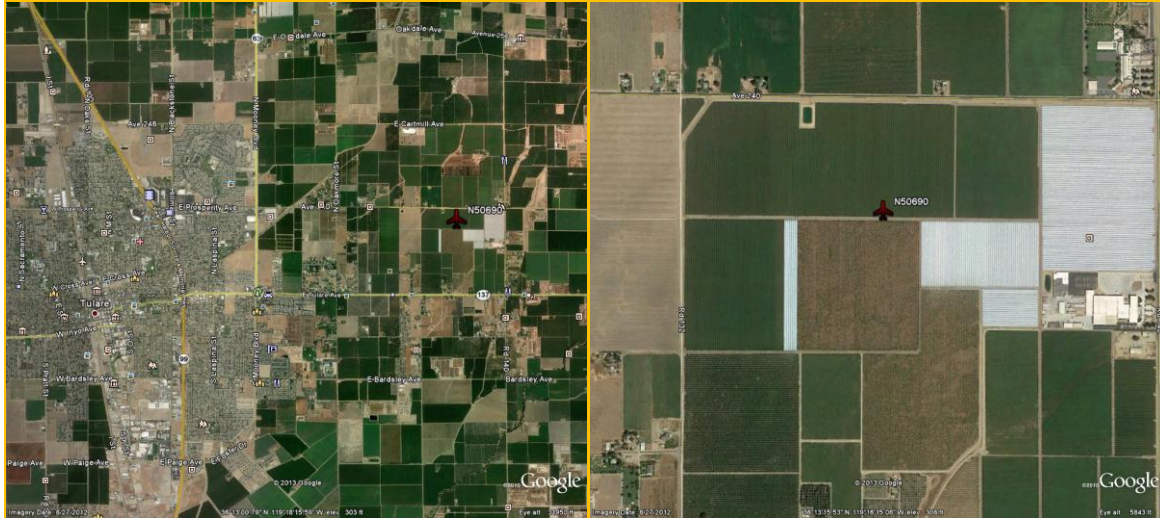
The airplane landed in an Easterly Direction on the access road and after touch down the left wing struck one of the vineyard end post's causing the aircraft to turn 90° to the left and causing significant damage to the left wing tip. Tire marks on the ground suggest the aircraft was already veering to the left after touch down.

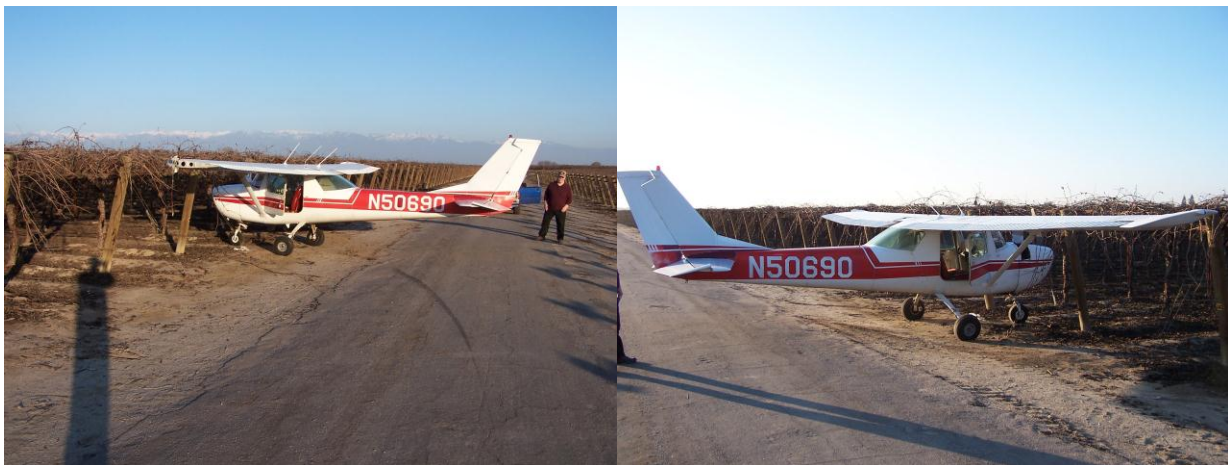
The left wings trailing edge root indicated torsion from the wing tip.

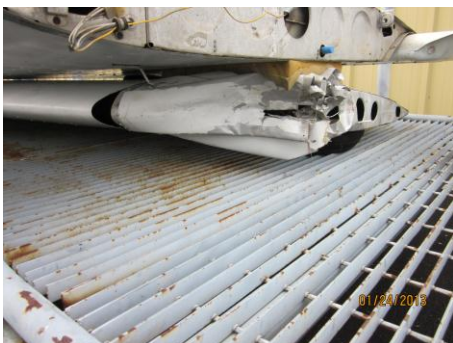
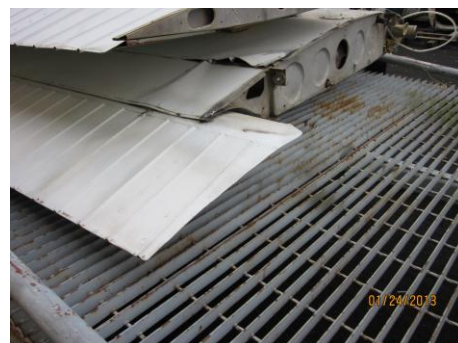
The right wing tip also sustained damage but it was not as severe as the left wing. The wing tip was removed after the accident. There were no indications of torsion on the right wing root.

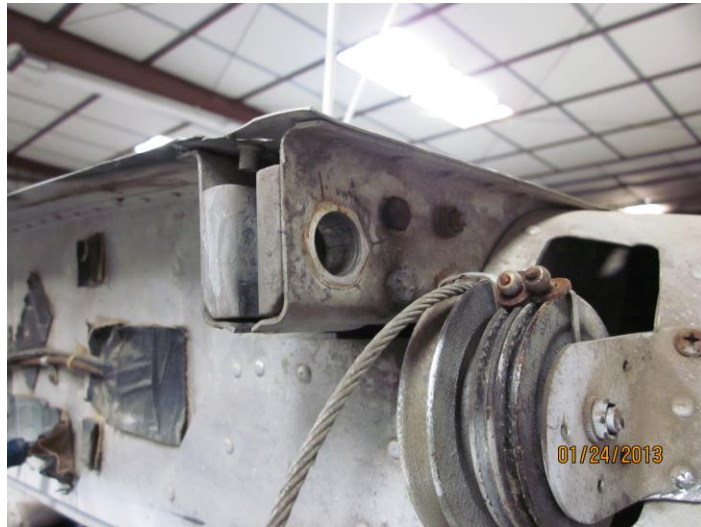
FAA Inspector Josh Brown found a cracked and deformed rear spar in the left wing. The cracked and deformed spar, by FAA standards, classified this as an accident.
