2019-11-23/N28037/8Y6
CLEAR LAKE, MN

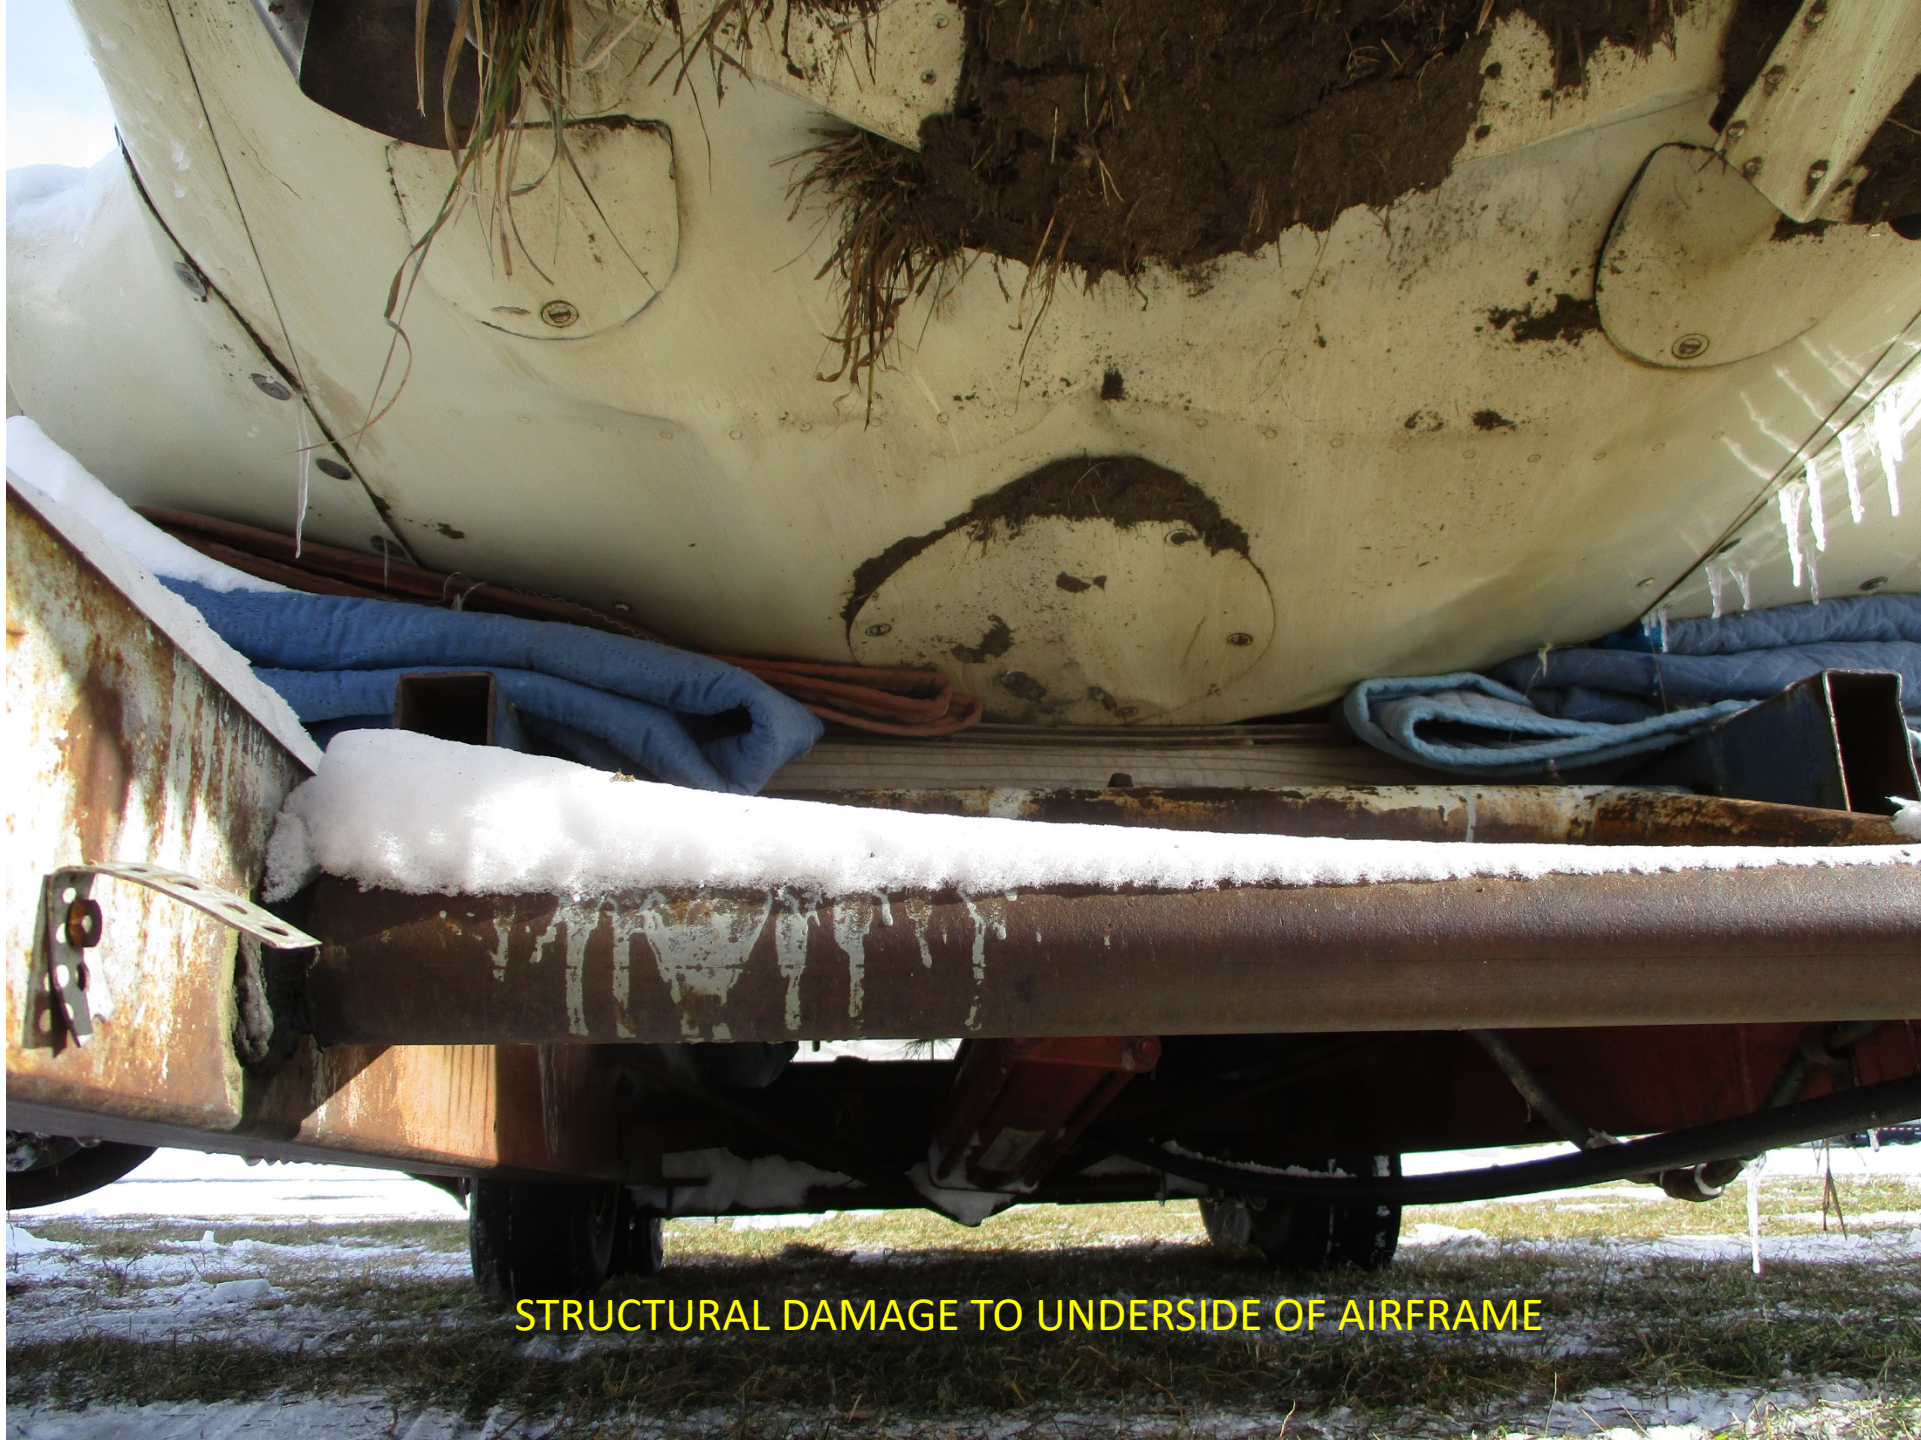
STRUCTURAL DAMAGE TO UNDERSIDE OF AIRFRAME

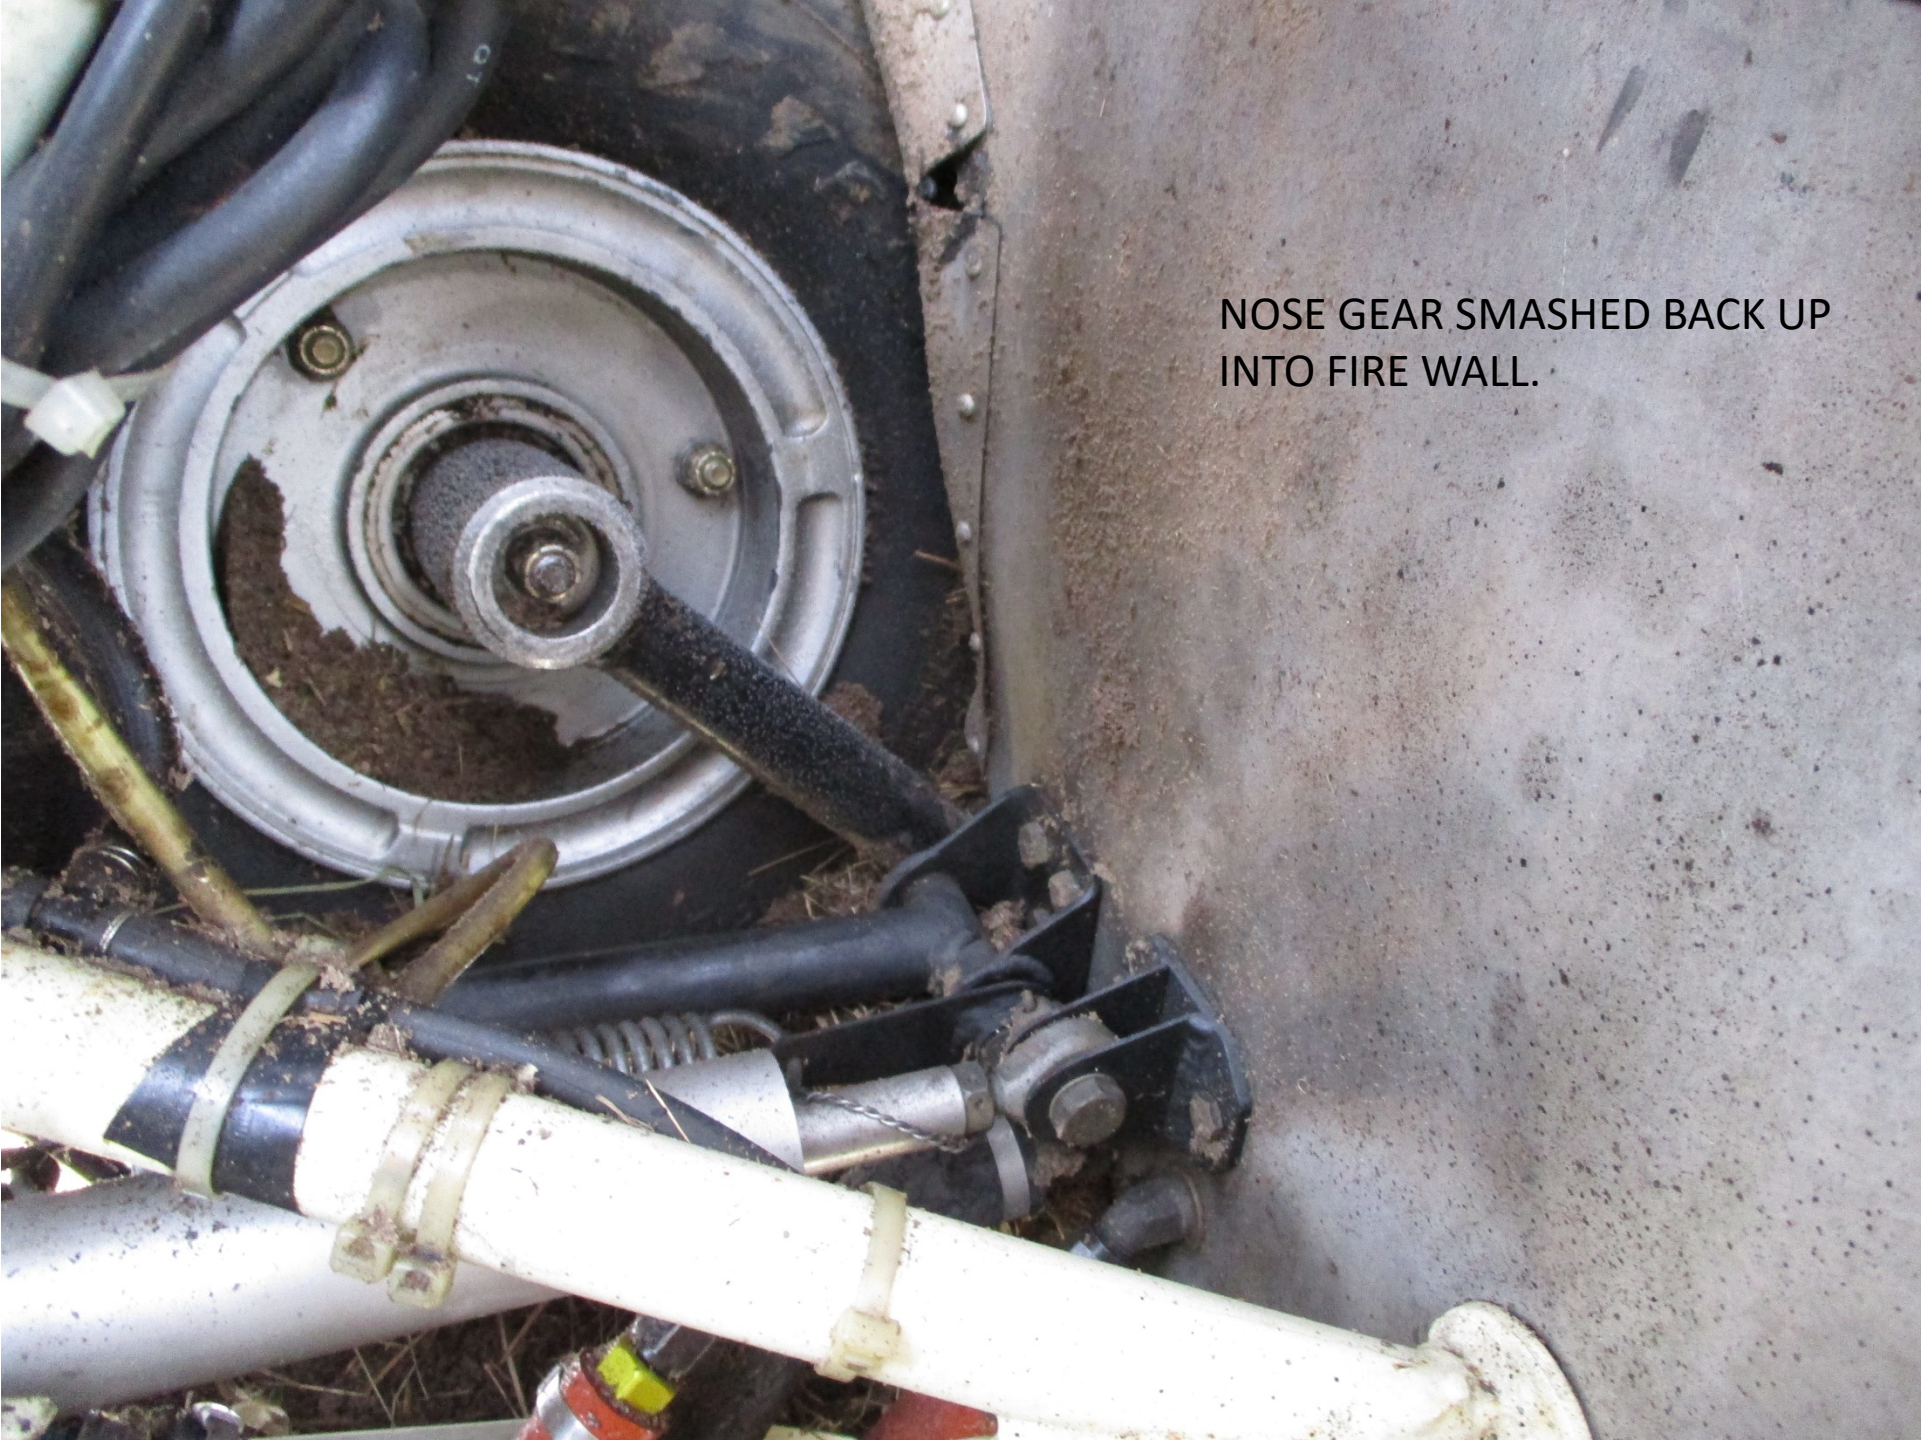
NOSE GEAR SMASHED BACK UP
INTO FIRE WALL.
