U.S. Department  
of Transportation  
**Federal Aviation  
Administration**

SAFO 08013  
DATE: 5/29/08

**Subject:** Safety Recommendation Concerning Piper PA-23 and PA-31 Series Nose Baggage Doors

## Supplement to Safety Alert for Operators (SAFO) #08013

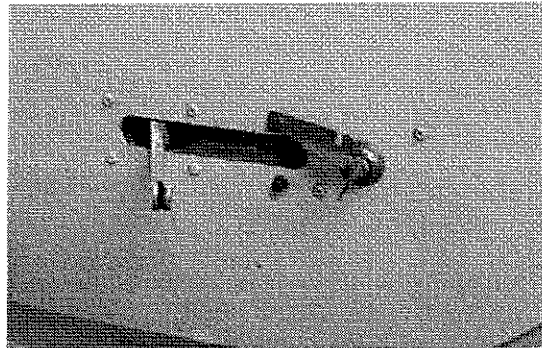
There is no evidence of an STC or Form 337 approving this modification in the aircraft airworthiness records in Oklahoma City.

A. Yes, Anchorage Aircraft Certification Office (ACO) reports that other Alaskan operators have adapted the latch modification pictured below.

4. Make sure latch and lock mechanisms conform to original type design and are in a condition for safe operation.

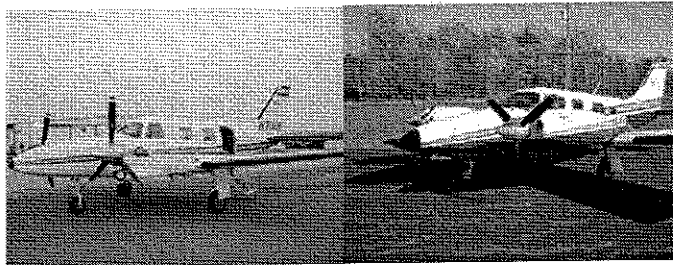
- A. Yes, the PA-42 Cheyenne aircraft have almost identical latching/locking mechanisms. The PA-34 Seneca is similar but uses a rotating handle and bayonet pins rather than a retracting lever and latching arms.

Piper PA-42 Cheyenne

Piper PA-34 Seneca

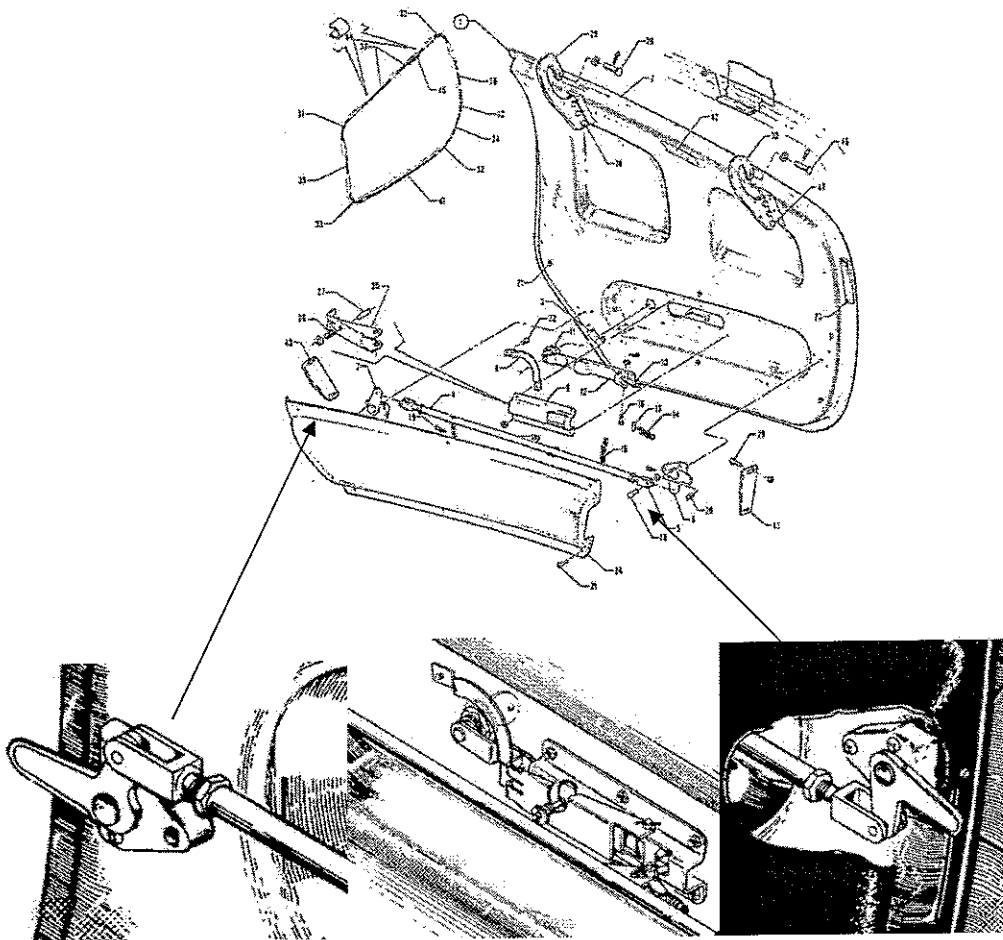
In the closed and locked position, the door is secured from opening at 4 locations; 2 gooseneck hinges at the top, and 2 arm assemblies, one at each end of the door (see drawing below). Each arm assembly (installed in the door) has a locking tab that makes contact pressure against the edge of a corresponding fuselage-mounted baggage door plate.

To open the door, a key is inserted into the lock assembly, and turned clockwise. This action rotates a cam plate in the lock assembly clear of the slot in the baggage door handle. The baggage door handle is now free to move. The operator first pushes on the forward part of the handle, which pivots the aft end of the handle outward. The operator then pulls outward on the aft end of the baggage door handle, which is now free to pivot about the handle center. This lever action causes the forward portion of the baggage door handle to rotate inward and aft, and consequently, also causes the baggage door latch tube assembly to move and release the locking tabs.
