Federal Aviation
Administration

ZODIAC CH 601 XL AIRPLANE SPECIAL REVIEW TEAM REPORT JANUARY 2010

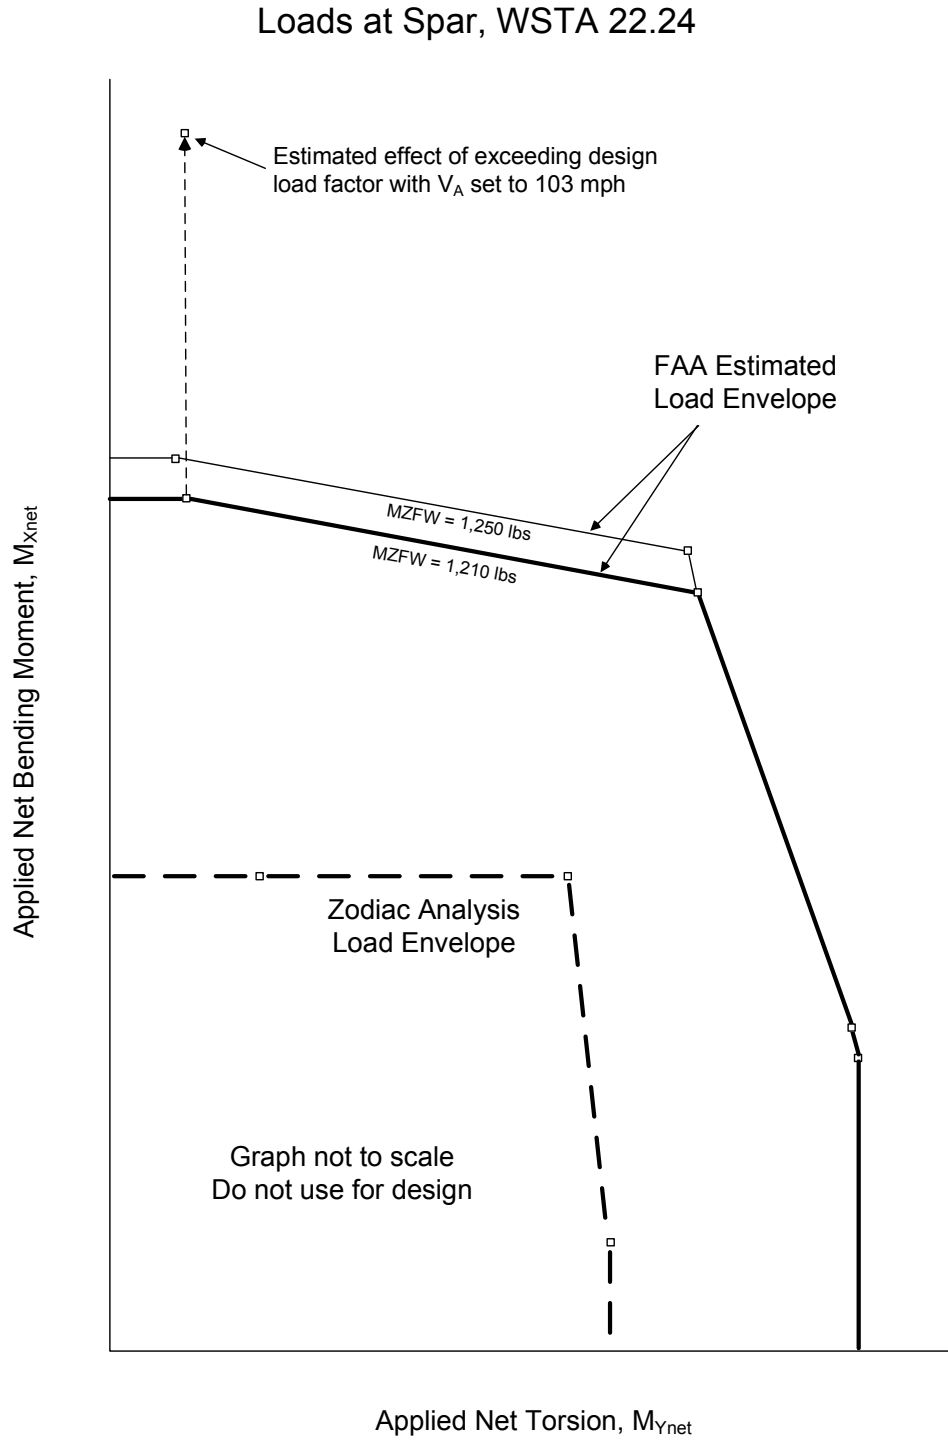
Figure 1: Comparison of FAA Estimated Loads with 'Zodiac CH 601 XL Stress Analysis and Tests'

The FAA initially focused on the methods used by the manufacturer to estimate wing design loads. We reviewed the structural loads analysis included in the report ‘Zodiac CH 601XLSA Stress Analysis and Tests’, available from the manufacturer. Our review focused on whether the manufacturer’s structural loads analysis complied with ASTM International F 2245-08a and if the ASTM standard is adequate to ensure an acceptable margin of safety. We limited our review to the analysis of the wing since the accidents of concern involved wing failure.

- The amount of lift produced by the portion of the wing planform covered by the fuselage. The manufacturer’s analysis assumes the wing planform covered by the fuselage is as effective in producing lift as an adjacent portion of exposed wing planform. This assumption may not be conservative and may be noncompliant with the ASTM F 2245 § 5.1.1.2 requirement that ‘...these loads must be distributed to conservatively approximate or closely represent actual conditions.’

- The correct definition of the maximum zero fuel weight (MZFW). The manufacturer’s analysis defines the MZFW as the maximum takeoff weight (MTOW) minus full fuel. This definition is incorrect. The intent of the MZFW is to design the wing for the condition where airplane weight is at a maximum but the wing fuel tanks are only partially full. Because the fuel load is alleviating for wing bending loads, using the proper fuel load to determine MZFW is important.

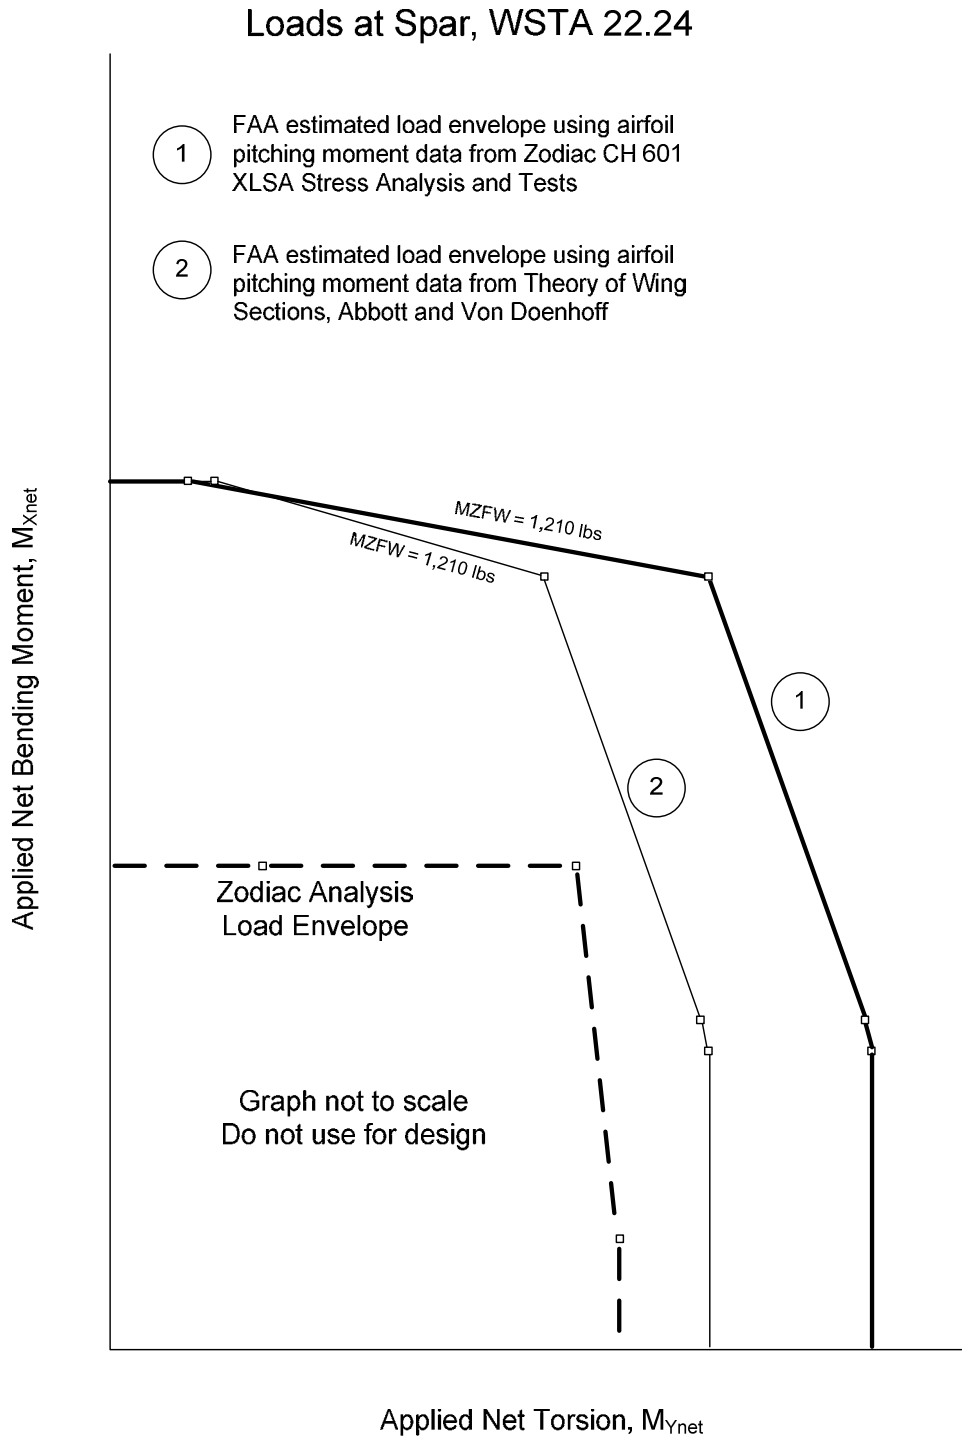
Figure 2: Effect of Pitching Moment Characteristics on Wing Design Loads

- The correct value for the maneuvering speed, V_A . The manufacturer determined V_A to be 90 knots (103) mph based on a stall speed, V_S , of 44 knots (51 mph). However, the manufacturer's flight test report documents a measured stall speed of 43 knots (49 mph). In addition, the flight test report did not appear to contain proper temperature corrections to convert the measured data to standard atmospheric conditions. Using data in the manufacturer's CH 601 XL flight test report and correcting to standard conditions reduces the stall speed to 41 knots (47 mph), resulting in a V_A of only 82 knots (94 mph). Using a V_A of 90 knots (103 mph) instead of 82 knots (94 mph), a pilot could inadvertently reach 4.8g instead of the intended 4.0g at V_A . The critical importance and intent of V_A is stated in FAA publication FAA-H-8083-3A Airplane Flying Handbook. The handbook defines the design maneuvering speed as the "...maximum speed at which the airplane can be stalled or full available aerodynamic control will not exceed the airplane's limit load factor. At or below this speed, the airplane will usually stall before the limit load factor can be exceeded." Operating below V_A can prevent overstressing the structure from purposeful pitch control inputs, and from vertical gusts from all but the most extreme turbulence. Pilots expect not to be able to exceed the design limit load factor at or below V_A . Unknowingly operating at speeds above the proper maneuvering speed may cause pilots to inadvertently exceed the design limit load factor, particularly at aft center of gravity where stick forces are known to be light and stick force gradients flatten out.

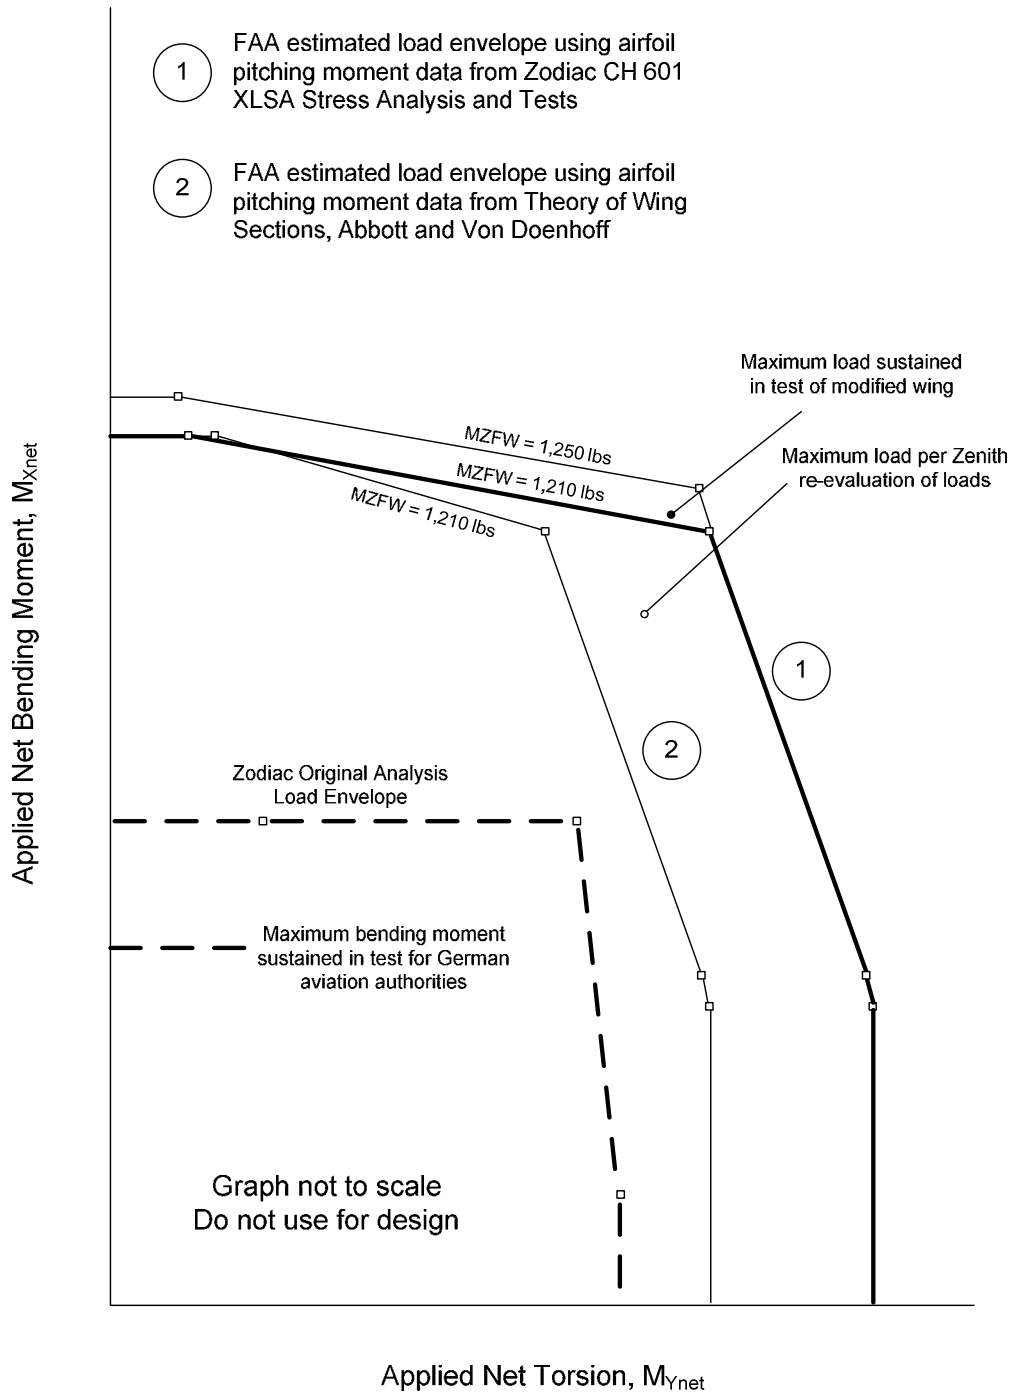
Figure 3: Revised Zodiac Analysis and Static Test Wing Design Loads

The manufacturer successfully tested the modified wing structure to loads higher than determined in their revised analysis. The wing structure did not fail at the ultimate test loads. However, the wing attachment bolts were bent and the attachment bolt holes were elongated, indicating there was permanent damage to the structure at these loads. We have depicted the loads from the manufacturer's revised analysis and static test in figure 3.

Despite disagreeing with our position on several significant issues, the maximum bending moment achieved in the static test is only a few percent below our estimated maximum required bending moment. The maximum torsion load achieved in the test may only be a few percent below our estimated maximum torsion provided the manufacturer can justify the airfoil pitching moment data with applicable test data. It is possible that if the manufacturer had continued the static test to structural failure, the ultimate test load could have equaled or exceeded FAA estimates of the required load envelope.

- The manufacturer stopped the static test of the modified structure approximately five percent below the FAA’s load estimates required for ASTM compliance. At the time of this report, the manufacturer was continuing to make modifications to the wing structure and the drawings referenced by the safety directive to provide further improvements. The manufacturer should consider additional structural testing and analysis once a final design is reached to demonstrate the new wing meets the ASTM standards.

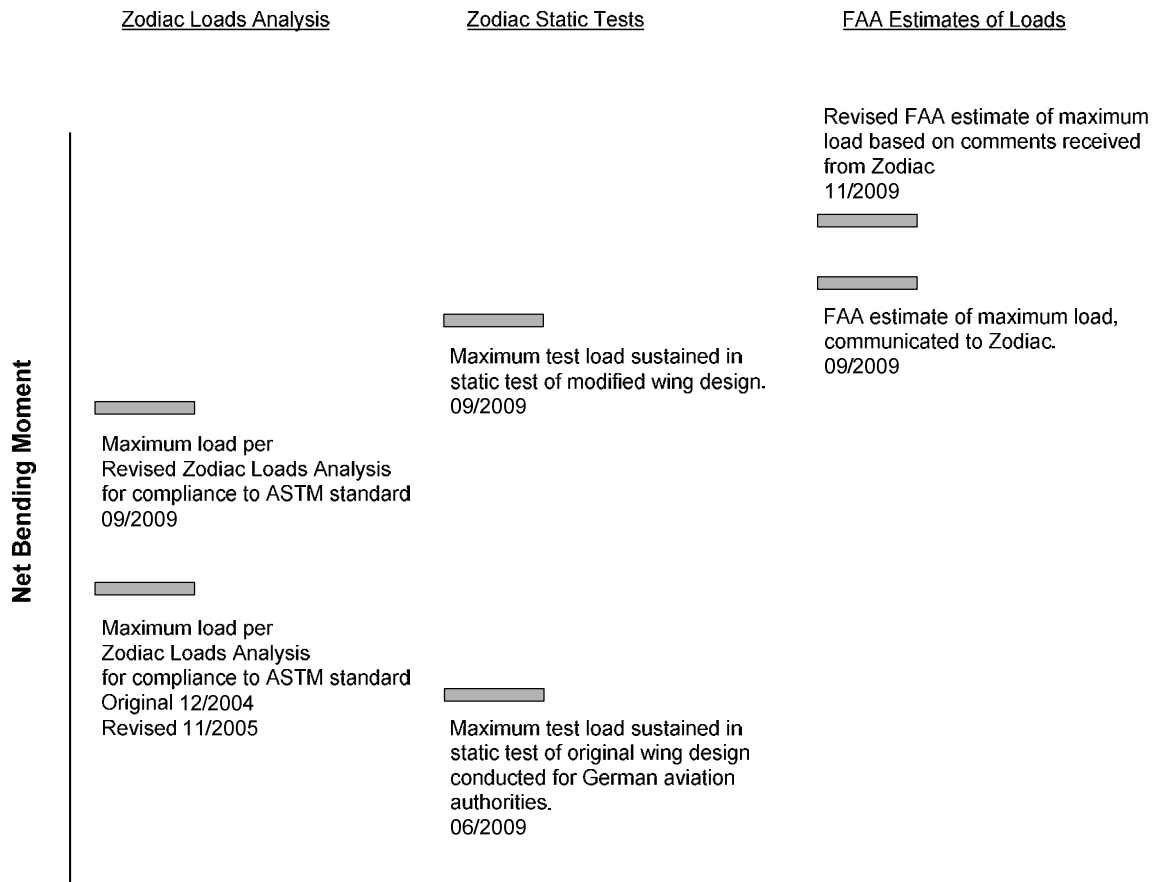
Figure 4: History of Zodiac Wing Structural Loads Analysis and Tests

Figure 4 presents a history of the manufacturer's loads analysis and static testing. We provide this information to provide a time line of the manufacturer's structural analysis and testing.

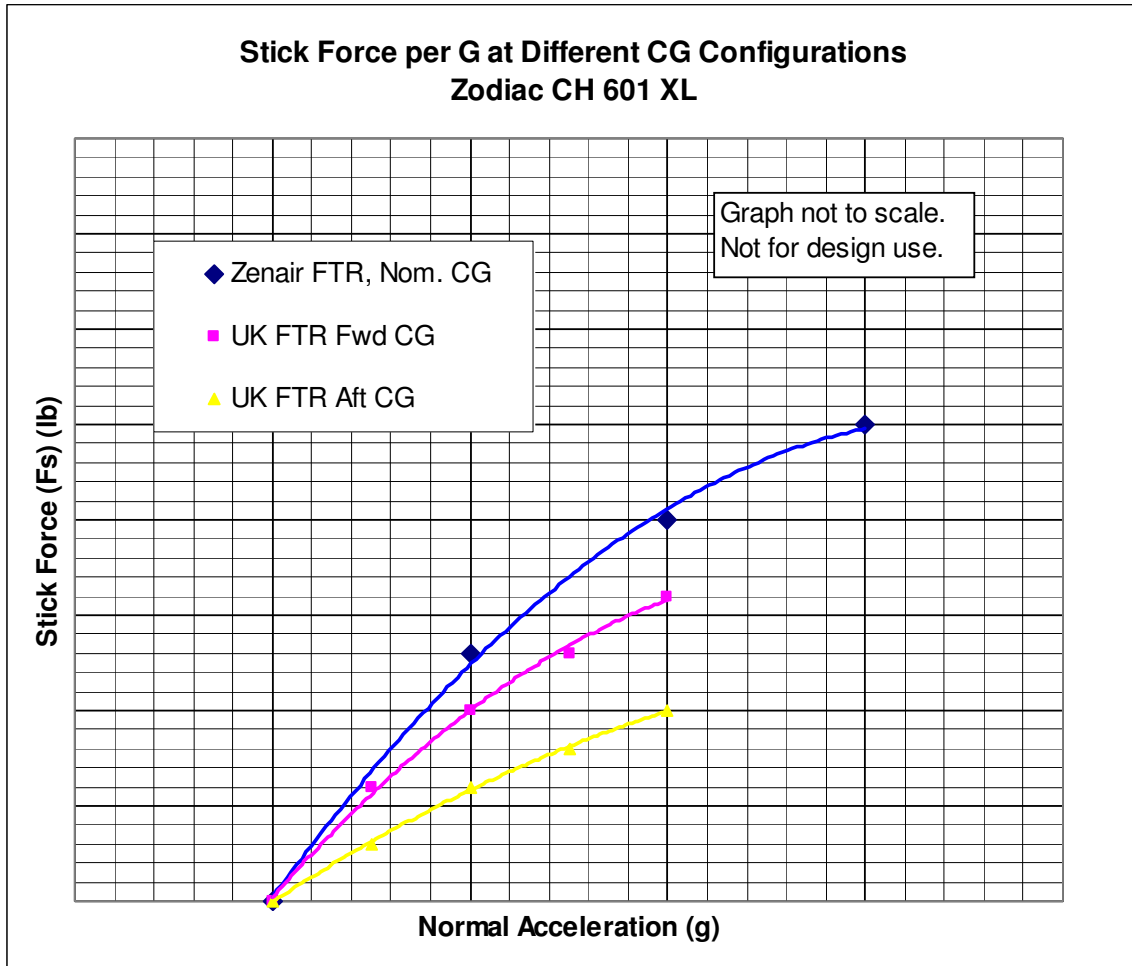
Figure 5: CH 601 XL Stick Force per g Evaluation

A manufacturer's flight test report dated November 2005 was used as the primary source of data for the FAA to evaluate the stick-force characteristics of the CH 601 XL against the FAA accepted version of the ASTM International, F 2245-07a, 4.5.2.2. The results were also compared to 14 CFR Part 23 § 23.155. The FAA found the manufacturer's Flight Test Report data is compliant with the ASTM standard. Although not required to comply with 14 CFR part 23, we found the data also meets the standards of 14 CFR Part 23 § 23.155(a) and (c).

The NTSB recommended testing the aircraft stick force per g at maximum aft center of gravity. However, there is no regulatory requirement for testing in this configuration in either the ASTM standard or in 14 CFR Part 23 § 23.155. For reference, the FAA's applicable guidance in AC 23-8B recommend testing at aft heavy and light center of gravity configurations to verify proper control forces.

Though not required to do so, it appears their tests followed the guidance provided by AC 23-8B. However, when applying this guidance to aft center of gravity data to match compliance with 14 CFR Part 23 § 23.155(a), Figure 5 shows the stick force at limit load appears to extrapolate to a value slightly less than the 15 pound minimum requirement at limit load. Though the CH 601 XL does not have to comply with 14 CFR Part 23, the data does indicate that stick force gradients may not be acceptable for aircraft that are intentionally or unintentionally flown outside the POH center of gravity limits. This is simply presented for regulatory comparison, as 14 CFR Part 23 § 23.155(a) is not currently reflected in the ASTM standards at any center of gravity configuration.

- The current ASTM Standard F2245, 4.5.2.2 is actually more stringent than its 14 CFR Part 23 § 23.155(c) counterpart and may remain unchanged.
- The ASTM standard does not currently require a minimum control force at the limit load factor. ASTM International should amend their standards to require a minimum control force at limit load factor, similar to concepts defined in 14 CFR Part 23 § 23.155(a).

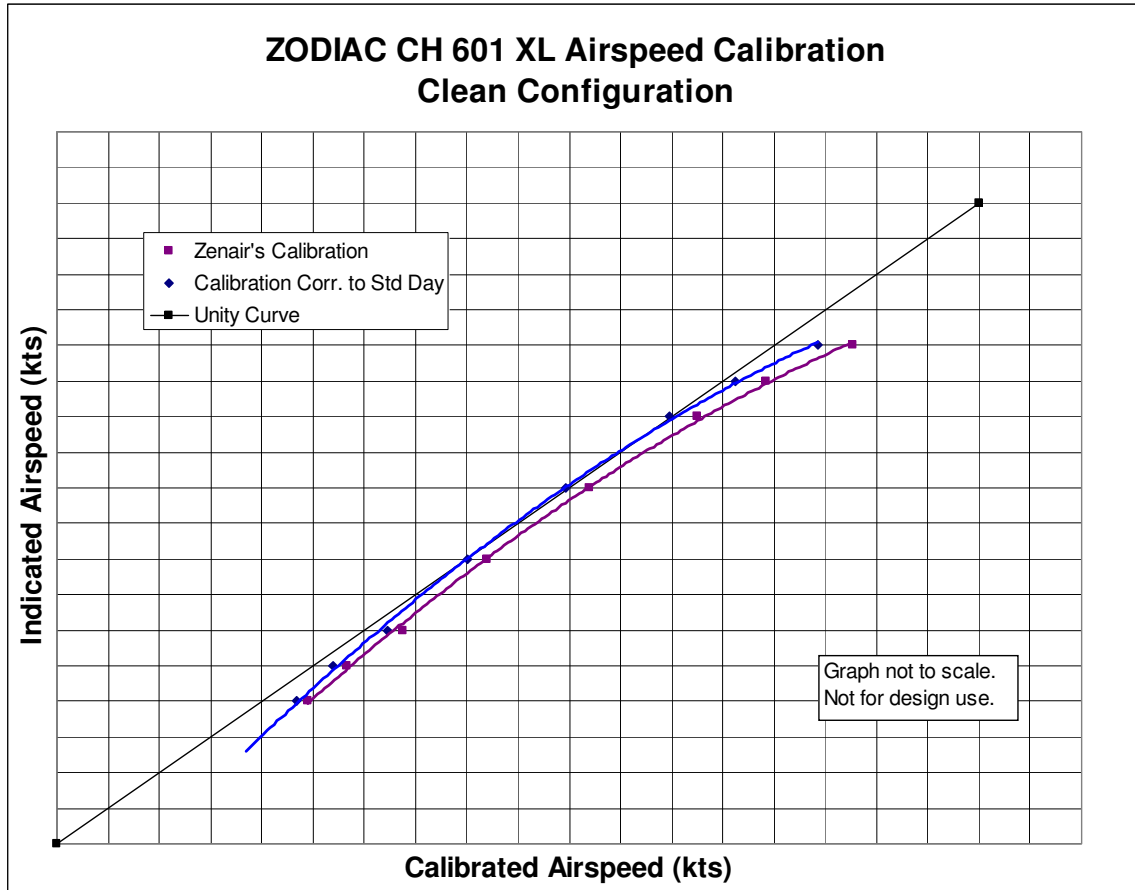
Figure 6: Standard Day Correction Effects on CH 601 XL Airspeed Calibration

Regarding stall speed, the manufacturer's flight test report determined the flaps up stall speed to be 35 knots indicated airspeed (KIAS) (40 mph) which was reported as 43 knots calibrated airspeed (KCAS) (50 mph). In reality, it was 43 knots true airspeed (KTAS) (49 mph), which after correcting to standard day conditions; the stall speed is calculated to be 41 KCAS (47 mph). The manufacturer's Airplane Flight Manual (AFM) reported a 43 knot (49 mph) flaps up stall speed indicating that standard day corrections were not applied to the flight test data.

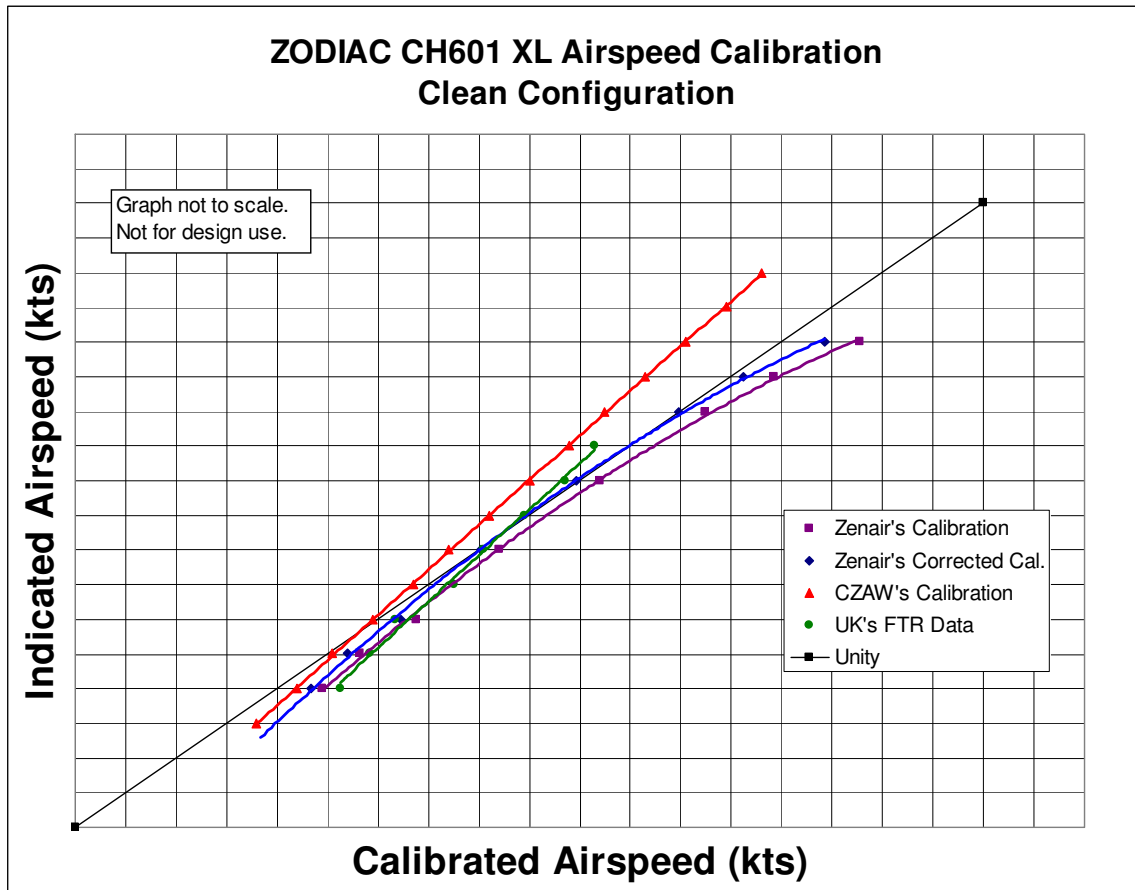
Figure 7: Zodiac CH 601 XL Airspeed Calibration Comparison

A comparison was made between CZAW and the manufacturer's airspeed calibrations. The calibrations were substantially different in both shape and magnitude. Without the flight test report, it is impossible to say which calibration is correct assuming that both designs are identical. Therefore, the potential to overspeed the aircraft exists. However, as part of the UK LAA flutter mitigation flight test program, an airspeed calibration was conducted and the results were overlaid with those from the manufacturer and CZAW, as seen in Figure 7. (Note: We have removed the actual airspeed values from figures 6 through 8 to protect the manufacturer's proprietary information and data.)

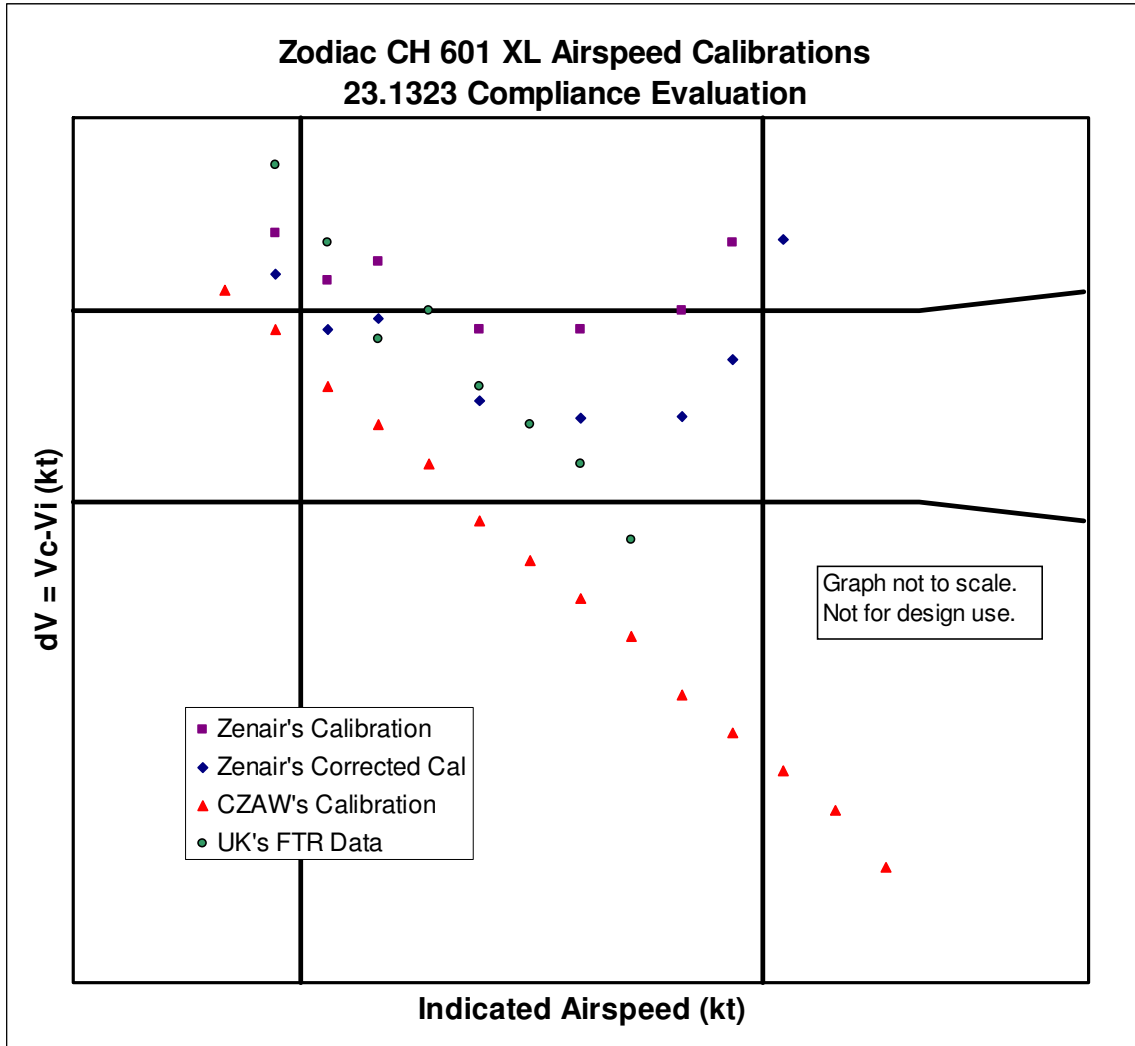
Figure 8: Zodiac Airspeed Calibration Evaluation per 14 CFR Part 23 § 23.1323(b)

The UK LAA's flight test results are similar in magnitude to the manufacturer's data, but trend with CZAW's data making the comparison inconclusive. Using a different approach to determine the validity of the calibration data, a 14 CFR Part 23 § 23.1323(b) analysis was performed on these data sets and shown graphically in Figure 8. It should be

To evaluate the airspeed error per 14 CFR Part 23 § 23.1323(b), the error dV , must be less than ± 5 knots or 3% bounded by a lower airspeed of $1.3V_{S1}$ to a maximum airspeed of V_{NE} . Using the manufacturer's values, this means that to meet 14 CFR Part 23 § 23.1323(b), all the applicable data needs to fall in the enclosed ± 5 knot rectangle.

With these criteria in mind, the manufacturer's original calibration did not meet 14 CFR Part 23 § 23.1323 until after correcting for standard day temperature conditions. For comparison, neither CZAW nor the UK LAA's data meets 14 CFR Part 23 § 23.1323, though they are not required to do so. However it is unusual for a low speed aircraft like the CH 601 XL to need a -24 knot static source error correction, indicating a potential error in the calibration methods used. If corrected improperly, this large airspeed error could translate into approximately a 2.8g load difference at maneuver speed for the CH 601 XL and CH 650. This evaluation suggests the need for an ASTM standard similar to
