SUMMARY OF FINDINGS

NTSB Accident Number: WPR13LA093

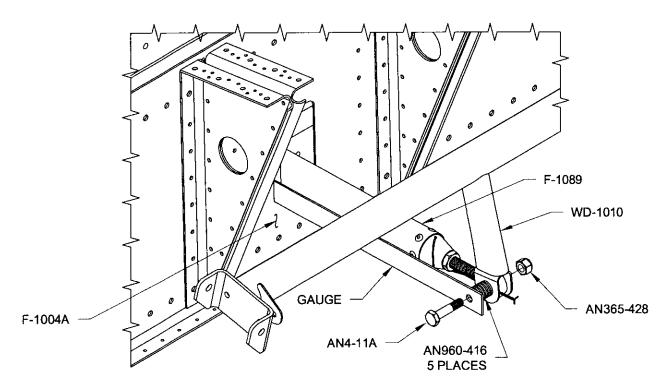
FIGURE 2: CONTROL COLUMN NEUTRAL POSITION

Step 2: Check the neutral position of the WD-1010 Control Column. Clamp the F-635 Elevator Bellcrank in its neutral position. See Page 11-7. Insert an AN4 bolt through the gauge. Lower the gauge and bolt into the tunnel and slip the bolt through the control column center clevis pinning the F-1089 Elevator Pushrod (Fwd) as shown in Figure 2. When the aft end of the gauge is butted up against the F-1004A Center Section Bulkhead the control column is in its neutral position. Adjust the F-1089 and/or F-1090 Elevator Pushrod lengths if/as required to move the control column to its neutral position.

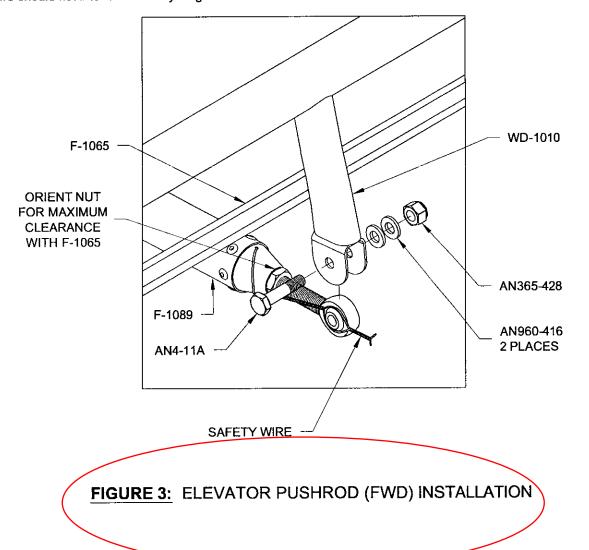
Step 3: Bolt the F-1089 Elevator Pushrod Assembly to the WD-1010 Control Column using the hardware shown in Figure 3. The loop in the safety wire goes aroung the bearing, passing between the rod end housing and the WD-1010 Control Column clevis and is captured by the AN4 bolt as shown in Figure 3. The safety wire should not interfere with anything at this connection.
