**Submission to the
National Transportation Safety Board**

Ravn Connect Flight 3153 Accident
Cessna 208B; N208SD
Togiak, Alaska; October 2, 2016

Case No. ANC17MA001; *Ravn Connect Flight 3153*;

NTSB Aircraft Accident Investigation Case No. ANC17MA001
Ravn Connect Flight 3153; October 2, 2016; Togiak, Alaska

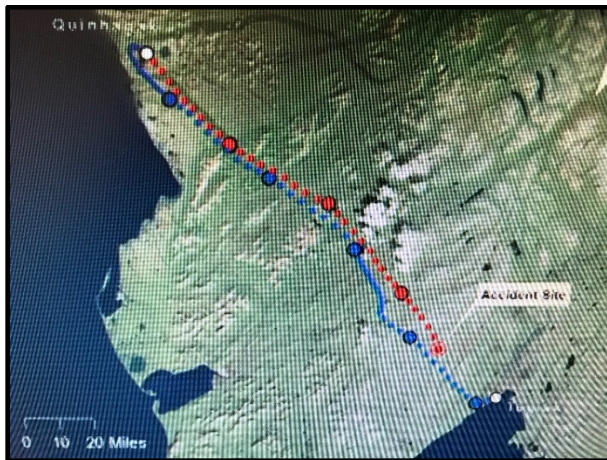
Another Hageland flight had also departed Quinhagak for Togiak about 10 minutes after flight 3153 and chose a longer, more southern route which allowed it to remain over lower terrain. As depicted in Figure 1 below in the blue track, the second airplane was slightly west of the track of the accident flight and deviated around the mountain where the accident occurred.³ Visual meteorological conditions (VMC) prevailed at the Togiak Airport, and company flight following procedures were in effect. However, as discussed later on page 4, the weather conditions at the accident site likely included cloud obscuration and low visibility.

Figure 1: Flight tracks of accident aircraft (in red), and another company flight that departed about 5 minutes later (in blue) which took a more southern track over lower terrain.

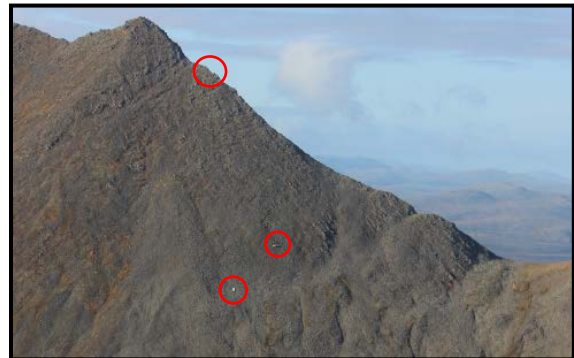
initial impact site on the top of the ridge is about 200 feet below the estimated 2,500-foot peak (see Figures 2 and 3 below).² Witness marks on the vertical speed indicator showed a steep rate of climb.

Figure 2: View of the opposite side of the mountain that was impacted by the accident airplane. Initial impact is denoted by the top circle (opposite side).

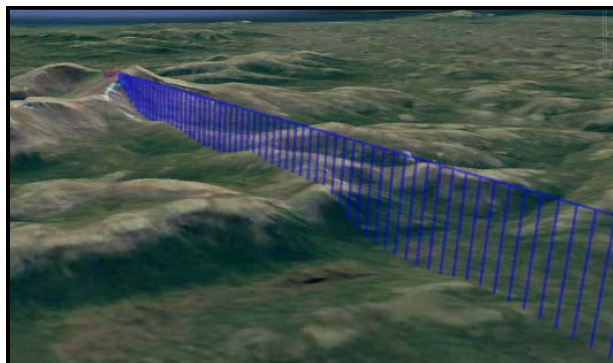
Figure 3: Flight track of accident airplane assuming direct line from last recorded spider track to impact site. (Source: Honeywell)

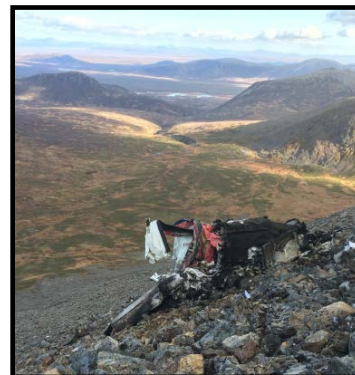
Figure 4: A portion of the airplane wreckage as found on the accident site.

No evidence was found to indicate any pre-impact mechanical malfunctions with the engine or airframe. Calculations made using an estimated passenger weight of 200 lbs., and assuming no cargo on board, indicate that the airplane's weight and center-of-gravity were within operating limitations set by the airplane manufacturer.

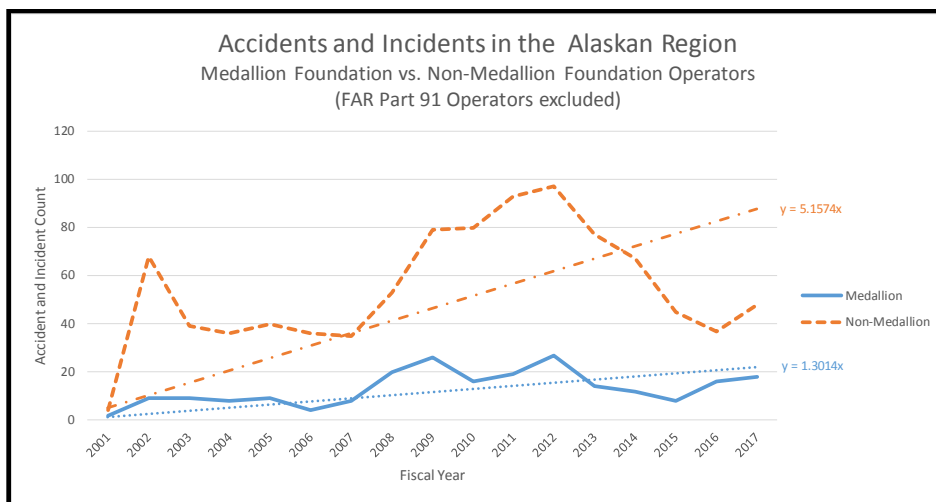
The analysis of the data indicate an increasing trend of the total number of all three report types among both Medallion and Non-Medallion commercial operators in the Alaskan Region since 2001.²³ One of the data runs that were plotted, shown below, was performed with only the accidents and incidents, because “occurrences” do not all necessarily relate to a safety risk.²⁴ This analysis indicates a data trend of a lower rate of increase of accidents and incident reports for **Medallion Operators** versus **Non-Medallion Operators**.²⁵

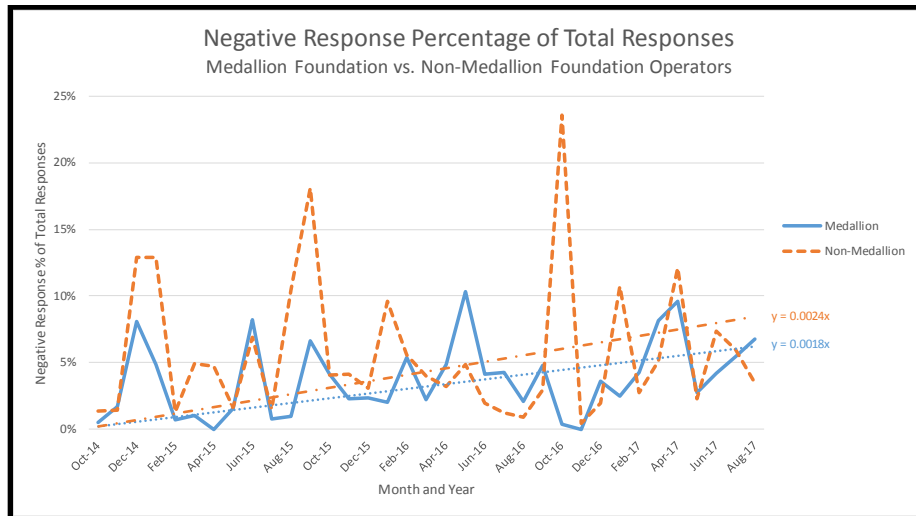
plotted for both Medallion and Non-Medallion operators in Alaska. The plot, shown below, indicates a generally increasing trend among both groups; however, since the introduction of SAS, negative responses as a percentage of total responses show a *lower rate of increase for Medallion Operators* versus *Non-Medallion Operators* (blue linear trend line is lower than orange). Additionally, the Medallion members appear much more consistent than the Non-Medallion Operators.²⁶

Finding 7: When taken in the aggregate, surveillance data for air carriers who are Medallion Foundation members indicate that they have a higher safety performance (i.e. lower risk indications) than those air carriers who are not members of Medallion.
