Date: March 14, 2017
To: Tim Sorensen, NTSB
From: Jay Boyle, Williams Int'l
Subject: Repair and NVM Report for FADEC SN CL11AW1879 and CL11AW1890

Disassembly, Inspection and Repair Notes for CL11AW1890 on Engine SN 211156 of Plane 525C-0072

Disassembly, Inspection and Repair Notes for CL11AW1879 on Engine SN 211155 from Plane 525C-0072

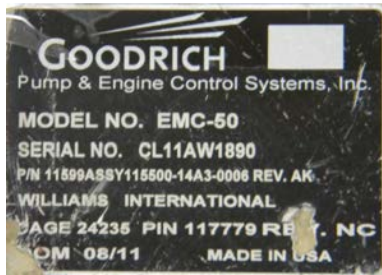
FADEC cables from the EMT Communication harness (TL-221207) were connected to CL11AW1890 with a little resistance from the damage to the pins. The FADEC was powered and the Non-Volatile Memory (NVM) data was downloaded using the Williams International Engine Maintenance Terminal WI_EMT (TL-110961) into file 525C-0072_2017-03-09_1419.einfo. This file shows that the FADEC serial number stored in the NVM is CL11AW1894. However, below is the actual label showing that the correct serial number of the FADEC is CL11AW1890. The value that is stored in NVM is an input by the user via the WI_EMT at the time of installing the FADEC. Therefore, the discrepancy with the actual serial number is indicating a user error when entering the serial number into NVM during the installation of this FADEC.
