Subject: Boeing Flight Simulations and FDR Data Analysis – National Air Cargo 747-400 N949CA Takeoff Accident at Bagram AFB, Afghanistan- 29 April 2013

Boeing Flight Simulations and FDR Data Analysis – National Air Cargo 747-400
N949CA Takeoff Accident at Bagram AFB, Afghanistan- 29 April 2013

Summary

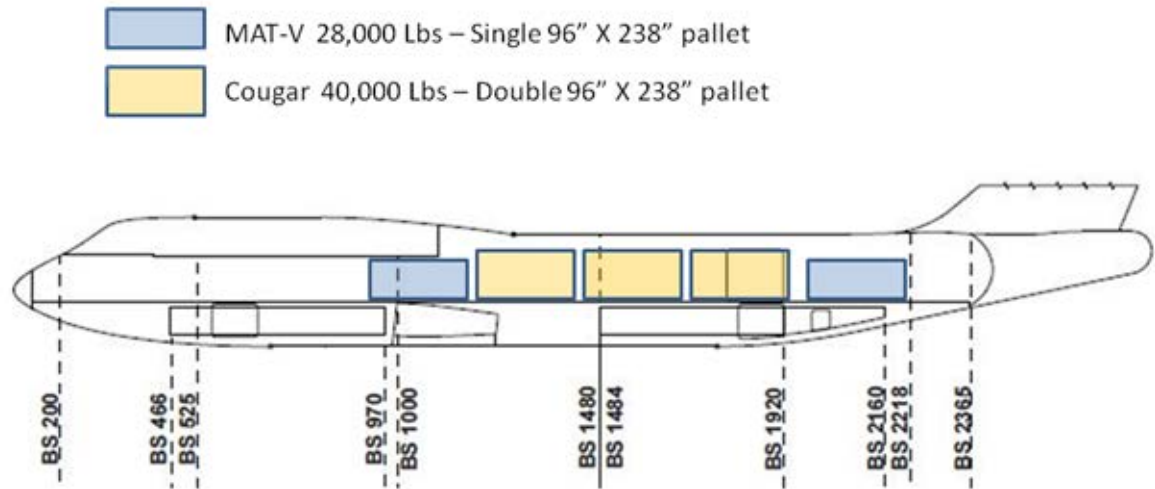
Graphic 1 - MRAP Loading Configuration on RT075

carried Cougars (see Graphic 1 for MRAP loading configuration). The crew members consisted of 4 flight crew, 2 mechanics, and 1 loadmaster.

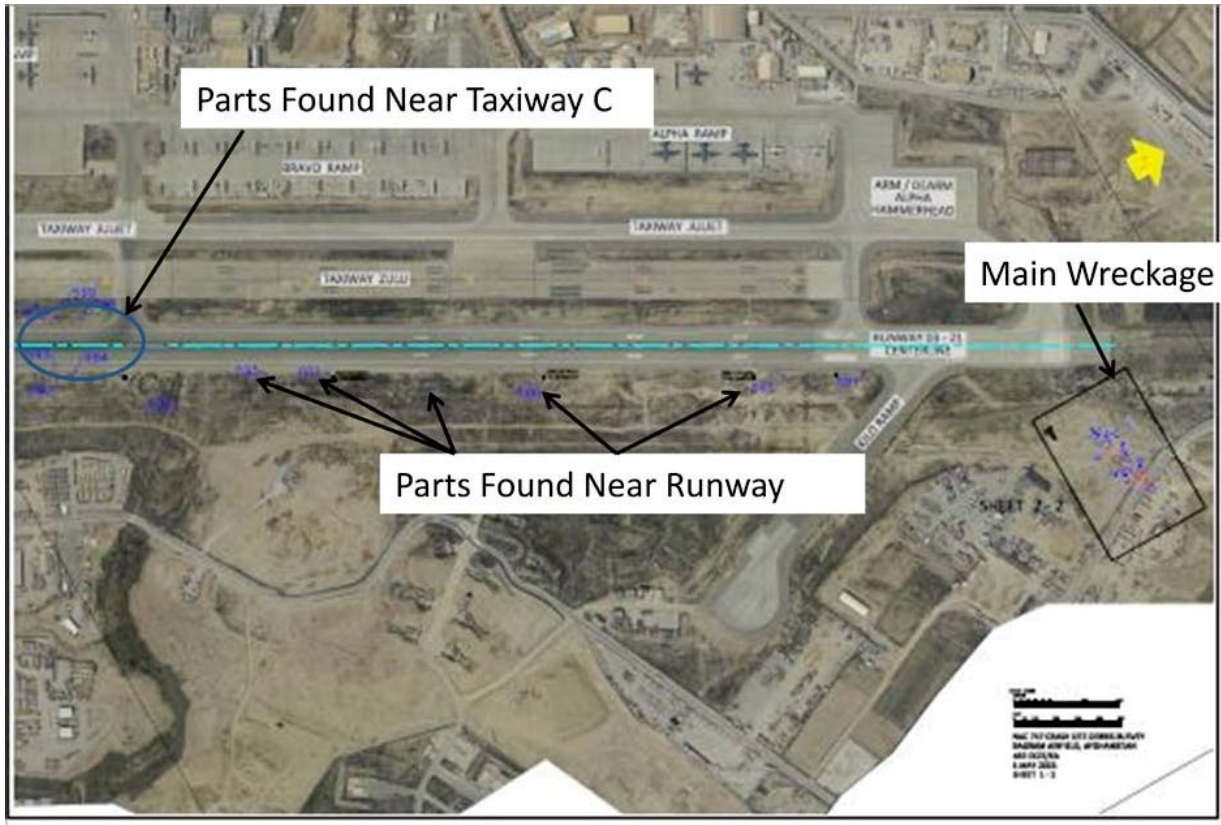
Graphic 2 – Location of Parts Found On or Near Runway

- Engines show high Revolutions Per Minute (RPMs) at impact
- Runway sweep found parts on runway near lift-off zone and all along flight path (see Graphic 2)
- Many of the parts on the runway were associated with Hydraulic System #2, so Hydraulic System #2 was suspected to have been compromised at or after lift-off (for reference,

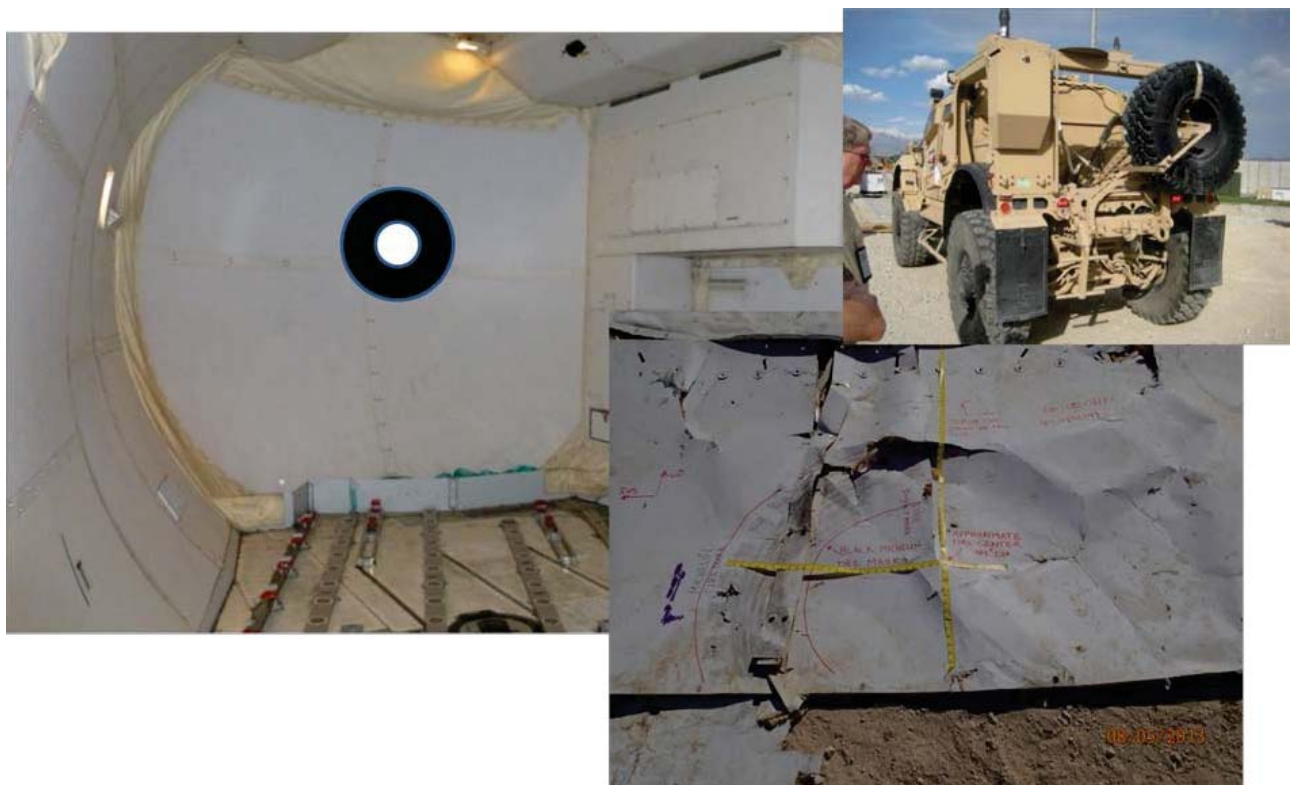
Graphic 3 – Spare Tire Imprint

Additionally, there were several findings associated with the aft pressure bulkhead, the aft-most MAT-V, and the remaining stabilizer structure. There was a tire imprint towards the center apex of the aft pressure bulkhead. It aligned with the location of the MAT-V spare tire that is situated at the rear of the vehicle (refer to Graphic 3 and 4). Graphic 3 shows a picture of the back of a MAT-V, a picture of the actual tire imprint on the aft pressure bulkhead, and a depiction of the tire relative to the cargo hold and aft pressure bulkhead. Another piece of evidence was the presence of orange paint marks on the rear side of the aft-most MAT-V (see Graphic 4). The orange paint on that structure appeared to match the orange paint from the FDR encasing. A depiction is shown in Graphic 4 that approximates the dimensions (including rear spare tire) of the aft-most MAT-V and its location within the cargo hold. Given the FDR/CVR recording failure, the discovery of airplane parts in the lift-off zone, the orange paint transfer from the FDR, and the spare tire imprint on the aft pressure bulkhead, this evidence supports the conclusion that at least the aft-most MAT-V broke loose from its restraints and moved aft during lift-off.

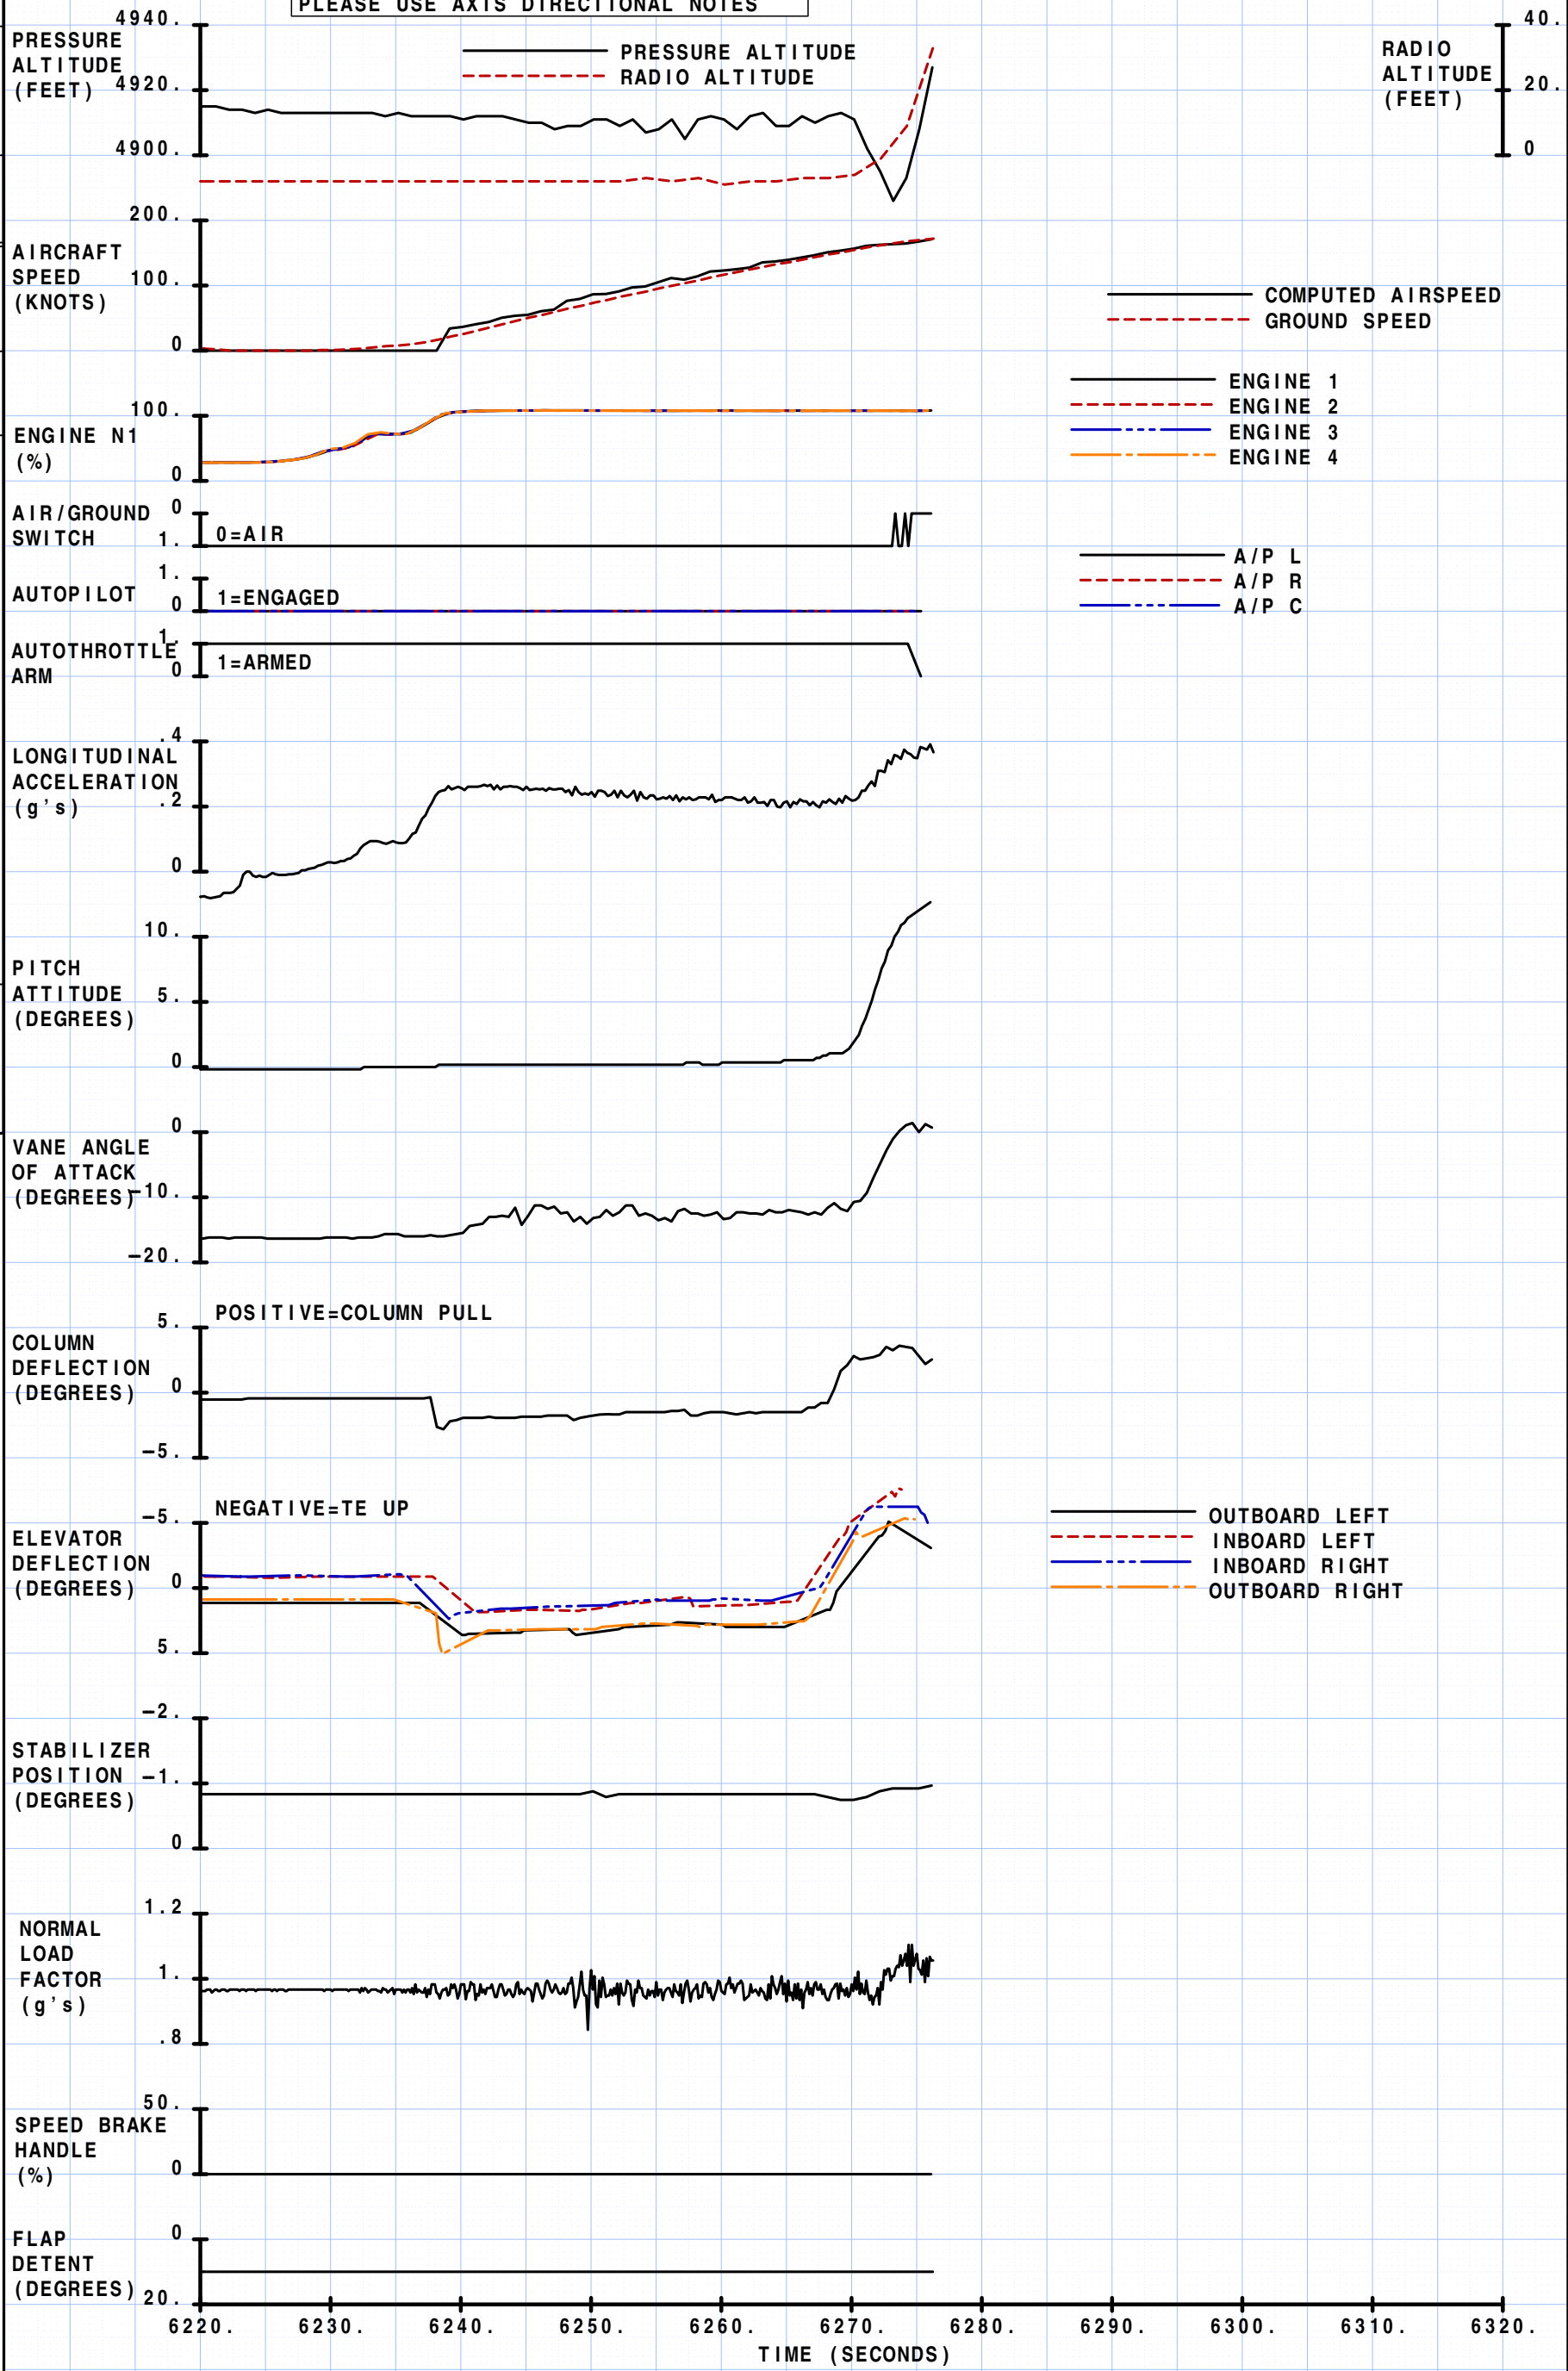
CALC	AERODYNAMICS	07MAY13	REVISID	DATE	MUA 747-400BCF ACCIDENT AFTER TAKEOFF	RT075
CHECK					29APR13 -- TIME-ALIGNED FDR DATA	
APPD					LONGITUDINAL PARAMETERS	FIGURE 1
APPD

The FDR data show the airplane configured for a flaps 10 takeoff with a recorded stabilizer setting of approximately -0.85 degrees (3.85 units) [Figure 1]. The recorded takeoff gross weight was approximately 676,000 pounds. However, Boeing Weights Engineering Group analysis indicated the actual gross weight should have been approximately 685,000 pounds when accounting for the pallets and tie-down straps used to restrain the MRAPs. Therefore, a gross weight of 685,000 pounds was used for all subsequent analyses. Maximum takeoff thrust was used (engine N1 = 108 percent). Slight left rudder, on average, was commanded during the takeoff roll to maintain runway centerline (Figure 2).

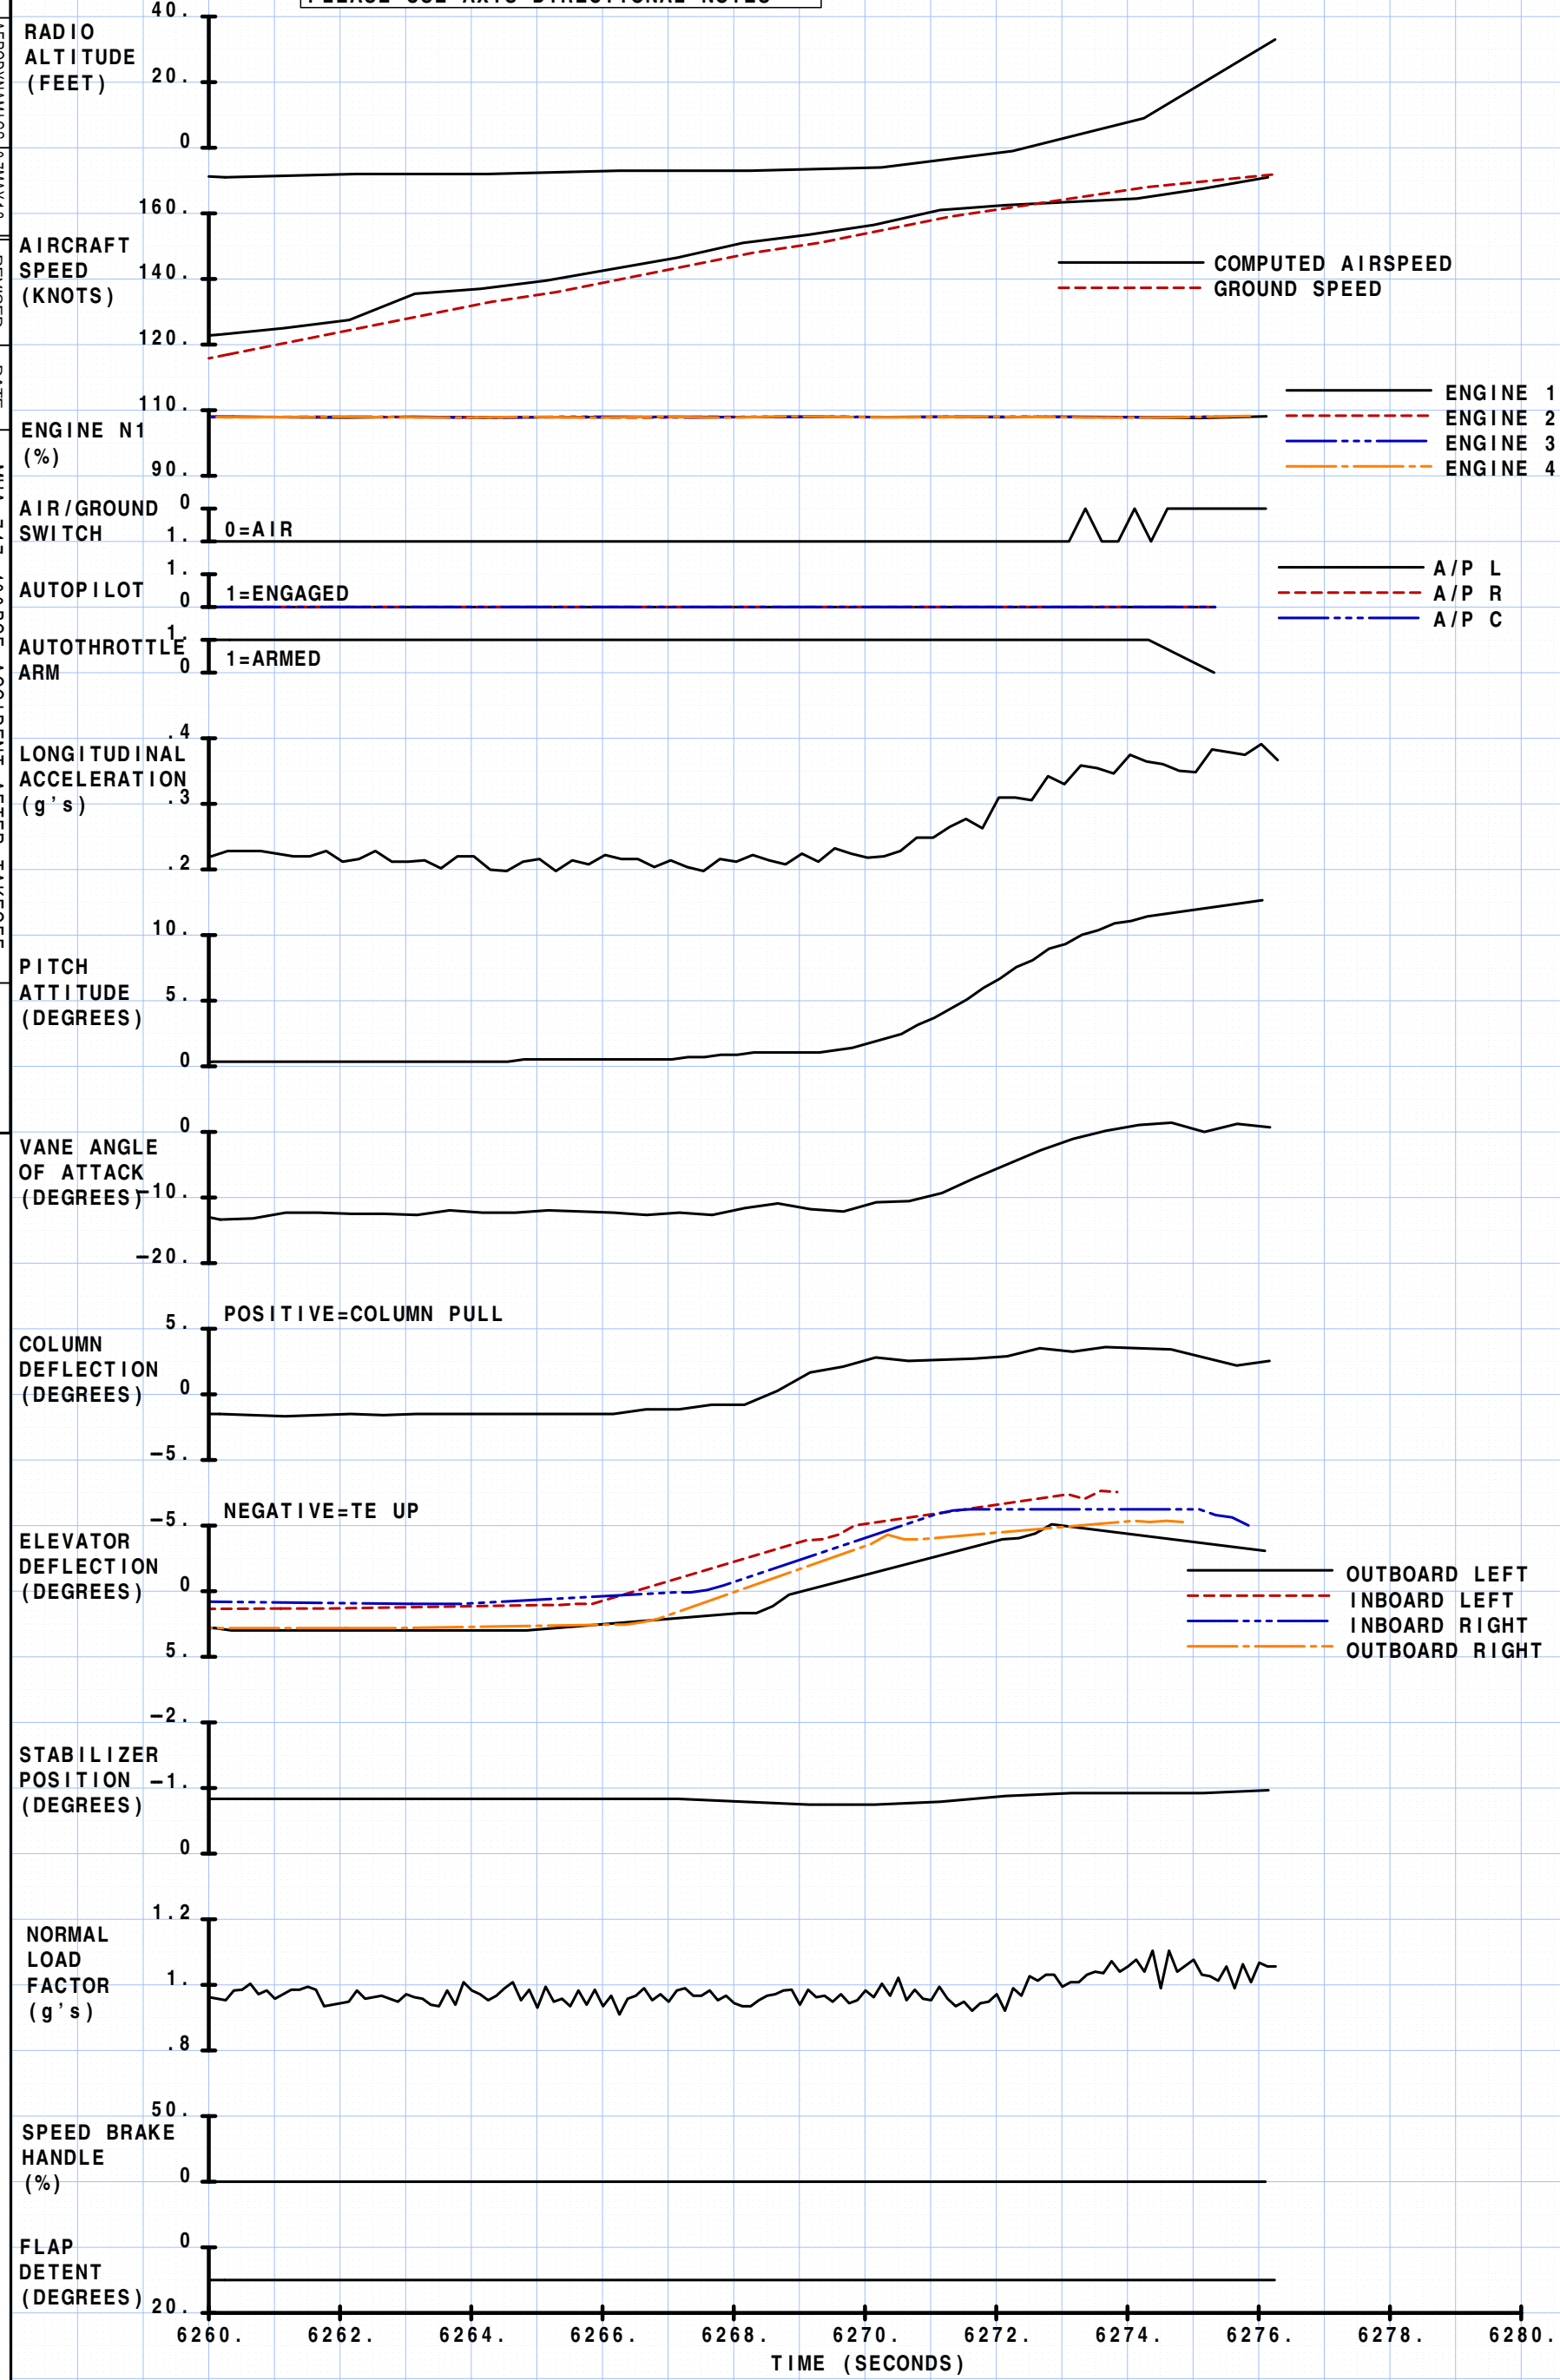
CALC	AERODYNAMICS	07MAY13	REVISED	DATE	MUA 747-400BCF ACCIDENT AFTER TAKEOFF	RT075
CHECK					29APR13 -- TIME-ALIGNED FDR DATA	
APPD					LONGITUDINAL PARAMETERS, ROTATION ZOOM	FIGURE
APPD						3

Fluctuations in computed airspeed were observed during the takeoff roll and were consistent with gusty wind conditions (Figures 3 and 4). Rotation was initiated with a nose-up column input around time 6268.5 seconds, and the airplane rotated to a normal takeoff pitch attitude (Figure 3). The air/ground discrete momentarily changed state to “air” twice before lift-off occurred at approximately time 6274.5 seconds. Valid data end approximately 2 seconds after lift-off (~ time 6276.3 seconds). Additional data were available beyond time 6276.3 seconds (approximately 3.5 seconds), but these data were determined to be invalid and therefore were not included in the plots.

The valid data end with the airplane at 33 feet radio altitude and 171 knots computed airspeed (V2+4) [Figures 3 and 4]. The airplane was pitched at approximately 13 degrees and banked right at approximately 4 degrees. Elevator deflections were around 5-6 degrees Trailing Edge (TE) up when the data end. The last valid recorded wind data indicate the winds were approximately 12 knots from 40 degrees true, which differed in direction from the reported METARs (Figure 4). The left rudder used during the takeoff roll (runway magnetic heading = 27 degrees) was consistent with the recorded wind data (right crosswind).

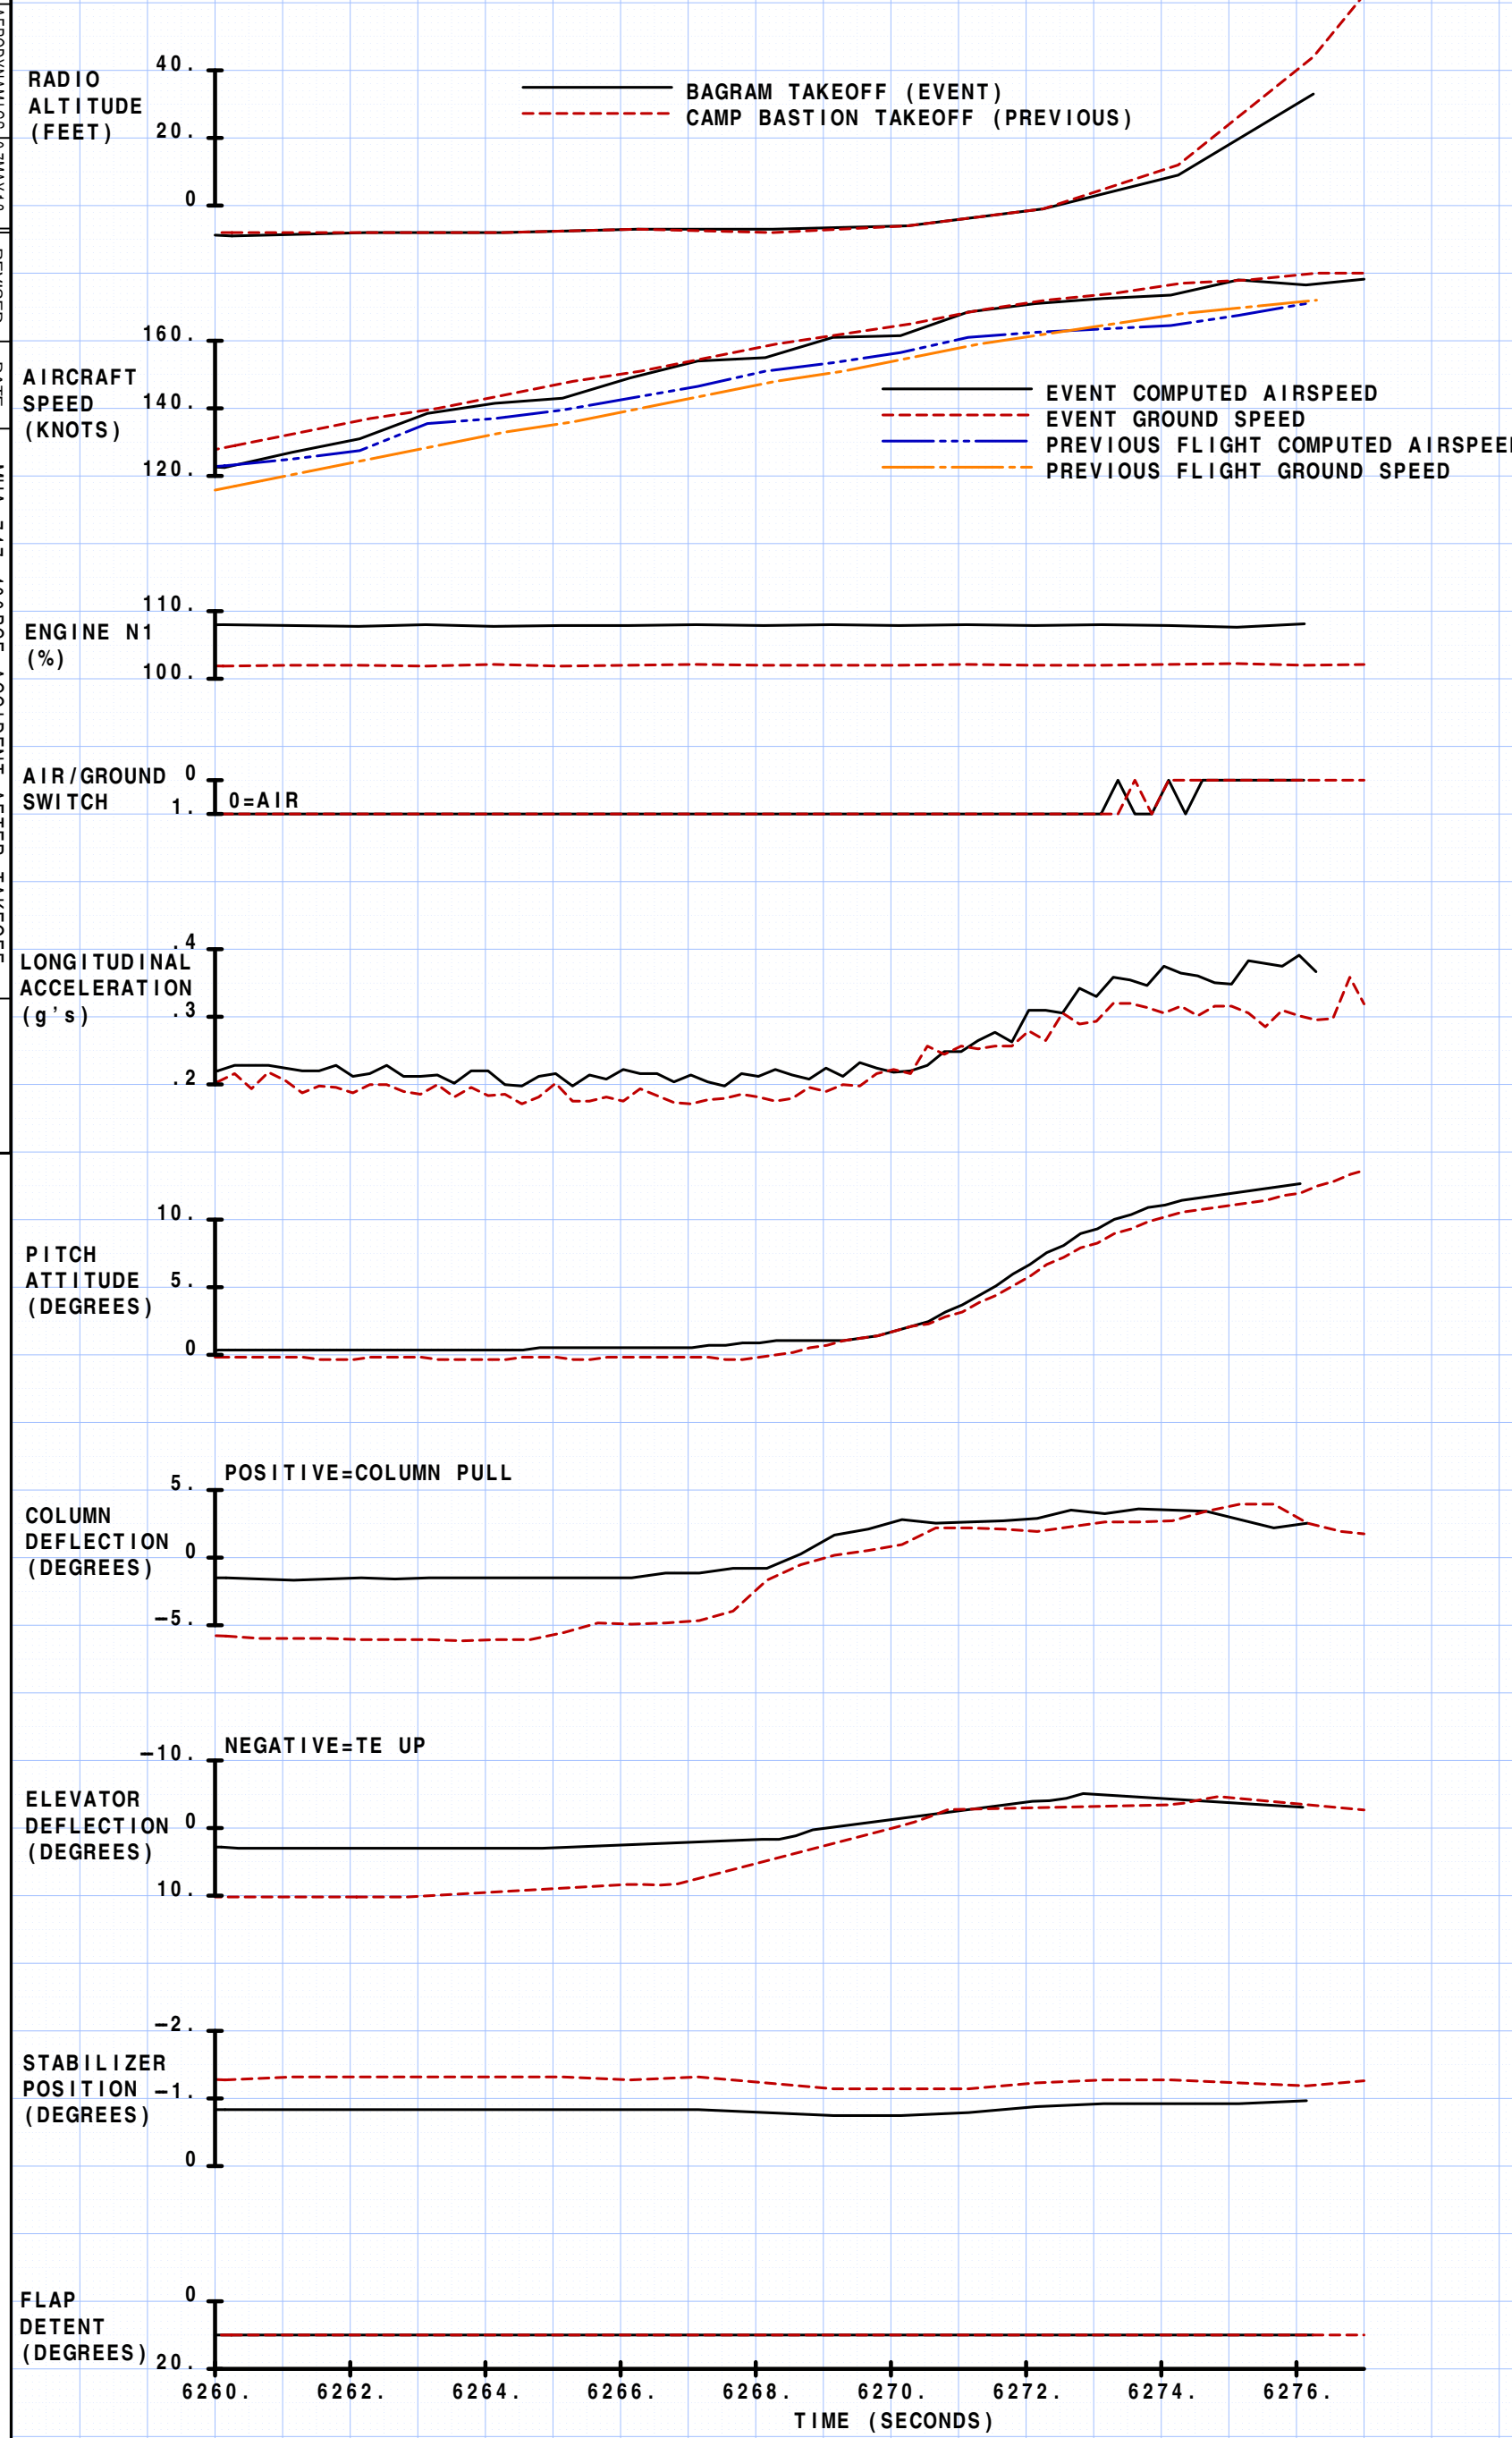
CALC	AERODYNAMICS	07MAY13
CHECK		
APPD		
APPD		
REVISD		
DATE		
MUA 747-400BCF ACCIDENT AFTER TAKEOFF		
29APR13 -- TIME-ALIGNED FDR DATA		
LONGITUDINAL PARAMETERS, TAKEOFF COMP		
FIGURE		RT075

Figure 5 shows a comparison of the pertinent longitudinal parameters for the takeoffs from OAZ and OAI. Both takeoffs were conducted at flaps 10, but the previous takeoff from OAZ had a lower airplane gross weight and lower thrust setting. In Figure 5, the two takeoffs were aligned approximately around the time of rotation initiation. The takeoffs matched very closely, and both appeared to be normal.

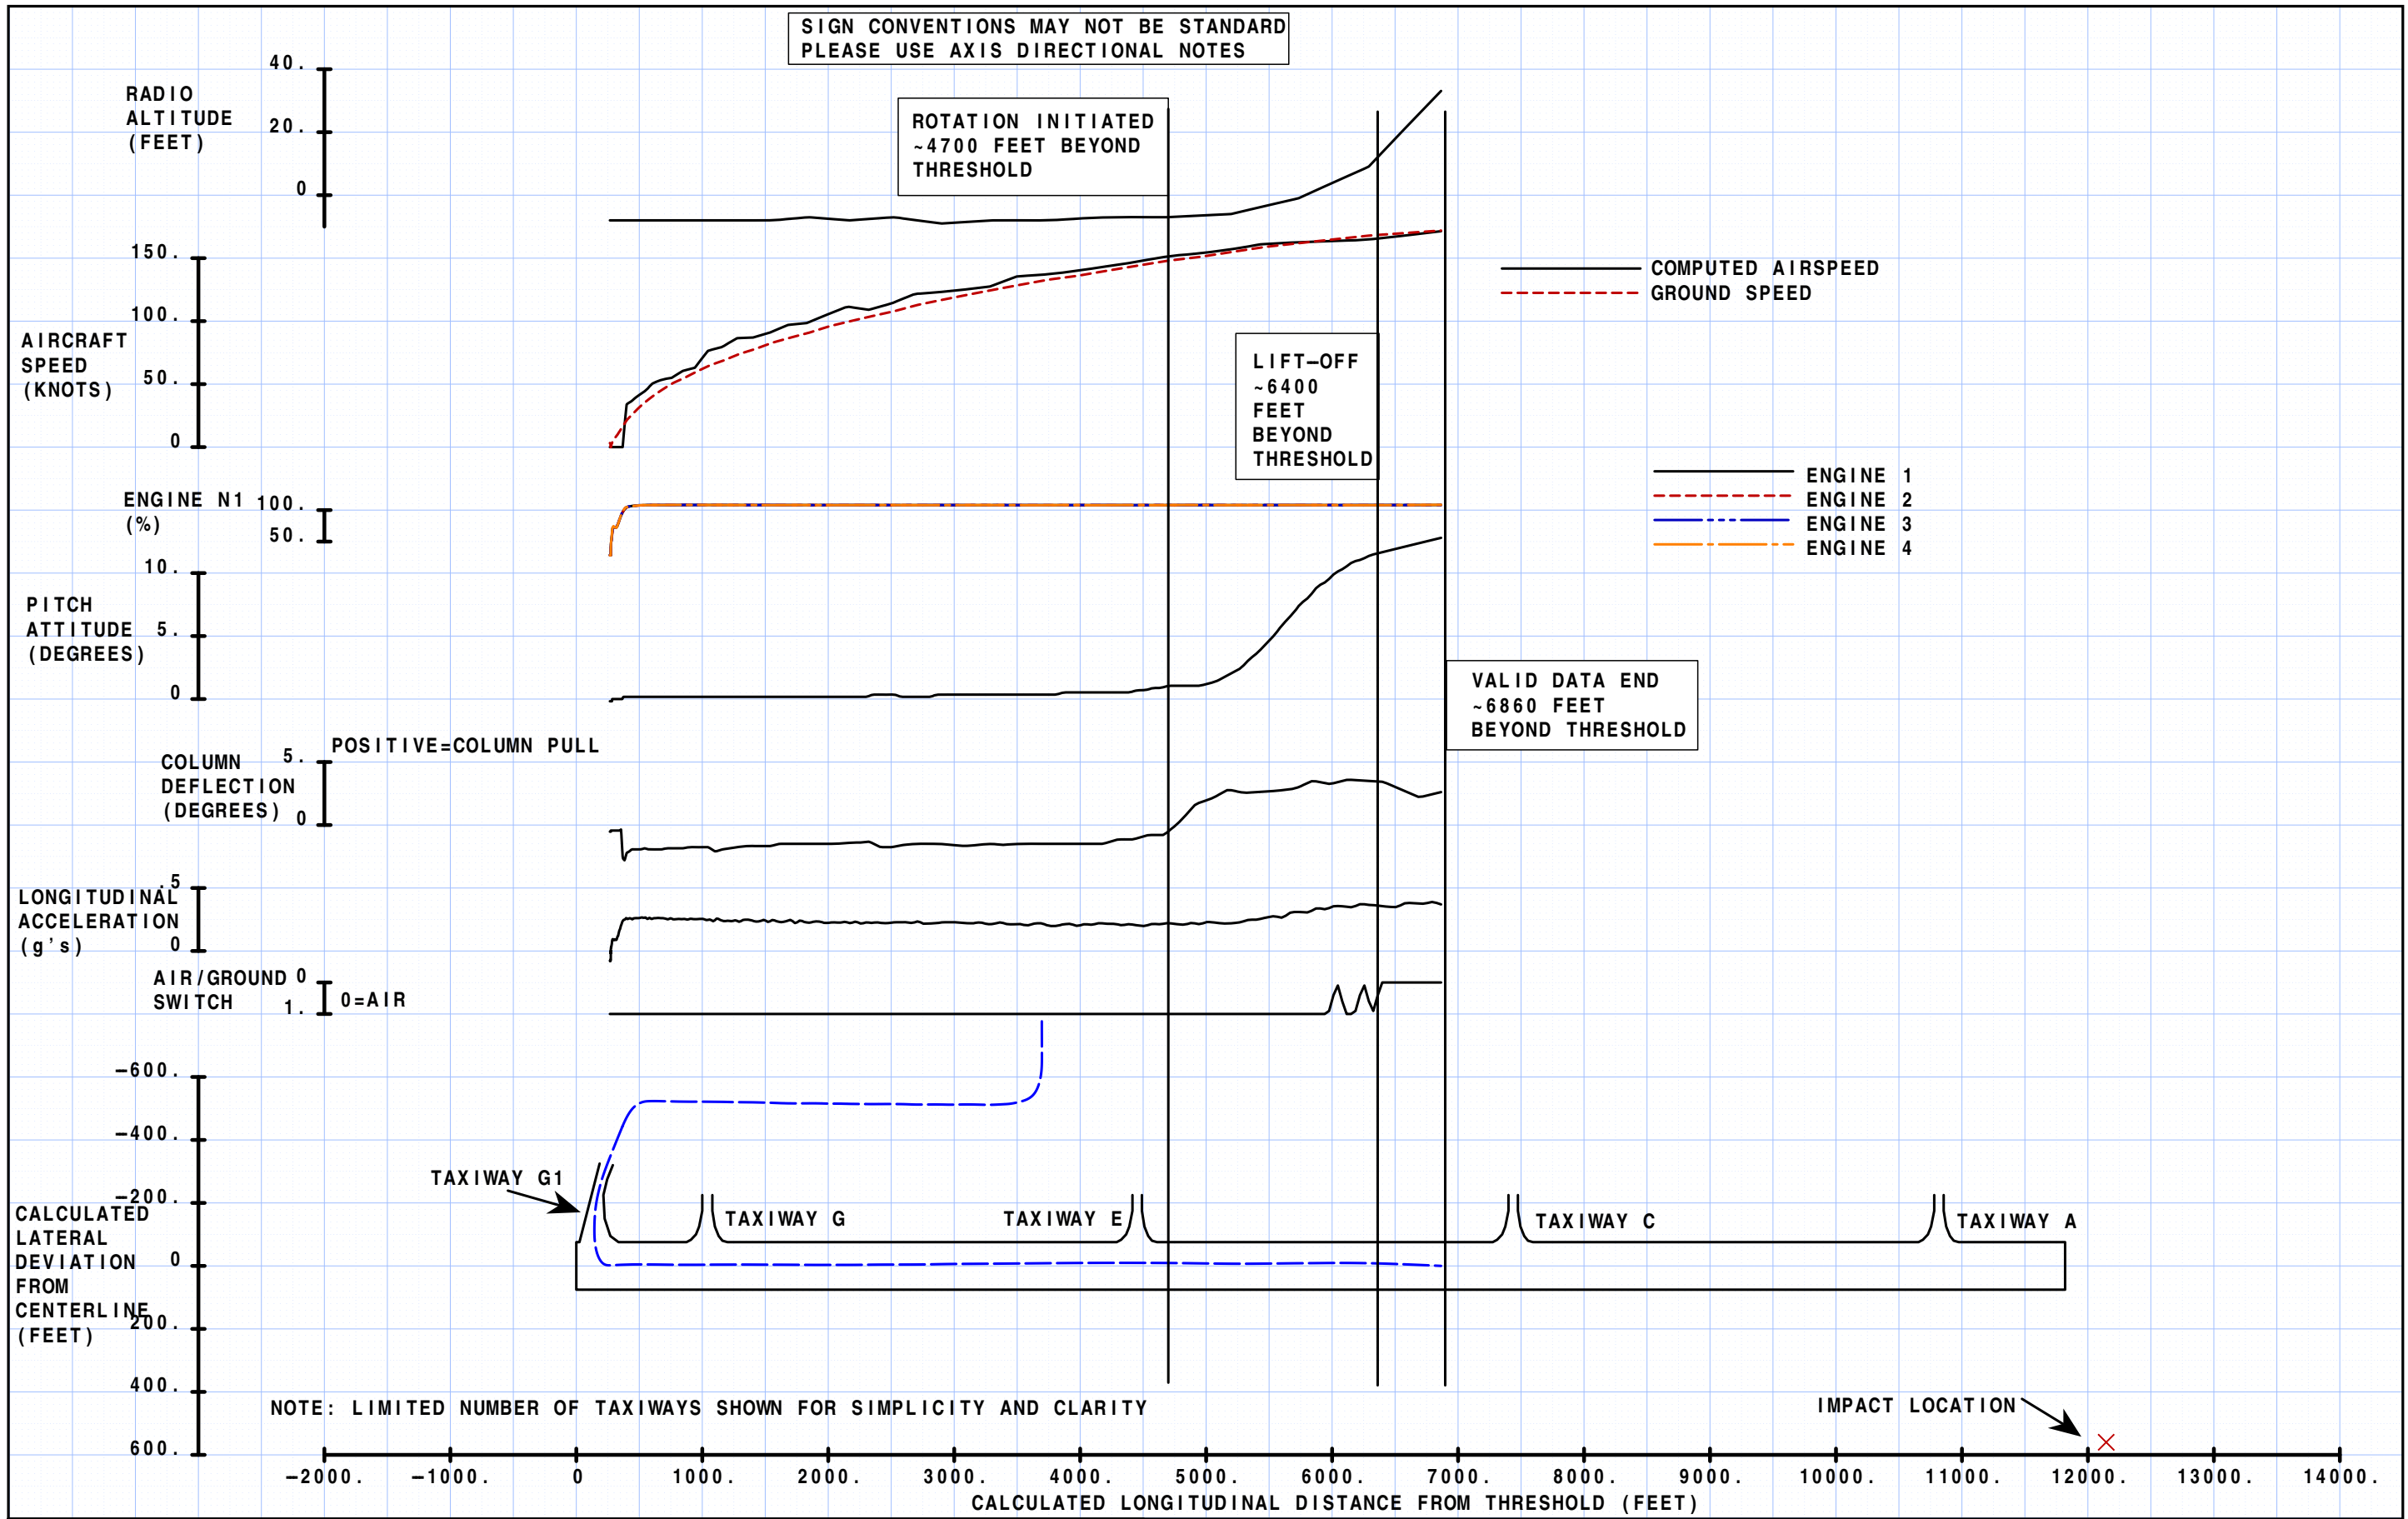
CALC	AERODYNAMICS	19SEP13	REVISED	DATE	MUA 747-400BCF ACCIDENT AFTER TAKEOFF 29APR13 -- TIME-ALIGNED FDR DATA GROUND TRACK PLOT	RT075
CHECK						FIGURE
APPD						6
APPD

A ground track was generated to show the airplane's path during taxi and takeoff (Figure 6). Runway 03 at OAI has a length of 11,819 feet and a width of 151 feet. Longitudinal and lateral distances were calculated using a combination of inertial data (ground speed, drift angle, heading) and airport information (runway dimensions, etc). The distances were then referenced to the runway based on the airplane's taxi on Taxiway G1 and turn onto Runway 03. These distances are referenced to the airplane Center of Gravity (CG).

The ground track was created in order to determine the location of the airplane at rotation initiation and at lift-off. These airplane locations were then compared with the locations of the airplane parts found on and near the runway (discussed below in Physical Evidence Discussion Section) to determine if they were consistent. The calculated data show that rotation was initiated approximately 4700 feet beyond the runway threshold, just after passing Taxiway E (Figure 6). Lift-off occurred approximately 6400 feet beyond the threshold, and the valid data end around 6860 feet beyond the threshold, just prior to passing Taxiway C. The location of ground impact is also shown in Figure 6. The airplane impacted the ground near the end of the runway, approximately 600 feet to the right of the runway centerline.
