Subject: Boeing Flight Simulations and FDR Data Analysis – National Air Cargo 747-400 N949CA Takeoff Accident at Bagram AFB, Afghanistan- 29 April 2013

Boeing Flight Simulations and FDR Data Analysis – National Air Cargo 747-400
N949CA Takeoff Accident at Bagram AFB, Afghanistan- 29 April 2013

Summary

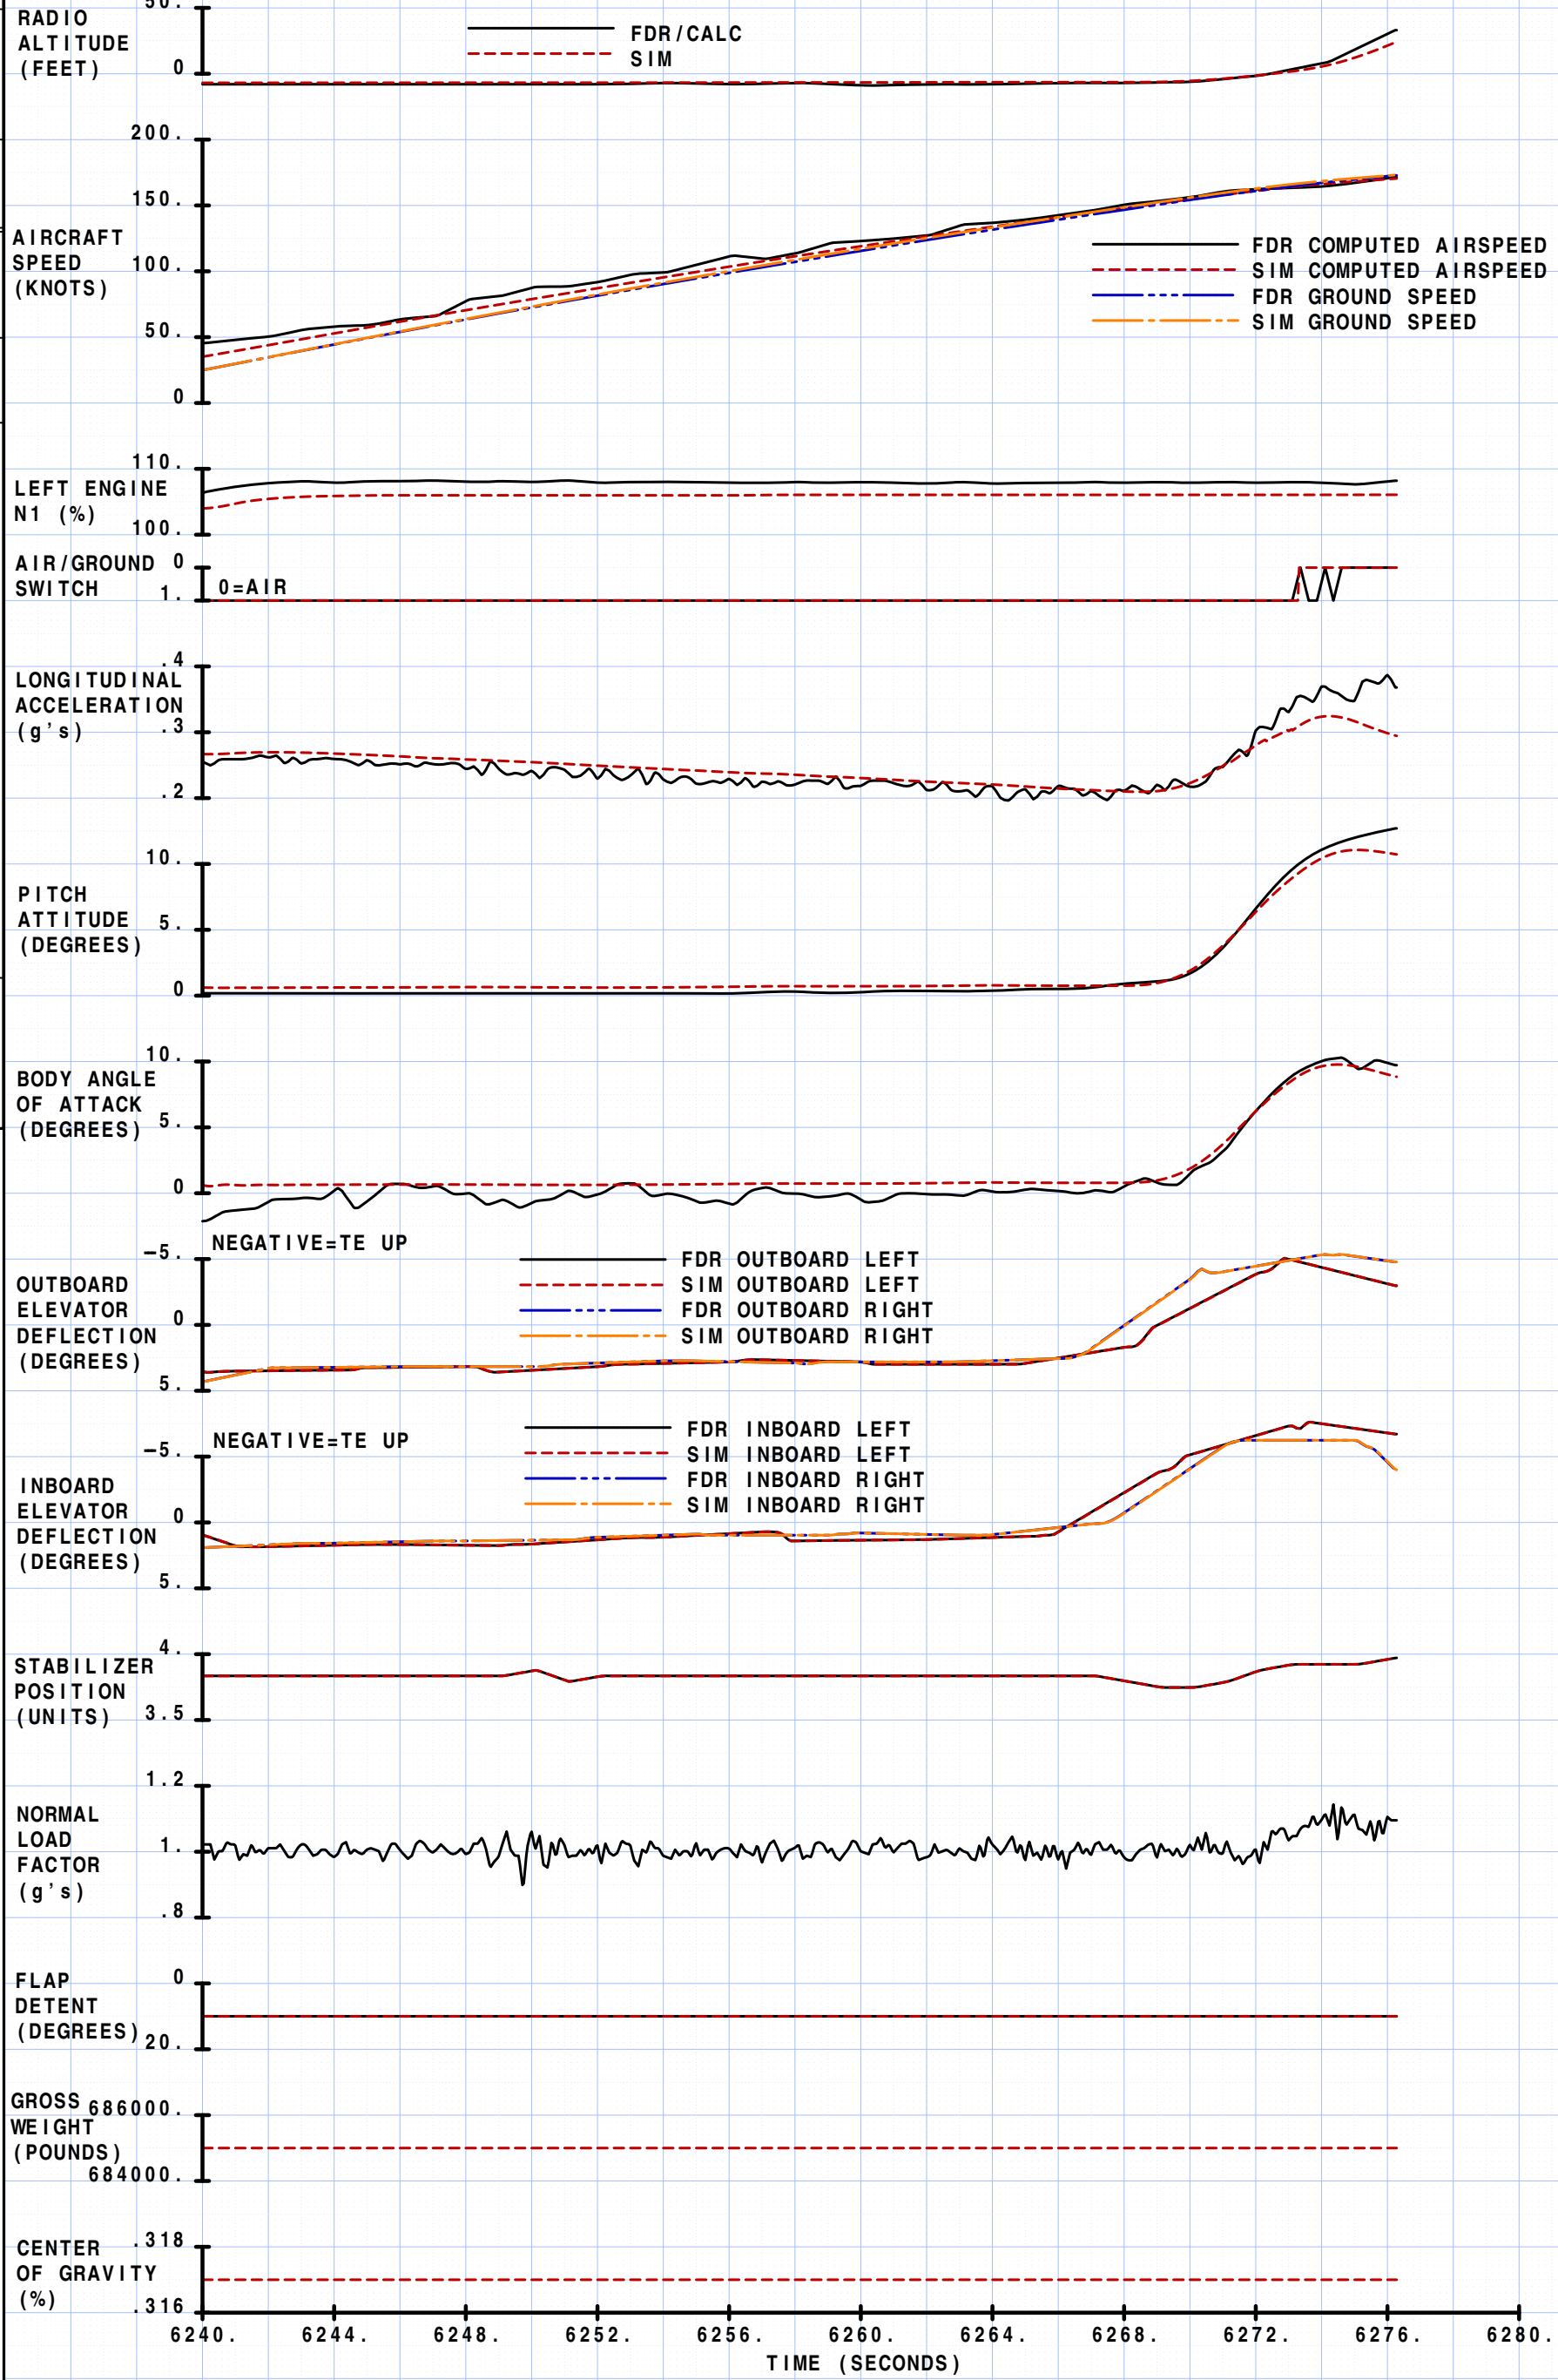
FIGURE 7

The majority of the resulting match was very close (Figures 7 and 8). However, during the last 3 seconds, the simulation parameters deviated from their FDR counterparts, most notably in pitch attitude, longitudinal acceleration, and radio altitude (Figure 7). Some deviations were also observed during the takeoff roll in some of the lateral-directional parameters, but this was most likely due to variations in the on-ground wind profile that could not be determined due to the difficulty in calculating winds on the ground (Figure 8).

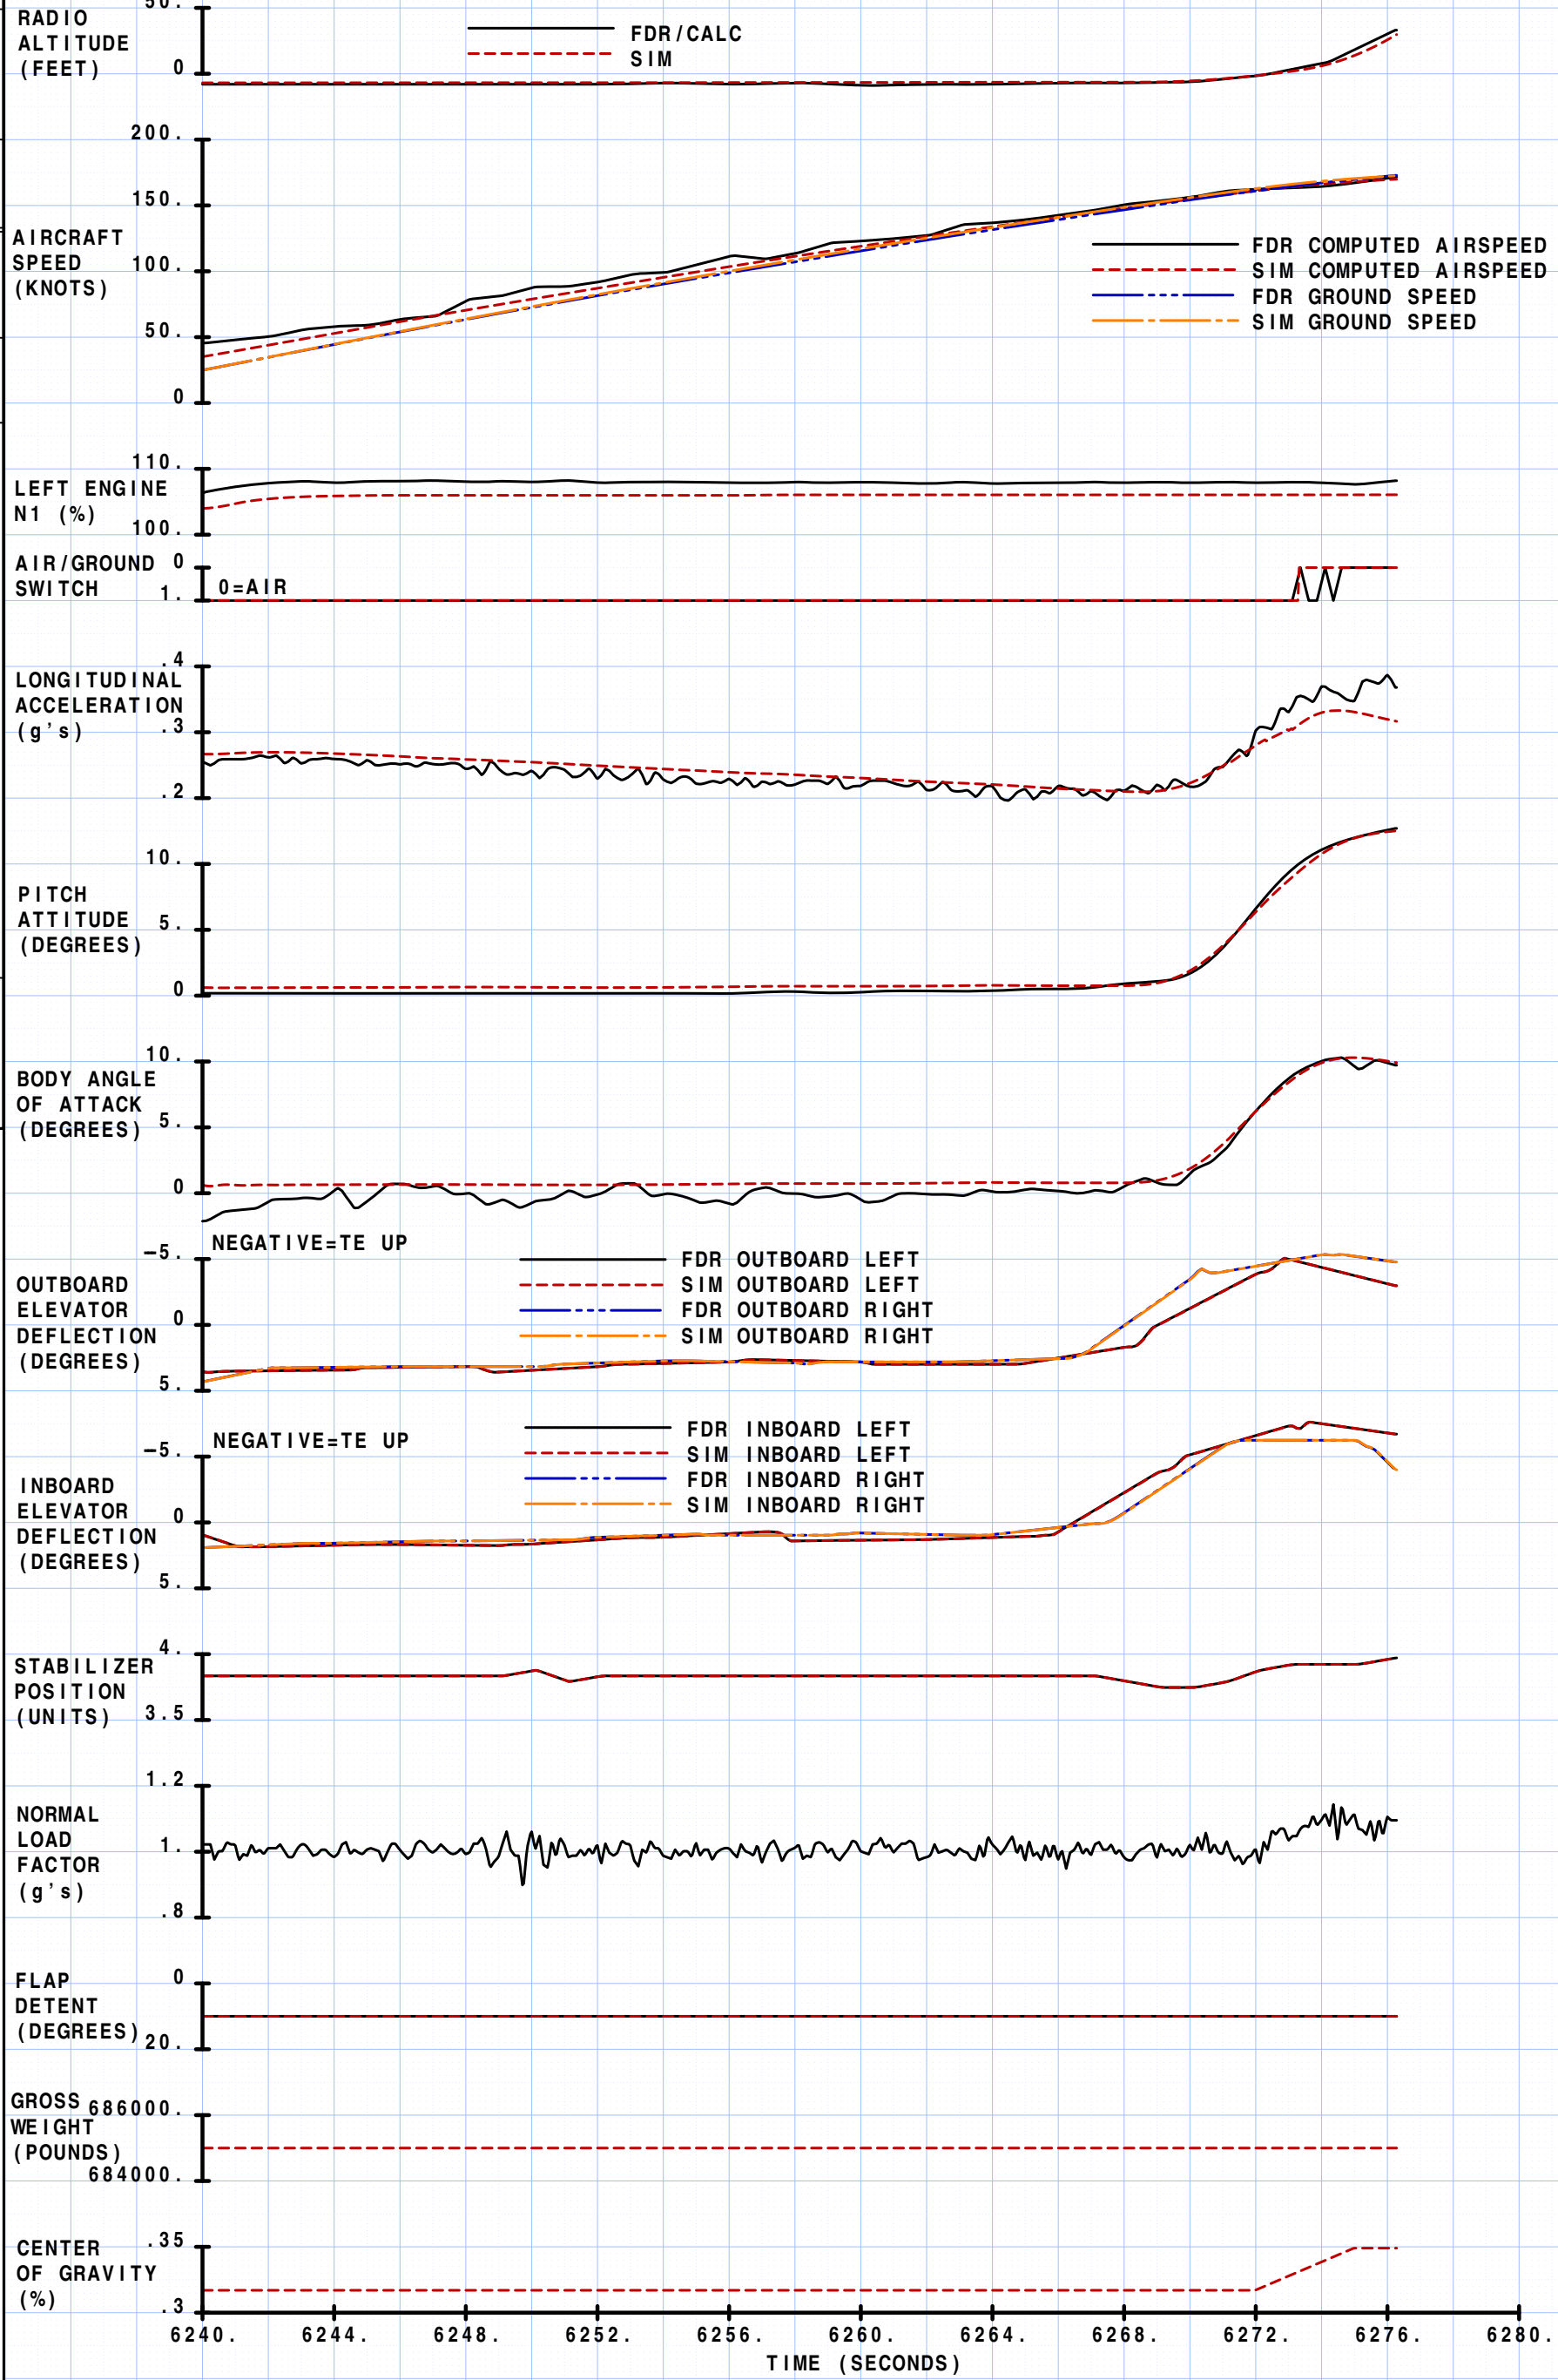
CALC	AERODYNAMICS	07MAY13	REVISED	DATE
CHECK				
APPD				
APPD				
MUA 747-400BCF ACCIDENT AFTER TAKEOFF 29APR13 -- TIME-ALIGNED FDR DATA LONG PARAMETERS, SIM MATCH W/ CG SHIFT				
				FIGURE
				RT075
				9

A hypothetical scenario was generated using this simulation match as a baseline (Figure 9). At time 6272 seconds, a CG shift was simulated that represented a scenario where the aft-most MRAP shifted to the stabilizer jackscrew. The Boeing Weights Engineering Group calculated that the CG would be 34.9 percent with the vehicle at that position. Starting at time 6272 seconds, a CG shift from 31.7 percent to 34.9 percent was ramped in over 3 seconds, where it was then maintained at 34.9 percent until the simulation was terminated one second later. The resulting simulation results matched better in pitch attitude, longitudinal acceleration, and radio altitude than the baseline results. These results support the previously stated hypothesis that the aft-most vehicle broke loose and shifted aft, most likely during the timeframe analyzed here.

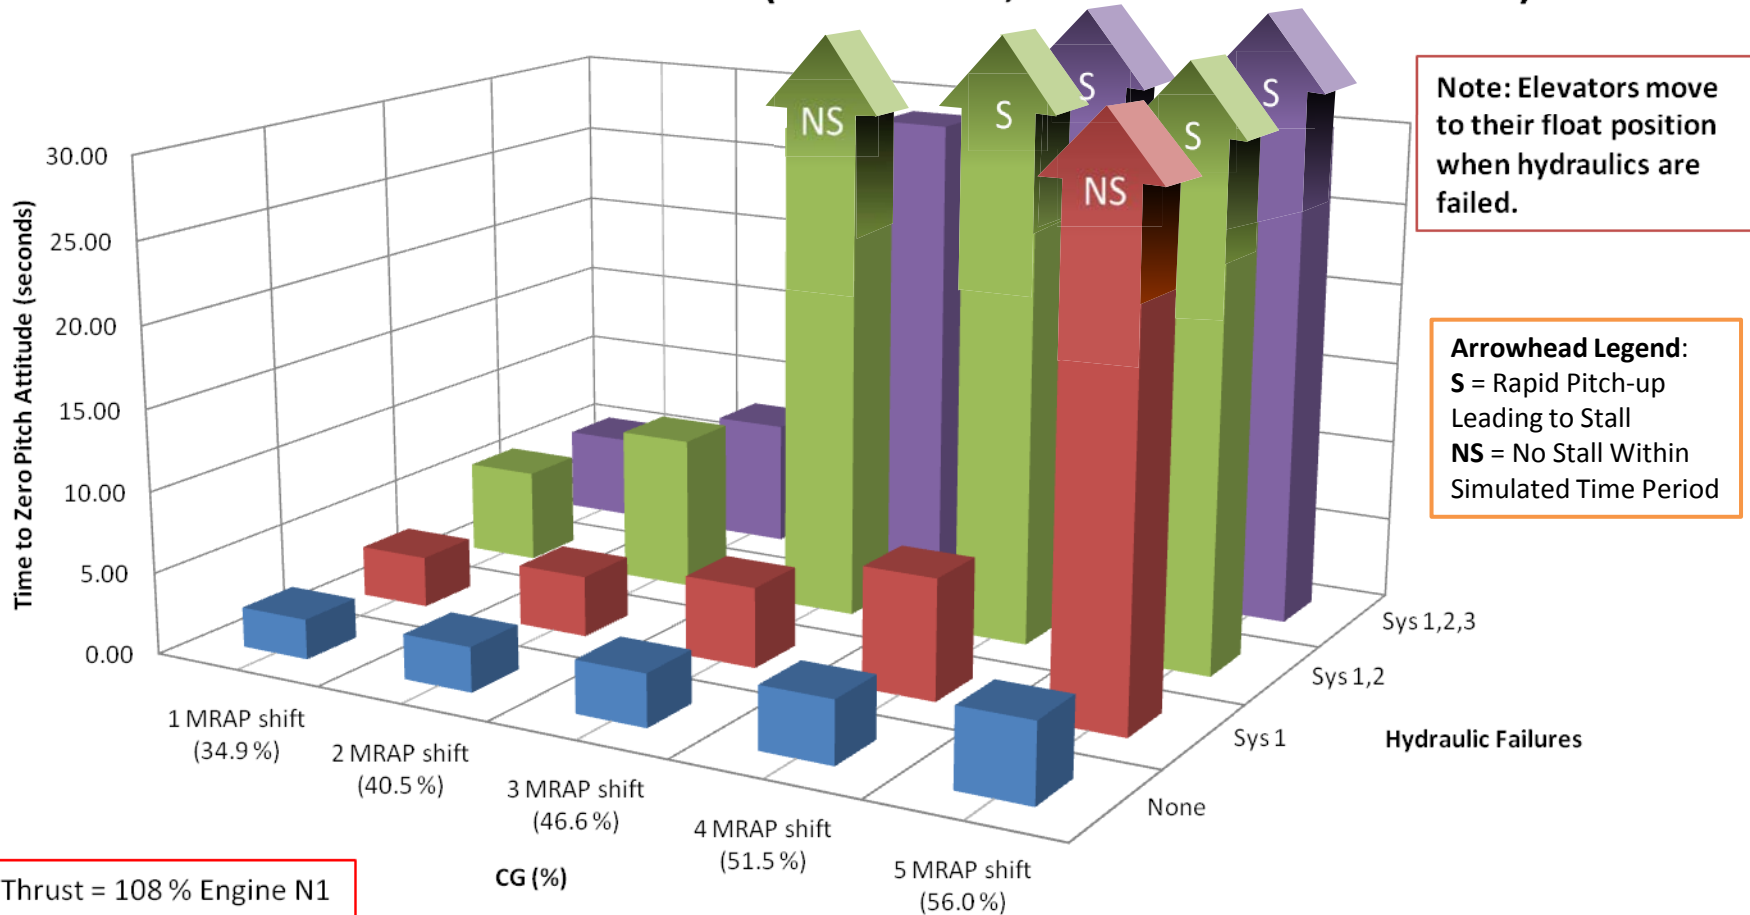
CALC	AERODYNAMICS	07MAY13	REVISED	DATE	MUA 747-400BCF ACCIDENT AFTER TAKEOFF 29APR13 -- TIME-ALIGNED FDR DATA SIM SCENARIO MATRIX RESULTS	RT075	
CHECK						FIGURE	
APPD							10
APPD

The results from this analysis are displayed in Figure 10 in the form of a three-dimensional bar chart. A supplemental plot is also included that shows the pitch attitude time history for each case (Figure 11). In Figure 10, the CG shifts are shown along the horizontal axis and the hydraulic failure scenarios are shown along the depth axis. The vertical axis shows the “Time to Zero Pitch Attitude” in seconds, and the table at the bottom of Figure 10 displays the exact values in seconds. The majority of the cases (13 out of 20) attained zero degrees pitch attitude within 10 seconds (Figures 10 and 11). Case #17 reached zero degrees pitch attitude in just under 30 seconds. One interesting observation to note is that the cases with the three failed hydraulic systems reached zero degrees pitch attitude faster than the cases with two failed hydraulic systems. This occurred because the LIB aileron floated to close to its maximum TE-up deflection (-18.5 degrees), resulting in more nose-down pitching moment with Hydraulic System #3 failed.

There were six cases where pitch attitude and pitch rate were not controllable. These cases are denoted with arrowheads in Figure 10 and with different, colored line types in Figure 11. Case #11 and #18 never reached zero degrees pitch attitude, but the simulation airplane also never pitched to a stall attitude either (Figure 11). These cases developed a divergent pitch oscillation where the airplane pitched up and down as airspeed slowed and increased, respectively. These two cases are marked with an “NS” in Figure 10, which indicates that in those two cases, the airplane did not stall within the simulated time period.

Cases #15, #16, #19, and #20 all exhibit a rapid pitch-up leading to an aerodynamic stall (Figure 11). These cases are marked with an “S” in Figure 10. These cases represent the scenarios where either four or five MRAPs shifted aft and at least Hydraulic Systems #1 and #2 had failed. All of

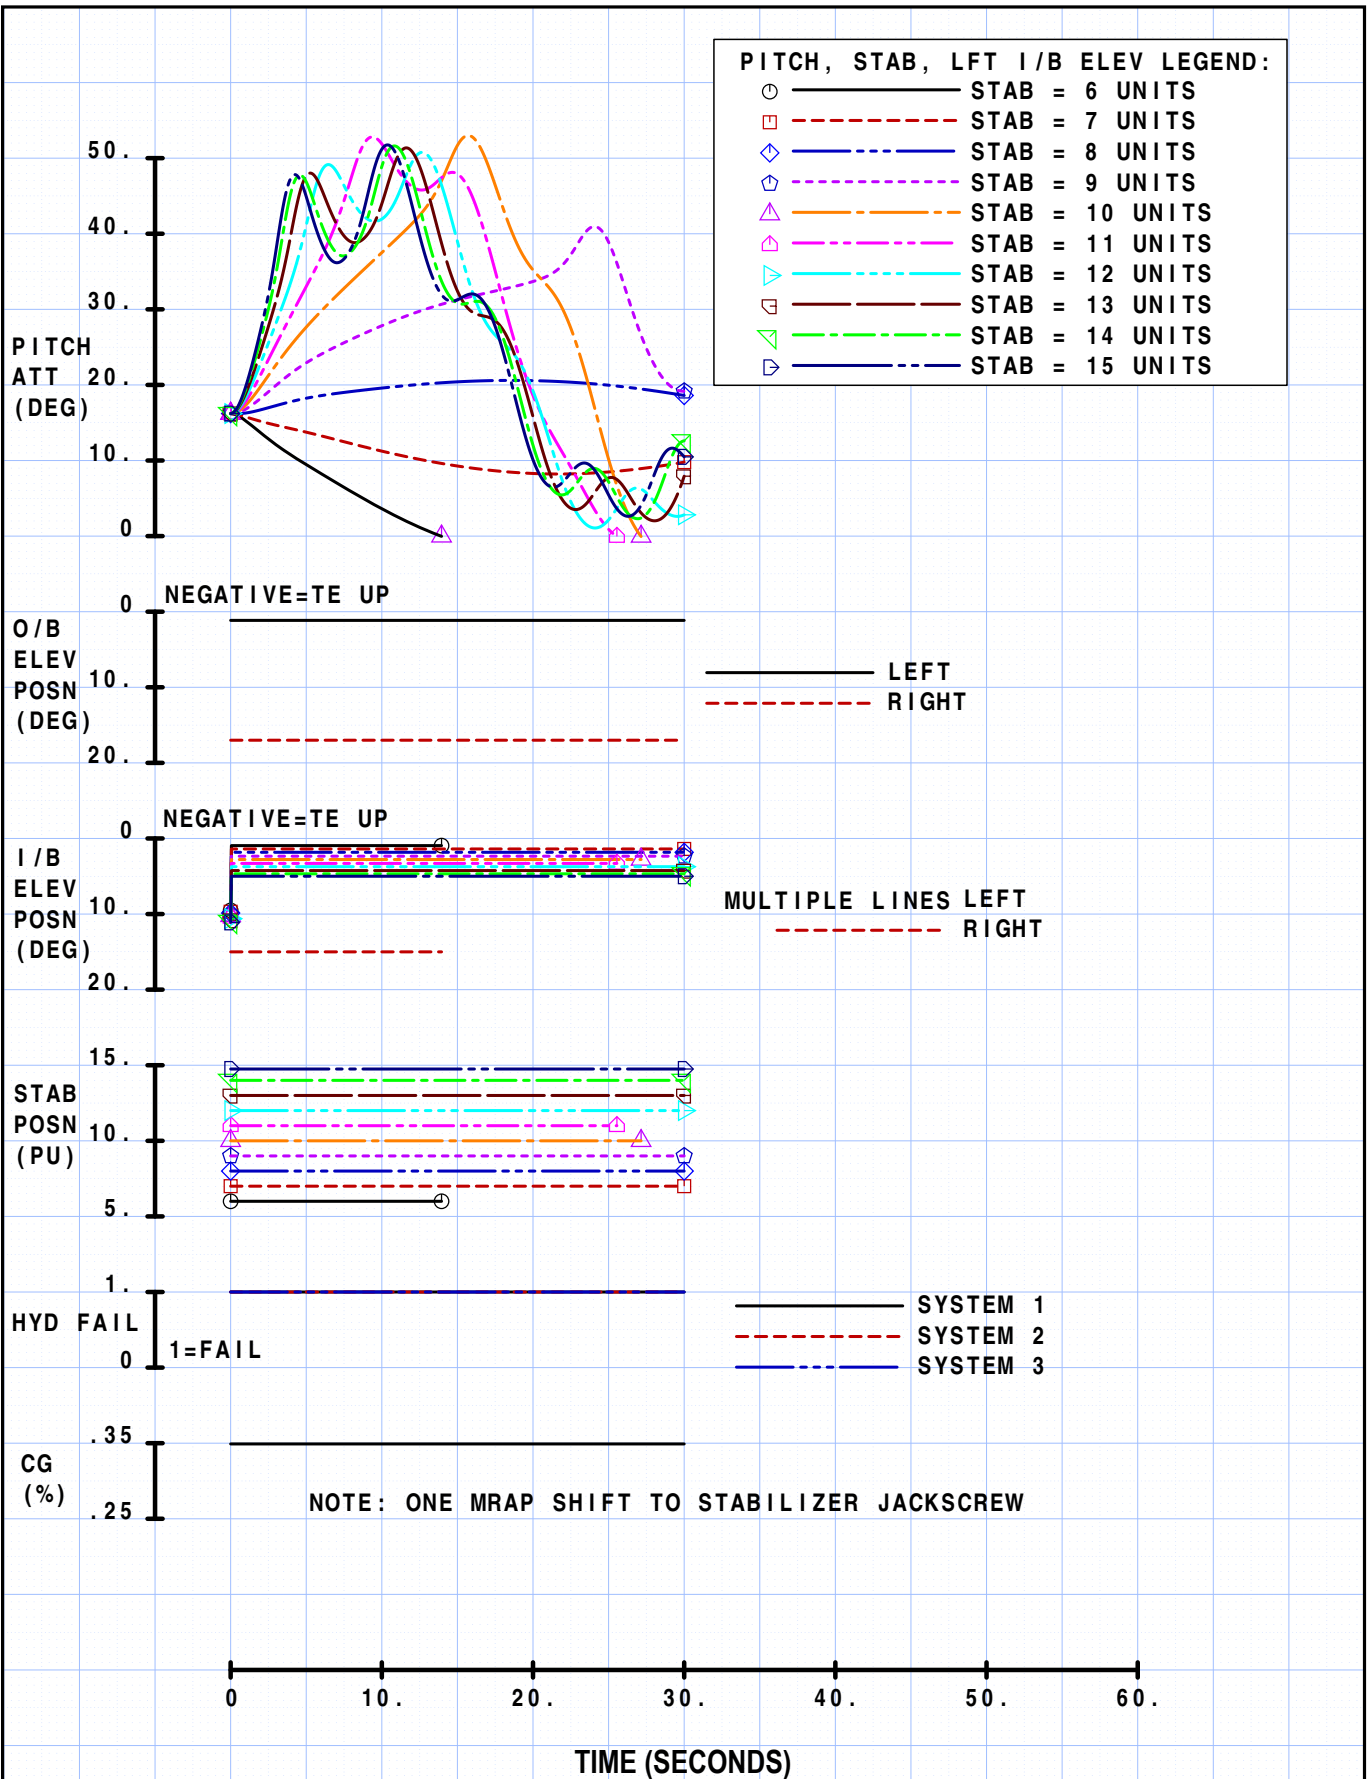
MUA 747-400BCF ACCIDENT AFTER TAKEOFF
 29APR13 -- SIMULATION DATA
 ND COL, 3 HYD FAIL, STAB TRADE STUDY

For the case with three hydraulic systems failed, a stabilizer position of at least 9 units was sufficient to result in an uncontrollable pitch-up (Figure 12). Larger stabilizer deflections resulted in a more rapid pitch-up. An additional stabilizer trade study was performed with only Hydraulic Systems #1 and #2 failed. This hydraulic system failure scenario was determined to be the most likely accident scenario, based on available evidence. Similar to the results in Figure 12, a stabilizer position of at least 9 units was sufficient to result in an uncontrollable pitch-up.
