## FRA field report CBTX 718470

Tank car: CBTX 718470

Derailment Site: In the area of Money MS

Inspection Date: 5-16-17

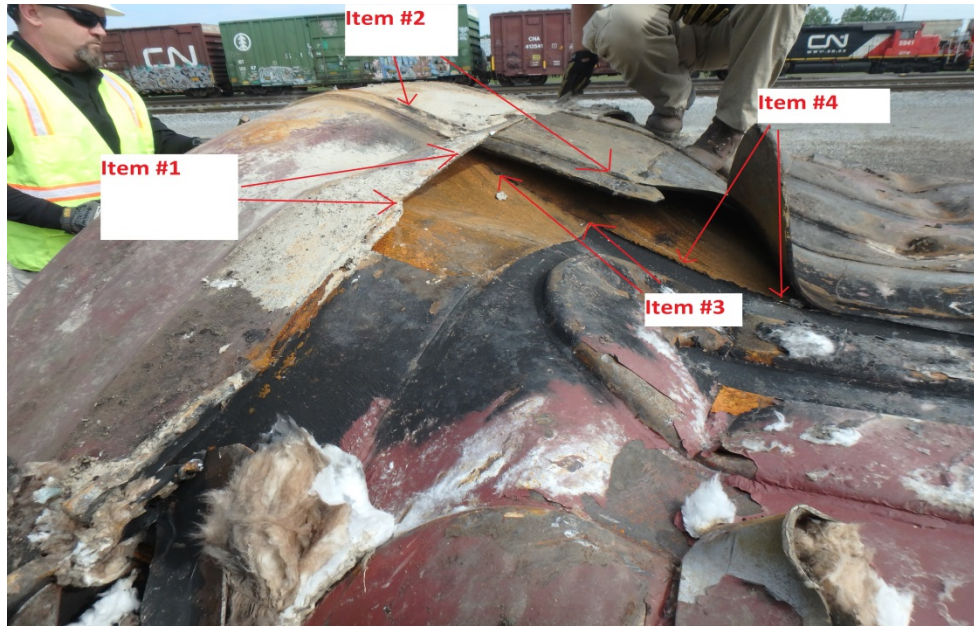
inability to inspect the size of the welds that were still on the attachments. The following photo illustrates what was observed:

- Item #1 Cradle pad is split in half and half is no longer there. It was split at the Heat Affected Zone created from the application of the body bolster.
- Item #2 is the remainder of the weld that attached the head brace and draft assembly to the head brace and sill pad. It sheared away in the throat of the weld leaving only half of the weld deposit on the pad.
- Item #3 is the cradle pad to draft sill weld and illustrates that it was not welded to the tank by design and therefore did not tear the tank.
- Item #4 is the draft sill pad sheared away in the throat of the pad to tank longitudinal weld possibly absorbing the energy of the impact.
