NATIONAL TRANSPORTATION SAFETY BOARD
Bureau of Technology
Washington, D. C.

Materials Laboratory
Report No. 87-89

METALLURGIST'S FACTUAL REPORT

Place : Marlin, Texas
Date : March 30, 1987
Vehicle : Piper PA-28-181, N8191U
NTSB No. : FTW 87-F-A087
Investigator: Warren V. Wandel (FTW-ASI)

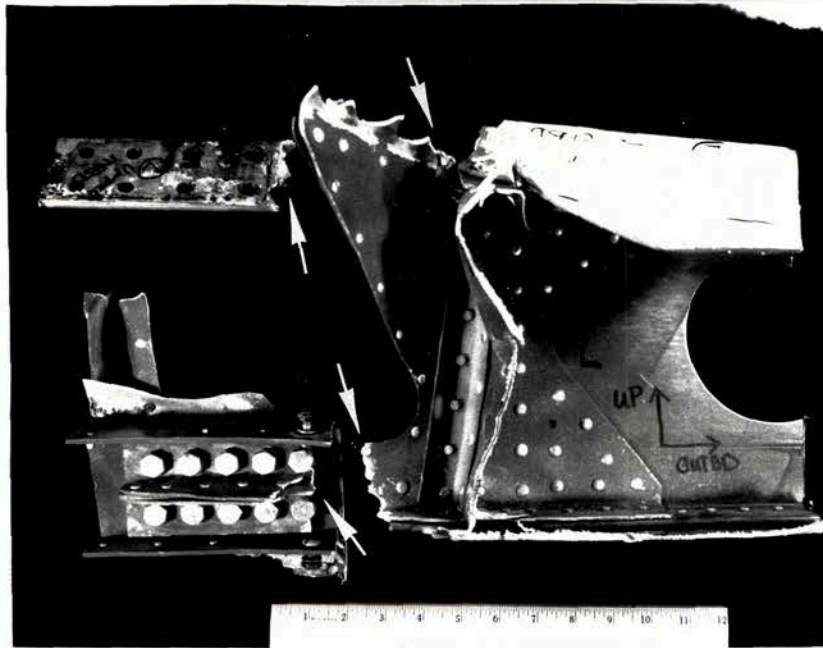
The left wing main spar assembly pieces are shown in figure 1. The spar had separated through the upper and lower spar caps and through the forward and aft sheet metal gusset webs. The locations of these fractures are denoted by arrows in figure 1.

Figure 1. An overall view of the as-received left wing spar pieces with the fracture locations denoted by arrows.

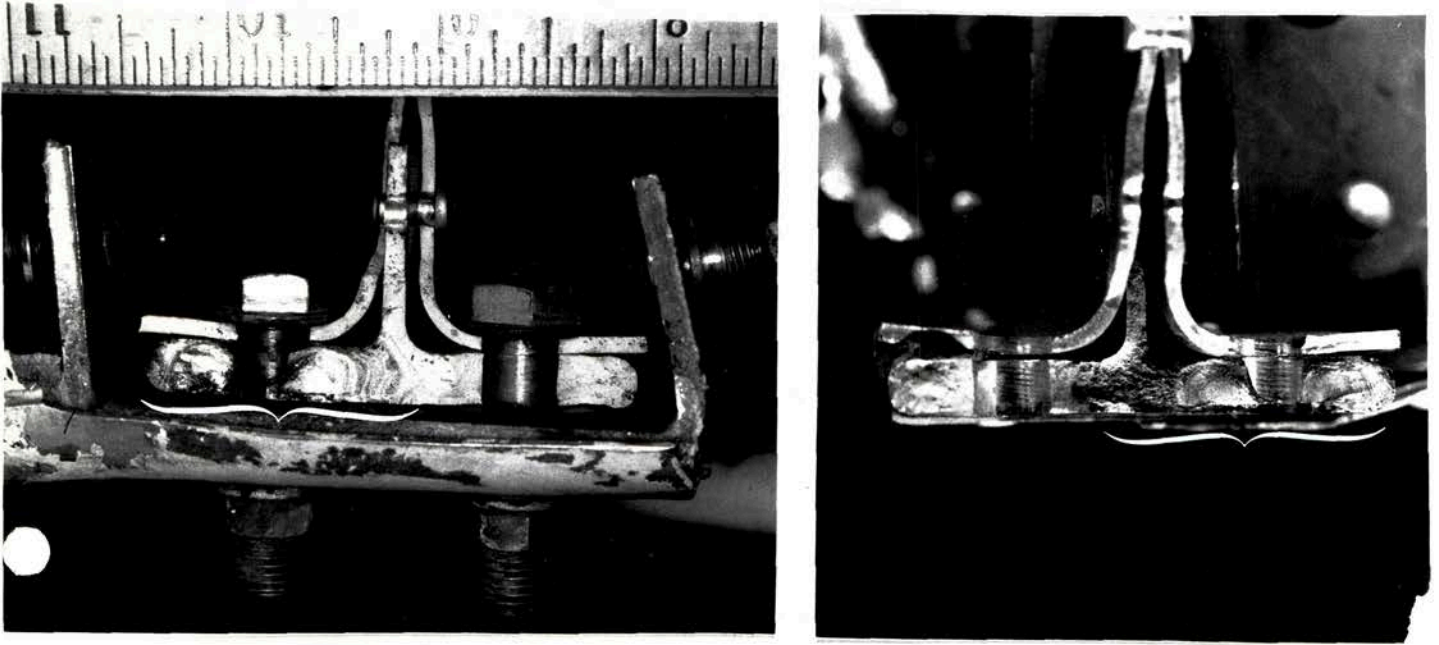
Initial examination of the lower spar cap fracture faces detected the fracture characteristics of fatigue cracks emanating from two areas near the outboard attach hole in the forward flange of the spar cap. Figure 2 displays photographs of both the inboard and outboard spar fracture faces, with the fatigue areas denoted by white brackets.

Figure 2. Inboard (left) and outboard (right) views of the lower spar cap fracture with the fatigue zones denoted by white brackets. Left view also shows fuselage carry through and attachment fasteners.

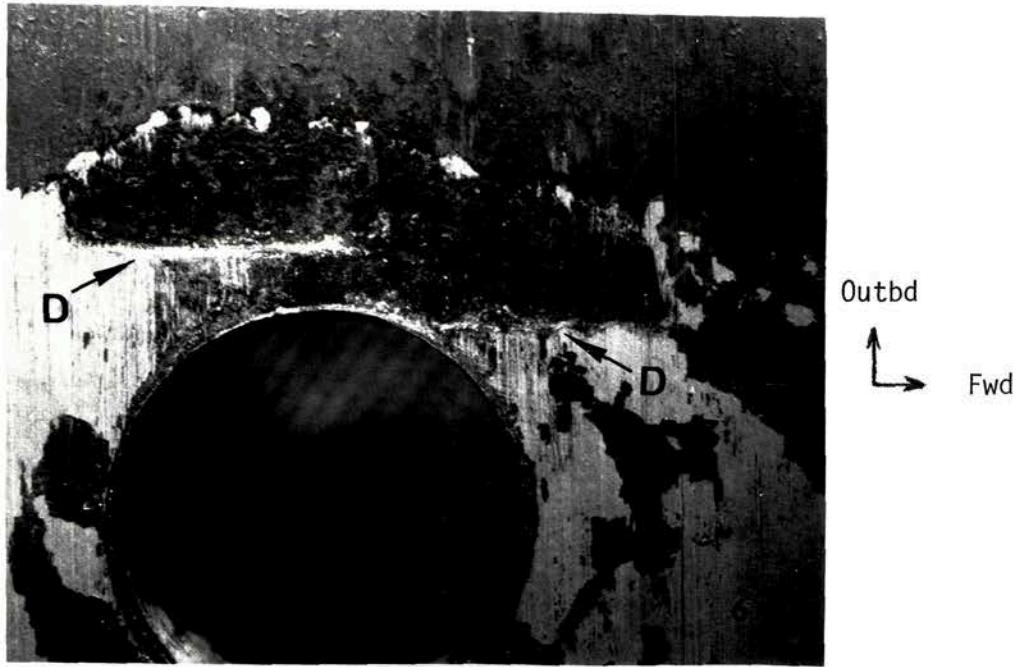
Figure 3. A view looking at the upper surface of the carry through at the forward outboard bolt hole (forward at right, outboard at top) showing the fretting demarkation lines which correspond to the spar fatigue planes.

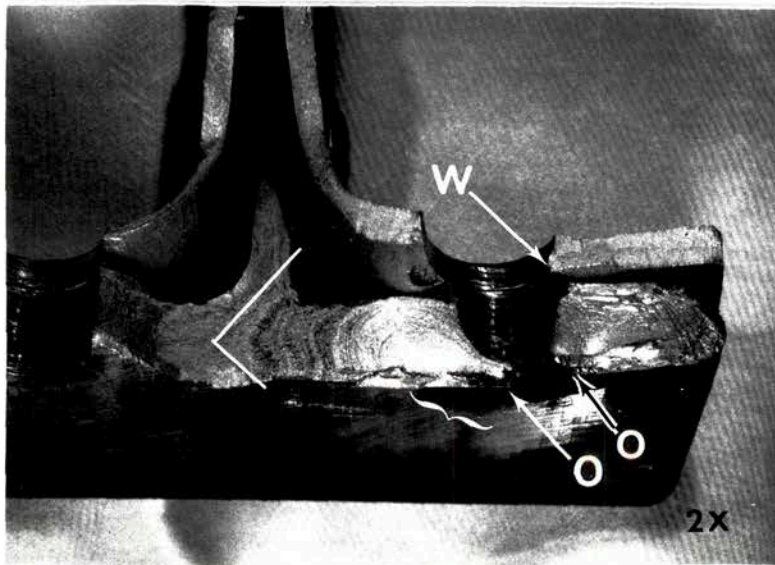
piece, white bracket in figure 4. Inspection of the lower surface of the inboard spar section immediately inboard of the fatigue zone did not detect any evidence of fretting damage, see figure 5.

Further examination identified a single point of fatigue initiation on each fatigue plane. Both fatigue origins were on the lower surface of the spar cap slightly away from the bolt hole. The fatigue origins are denoted by arrows "O" in figures 4 and 5. The origin on the forward (most inboard) fatigue plane was just inboard of the outboard edge of the bolt hole and about 0.14 inch forward of the spanwise centerline of the bolt hole. The aft (most outboard) fatigue plane origin was offset about 0.06 inch outboard of the hole edge and the forward fatigue plane and approximately 0.07 inch aft of the bolt hole centerline.

Fatigue growth in the forward fatigue plane was generally upward and forward and entirely penetrated the portion of the spar flange between the bolt hole and the forward edge of the spar cap. The aft fatigue plane extended upward through the flange thickness and aft, terminating at a position slightly aft of the spar web as denoted by the white line in figure 4.

Figure 4. View looking outboard at the outboard spar fracture face with forward at right. The fatigue origins, arrows "O", and terminus white line, are denoted along with the lower surface fretting, white bracket, and location of web fatigue crack arrow "W".

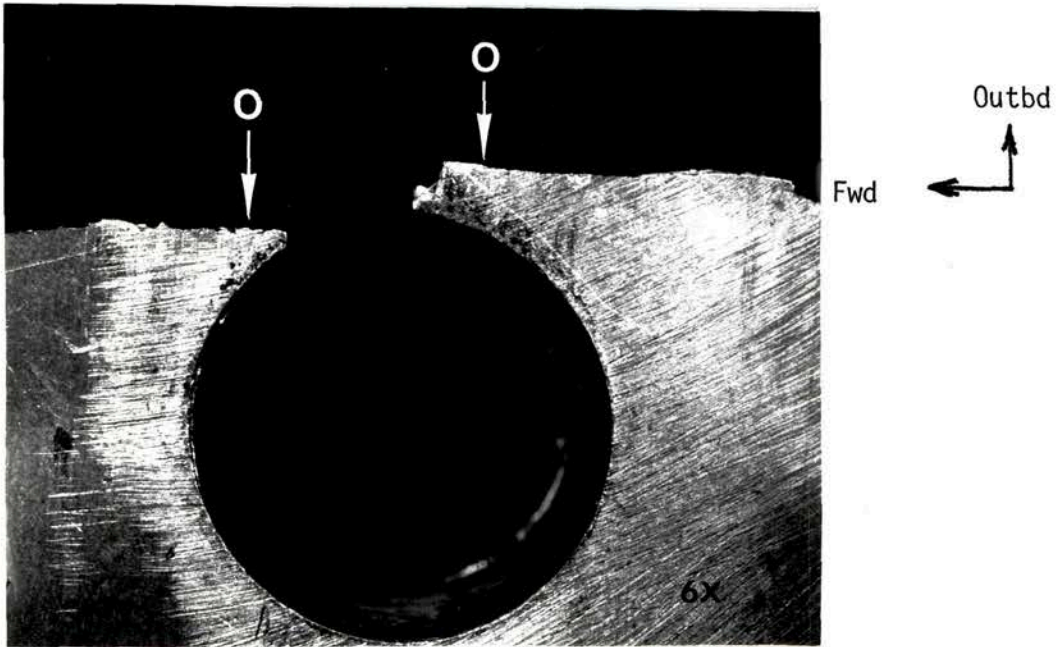
With the inboard spar section removed from carry through structure, both fracture faces were cleaned with a mild detergent solution in water and repeated applications and stripping of replication tape. The cleaned fatigue zone of the outboard fracture half is shown in figure 4. Magnified examination of the spar fracture established that the fatigue region was composed of two independent fatigue planes that were slightly offset to each other in the spanwise direction. Both fatigue planes had intersected the forward outboard attachment bolt hole near the outboard edge of the hole. Figure 5 illustrates the orientation and relationship of the two fatigue planes and the bolt hole.

Figure 5. Photograph displaying the lower spar surface adjacent to the fatigue zones showing the relative positions of fatigue origins, planes and bolt holes. Forward at left, outboard at top.

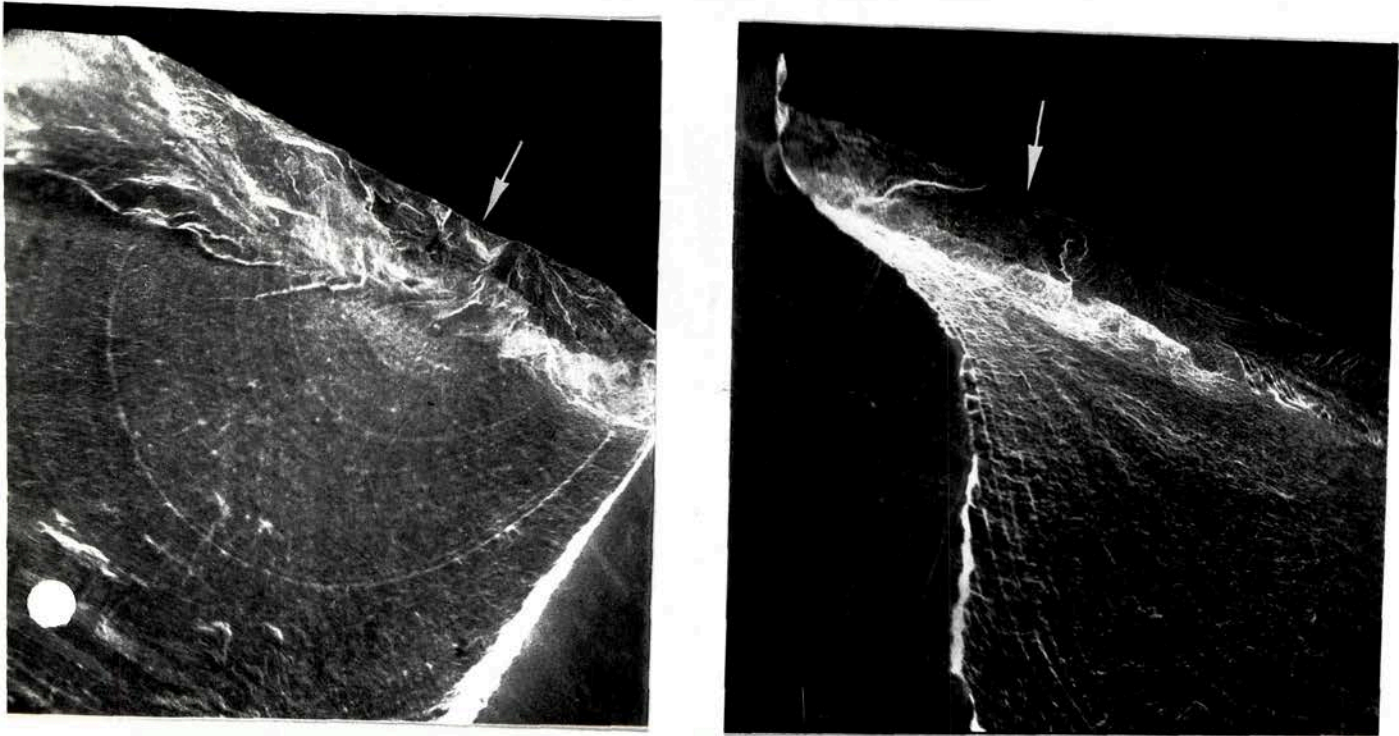
single location for each fatigue plane on the lower spar cap surface also confirming the previous visual observations. The two fatigue origin areas, arrows "O" are shown in the SEM macrographs of figure 6.

Figure 6. SEM macrographs (10X) of the two fatigue origins, forward fatigue plane at left, aft fatigue plane at right.

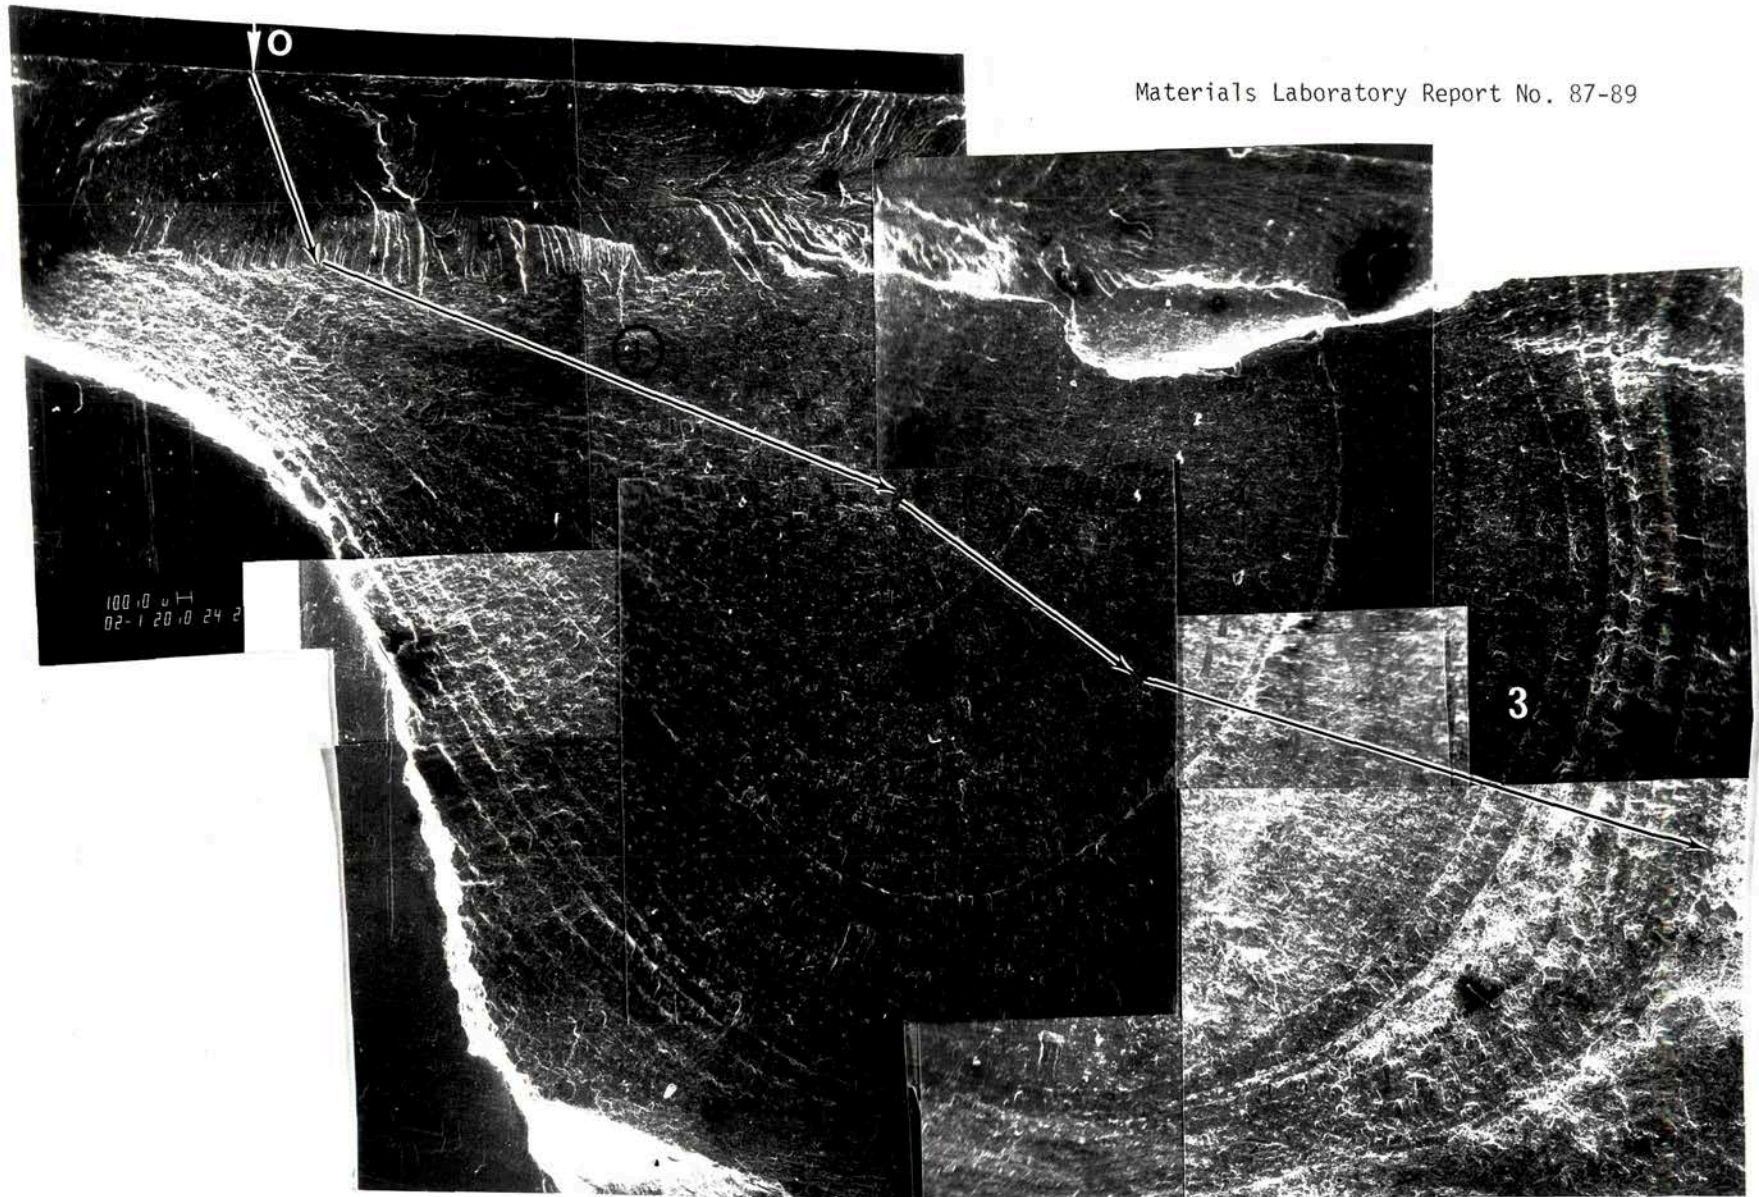
A fatigue striation count was undertaken along the centroid line of the fatigue propagation directions on the aft fatigue plane. Fatigue striation spacing, expressed as striations per inch (S/I), was determined at three positions along the centroid of propagation. These spacings were then linearly integrated over the distance to the previous measurement position. Adding the three integrated spacing measurements, in this manner, results in a conservative estimate of the total fatigue striations for a given length of propagation. For the aft fatigue plane, a minimum of 30,265 fatigue striations were present in the initial 0.49 inch of measured fatigue propagation. The propagation centroid line, fatigue origin, and three measurement points are located on the SEM montage in figure 7. The measurement data at the three points are listed in Table B.

Figure 7. SEM fractograph montage of the aft fatigue plane showing the origin (Arrow "0") and centroid of progression (black/white lines). Circled number indicates approximate locations of striation spacing measurements.

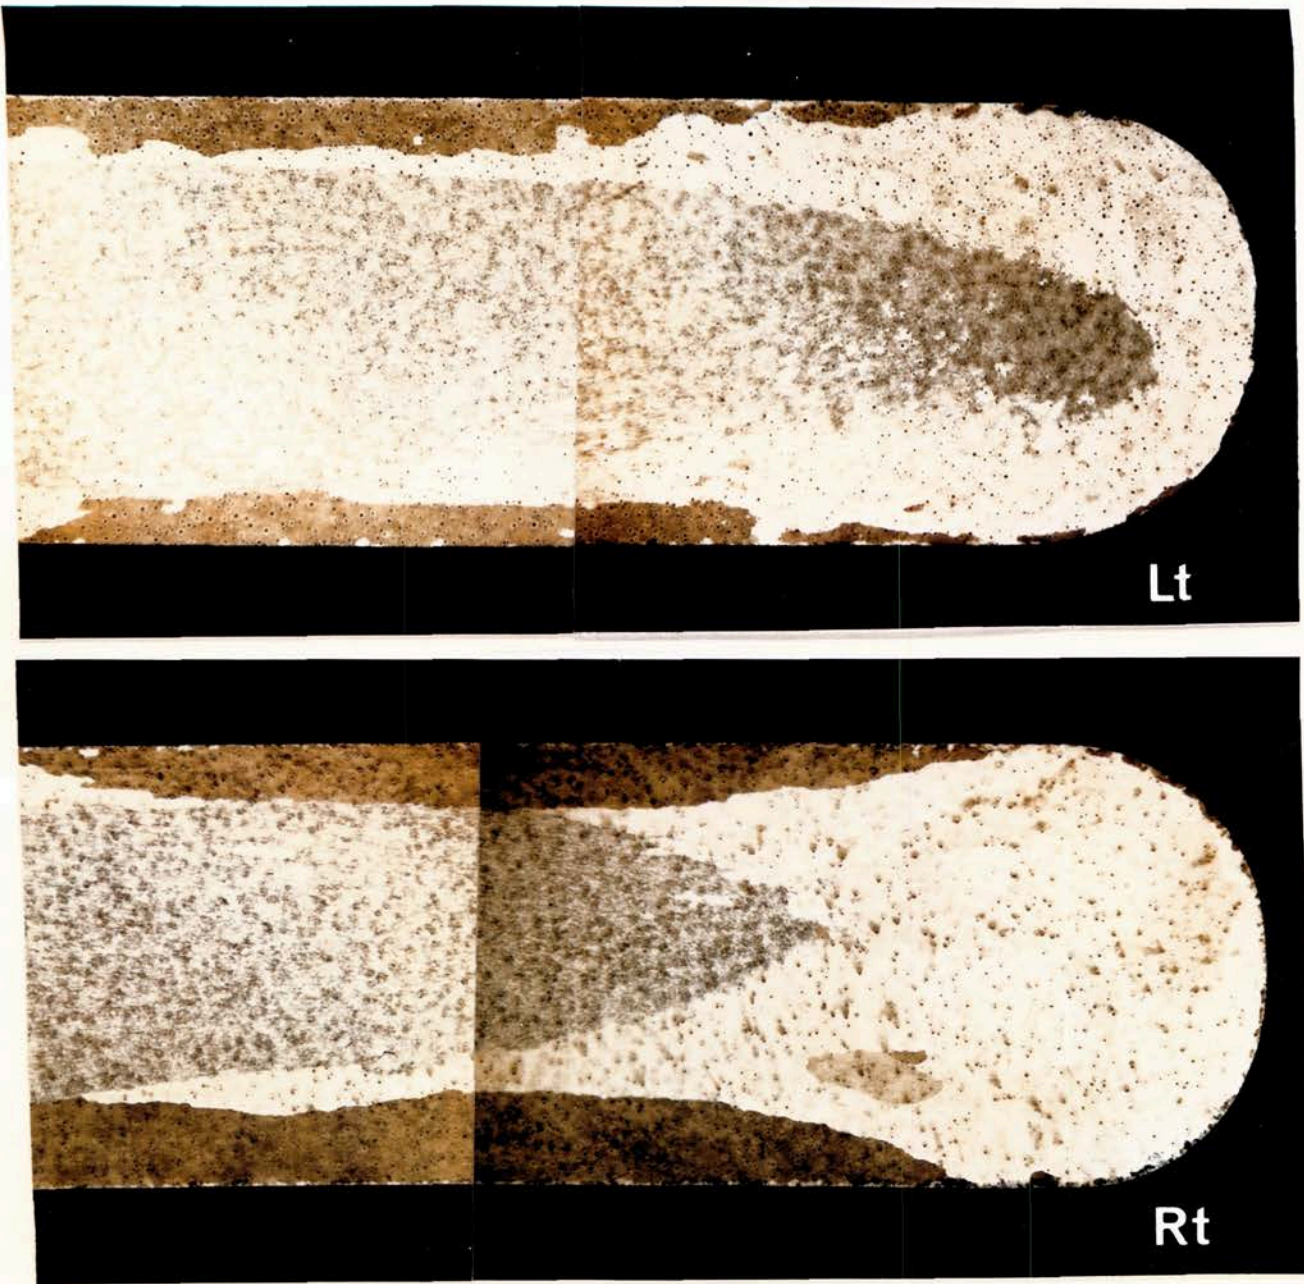
Additional metallographic specimens were prepared from the inboard portions of the left and right wing lower spar caps for microstructure examination. The microstructures shown in figure 8 are from the forward flanges of the spar caps approximately 1.25 inches inboard of the respective fractures. Again, these specimens exhibited a microstructure typical of an aluminum alloy extrusion. Further, the microstructures appeared to be consistent with the specified material and temper, 2024-T3511.

Figure 8. Micrographs of the left and right lower spar caps showing the typical microstructure. Keller's Reagent etch. (6.4X mag.)

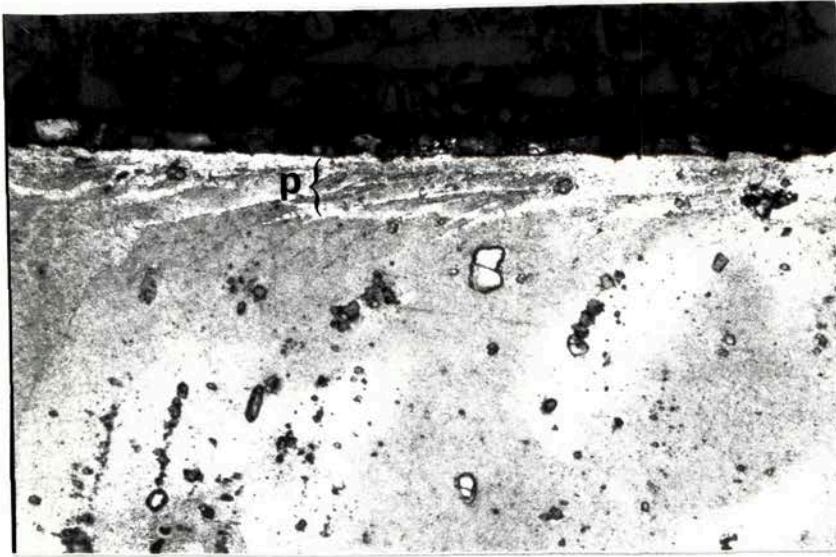
A microsection was also prepared through the left wing lower spar cap aft outboard bolt hole at the fracture plane. This section revealed a layer of plastic deformation adjacent to the bolt hole surface, as denoted by brackets "P" as in figure 9.

Figure 9. Micrograph showing the metal flow layer, bracket "P" adjacent the left wing spar outboard aft attachment bolt hole.

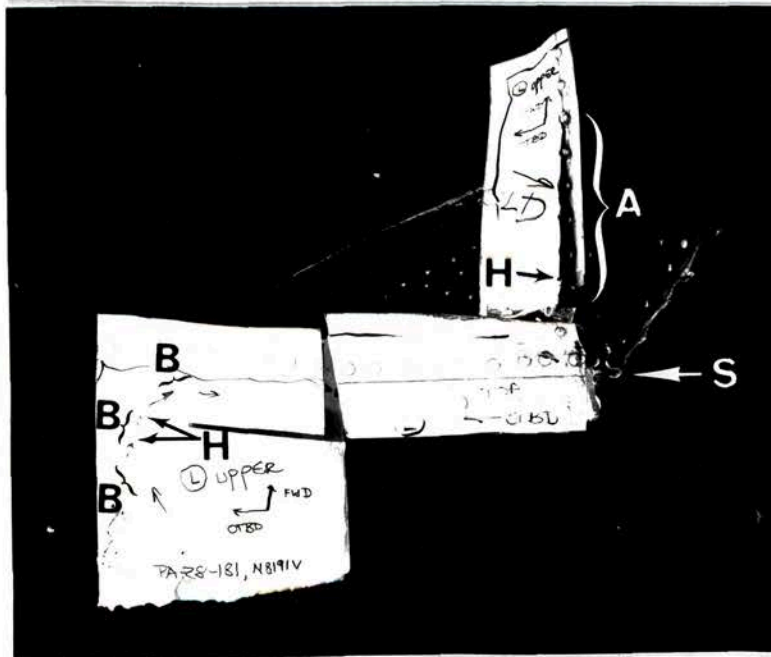
Two portions of the left wing upper skin were received separate from the spar assembly section. Figure 10 shows the location of the two skin pieces in relation to the spar. The skin piece forward of the spar at the wing root area contained a 5.6 inch long crack (see bracket "A", figure 10) between 6 rivets attaching the upper skin to the most inboard wing rib. The outboard aft wing skin section was cracked at three locations adjacent to three skin to second inboard wing rib rivets. These cracks are identified in figure 10 by brackets "B".

At both cracking locations, there were non-original manufacture holes drilled through the skins at the locations of the cracks, as if the cracks had been "stop drilled" (see arrows "D" in figure 10).

along the crack plane indicate the overall crack was formed by the intersections of six independent fatigue cracks. The independent cracks appeared to have initiated on the upper surface of the skin under the edges of the rivet heads.

Examinations of the crack faces from the outboard aft skin cracks (brackets "B") also identified fatigue progressions features. As with the inboard cracks, the fatigue cracks were determined to have initiated on the upper surface of the skin under the manufactured heads of the rivets.

Figure 10. View of the additional upper skin pieces with the cracks at brackets "A" and "B". Stop drill holes at arrows "H" and spar at arrow "S".
