# National Transportation Safety Board

## GEAR BOX EXAM FACTUAL REPORT

ERA14LA130

Vehicle: Victor M Cordero, RV-9A, S/N 90319, N19VC, Experimental Amateur Built

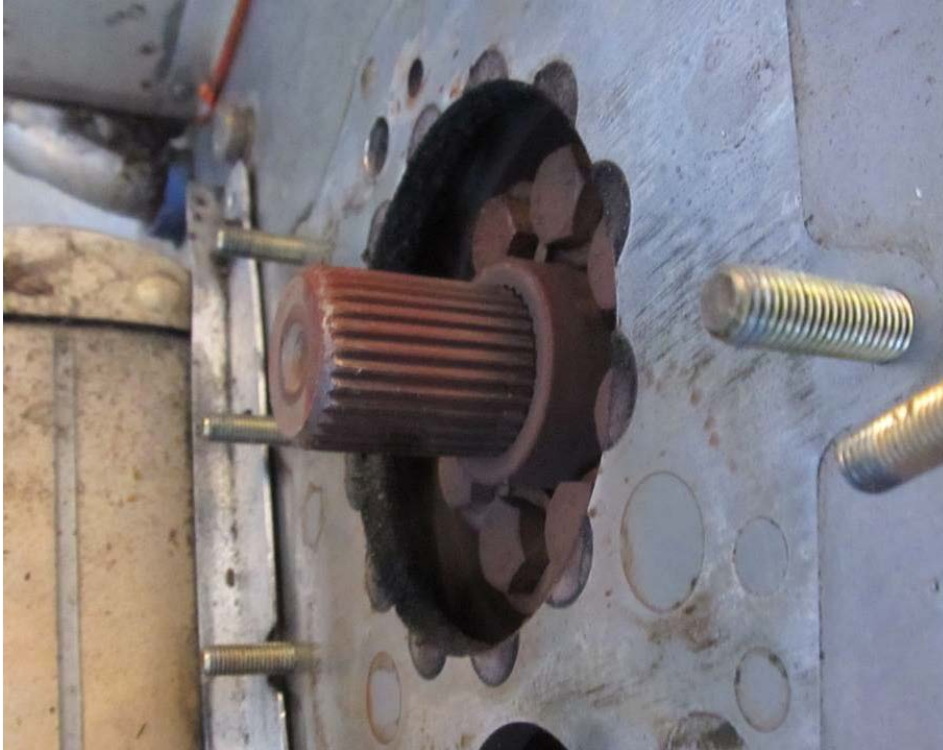
Upon disassembly of the spline shaft from the PRSU, approximately one teaspoon of red dust (consistent with ferrous fretting-wear debris) was observed in the cavity of the PRSU input spline. Examination of the spline shaft and drive disk adapter using a 5X to 50X stereo zoom microscope revealed the flanks of the spline shaft teeth that mate with the drive disk adapter were worn by about 75%, with the tips of the teeth forming sharp cusps that had been bent over consistent with rotation of the spline shaft within the drive disk adapter. Wear surface features on the spline shaft teeth were consistent with fretting wear that had progressed to adhesive wear.

**Photo 3 – The spline shaft is inserted into the drive disk adapter. A puller was used to remove the spline shaft and bearing. Red dust coated the spline shaft. Much of the dust could be picked up with a magnet. Examination indicated that the dust was the consistent with fretting corrosion.**

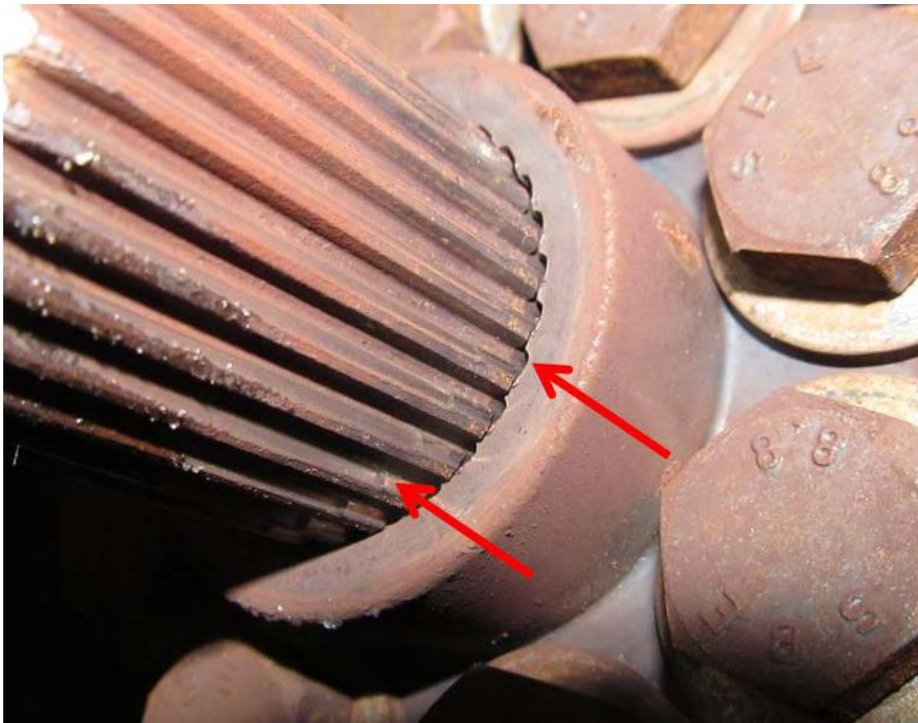
The grooves in the drive disk adapter were worn such that the wall between grooves was thinned by more than 75%, forming sharp cusps that had been bent over consistent with rotation of the spline shaft within the drive disk adapter. Wear surface features on the groove surfaces of drive disk adapter were consistent with fretting wear that had progressed to adhesive wear.

Examination of the spline shaft teeth that mate with the PRSU input spline using a 5X to 50X stereo zoom microscope revealed the flanks of the spline shaft teeth were worn by more than 25%. Wear surface features on the spline shaft teeth were consistent with fretting wear that had progressed to adhesive wear.

**Photo 4 – There is more than 25% wear of the teeth on the PSRU end of the spline (left arrow). There is more than 75% wear of the walls on the drive disk adapter (right arrow).**

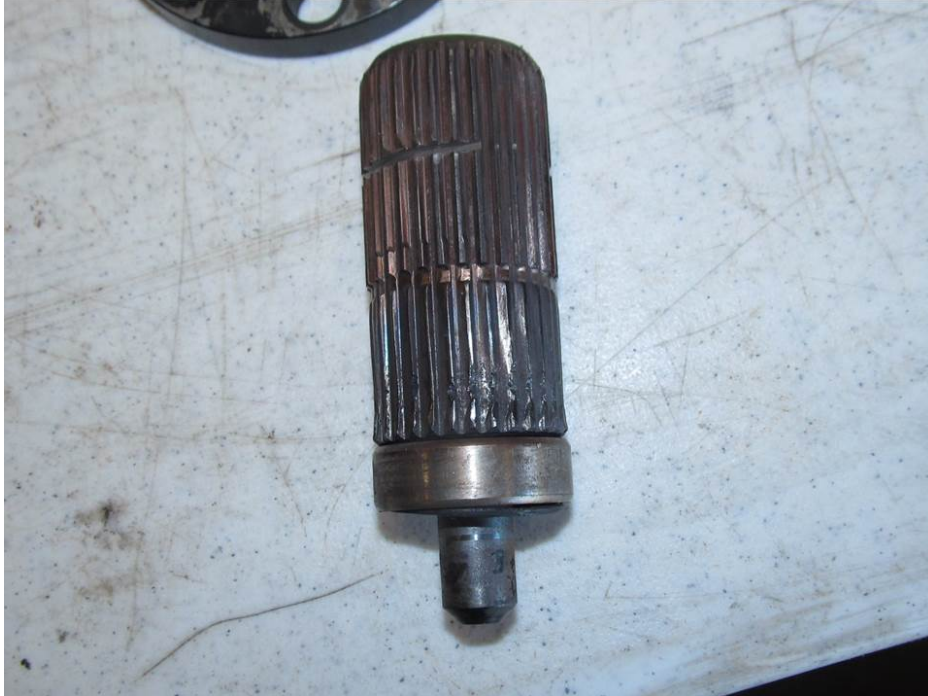
Examination showed that the splined components were free of lubrication and severely worn. At the engine end of the spline components, the spline shaft teeth and the walls of the drive disk adapter grooves were worn to the point that the spline shaft would rotate freely within the adapter. The remaining material bent over at the tips of the thinned spline teeth and thinned walls.

**Photo 5 –There was direct mechanical damage and more than 75% wear of the spline teeth on the engine end of the spline shaft. The tips of the spline teeth were rolled over. The cuts on the PSRU-end of the drive shaft were made to facilitate the use of a puller. There is more than 25% wear of the spline teeth on the PSRU end of the spline shaft.**

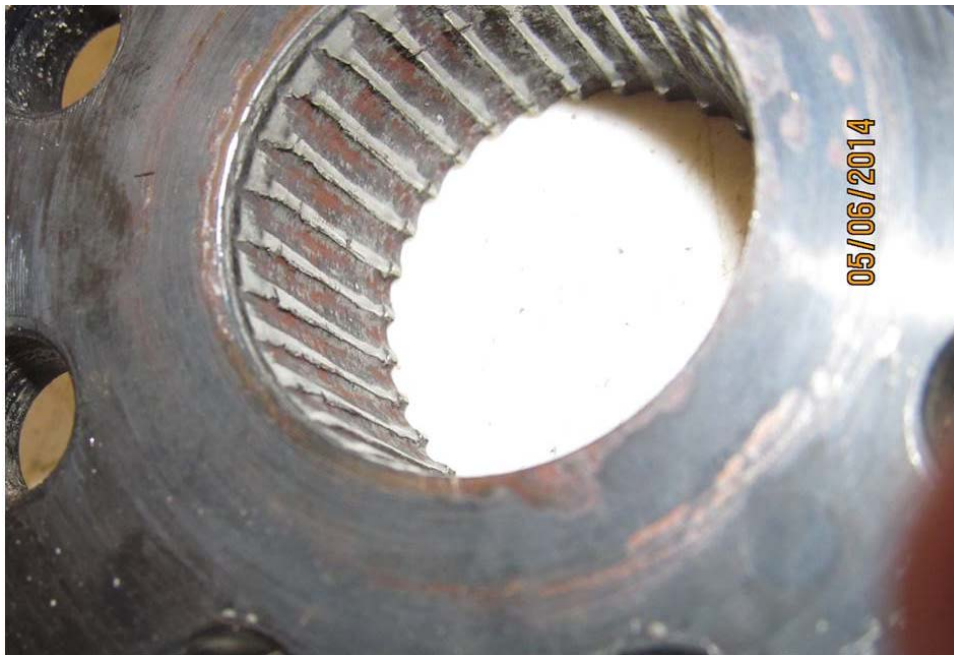
**Photo 6 –There was over 75% wear of the walls on the drive disk adapter. The tips of the walls were bent over.**

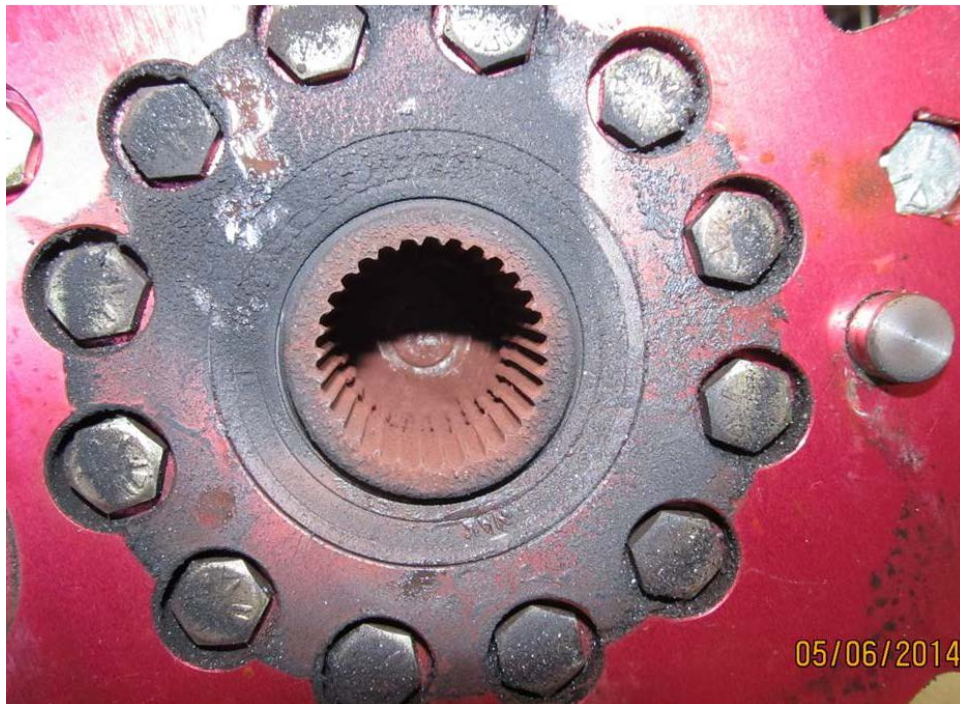
Further examination showed similar, but less severe wear at the PSRU end of the spline components. The PSRU input spline grooves were worn such that the widths of the walls between grooves were 40% less than the original width. The spline teeth on the PSRU-end of the spline shaft were worn such that the thicknesses of the teeth were more than 25% less than the original thickness. The spline shaft would wobble when inserted into the PSRU input spline. There was free play when the spline shaft was rotated while inserted into the input spline.

**Photo 8 – The PSRU input spline groove walls are severely worn. There was about 1 teaspoon of red dust in the cavity. The presence of red dust is consistent with fretting wear.**
