National Transportation Safety Board

SPLINE WEAR MEASUREMENTS REPORT

ERA14LA130

Vehicle: Victor M Cordero, RV-9A, S/N 90319, N19VC, Experimental Amateur Built

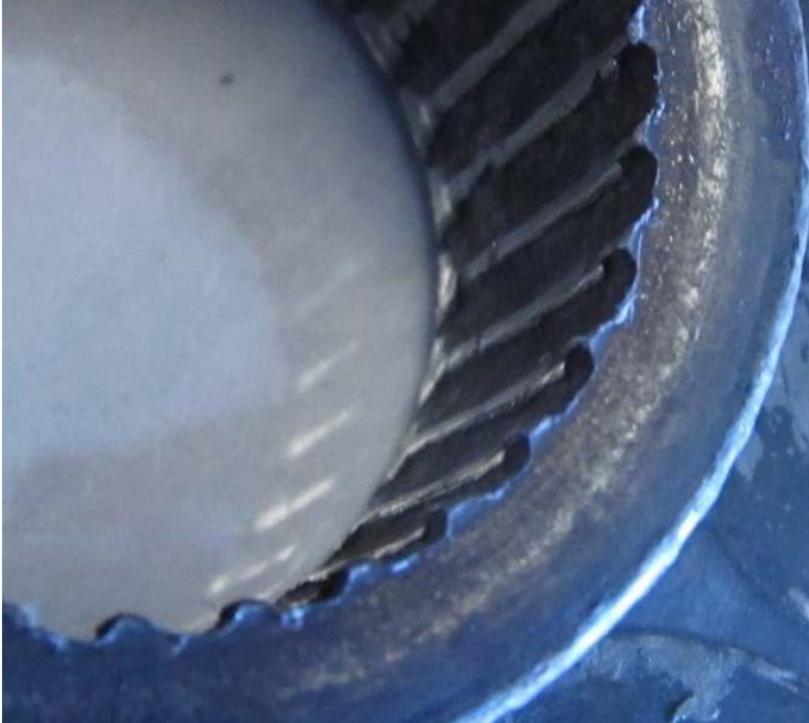
Examination showed that, at the engine end, the spline shaft teeth and the walls of the drive disk adapter grooves were worn to the point that the spline shaft would rotate freely within the adapter. The remaining material rolled over at the tips of the thinned spline teeth and thinned walls.

Photo 1 – Drive Disk Adapter - The thicknesses of the walls between the spline grooves on the drive disk adapter were reduced by more than 75% due to wear. The remaining thinned-edges of the groove walls were bent over due to rotation of the spline shaft within the drive disk adapter.
