## **FACTUAL REPORT OF INVESTIGATION**

**Naperville, IL; 1/27/2014  
HWY14FH002**

**NATIONAL TRANSPORTATION SAFETY BOARD  
OFFICE OF HIGHWAY SAFETY  
WASHINGTON, D.C.**

NTSB #: **HWY14FH002**

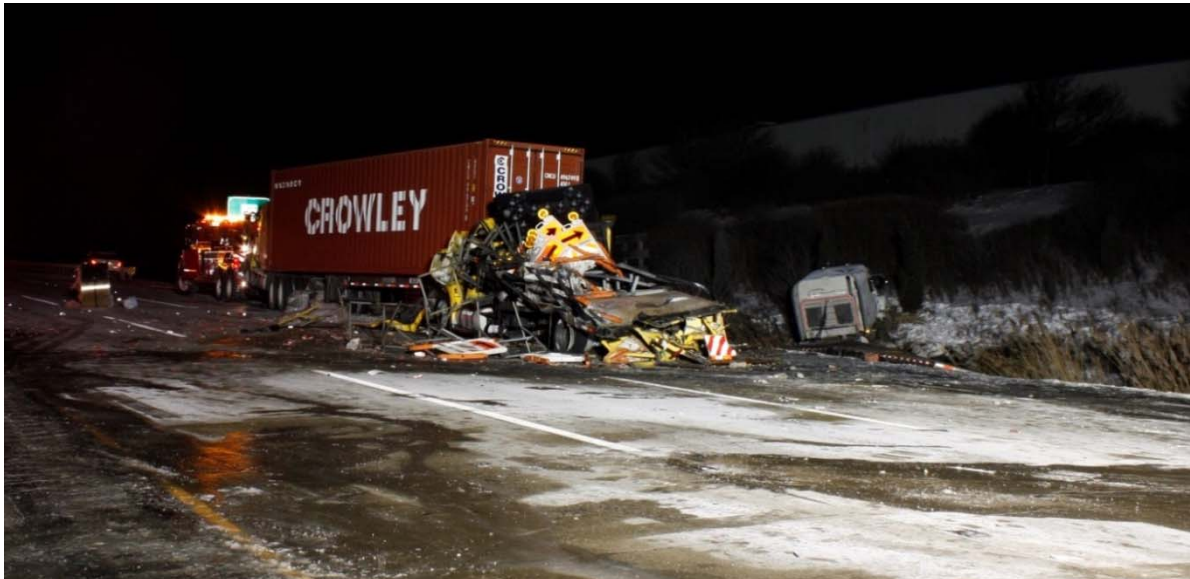
**Figure 1.** Accident scene view looking east showing the heavy duty tow truck, disabled intermodal combination vehicle, and the ISTHA HELP truck at final rest in the right lane of eastbound I-88. The 2004 Freightliner combination can be seen off in the right ditch

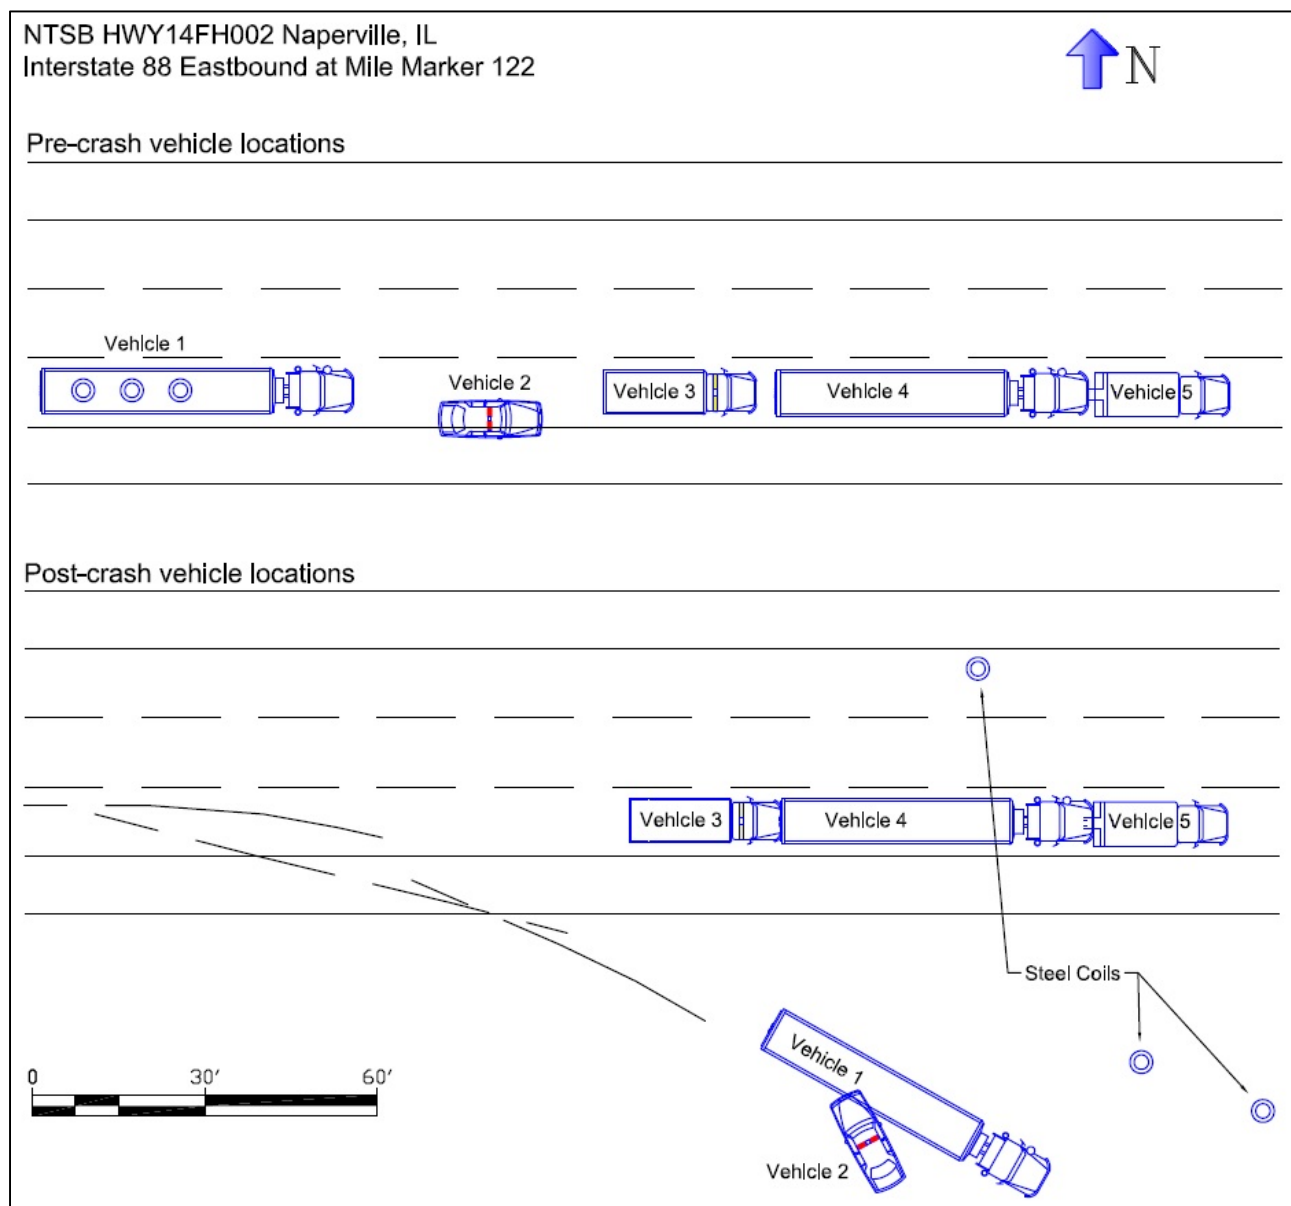
The Illinois State Police documented the accident scene and noted only post-crash tire marks from the Freightliner combination vehicle in the right lane of the interstate. The tire marks continued into the right shoulder and ditch to where the Freightliner combination vehicle and ISP patrol car came to rest. **Figure 1** below shows an eastbound view of the accident scene. **Figure 2** is a set of scene diagrams showing the pre-crash and post-crash locations of the accident vehicles.

**Figure 2.** Scene diagrams showing the pre-crash and post-crash locations of the accident vehicles.
